# SIR FREDERICK MESSER - SEVEN SISTERS

## LANDSCAPE MANAGEMENT PLAN

**Sir Frederick Messer Estate,  
Haringey – BS 5837:2012  
Arboricultural Report and  
Impact Assessment  
Oobe Ltd**

**Report Title:** Sir Frederick Messer Estate, Haringey – BS 5837:2012  
Arboricultural Report and Impact Assessment

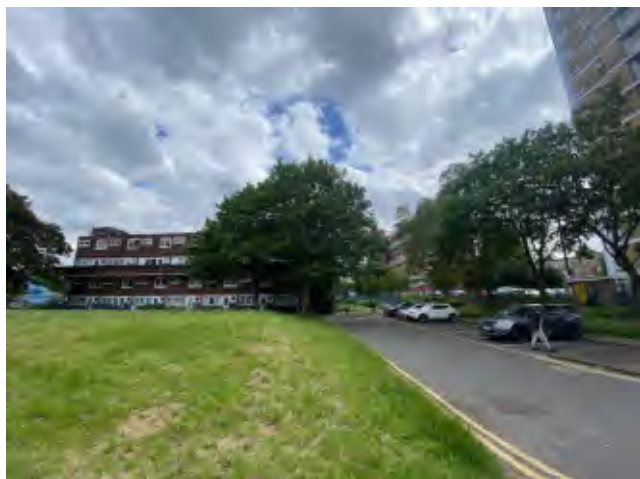
**Plate 1:** T047 to T054 looking east.

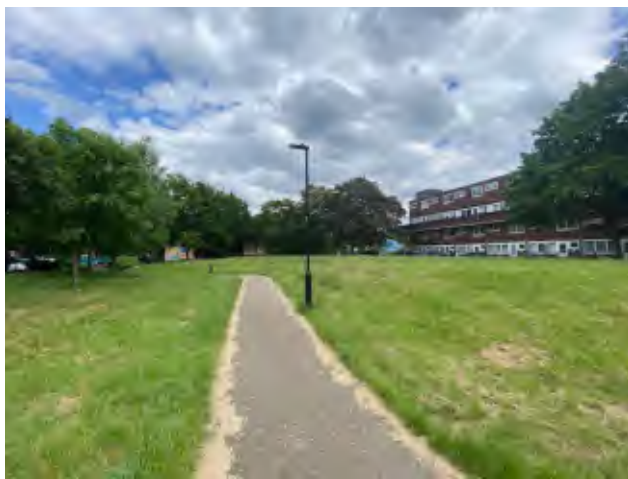
**Plate 2:** Looking northeast – T035 to the left, T036 to T046 beyond

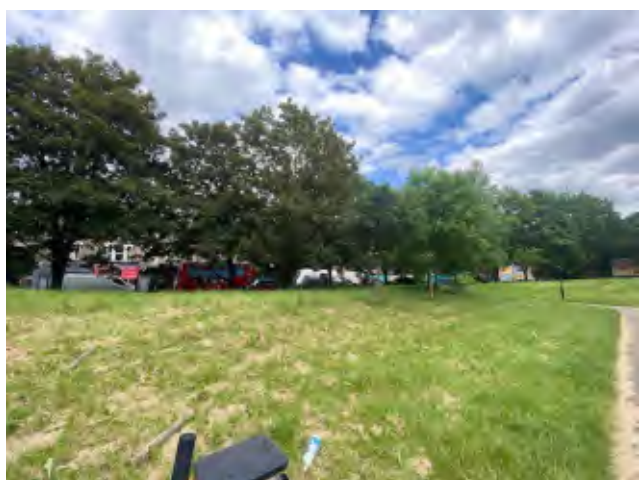
**Plate 3:** Looking north – T023 to T035

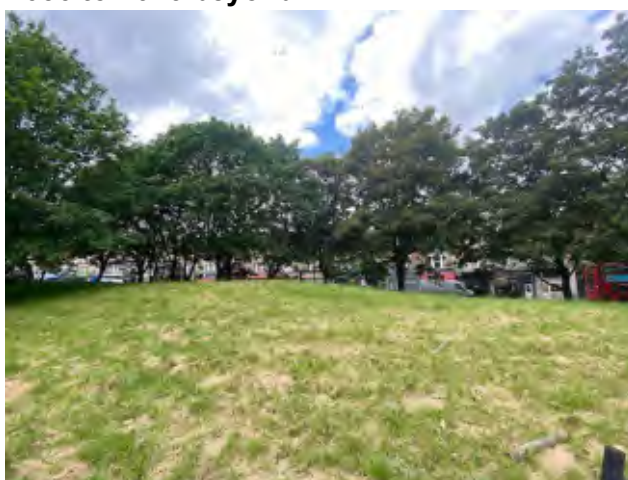
**Plate 4:** Looking west – T020 to T022

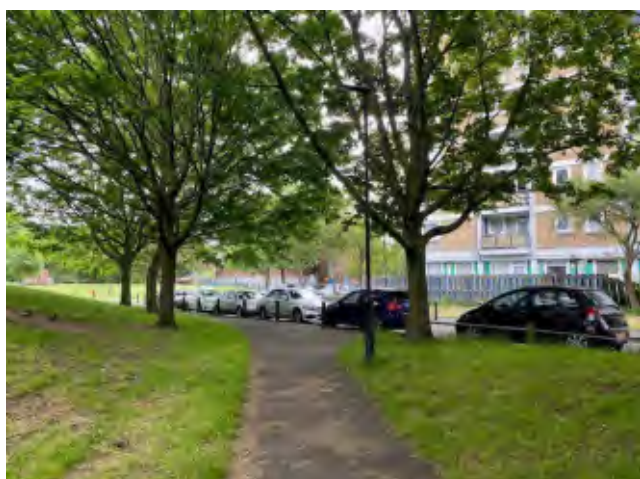
| Tree No. | Species | Height (m) | No. of Stems | Stem Dia. @ 1.5m (mm) | Crown Spreads (m) | | | | Height of Crown Clearance (m) | Age Class | SLE | Overall Condition | Comments | Management | Category | RPA Radius (m) | RPA Area (m <sup>2</sup> ) |
|---|---|---|---|---|---|---|---|---|---|---|---|---|---|---|---|---|---|
| T013 | Norway maple<br>( <i>Acer platanoides</i> ) | 16 | 1 | 450 | 6 | 6 | 6 | 6 | 2.5 | Early Mature | 20+ Years | Fair | Longitudinal cavity on northwest side of stem from historical branch tear showing moderated decay and good wound closure. Soil erosion at base with exposed surface roots. Minor to moderate deadwood currently presents a low risk. Ground clearance over road currently 2 metres. | Fell to ground level to facilitate the development. | C1 | 5.4 | 92 |

**Plate 5:** Looking northeast – T005, T012 to T014

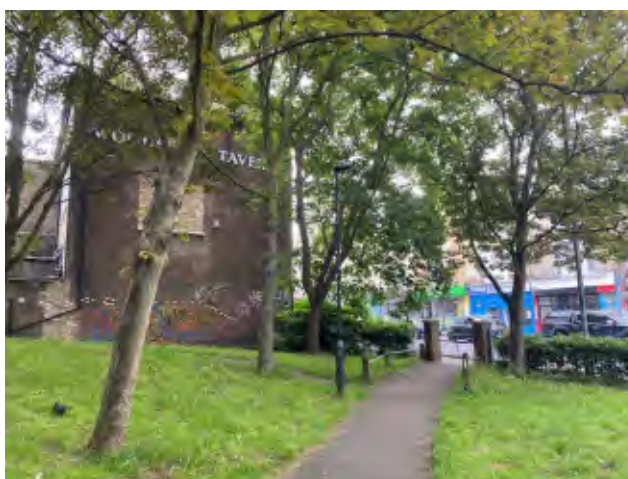
| Tree No. | Species | Height (m) | No. of Stems | Stem Dia. @ 1.5m (mm) | Crown Spreads (m) | | | | Height of Crown Clearance (m) | Age Class | SLE | Overall Condition | Comments | Management | Category | RPA Radius (m) | RPA Area (m <sup>2</sup> ) |
|---|---|---|---|---|---|---|---|---|---|---|---|---|---|---|---|---|---|
| T010 | Sycamore<br>( <i>Acer pseudoplatanus</i> ) | 15 | 1 | 320 | 6 | 5 | 3 | 4 | 4 | Early Mature | 20+ Years | Fair | Slight lean north. Old pruning wounds exhibiting closure and minor deadwood to lower crown. Minor pocket cavities throughout stem. Limited rooting area to north from footpath.<br>Acceptable condition at present. | | B2 | 3.8 | 45 |

**Plate 6:** Looking west, T008 to T010 & T015

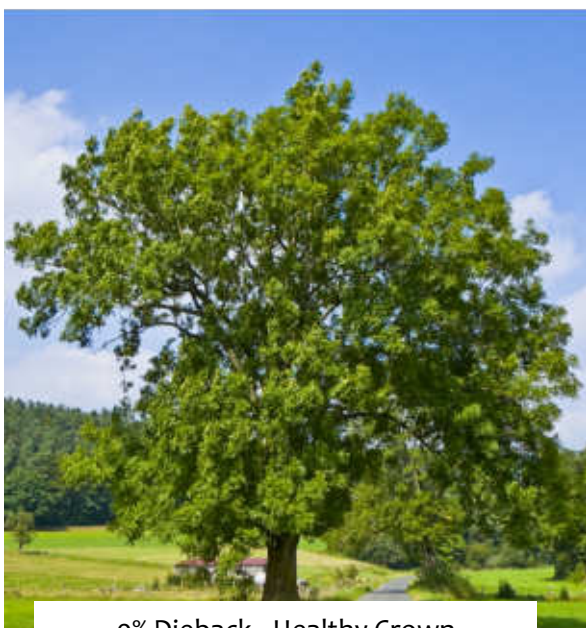
0% Dieback - Healthy Crown

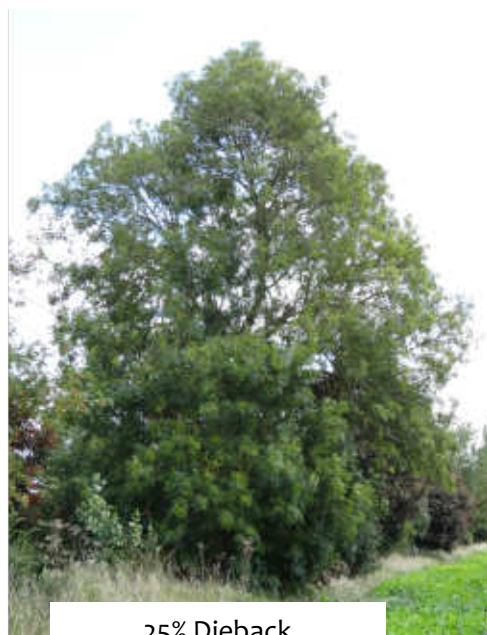
25% Dieback

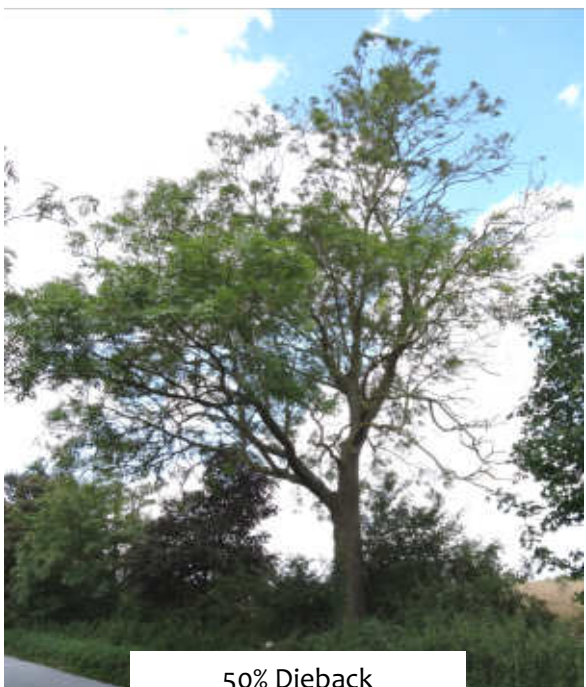
50% Dieback

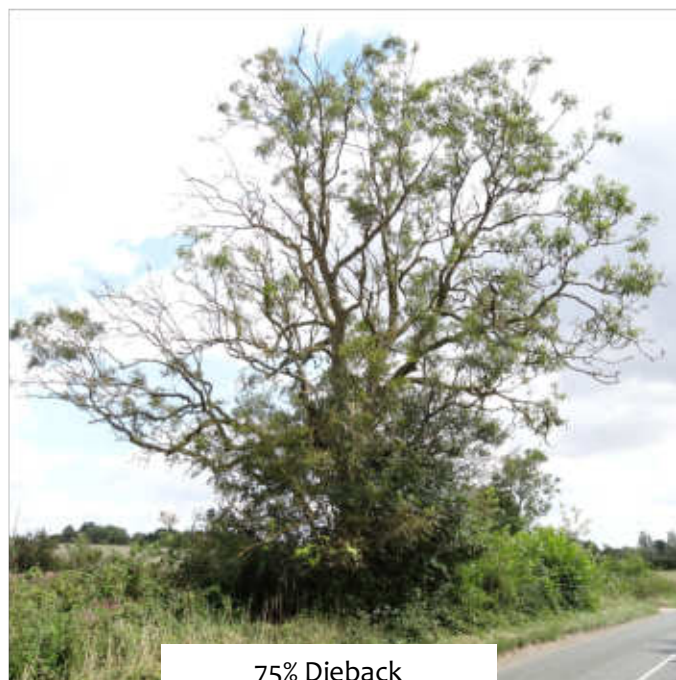
75% Dieback
