# Window Condition Survey Report

**Albion Lodge,  
Fortis Green,  
London,  
N2 9EP**

**4 FEBRUARY 2026**

**Heritage Window Consultancy Ltd**

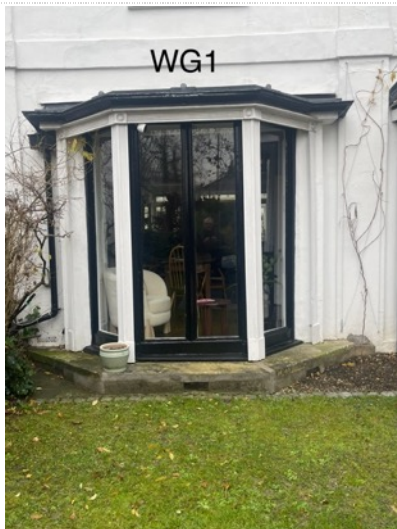
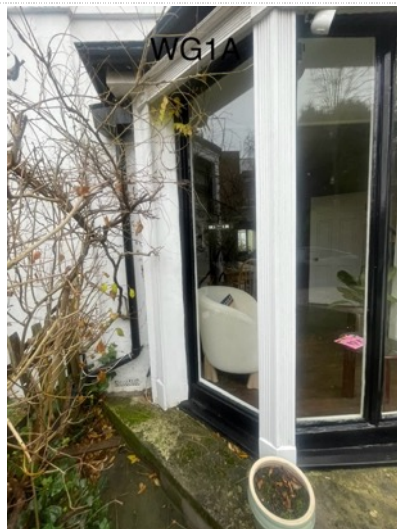
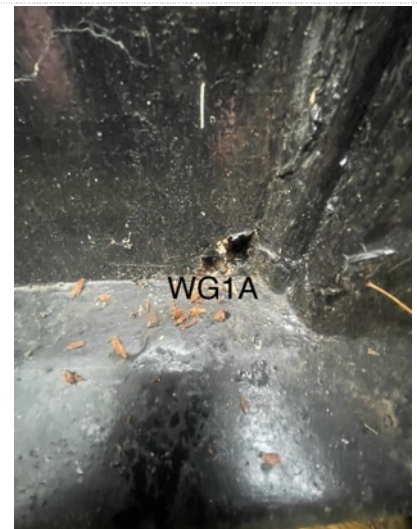
**Condition:** The window is in fair condition overall.

**Repair Assessment:** Minor repairs are required, including the removal of localised areas of decayed timber evident to the bottom rail.

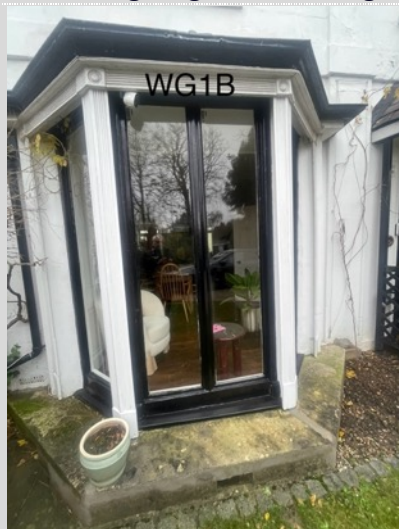
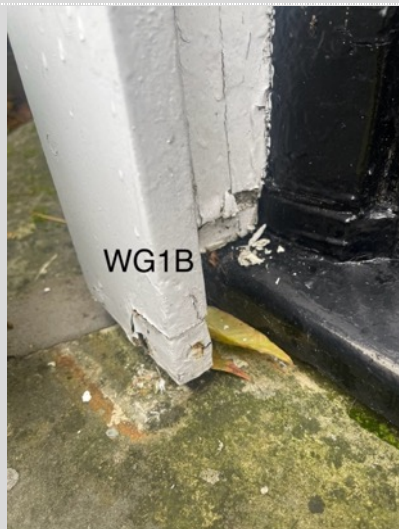
## WG1B

**Condition:** Fair

**Repair Assessment:** Minor repairs are required. Remove areas of rotten timber evident to the bottom rail section.

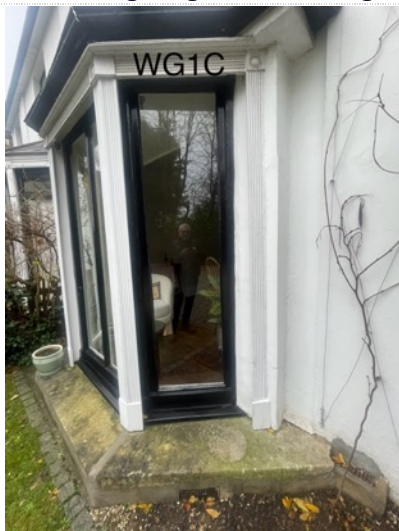
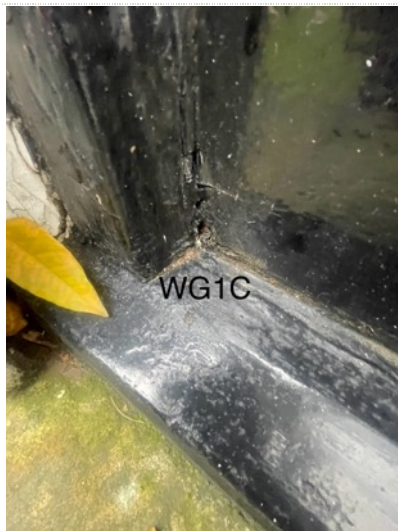
## WG1C

**Condition:** Fair

**Repair Assessment:** Minor repairs are required. Remove areas of rotten timber evident to the bottom rail section.

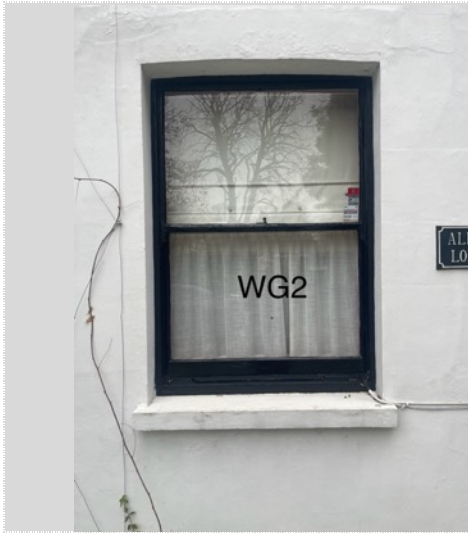
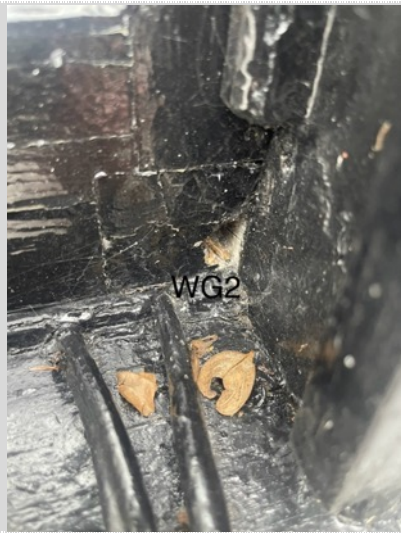
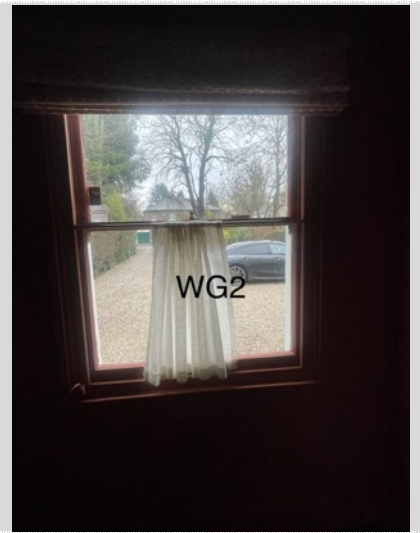
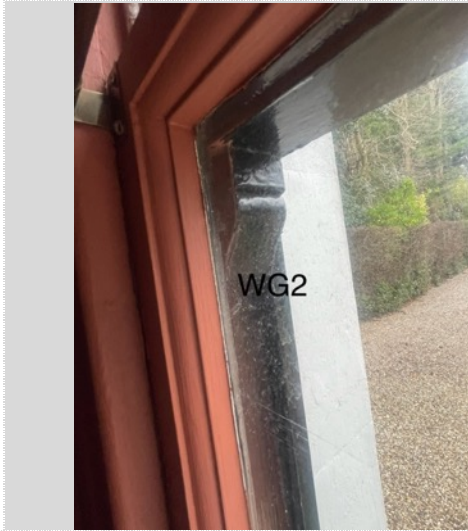
## WG2

**Condition:** Overall fair. Localised decay is present to the bottom rail of the bottom sash, with evidence of poorly executed past repairs and associated loss of historic fabric.

**Repair Assessment:** Repair has been fully considered; however, due to inappropriate previous repairs and the loss of historic fabric, the sashes are considered beyond viable repair.

The proposals result in less than substantial harm, mitigated by the retention of the significant C19 sash box and the replacement of inappropriate sashes with accurate replicas. The works deliver clear conservation and thermal performance benefits.

- Retain and refurbish the existing C19 sash box.
- Replace both sashes with faithful timber replicas, matching the existing one over one configuration and incorporating appropriate C19 horn detailing.
- Incorporate heritage slimline double glazing and discreet integrated draught-proofing.
- Full external redecoration of the sash box.

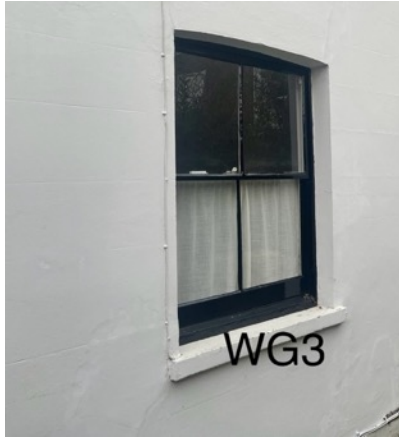
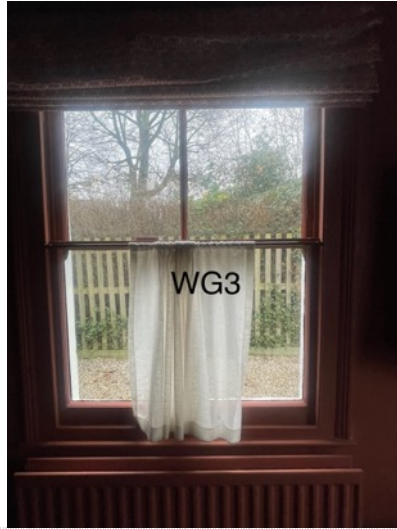
### WG3

**Condition:** The sash box and both sashes are in fair overall condition. The sash box retains historic fabric and detailing, while the sashes show evidence of alteration and replacement.

**Repair Assessment:** Repair has been fully considered. However, both sashes have been replaced, as evidenced by the use of 25mm ovolo glazing bars, which are not characteristic of early to mid C19 profiles. As such, repair of the existing sashes would not result in a meaningful conservation outcome, nor would it reinstate appropriate historic detailing.

- Retain and refurbish the existing C19 sash box.
- Replace both sashes with faithful timber replicas, based on the existing configuration and proportions, and incorporating appropriate C19 horn detailing consistent with the historic character of the property.
- Incorporate heritage slimline double glazing within the replacement sashes to improve thermal performance while maintaining historic appearance.
- Install discreet, integrated draught-proofing to improve comfort and operational performance.
- Undertake full external redecoration of the sash box.

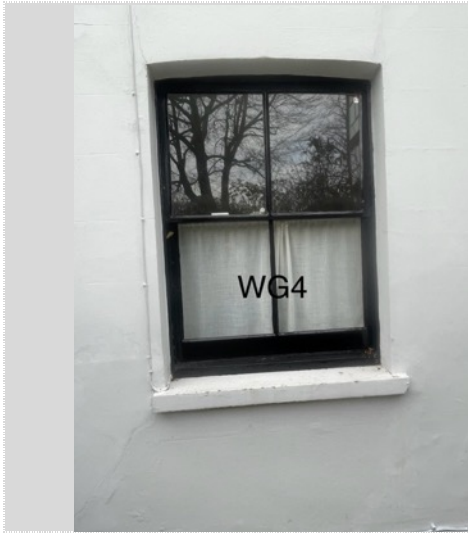
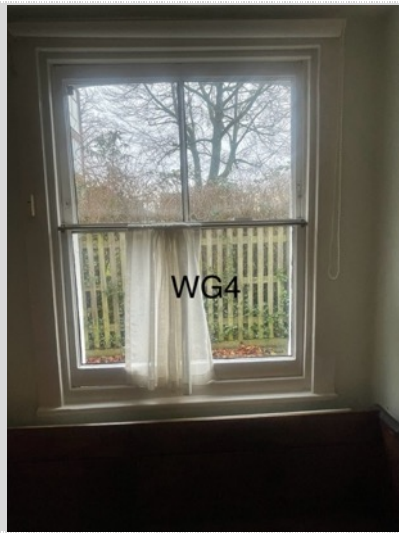
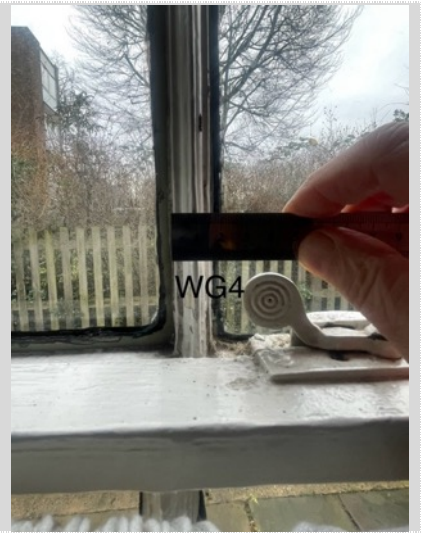
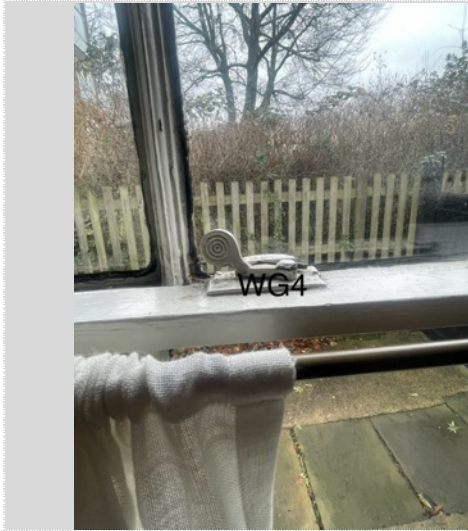
## WG4

**Condition:** The sash box and both sashes are in fair overall condition and retain a high proportion of historic fabric and detailing. Crown glass is evident within the bottom left-hand pane of the lower sash.

**Repair Assessment:** Repair has been fully considered and, given the survival of historic fabric and glazing, is considered the most appropriate and conservation-led approach.

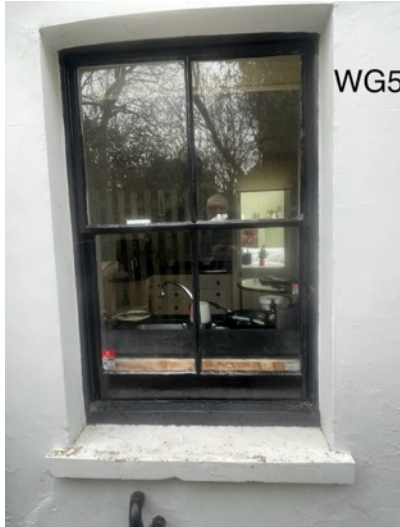
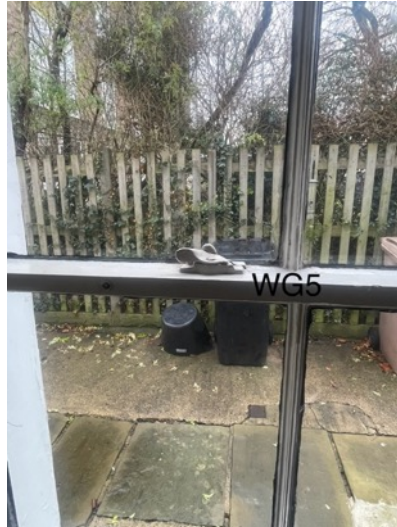
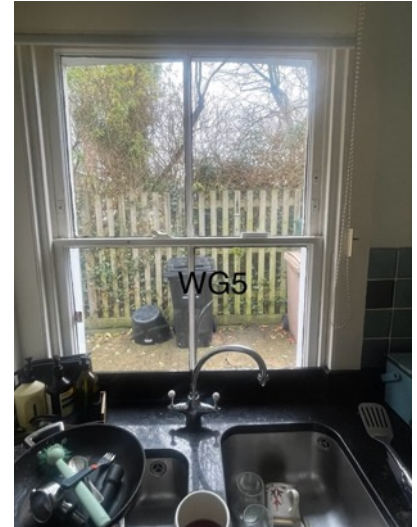
## WG5

**Condition:** The sash box and both sashes are in fair overall condition and retain a high proportion of historic fabric and detailing. Crown glass is evident.

**Repair Assessment:** Repair has been fully considered and, given the survival of historic fabric and glazing, is considered the most appropriate and conservation led approach.

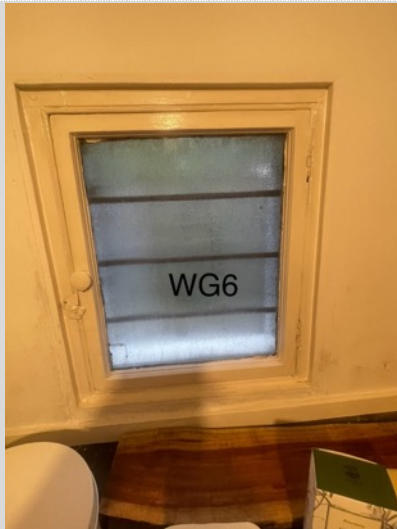
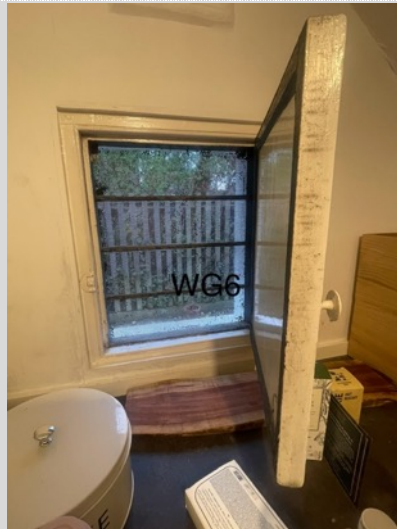
## WG6

**Condition:** The casement frame and casement are in fair overall condition and retain a high proportion of historic fabric and detailing.

**Repair Assessment:** Repair has been fully considered and, given the survival of historic fabric and glazing, is considered the most appropriate and conservation-led approach.

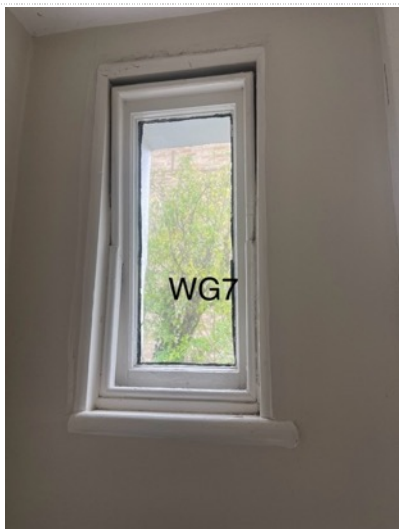
## WG7

**Condition:** The casement frame and casement are in fair overall condition and retain a high proportion of historic fabric and detailing.

**Repair Assessment:** Repair has been fully considered and, given the survival of historic fabric and glazing, is considered the most appropriate and conservation-led approach.

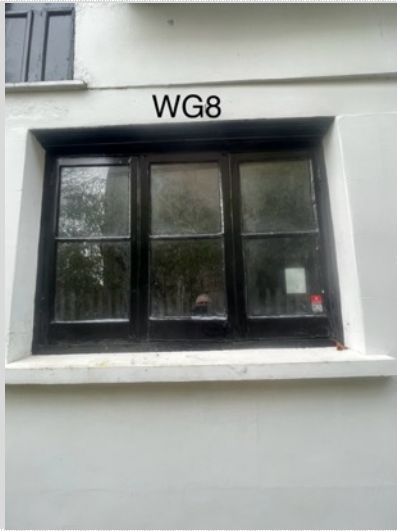
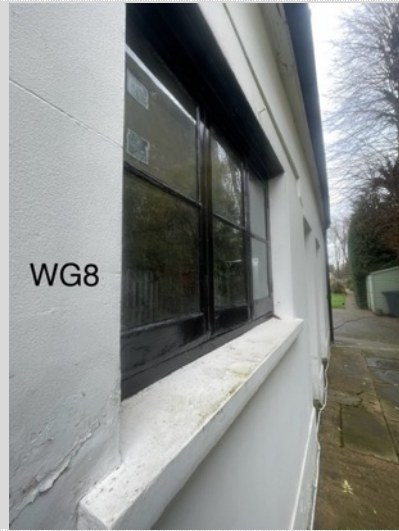
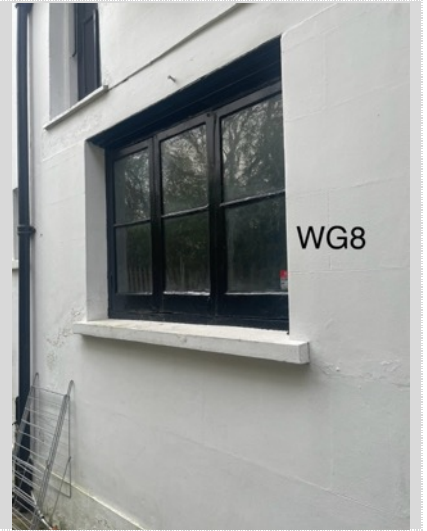
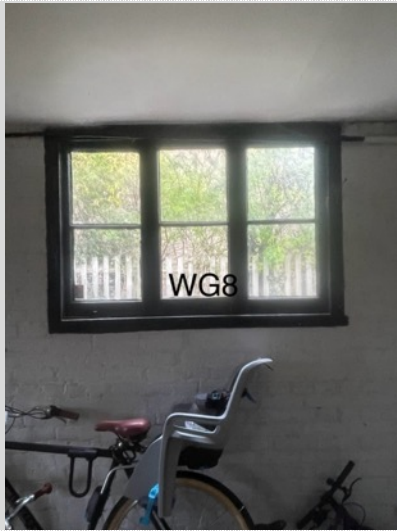
### WG8

**Condition:** The casement frame and casements are in fair overall condition and retain a high proportion of historic fabric and detailing.

**Repair Assessment:** Repair has been fully considered and, given the survival of historic fabric and glazing, is considered the most appropriate and conservation-led approach.

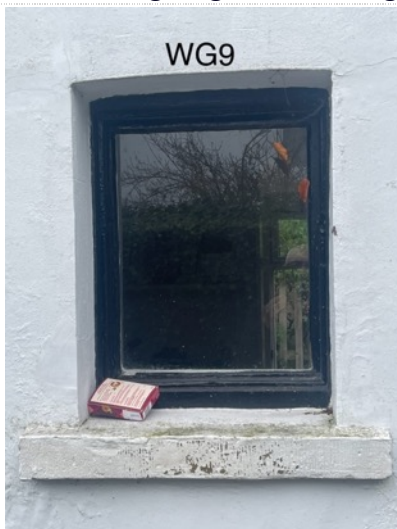
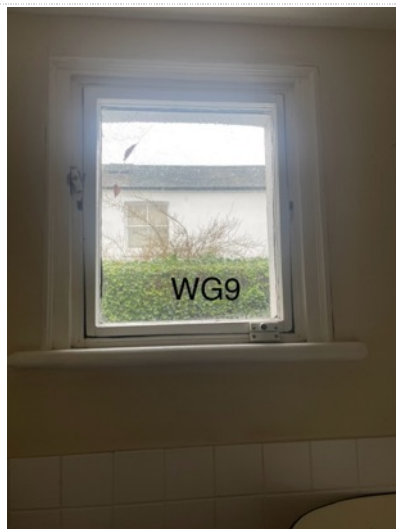
## WG9

**Condition:** The casement frame and casement are in fair overall condition and retain a high proportion of historic fabric and detailing.

**Repair Assessment:** Repair has been fully considered and, given the survival of historic fabric and glazing, is considered the most appropriate and conservation-led approach.

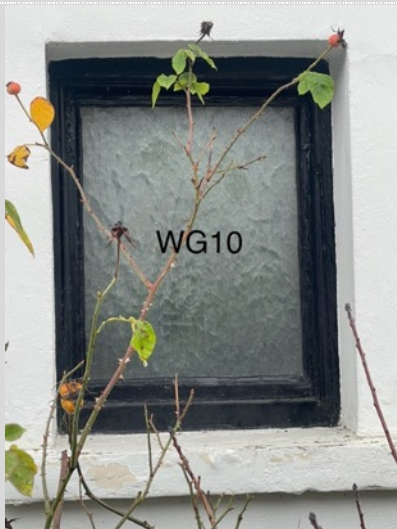
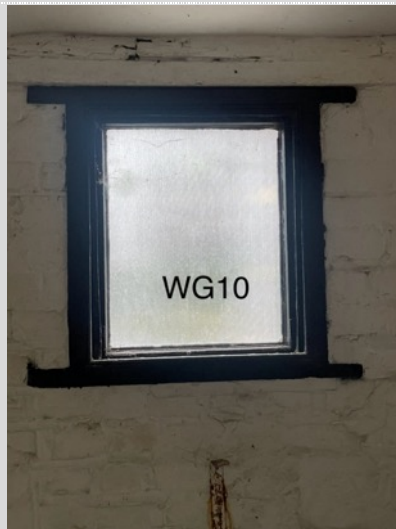
## WG10

**Condition:** The casement frame and casement are in fair overall condition and retain a high proportion of historic fabric and detailing.

**Repair Assessment:** Repair has been fully considered and, given the survival of historic fabric and glazing, is considered the most appropriate and conservation-led approach.

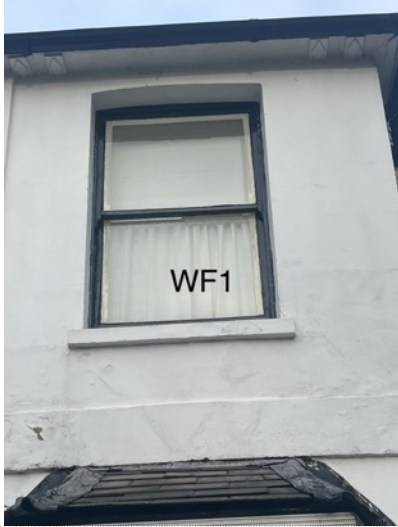
## WF1

**Condition:** The sash box and both sashes are in fair overall condition.

**Repair Assessment:** Repair has been fully considered and assessed.

- Retain and refurbish the existing C19 sash box.
- Replace both sashes with replica timber sashes and incorporate slimline heritage double glazing.
- Install discreet, integrated draught-proofing to improve comfort and performance.
- Undertake full external redecoration of the sash box.

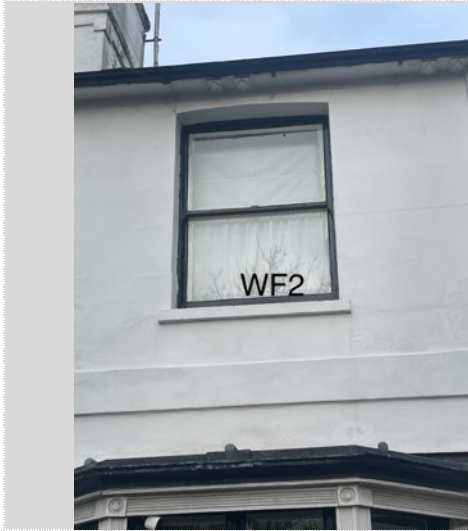
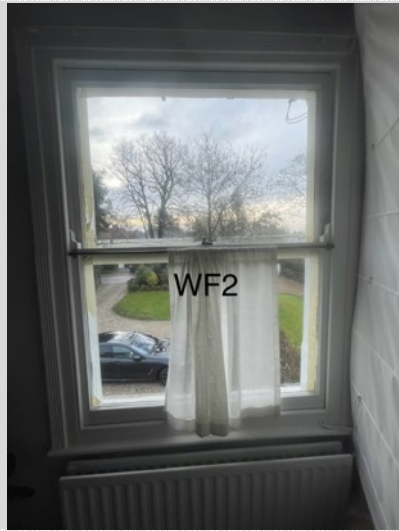
## WF2

**Condition:** The sash box and both sashes are in fair overall condition.

**Repair Assessment:** Repair has been fully considered and assessed.

- Retain and refurbish the existing C19 sash box.
- Replace both sashes with replica timber sashes and incorporate slimline heritage double glazing.
- Install discreet, integrated draught-proofing to improve comfort and performance.
- Undertake full external redecoration of the sash box.

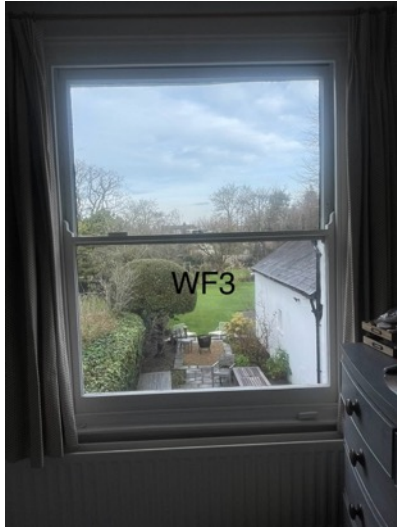
### WF3

**Condition:** The sash box and both sashes are in fair overall condition.

**Repair Assessment:** Repair has been fully considered and assessed.

- Retain and refurbish the existing C19 sash box.
- Replace both sashes with replica timber sashes and incorporate slimline heritage double glazing.
- Install discreet, integrated draught-proofing to improve comfort and performance.
- Undertake full external redecoration of the sash box.

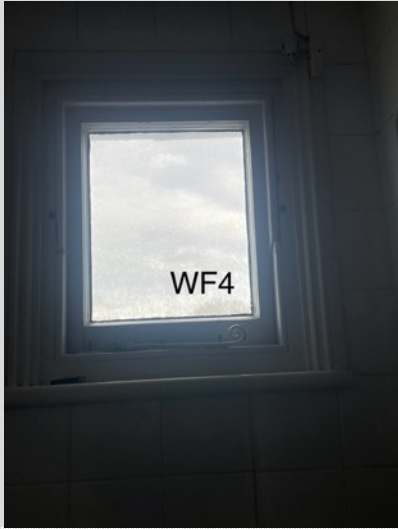
#### WF4

**Condition:** The casement frame and casement are in fair overall condition and retain a high proportion of historic fabric and detailing, including the monkey tail stay.

**Repair Assessment:** Repair has been fully considered and, given the survival of historic fabric and glazing, is considered the most appropriate and conservation-led approach.

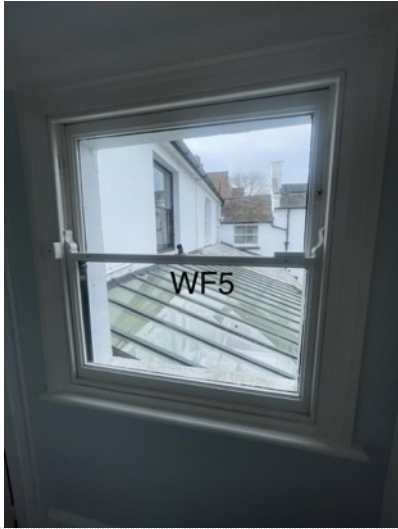
## WF5

**Condition:** The sash box and both sashes are in fair overall condition.

**Repair Assessment:** Repair has been fully considered and assessed.

- Retain and refurbish the existing C19 sash box.
- Replace both sashes with replica timber sashes and incorporate slimline heritage double glazing.
- Install discreet, integrated draught-proofing to improve comfort and performance.
- Undertake full external redecoration of the sash box.

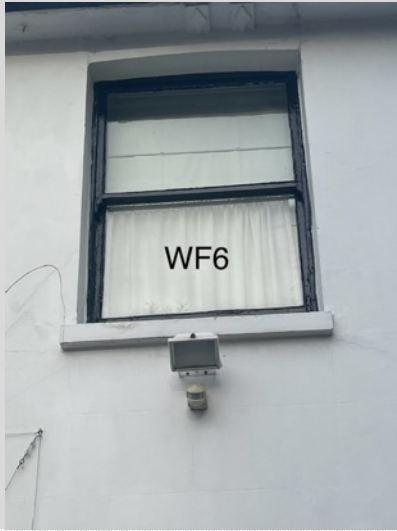
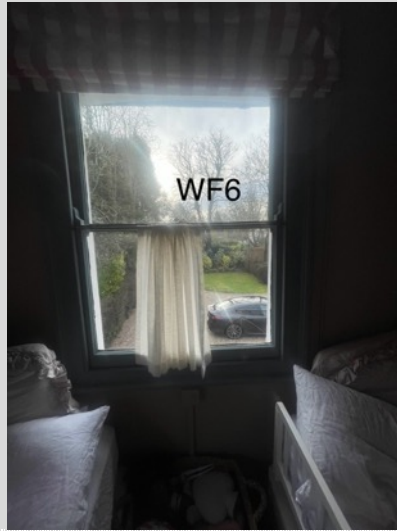
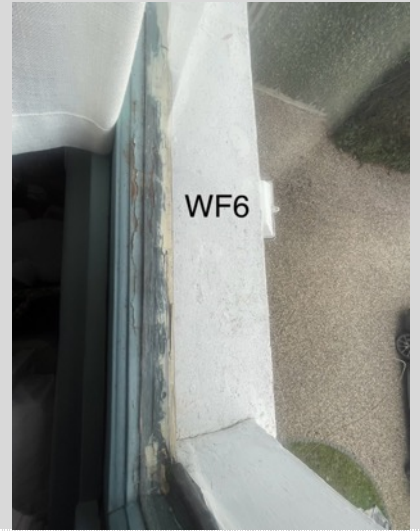
## WF6

**Condition:** The sash box requires restoration works, including replacement of the cill. Both sashes are in fair overall condition.

**Repair Assessment:** Repair has been fully considered and assessed.

- Retain and refurbish the existing Mid C19 sash box, including like-for-like replacement of the timber cill in a suitable hardwood, such as sapele.
- Replace both sashes with replica timber sashes and incorporate slimline heritage double glazing.
- Install discreet, integrated draught-proofing to improve comfort and performance.
- Undertake full external redecoration of the sash box.

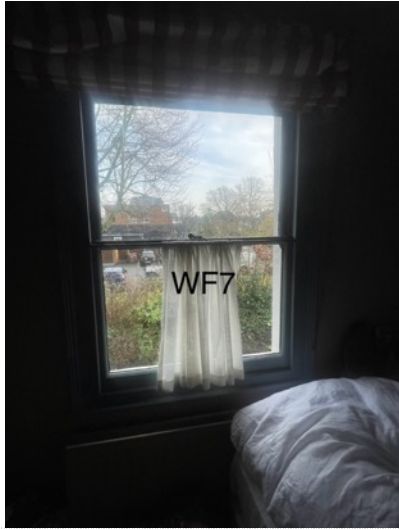
## WF7

**Condition:** The sash box and both sashes are in fair overall condition.

**Repair Assessment:** Repair has been fully considered and assessed.

- Retain and refurbish the existing Mid C19 sash box.
- Replace both sashes with replica timber sashes and incorporate slimline heritage double glazing.
- Install discreet, integrated draught-proofing to improve comfort and performance.
- Undertake full external redecoration of the sash box.

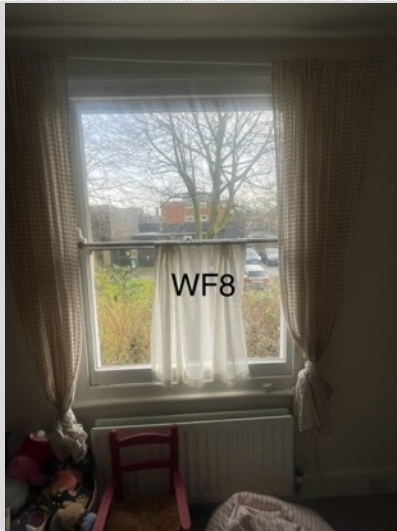
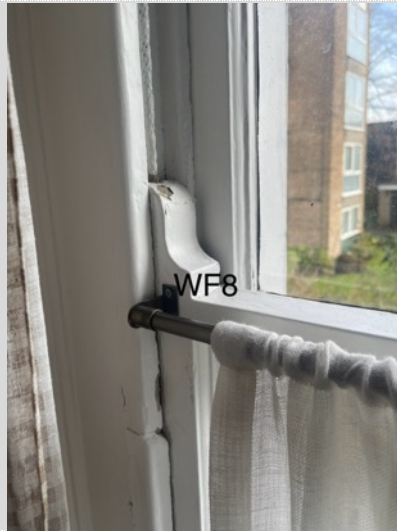
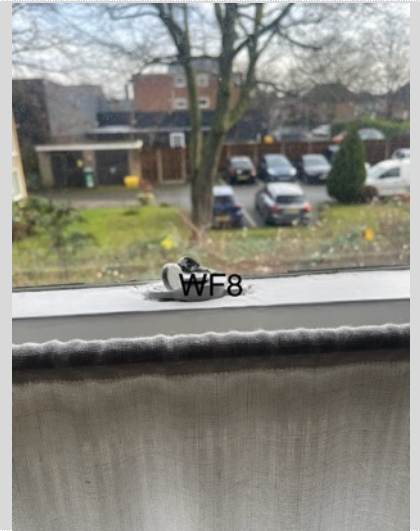
## WF8

**Condition:** The sash box requires restoration works, including replacement of the cill. Both sashes are in fair overall condition.

**Repair Assessment:** Repair has been fully considered and assessed.

- Retain and refurbish the existing Mid C19 sash box, including like-for-like replacement of the timber cill in a suitable hardwood, such as sapele.
- Replace both sashes with replica timber sashes and incorporate slimline heritage double glazing.
- Install discreet, integrated draught-proofing to improve comfort and performance.
- Undertake full external redecoration of the sash box.

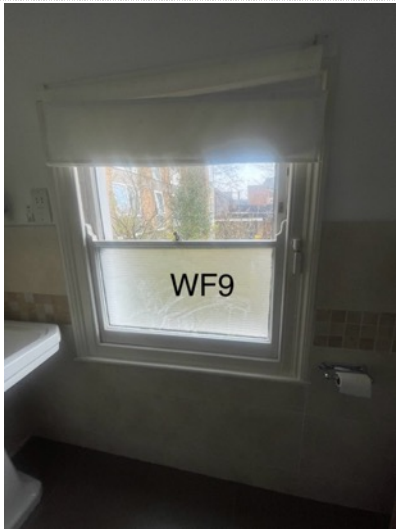
## WF9

**Condition:** The sash box requires restoration works, including replacement of the cill. Both sashes are in fair overall condition.

**Repair Assessment:** Repair has been fully considered and assessed.

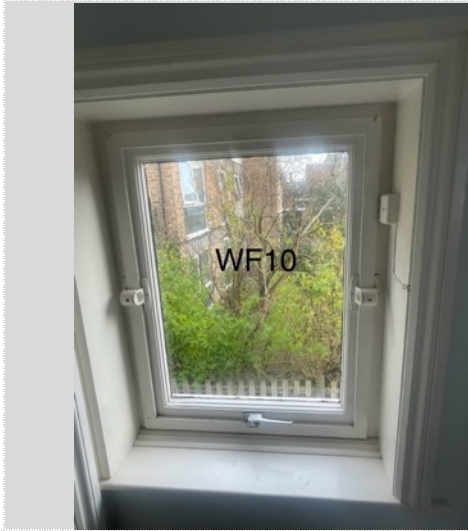
#### WF10

- Age: Modern casement window
- Condition: Average
- Heritage Significance: Low

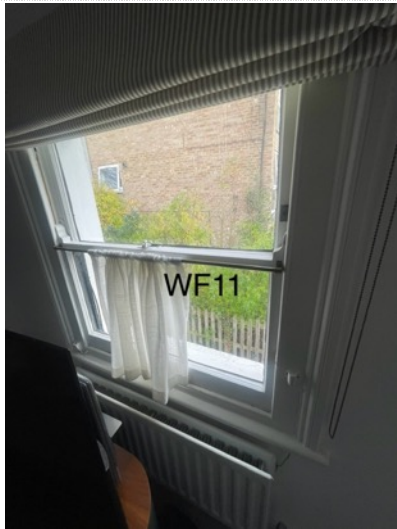
## WF11

- Age: Mid C19 sash box; Mid C20 sashes
- Condition: Average
- Heritage Significance:
- Sash box – High

- Sashes – Low

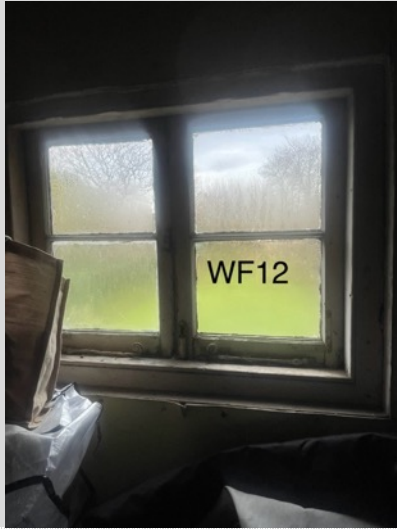
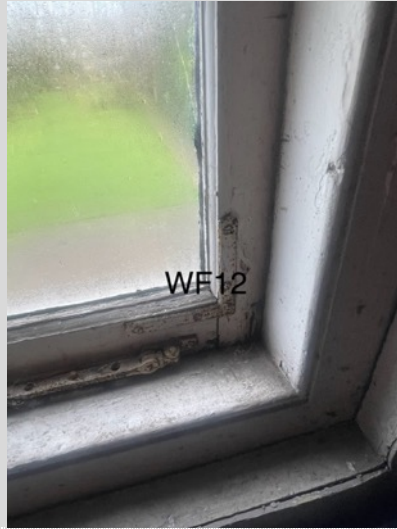
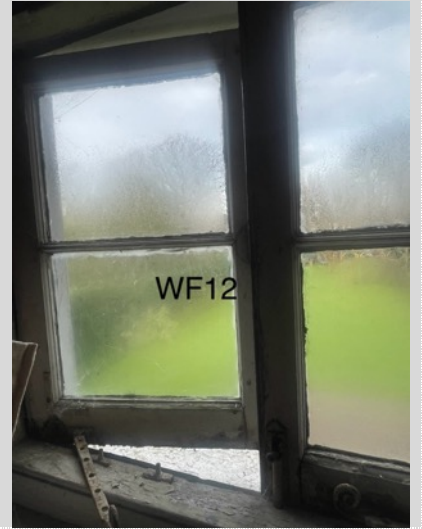
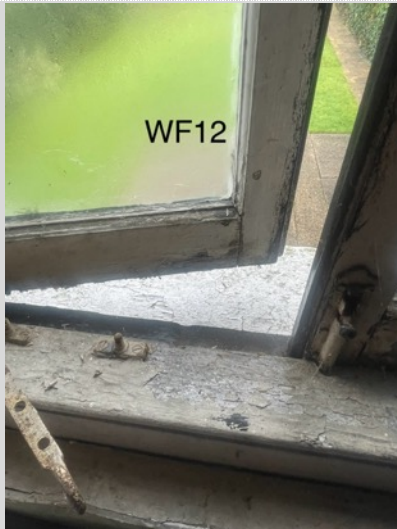
## WF12

- Age: Mid C19 casement window
- Condition: Average
- Heritage Significance: High
