## SPECIFIC STRUCTURAL REPORT

For 223 Archway Road, London, N6 5BN

**Cholmeley Park House**

DATE: 17/10/2023

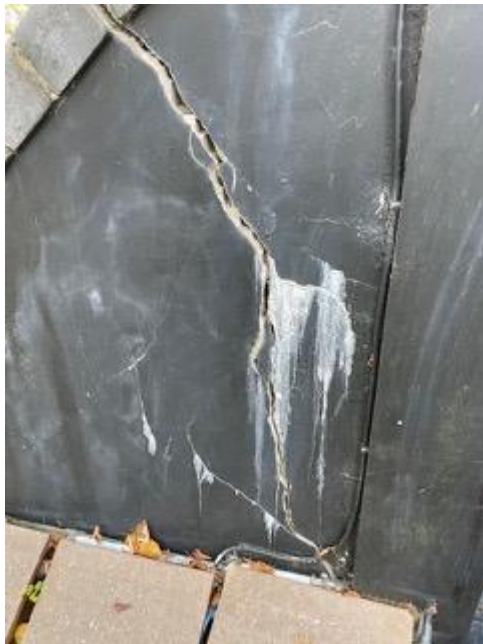
Location: External Elevations Front.

*Image of front staircase cracking.*

The diagonal nature of the crack shows that movement is present between the base of the staircase and where the staircase is fixed back into the supporting masonry wall in the flat below. We recommend heli-bar stitching the crack to stop the differential separation re-occurring. The remedial section shall elaborate further.

1. Location front and side foliage/tress: We recommend for the trees to be completely removed with their roots poisoned. This is to control and reduce any induced movement created by the roots onto the front staircase. If this cannot be carried out due to tree protection orders, then we recommend for the trees to be seasonally pruned to maintain a height from 8 – 10m high maximum. This will reduce and control the moisture levels absorbed by the trees roots.
2. We recommend for the staircase crack to be heli-bar stitched together. Where the vertical/diagonal crack is present heli-bars must be fixed at 300mm centres along the full height of the side of the staircase. One bar must be fixed at the top and bottom.

- a) Rake out or cut slots in horizontal mortar joints to specified depth & at vertical spacings. Use power / hand chisel to continue slots 500mm past crack where applicable.
- b) Vacuum out slots & thoroughly flush with water.
- c) Cut a piece of 16mm thick helical bar to the required length (1m minimum) & inject a bead of Helibond to the back of the slot.
- d) Insert the Helibar & push into the grout to obtain good coverage.
- e) Insert a further bead of Helibond over the exposed Helibar finishing 10-15mm from the face of the wall & iron in using a finger trowel.
- f) Make good the vertical crack with Epoxy Resin filler (crack bond tie).

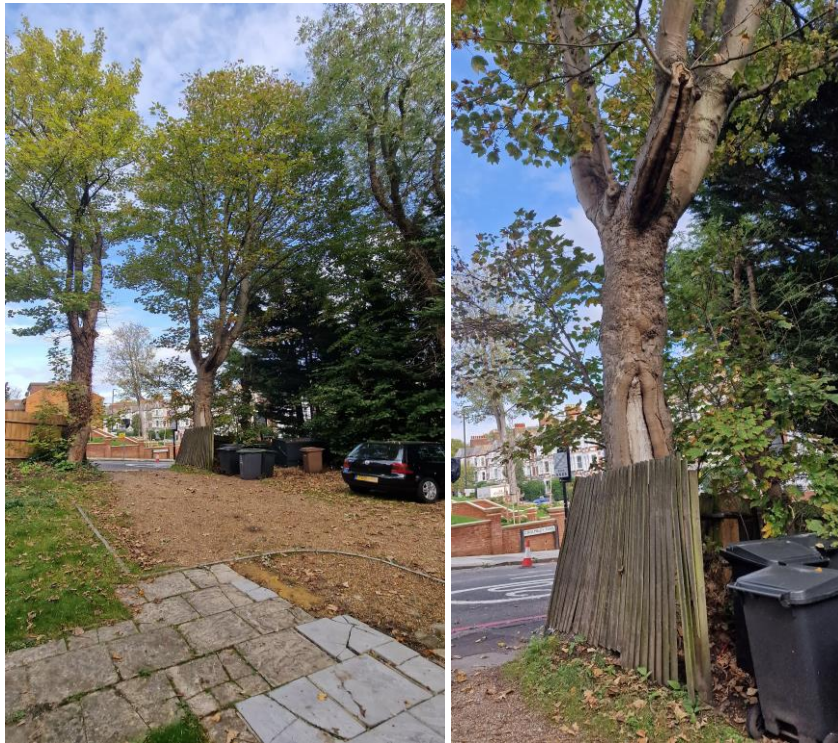
*Image of front trees to the side entrance.*

The trees were established to be local to the entrance, approximately 15m high and of high-water demand. We also observed cracking and swelling in the grounds. This leads us to believe that the tree roots are causing unnatural drainage paths and disturbing the grounds. The trees must be pollarded to a height of 8-10m high maximum. If possible we recommend for the entire removal of the trees with their roots poisoned.

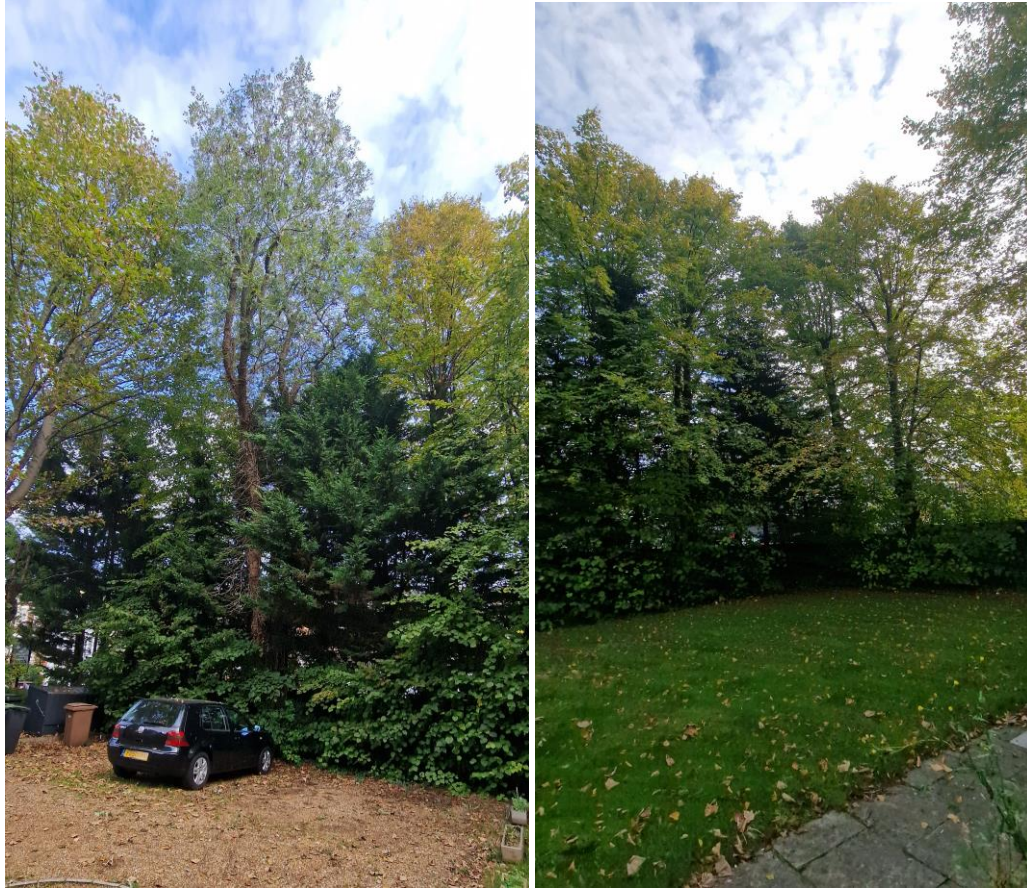
Image of front trees to the very front local to the main road.

The trees were established to be local to the front, approximately 12-15m high and of high to medium-water demand. We also observed cracking and swelling in the grounds. This leads us to believe that the tree roots are causing unnatural drainage paths and disturbing the grounds. The trees must be pollarded to a height of 8-10m high maximum. Alternatively, the trees should be removed, and all roots poisoned. This is to control the pressure from the roots and soil.

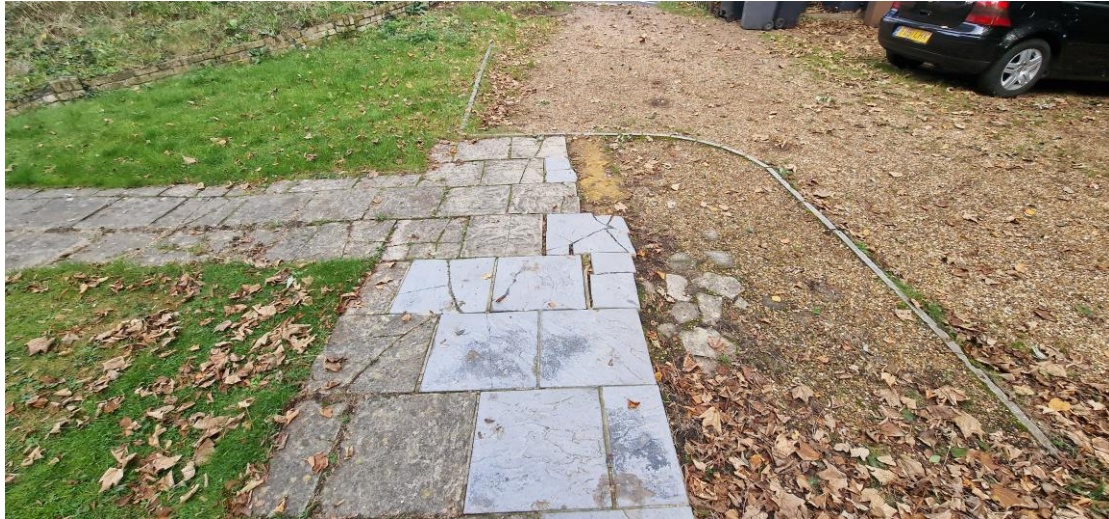
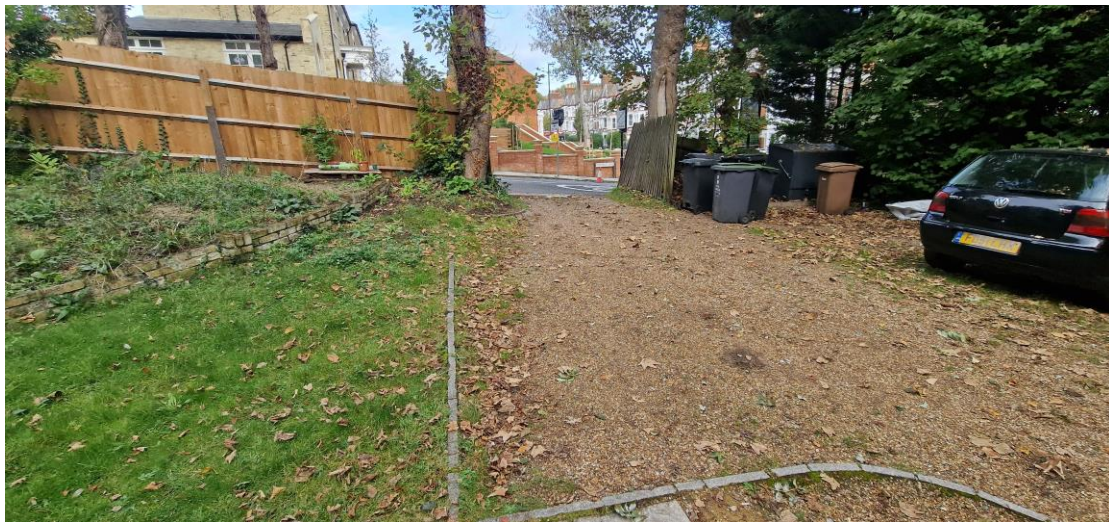
*Image of cracked and swollen grounds.*

The images above show swelling and cracking in the grounds. These are primary signs that the roots are present in the grounds, causing unnatural drainage paths. Taking into consideration the clay ground conditions, this further adds to the roots absorbing more moisture than recommended, thus causing ground movement.
