# Tree Condition Report

## & Management Recommendations

26 Queens Avenue  
Muswell Hill  
London  
N10 3NR

**Dated**  
27<sup>th</sup> October 2025

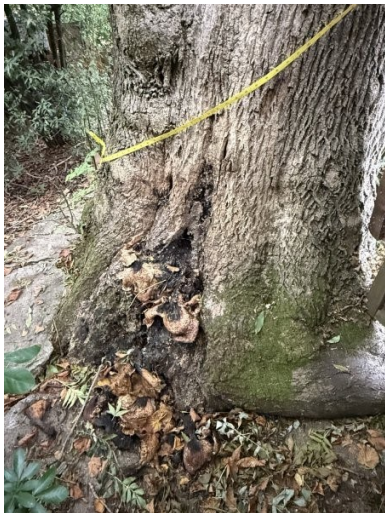
- 2.1.2. *Cerioporus squamosus* fruiting bodies are present at the base of the tree (see Photo 1), and a sounding mallet indicates significant decay is present. Moreover, a large wound is present to the main stem where another stem has historically failed. The remaining stem has an opening of around 25% of its diameter with significant decay developing. There is good wound wood present, reinforcing the wound and associated internal decay.

Photo 1. T001 (fungal fruiting bodies at base)

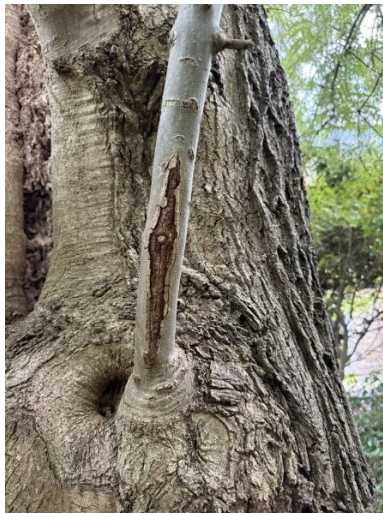
- 2.1.3. Physiologically, the upper canopy of the tree appears to be in a good condition, with no observable symptoms of ash dieback (see Photos 5 and 8). However, symptoms of ash dieback were present to epicormic growth close to ground level (see Photos 2 to 4).

Photo 2. T001 symptom of ash dieback (lesion)

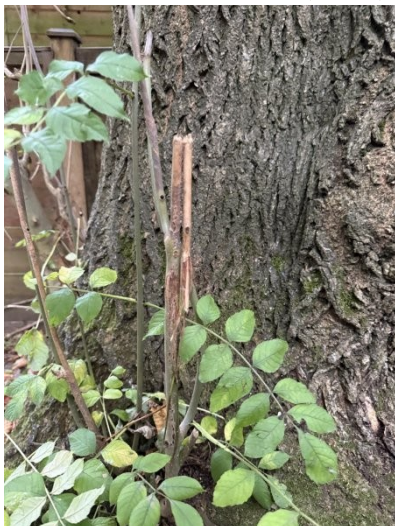
Photo 3. T001 symptom of ash dieback (lesion)

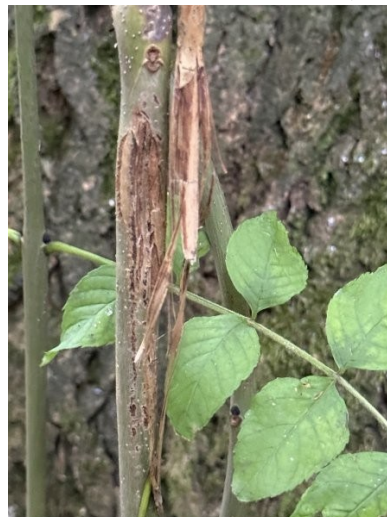
Photo 4. T001 symptom of ash dieback (lesion)

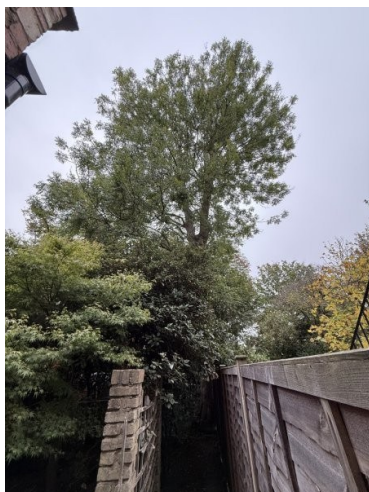
Photo 5. T001

- 2.1.1. T001 is an early mature common ash tree located in the rear garden. The stem of this tree is mostly within the subject property; however it does straddle the site boundary. This tree's potential targets include the surrounding gardens and dwellings. T001 has previously been topped at c. 15m and the topping points now have significant re-growth (see Photo 5).

- 2.1.6. As the tree was previously topped to a height of around 15m, the subsequent regrowth is unsuitable for use as an anchor point for climbing. In addition, the tree's position within a rear garden means there is no access for an elevated work platform. For these reasons, carrying out a 3m crown reduction is not practical.
- 2.1.7. We recommend reducing T001 back to its previous topping points (a 6 to 6.5m reduction in height). This is a more feasible option and would substantially improve the tree's safety factor and increase the likelihood of its

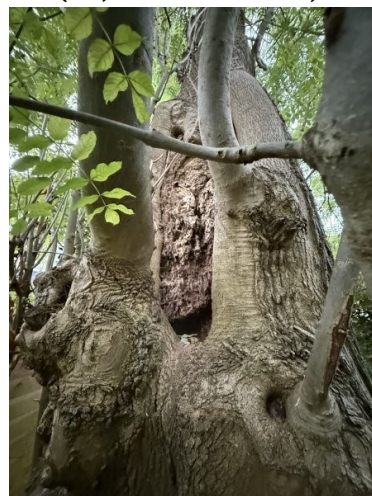
- 2.1.4. The dimensions of the tree and estimated dimensions of the wound and decay to the main stem have been used to calculate the safety factor of the stem at this point, using TreeCalc (tree statics modelling software). A desired safety factor of 1.5 is usually used in tree statics calculations, as unlike non-living structures, trees are able to grow and react to decay and defects and even increase their safety factor over time. In this case, a desired safety factor of 3 has been used, to account for the fact that the extent of decay was estimated as the affected area was inaccessible, and as there are symptoms of ash dieback present, which may begin to affect the tree's ability to respond to internal decay (although the tree appears in good health at present).

- 2.1.5. The results suggest that a reduction in tree height of 3m is required to achieve the desired safety factor. These results consider wind speeds of 22.5m/s (Wind force 9, strong gale) and the stem at the height of the defect having a 25% opening and 20% residual timber,

Photo 6. T001 (major wound to stem)

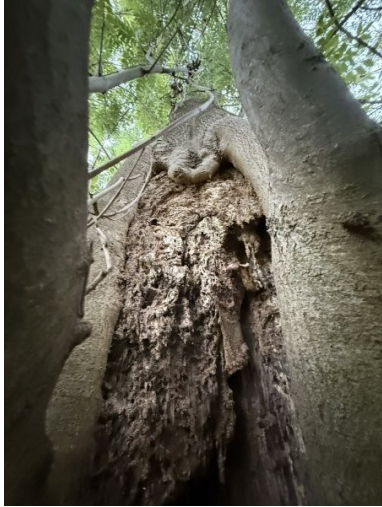
Photo 7. T001 (major wound to stem)

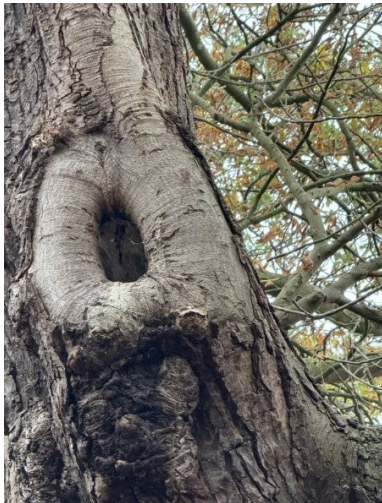
- 2.1.8. T002 is a horse chestnut located to the rear of the garden. Potential targets include the surrounding gardens and an adjacent dwelling. T002 as high ecological value, with multiple cavities, woodpecker holes and tear wounds with exposed heartwood (see photos 11 to 16). These are important habitat features but do represent potential defects within the structure of the tree/tree parts.

Photo 11. T002 (cavity good wound wood)

- 2.1.10. Given a dwelling is within the target zone of the tree, a balance must be struck between retaining important habitat features and reducing the likelihood of stem/limb failure. Therefore, to reduce the lever arm forces acting on the various defects within the stem and scaffold limbs, a 3m reduction in overall height and 1.5m to 2m reduction in radial spread is recommended.

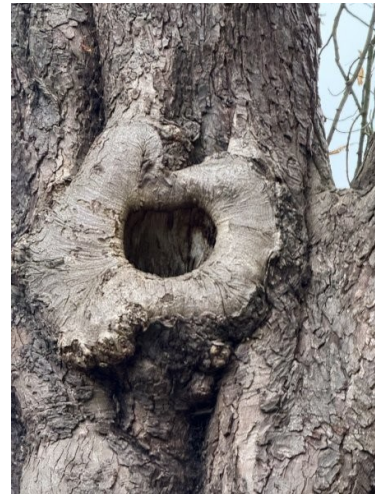
Photo 12. T002 (cavity good wound wood)

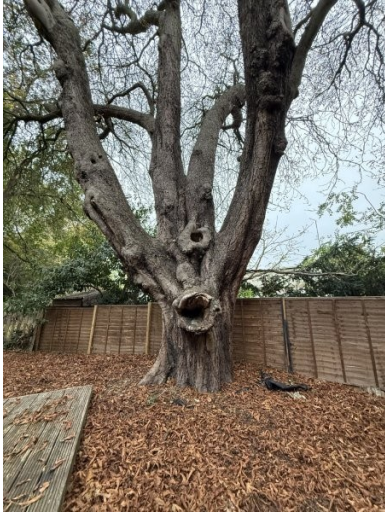
Photo 13. T002 large cavities to stem

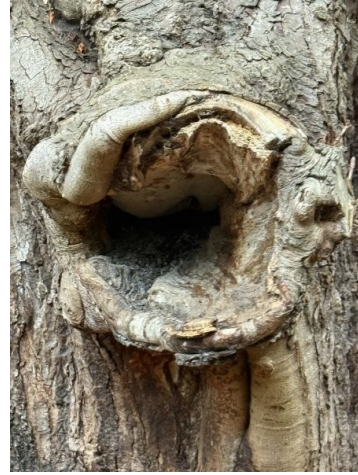
Photo 14. T002 large cavity to stem at c. 1.5 (Ganoderma bracket inside).

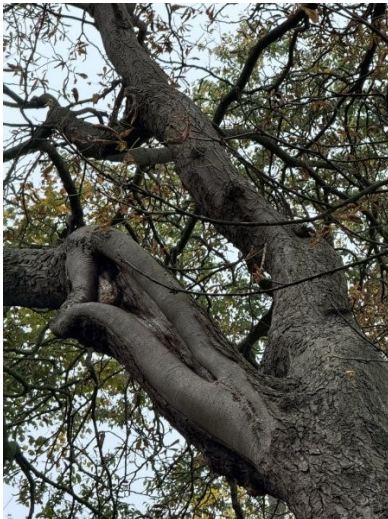
Photo 15. T002 (tear wound).

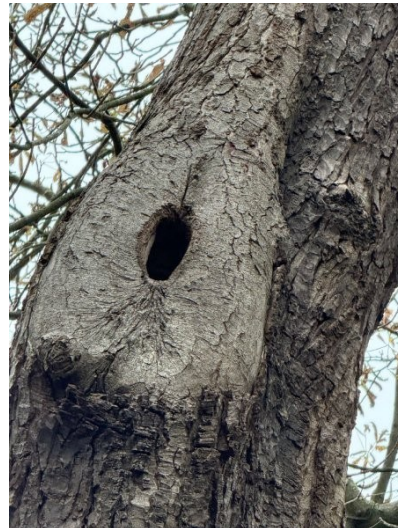
Photo 16. T002 (woodpecker hole).
