# Site Investigation Report

195580.1.USI

Auger were commissioned by Crawford & Co to undertake a site investigation and CCTV inspection of the underground drainage within the area of concern (AOC) at the property.

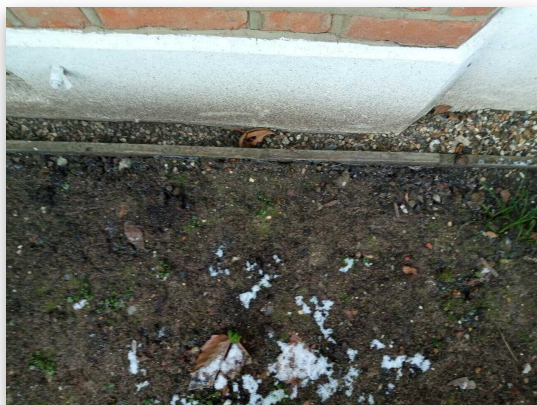
Fig 1.1: Trial Hole 1 Location

TH1 was undertaken in the desired location, we were able to expose the footings and we collected the requested soil and root samples.

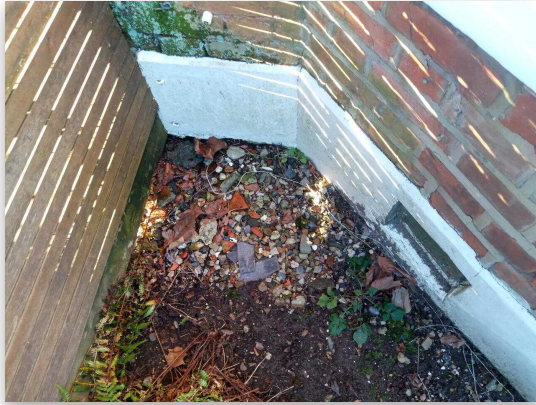
Fig 2.1: Trial Hole 2 Location

TH2 was undertaken in the desired location, we were able to expose the footings and we collected the requested soil and root samples. Within TH2, we also took footing measurements from the **Main House**. These measurements are shown in Trial Hole Log 2b below.

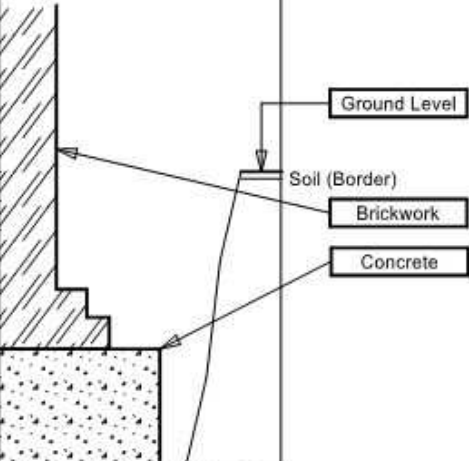
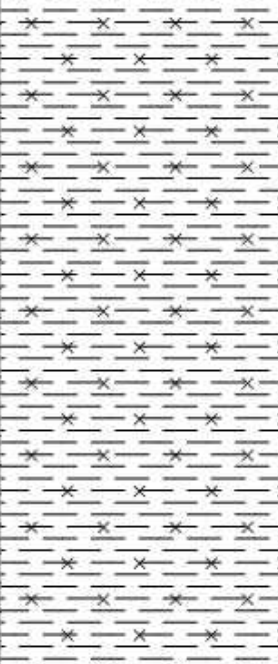
## Trial Hole Log No.1

Location: Front right of bay

| Depth<br>(m) | Symbolic Log | Strata Description | Insitu Tests | | Soil<br>Sample | Root<br>Sample |
|---|---|---|---|--|---|---|
| 2.5 | | Moist very stiff brown silty CLAY | 150kpa | | Soil<br>@ 2.5m | |

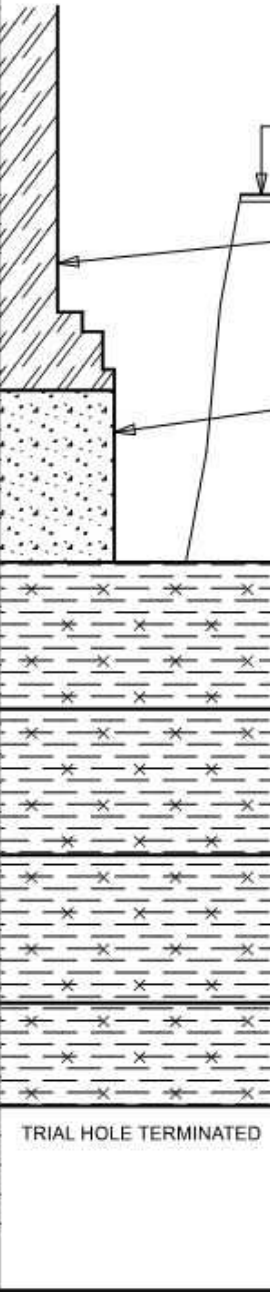
## Trial Hole Log No.2

Location: Front left junction between bay and house

| Depth<br>(m) | Symbolic Log | Strata Description | Insitu Tests | | Soil<br>Sample | Root<br>Sample |
|---|---|---|---|--|---|---|
| | | Moist very stiff brown fine to medium<br>gravelly silty CLAY | 108kpa | | Soil<br>@ 1.25m | Root<br>@ 1.25m |
| | | Moist very stiff brown silty CLAY | 116kpa | | Soil<br>@ 1.75m | Root<br>@ 1.75m |
| | | Moist very stiff brown fine to medium<br>gravelly silty CLAY | 128kpa | | Soil<br>@ 2.25m | |
| | | Moist very stiff brown silty CLAY | 150kpa | | Soil<br>@ 2.75m | |

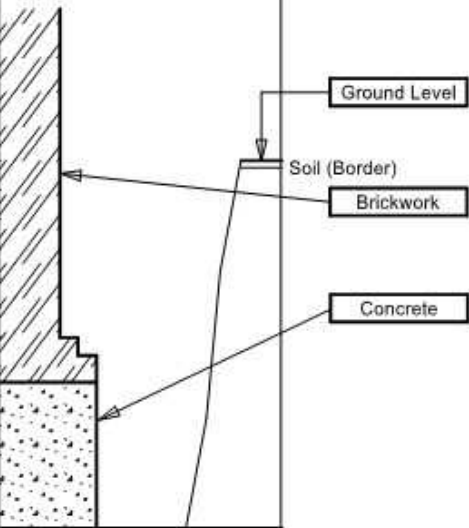
## Trial Hole Log No.2b

Location: House

| Depth<br>(m) | Symbolic Log | Strata Description | Insitu Tests | | Soil<br>Sample | Root<br>Sample |
|---|---|---|---|--|---|---|
| 0.0 | <p>Ground Level</p> <p>Soil (Border)</p> <p>Brickwork</p> <p>Concrete</p> | | | | | |
