# Earlsmead Primary School – Condition Survey Report

London Borough of Haringey

February 2026

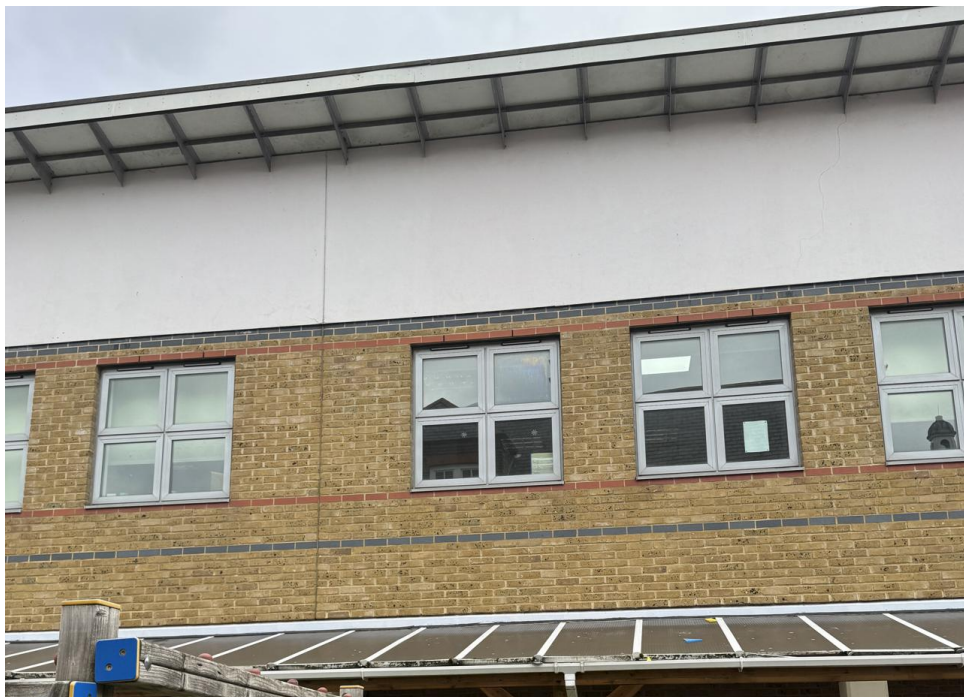
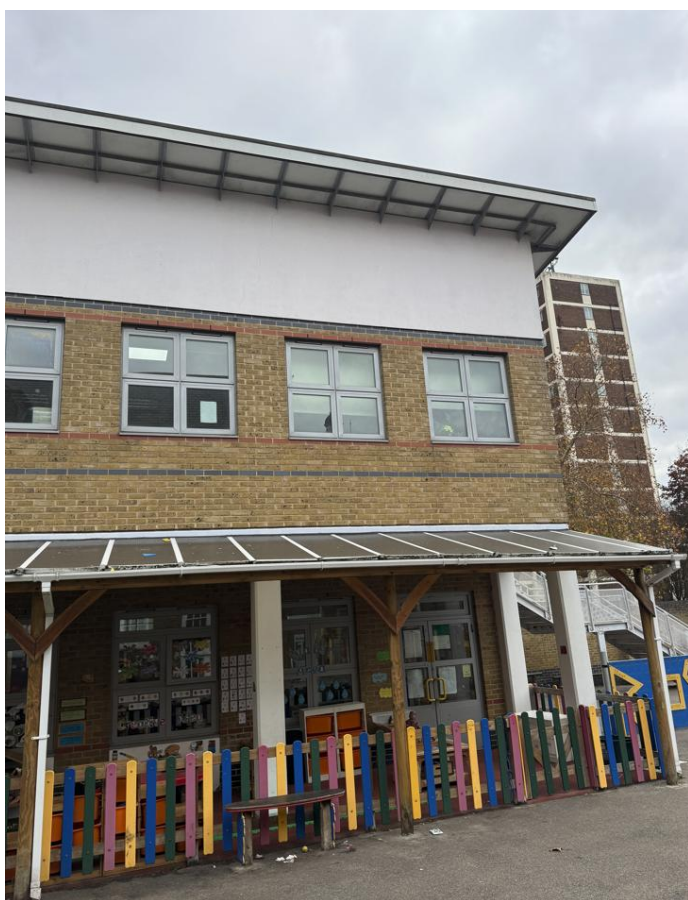
Block B windows

External windows comprise of powder coated aluminium which are all in a good condition. However, we did note that there was 3nr blown windowpanes which should be replaced. There was missing ironmongery noted on some of the windows which require replacement. We recommend that an allowance for ease and adjustment of existing windows to ensure correct operation.

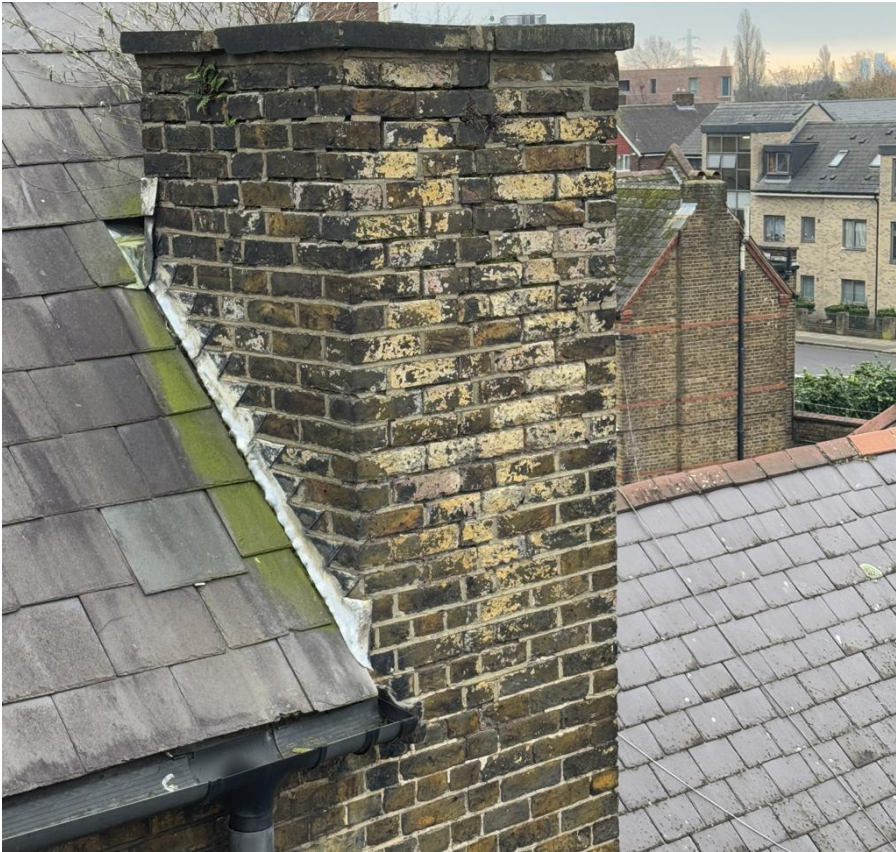
Chimney

All of the chimneystacks appear to be generally upright. There are isolated areas of defective pointing and sand/cement flaunching which requires remedial repairs which should be addressed.

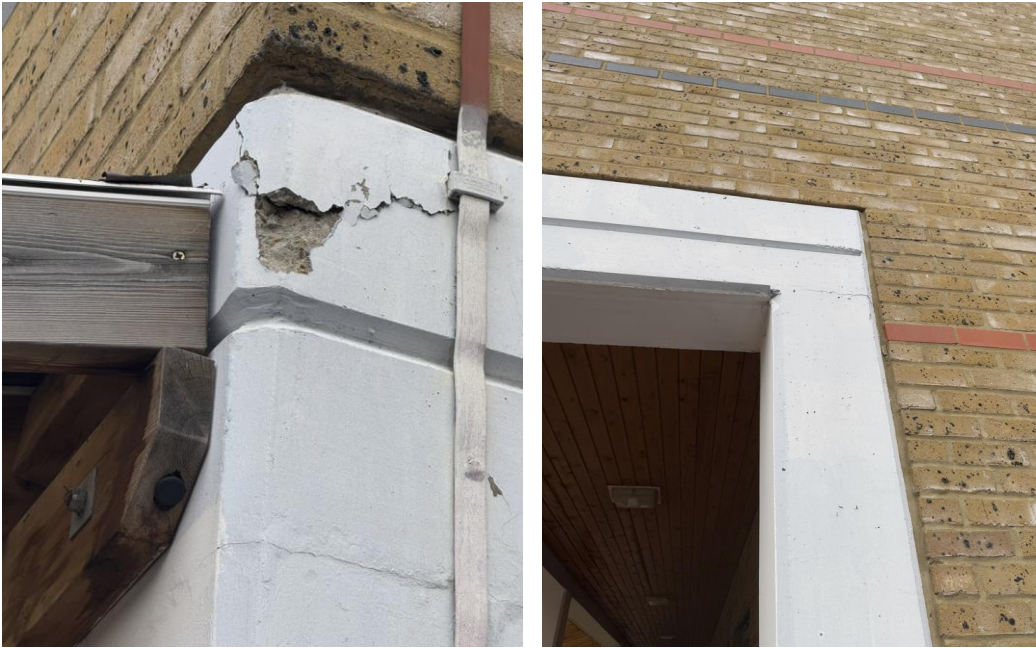
External decorations to rendered finishes and concrete banding are in a reasonable condition. However, we recommend that further decorative works are to be completed in conjunction with the repairs identified to the rendered finishes. There are some stone structural works required as per below photo.

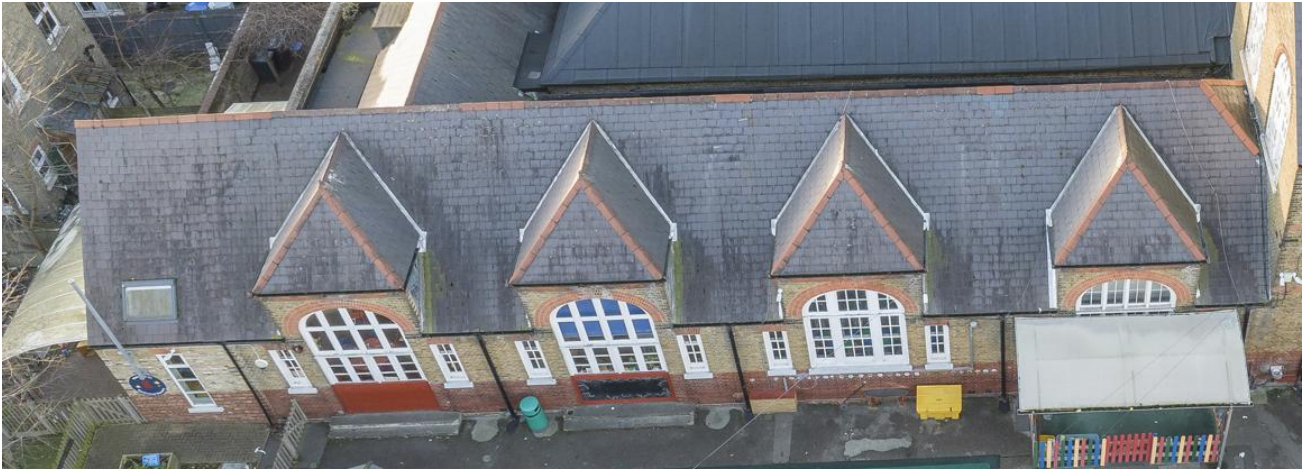
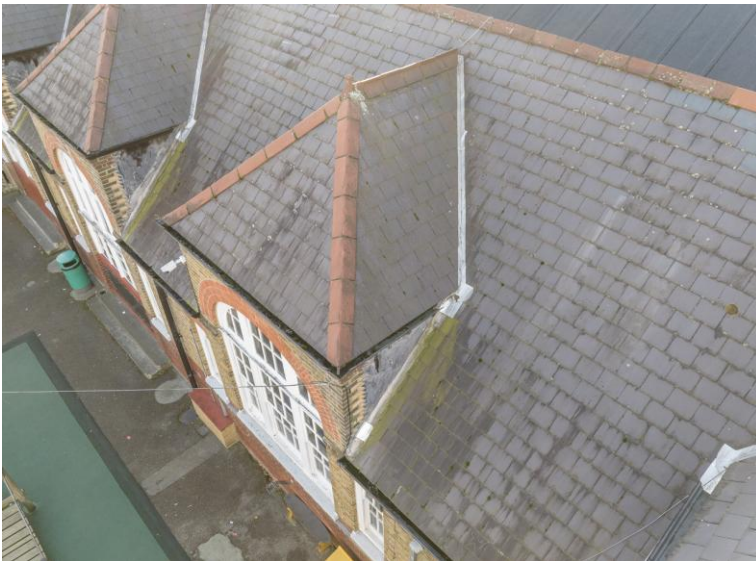
Roof A1

In summary the roof and associated details are in a fair condition, undertaking repairs highlighted above should prolong the roofs longevity for another 5-10 years.

Our recommendation would be to replace defective roof tiles with new and all associated details including rainwater goods. The lightening conductor will need removal and reinstatement. The expected life expectancy will provide an additional 20-30 years.

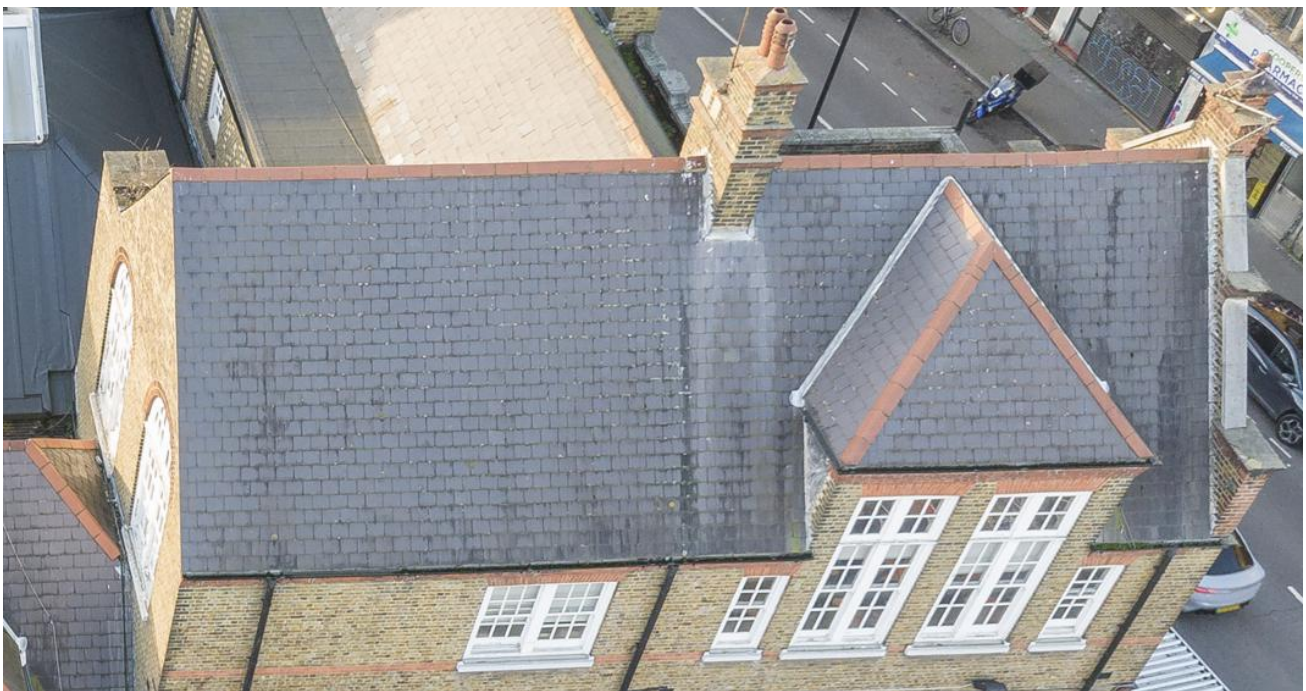
Roof A2

In summary the roof and associated details are in a fair condition, undertaking repairs highlighted above should prolong the roofs longevity for another 5-10 years. However, considerations should be made for full replacement of the roof covering to reduce maintenance liabilities, access etc.

Our recommendation would be to replace defective roof tiles with new. The lightening conductor will need removal and reinstatement. The expected life expectancy will provide an additional 20-30 years.

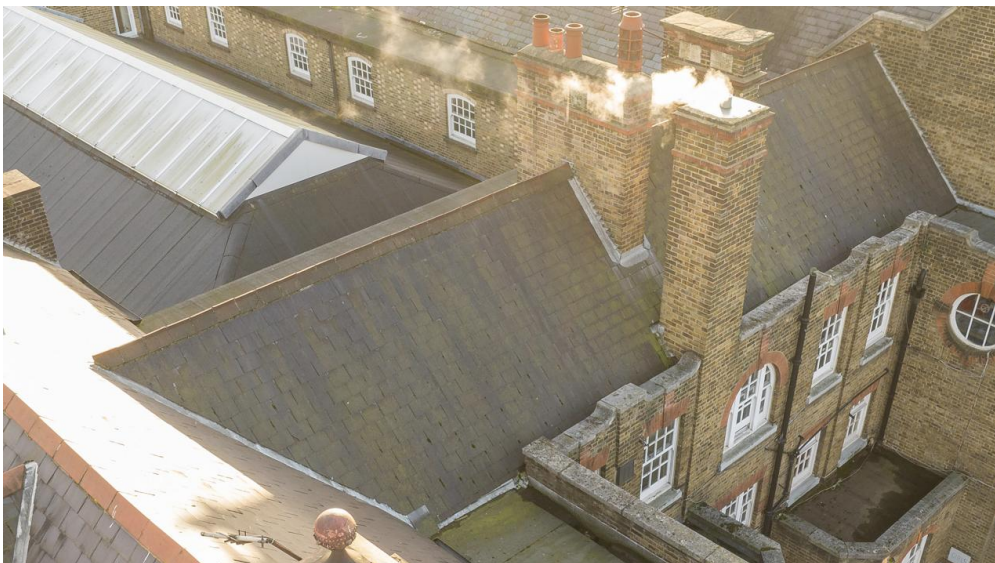
Roof A3

In summary the roof and associated details are in a fair condition, undertaking repairs highlighted above should prolong the roofs longevity for another 5-10 years. However, considerations should be made for full replacement of the roof covering to reduce maintenance liabilities, access etc.

Our recommendation would be to replace defective roof tiles with new. The lightening conductor will need removal and reinstatement. The expected life expectancy will provide an additional 20-30 years.

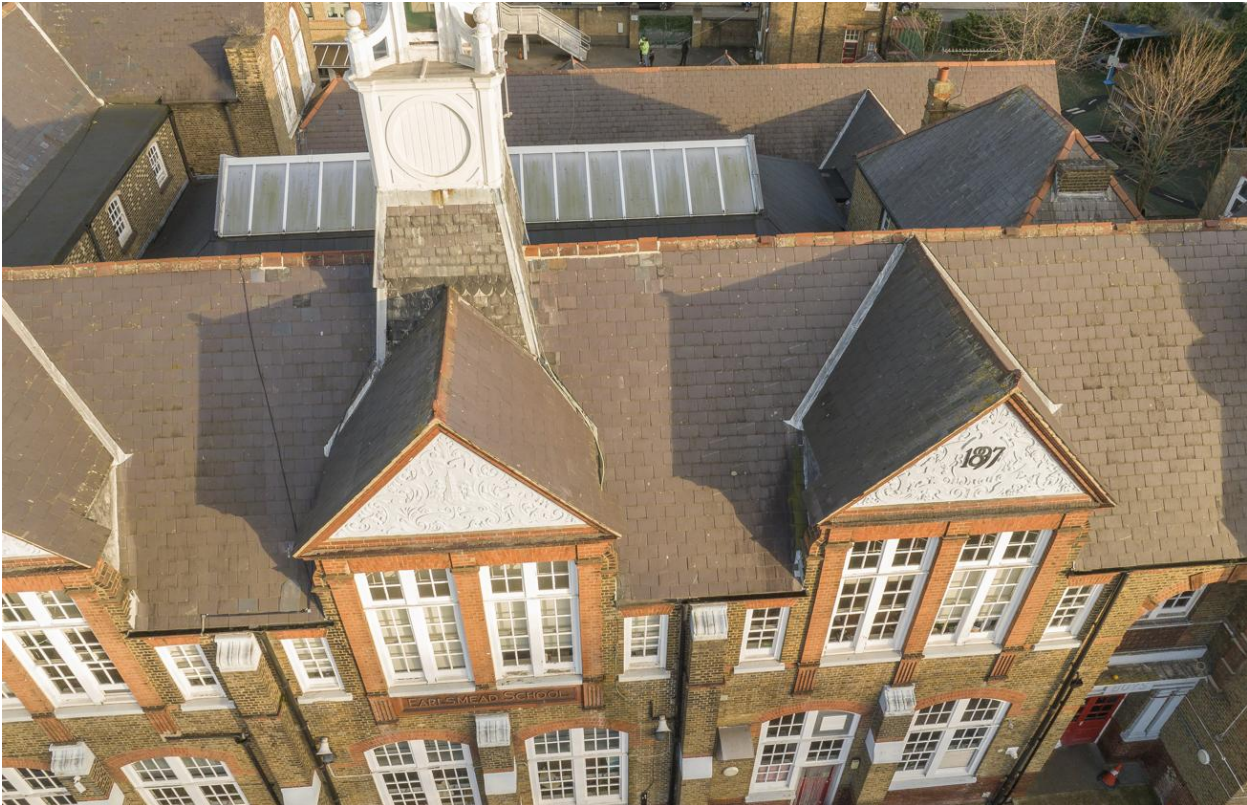
Roof A4

In summary the roof and associated details are in a fair condition, undertaking repairs highlighted above should prolong the roofs longevity for another 5-10 years. However, considerations should be made for full replacement of the roof covering to reduce maintenance liabilities, access etc.

Our recommendation would be to replace defective roof tiles with new The lightening conductor will need removal and reinstatement.

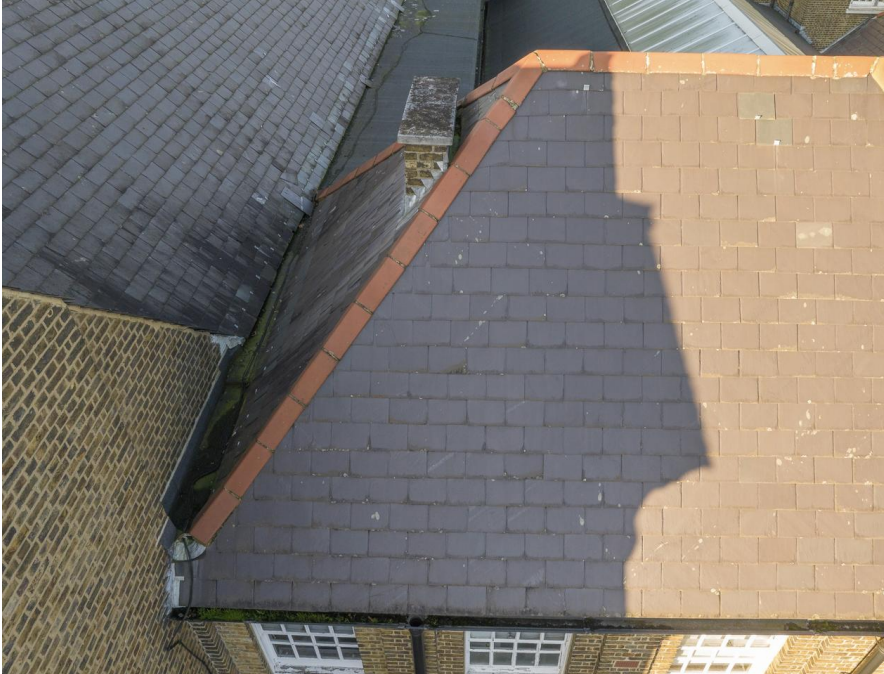
Roof A5

In summary the roof and associated details are in a fair condition, undertaking repairs highlighted above should prolong the roofs longevity for another 10-15 years. However, considerations should be made for full replacement of the roof covering to reduce maintenance liabilities, access etc.

Our recommendation would be to replace defective roof tiles with new including rainwater goods. The lightning conductor will need removal and reinstatement.

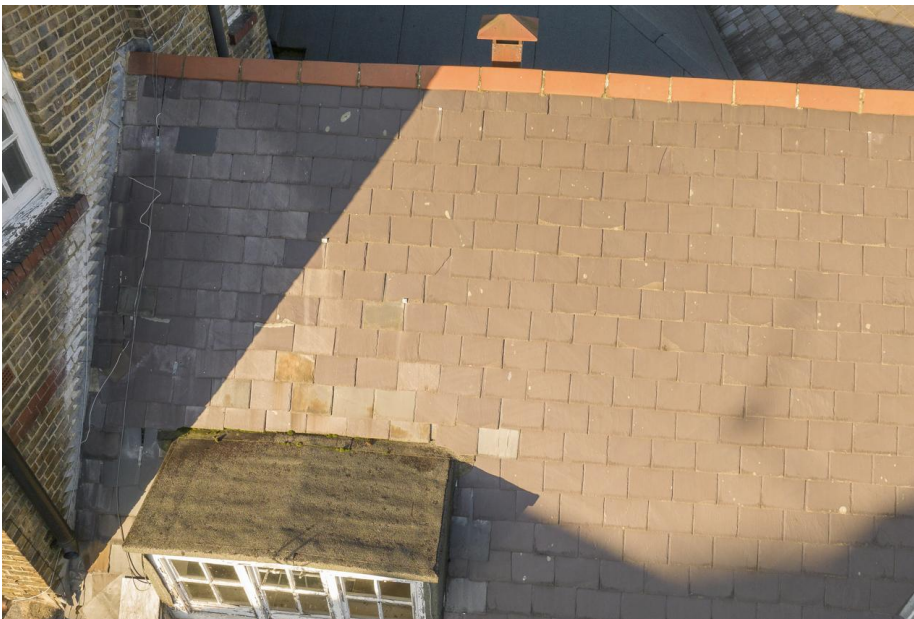
Roof A6

In summary the roof and associated details are in a fair condition, undertaking repairs highlighted above should prolong the roofs longevity for another 5-10 years. However, considerations should be made for full replacement of the roof covering to reduce maintenance liabilities, access etc.

Our recommendation would be to replace defective roof tiles with new including rainwater goods. The lightening conductor will need removal and reinstatement.

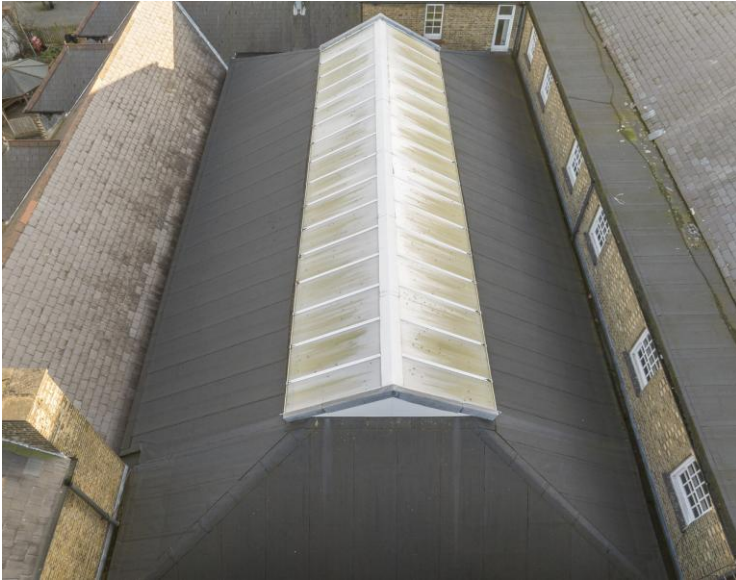
Roof A7

The perimeter of the roof on the 3 nr enclosed sides is formed by a felt lined valley gutter with lead cover flashings chased into the adjacent brickwork. Drainage is via internal rainwater outlets which have wire balloon grates. At the time of the inspection some minor build-up of leaves was noted but not sufficient to prevent the free flow of rainwater from the roof. We note that any lack of routine clearing of debris could result in the gullies surcharging.

We recommend that the roof lining be stripped back to the joists and re finished. Felt can be re used to be cost effective however we believe the original covering was likely a natural slate as with the surrounding pitches. Attention should also be paid to the lantern light and thermal performance; we suggest upgrade to a polycarbonate unit.

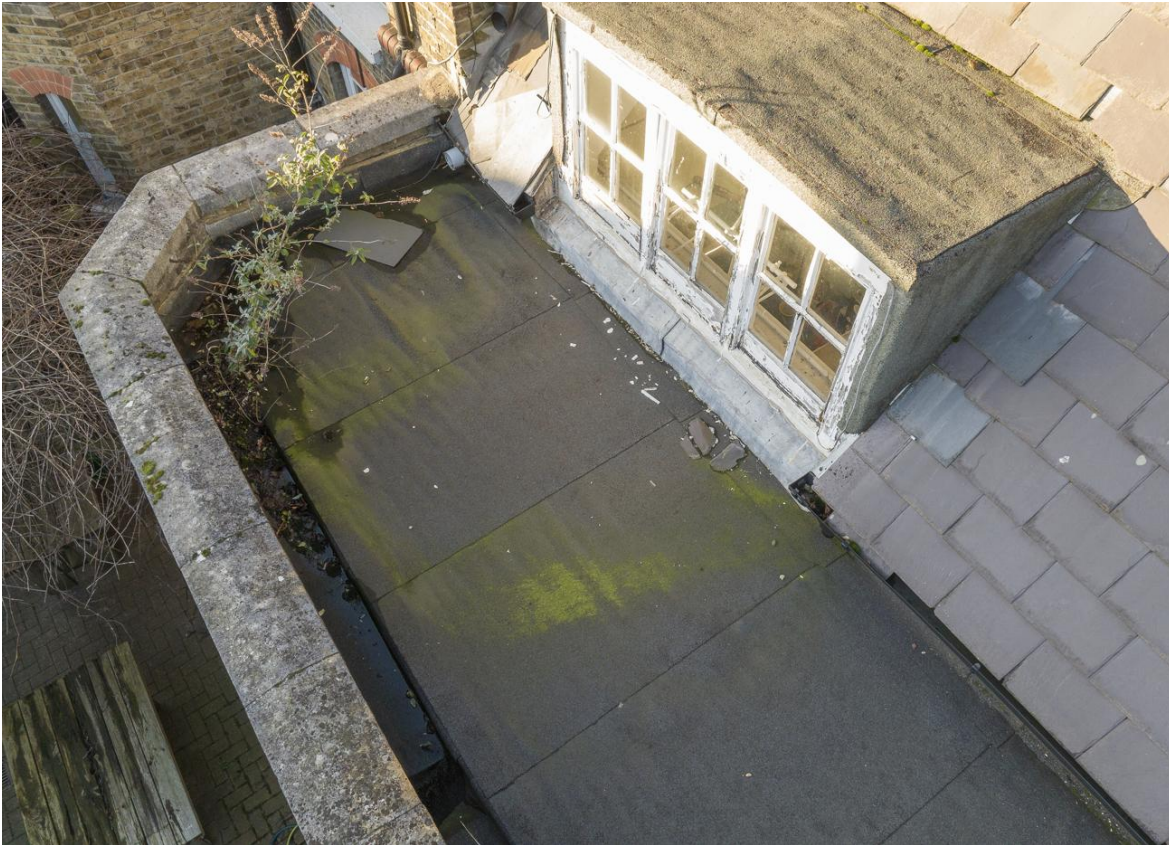
Roof A8

In summary the roof and associated details are reaching the end of useful life.

Our recommendation would be to replace the roof and all associated details and upgrade the thermal performance to at least the latest building regulation. The downpipe and hopper should be removed and replaced.

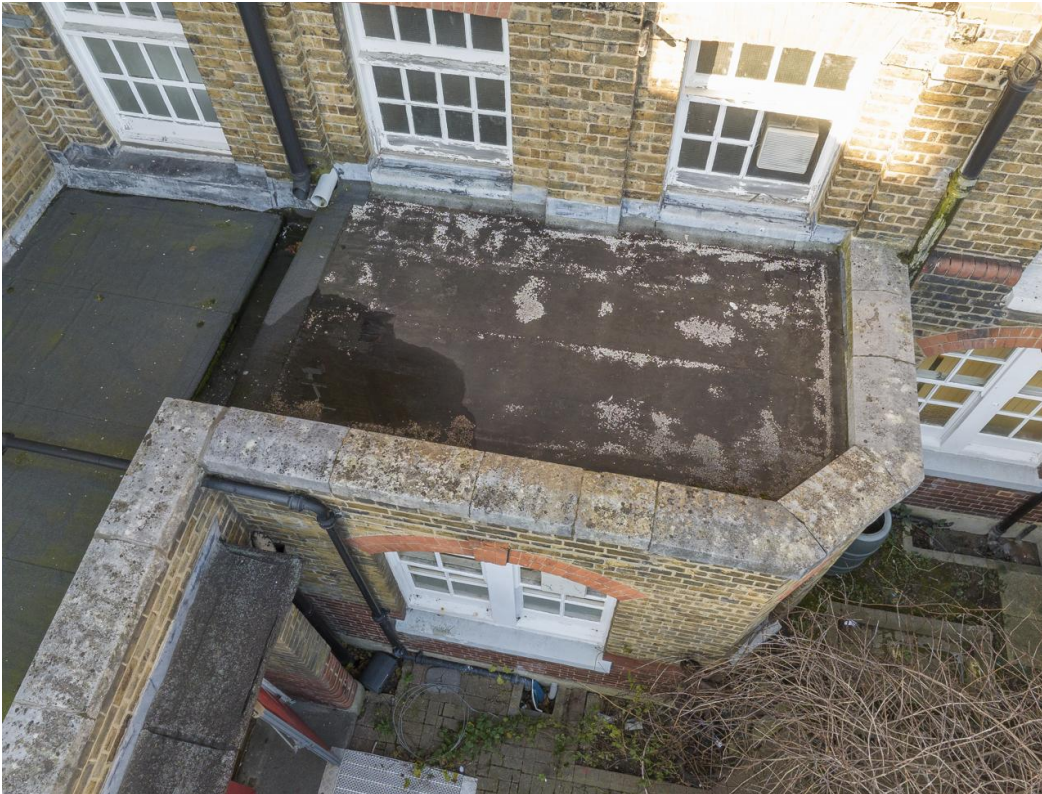
Roof A9

Although not significantly leaking at the time of our inspection, we suspect that this roof is of some age and will have a maximum life expectancy of 2-3 years.

Our recommendation would be to replace the roof and all associated details and upgrade the thermal performance to at least the latest building regulation. The downpipe and hopper should be removed and replaced.

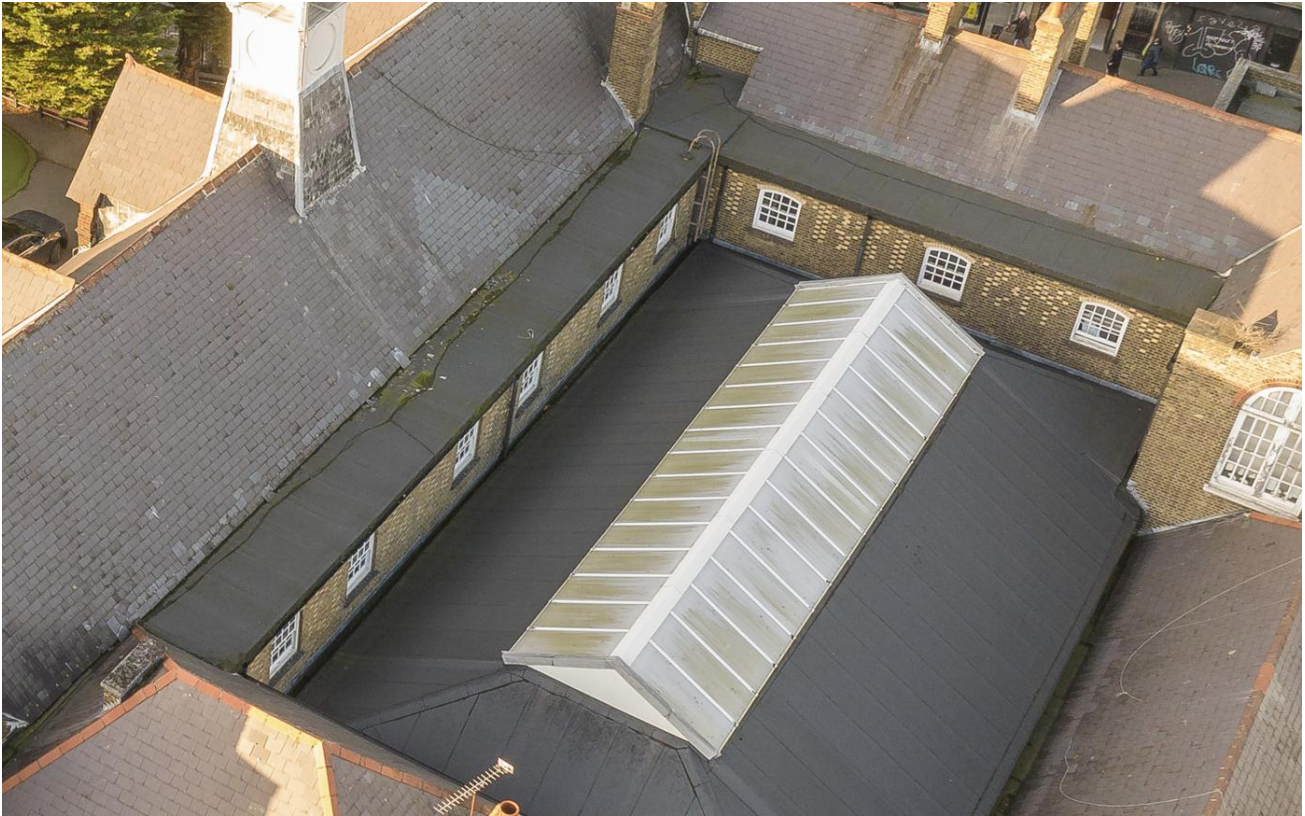
Roof A10

In summary the roof and associated details are reaching the end of useful life.

Our recommendation would be to replace the roof and all associated details and upgrade the thermal performance to at least the latest building regulation. The downpipe and hopper should be removed and replaced.

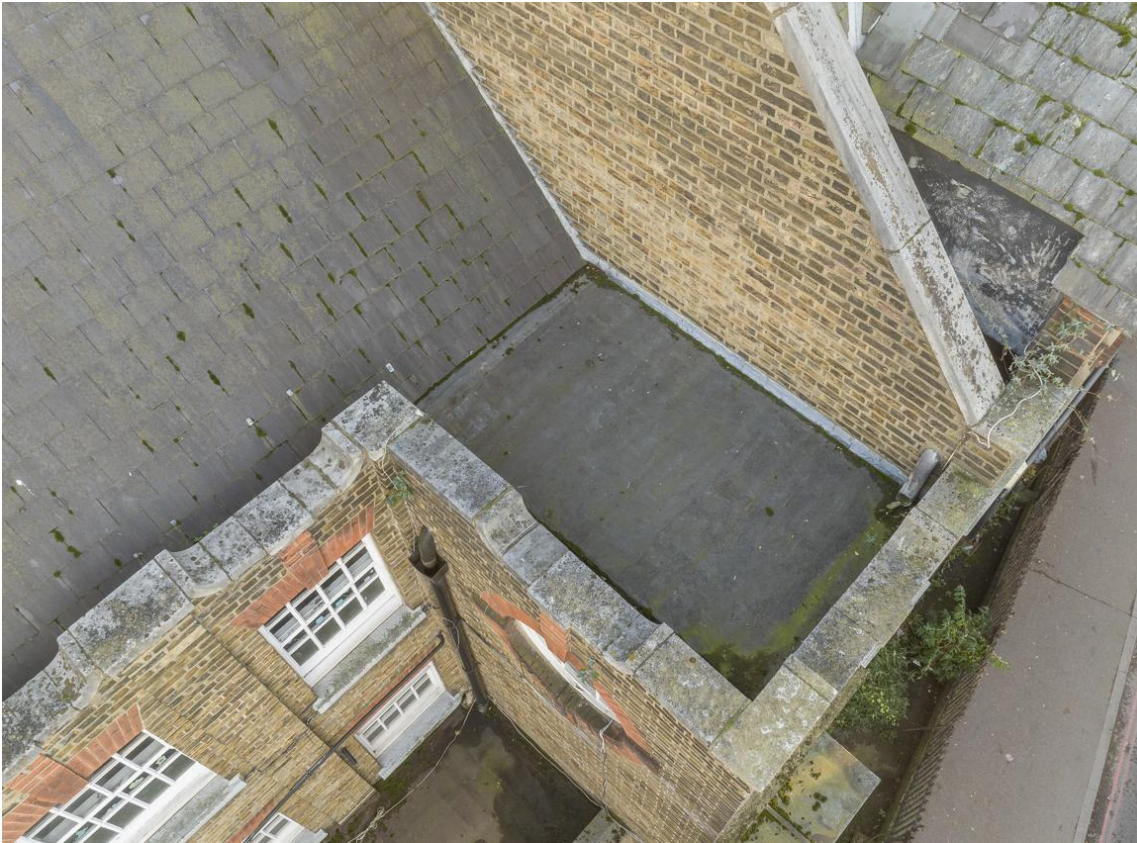
Roof A11

Although not significantly leaking at the time of our inspection, we suspect that this roof is of some age and will have a maximum life expectancy of 2-3 years.

Our recommendation would be to replace the roof and all associated details and upgrade the thermal performance to at least the latest building regulation. The downpipe and hopper should be removed and replaced.

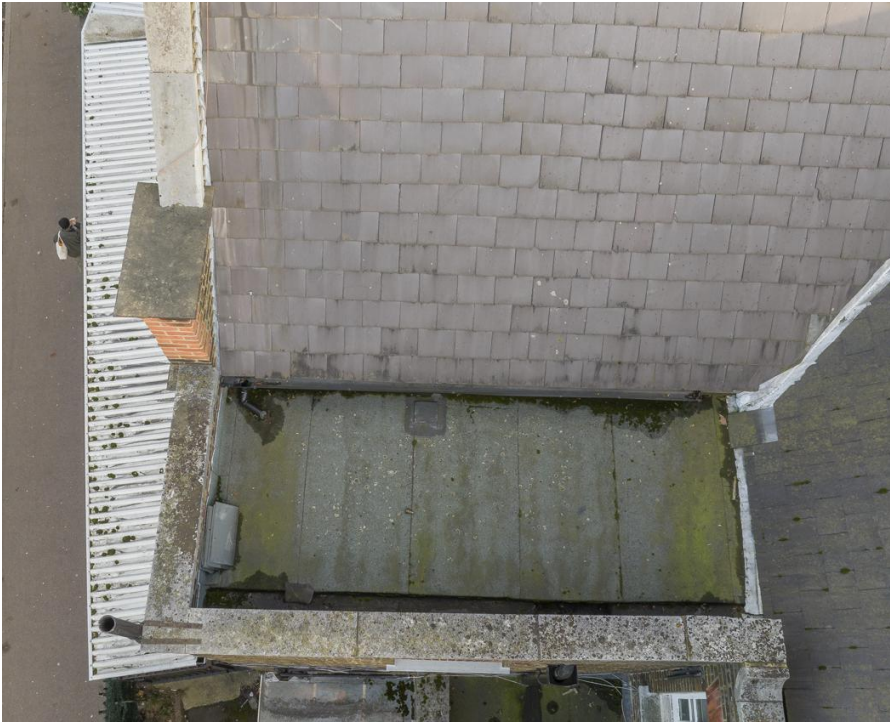
Roof A12

There is evidence of moss and plant growth evident behind the parapet wall. This should be removed, and further investigation to determine the condition of the lead flashing.

Our recommendation would be to replace the roof and all associated details and upgrade the thermal performance to at least the latest building regulation. The downpipe and hopper should be removed and replaced.

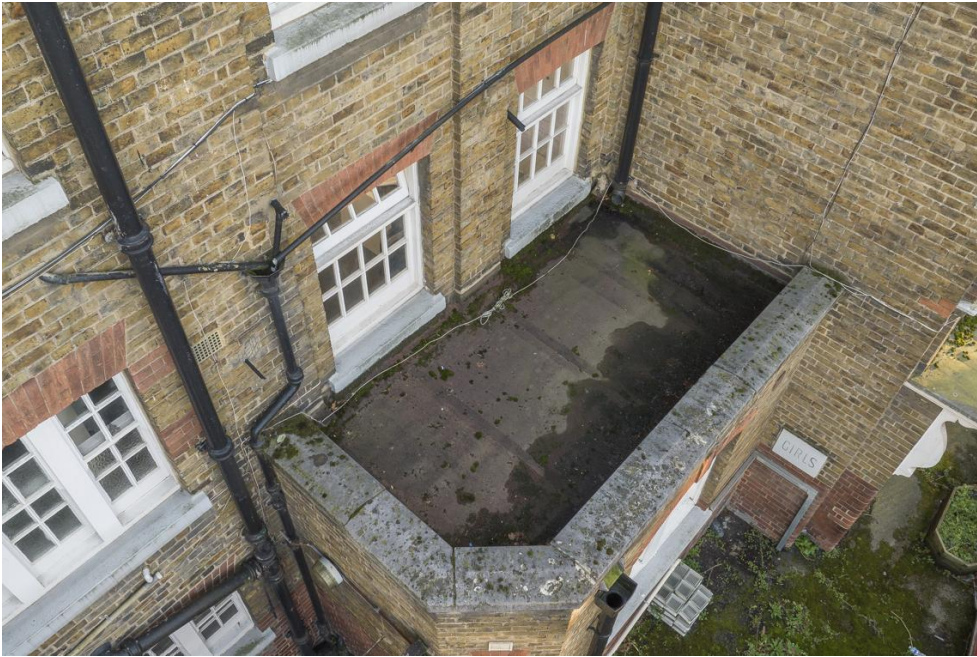
Roof A13

Although not significantly leaking at the time of our inspection, we suspect that this roof is of some age and will have a maximum life expectancy of 2-3 years.

Our recommendation would be to replace the roof and all associated details and upgrade the thermal performance to at least the latest building regulation.

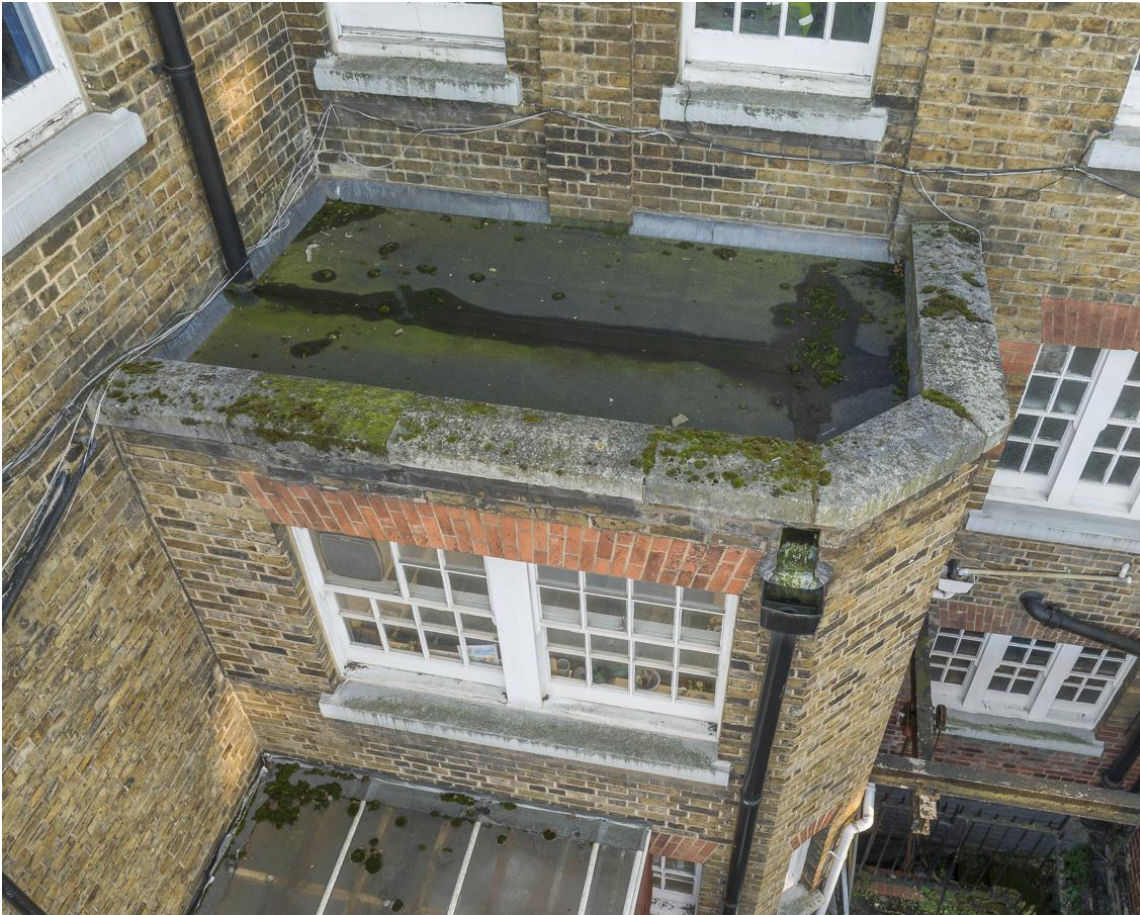
Roof A14

Although not significantly leaking at the time of our inspection, we suspect that this roof is of some age and will have a maximum life expectancy of 5-7 years.

Our recommendation would be to replace the roof and all associated details and upgrade the thermal performance to at least the latest building regulation. The downpipe and hopper should be removed and replaced.

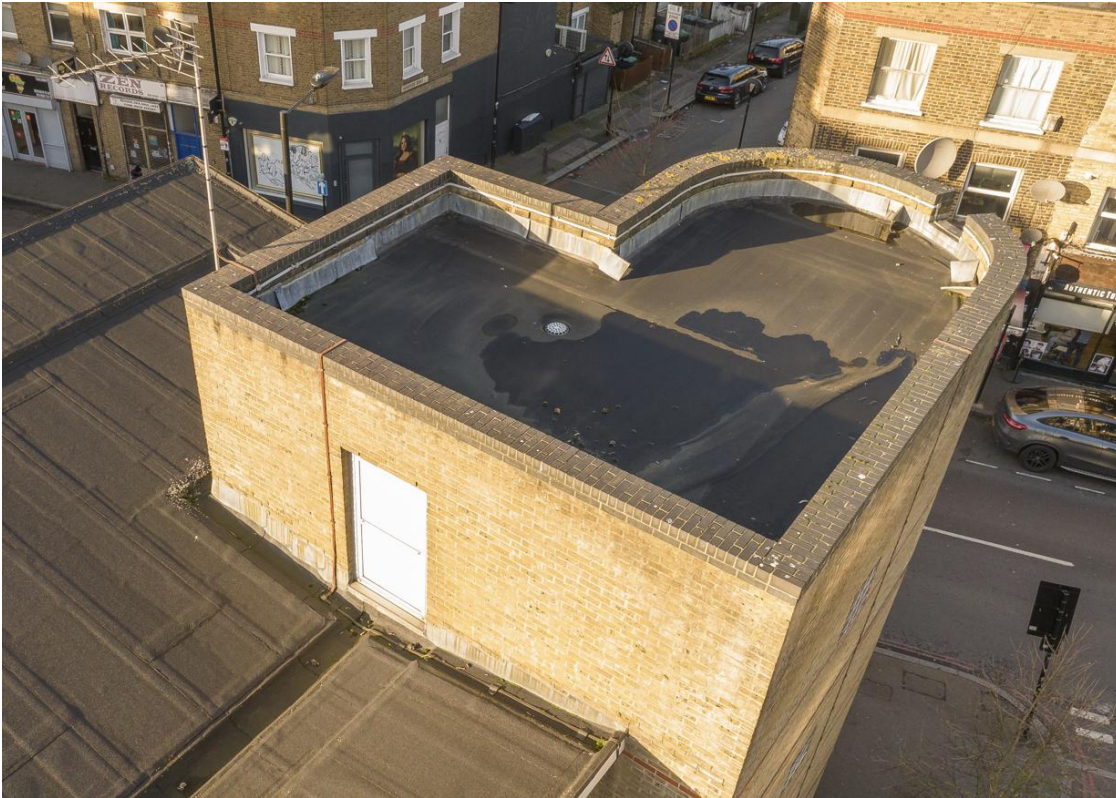
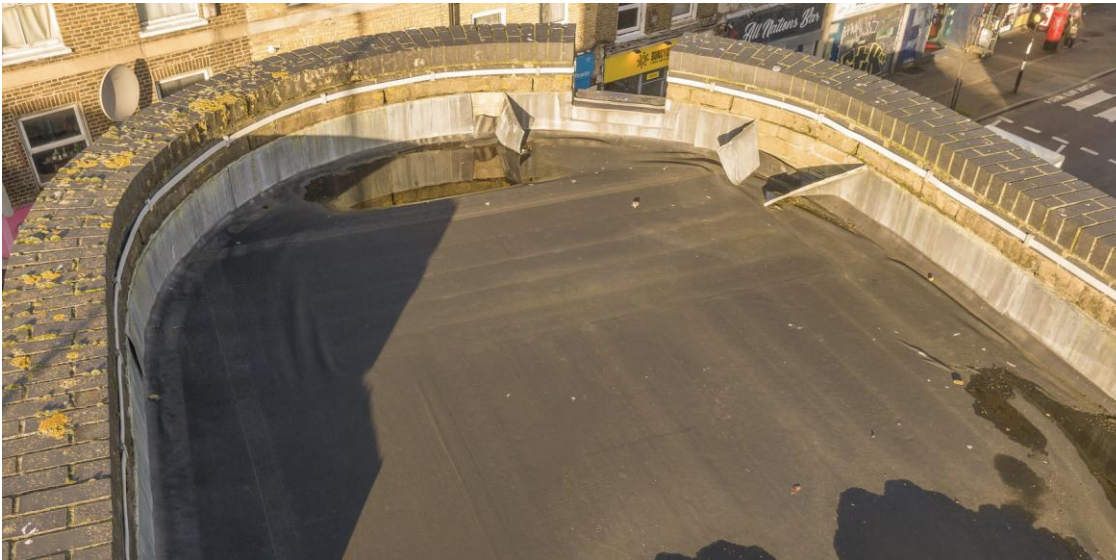
B3

This roof could only be inspected via the drone photographs. This roof consists of a single ply membrane covering, with a concealed central gully which has a plastic balloon wire installed to prevent debris becoming lodged within the downpipe.

In summary the roof and associated details reaching the end of useful life.

Our recommendation would be to replace the roof and all associated details and upgrade the thermal performance to at least the latest building regulation.

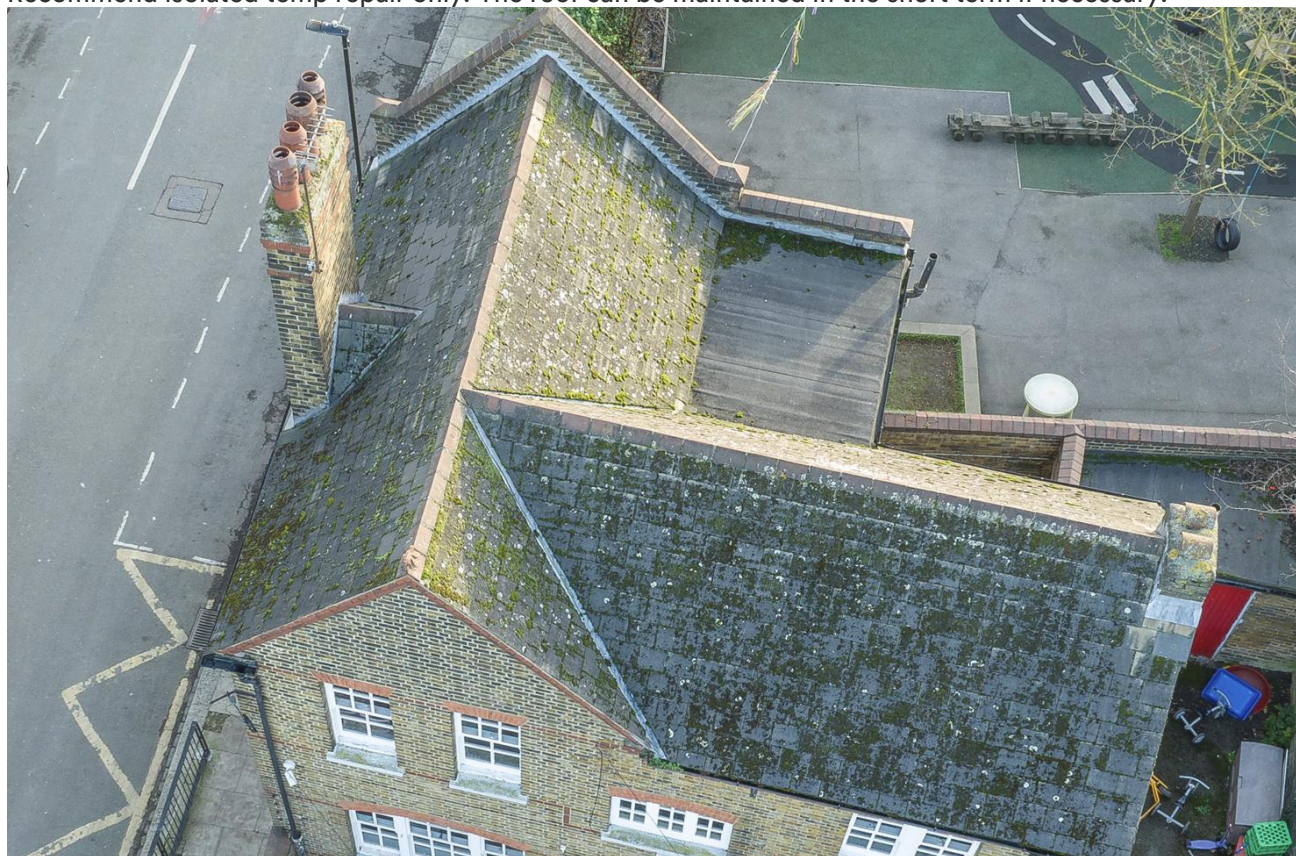
Roof D1

A timber fascia board has been provided to the perimeter of the building, the timber fascia is exhibiting signs of early timber decay, and we would recommend that the fascia's are replaced with a new uPVC fascia board which is less extensive from a maintenance point of view.

Recommend isolated temp repair only. The roof can be maintained in the short term if necessary.
