# The Mulberry Primary School – Condition Survey Report

London Borough of Haringey

March 2026

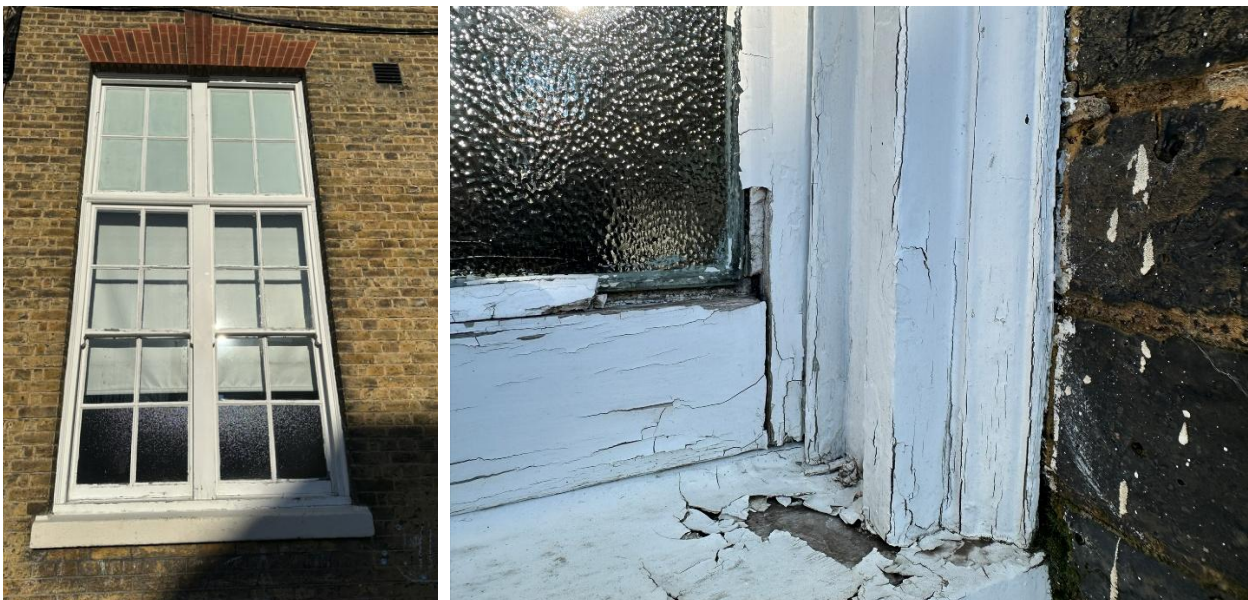
##### W/A/G25

*Poor condition of timber double hung sashes*

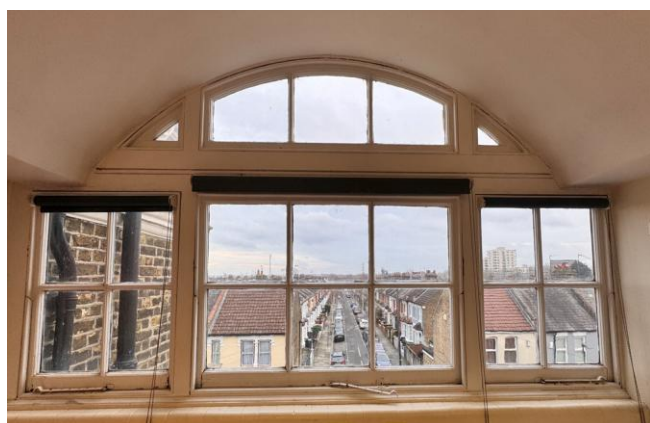
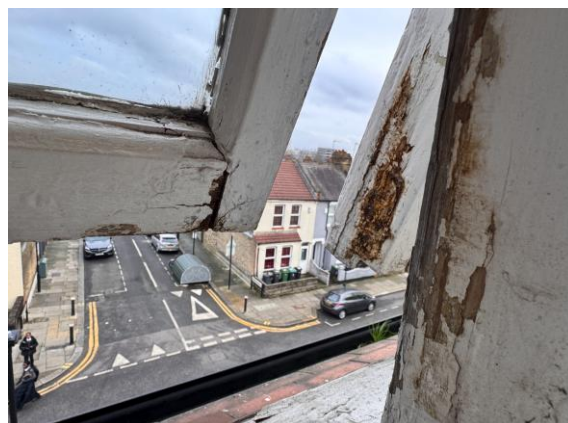
W/A/D05

*Poor condition of timber casement sashes*

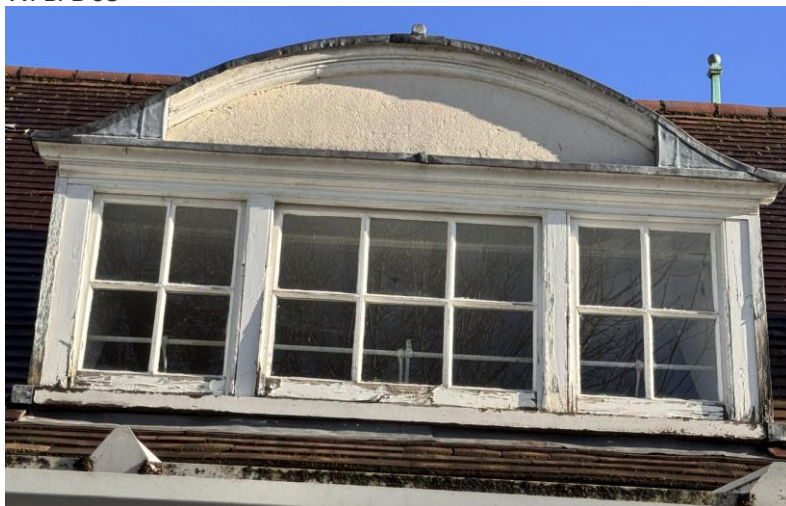
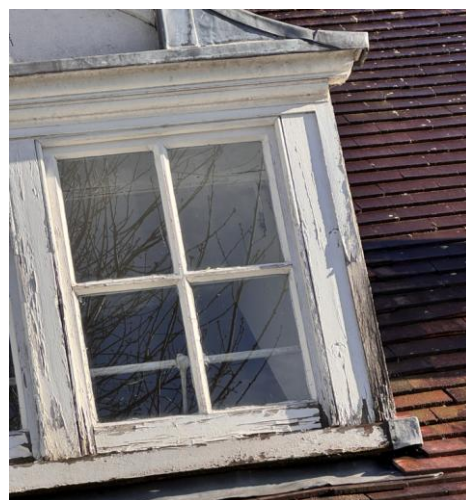
W/B/D09

External windows are in poor condition. The windows were either fixed or painted shut. There were panes of broken glass, defective sash cords, parting and cover beads. Where we could open windows, they were difficult to open, with poor ironmongery. All windows require extensive easing and adjusting, repairs and replacement of ironmongery. Decorations are poor. Although some windows could be repaired and replaced as required, they will only provide a further 10-year life expectancy if well maintained. Heat loss will continue, and further deterioration will occur. They will remain a continual maintenance liability.

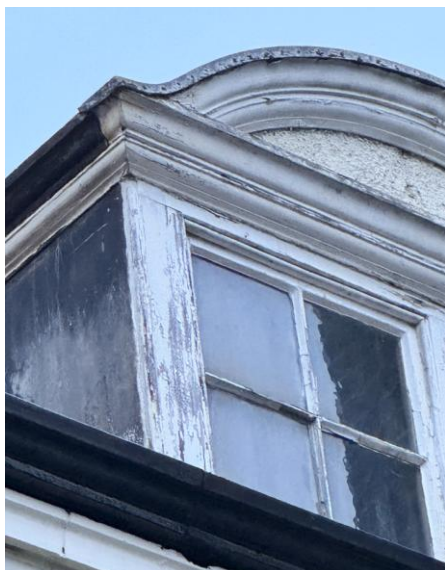
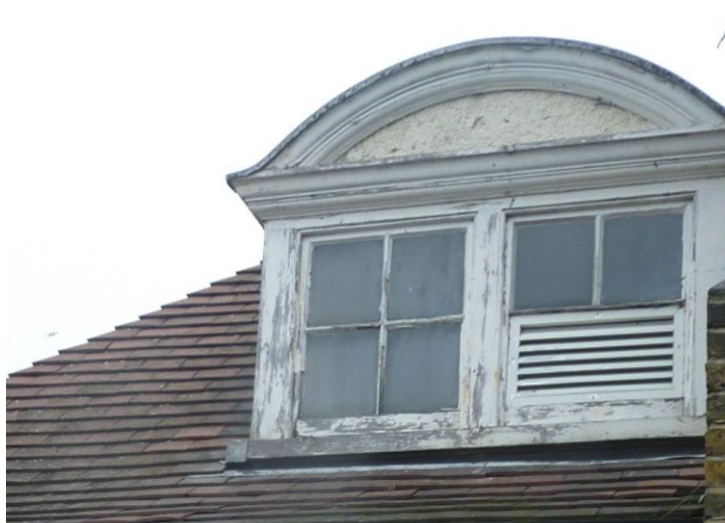
W/C/D04

External timber windows are in a poor condition. Some windows are painted shut. There were panes of broken glass and defective sash cords. Where we could open windows, they were difficult to open, with poor ironmongery. All windows require extensive easing and adjusting, repairs and replacement of ironmongery. Decorations are poor. Although some windows could be repaired and replaced as required, they will only provide a further 10-year life expectancy if well maintained. Heat loss will continue, and further deterioration will occur. They will remain a continual maintenance liability. The more modern aluminium replacement windows are in reasonable condition, require easing and adjusting and refixing of ironmongery for correct operation.

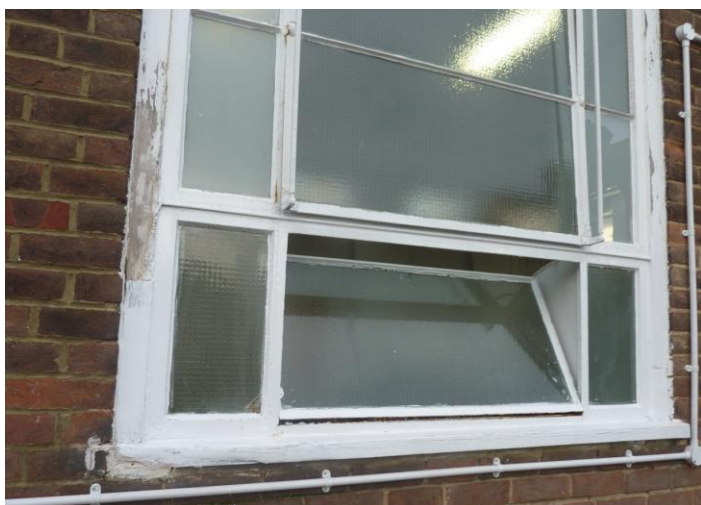
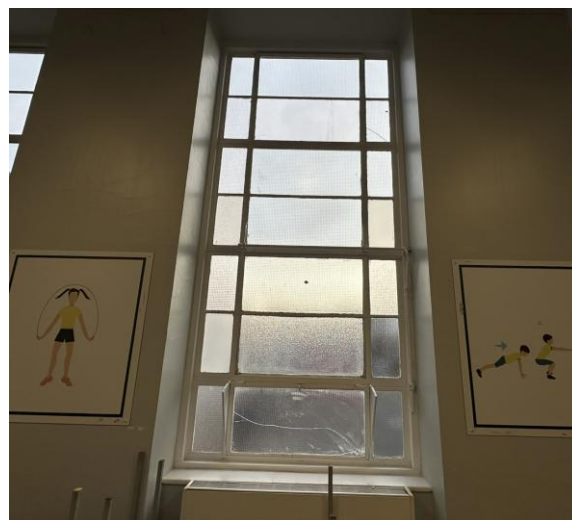
External metal casement windows in timber surrounds are in poor condition and have reached the end of useful life. There were panes of broken glass, rusting and timber decay. Where we could open windows, they were difficult to open, with poor ironmongery. Decorations are poor. The more modern uPVC replacement windows are in reasonable condition, require easing and adjusting, refixing of ironmongery for correct operation. These windows also require winding gear so they can be operated correctly.

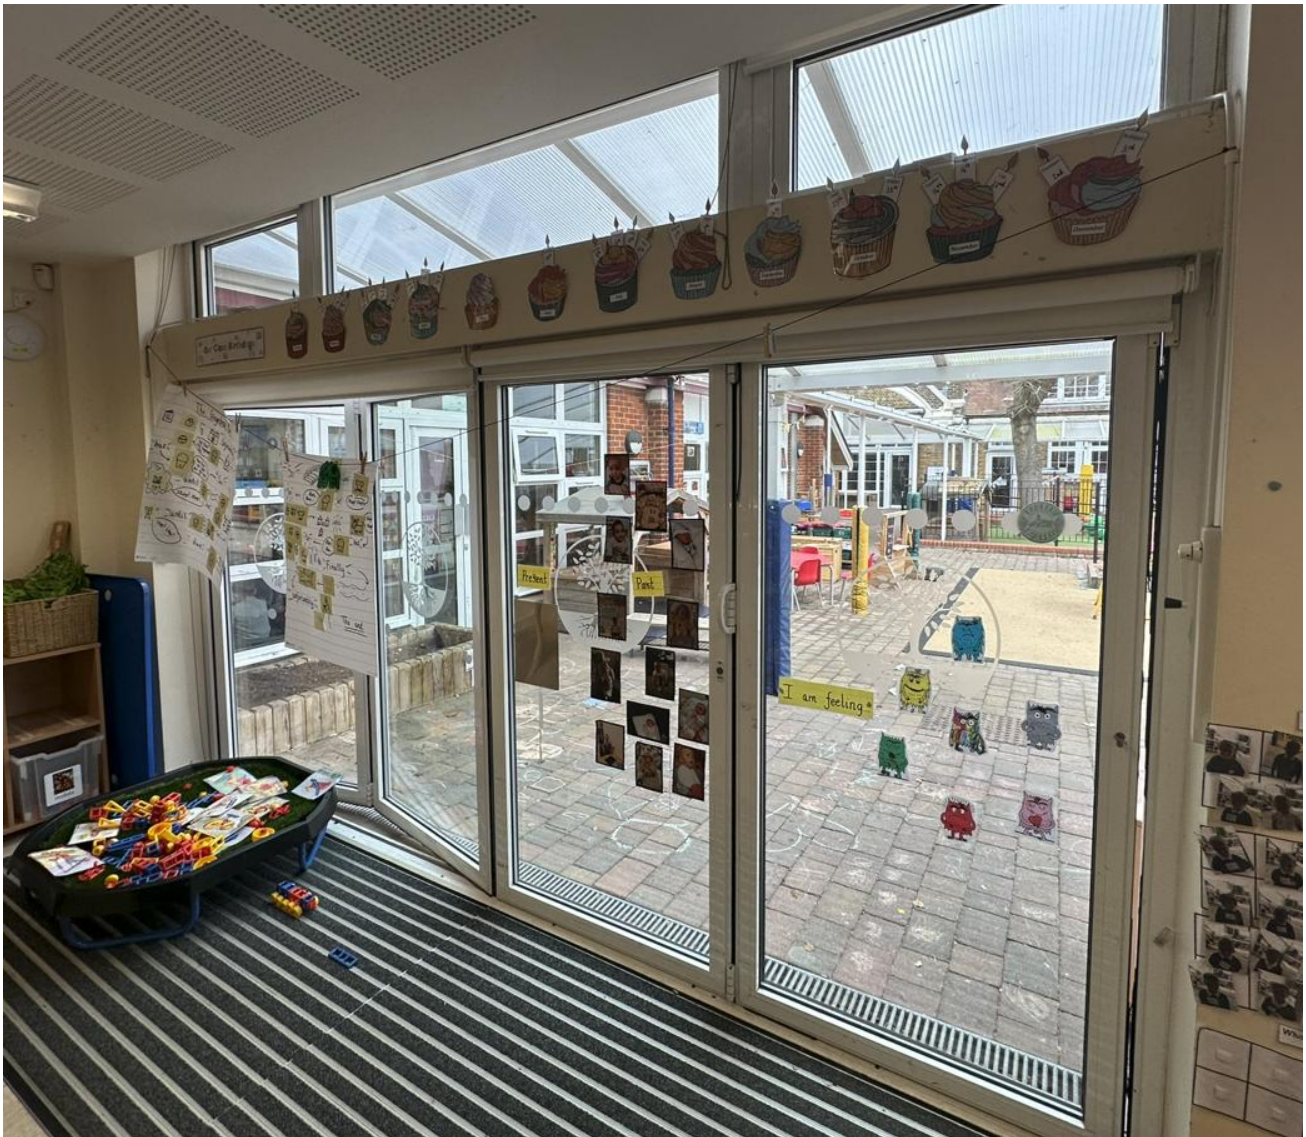
W/E/G04

This building was of more recent construction and in reasonably good condition for its age. Minor repairs are required to the roof and external windows and doors would benefit with easing and adjusting for correct operation.

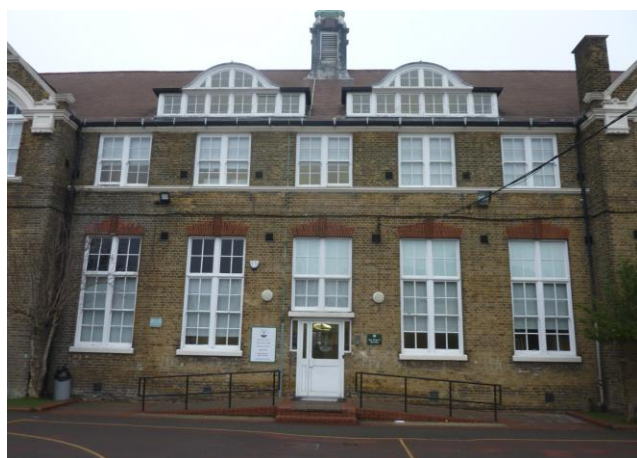
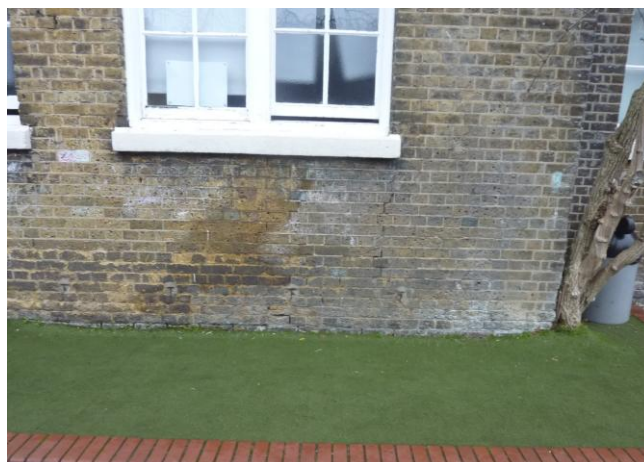
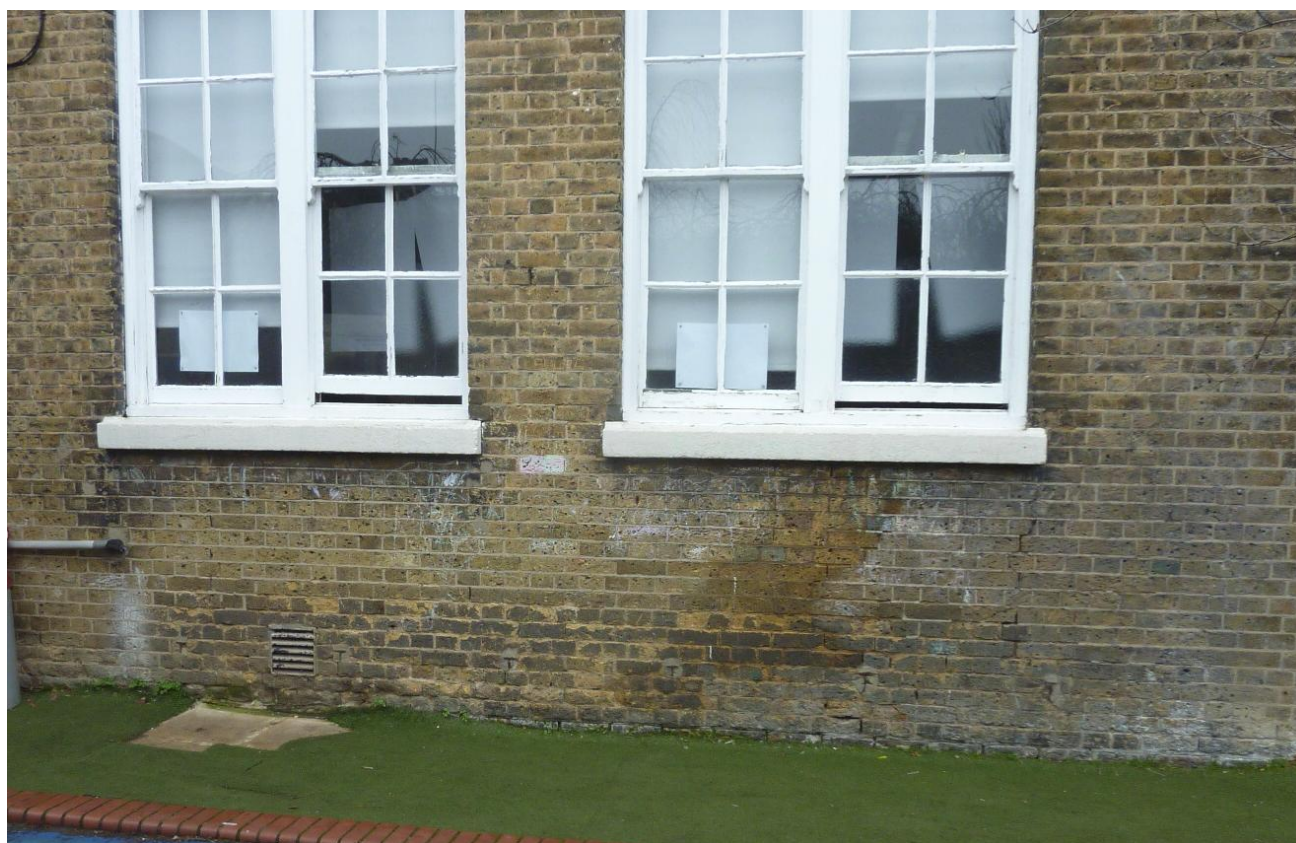
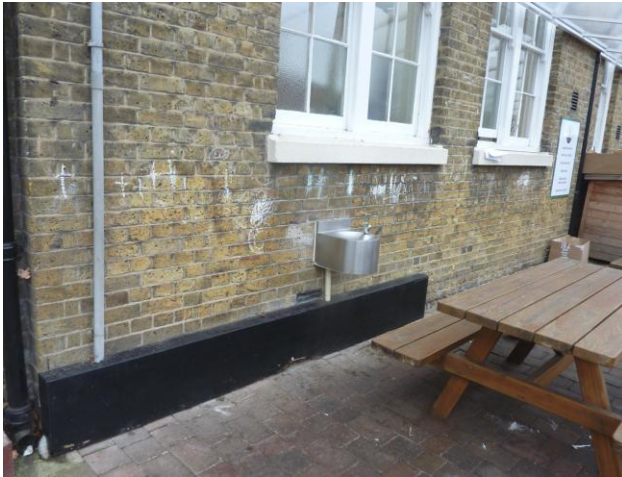
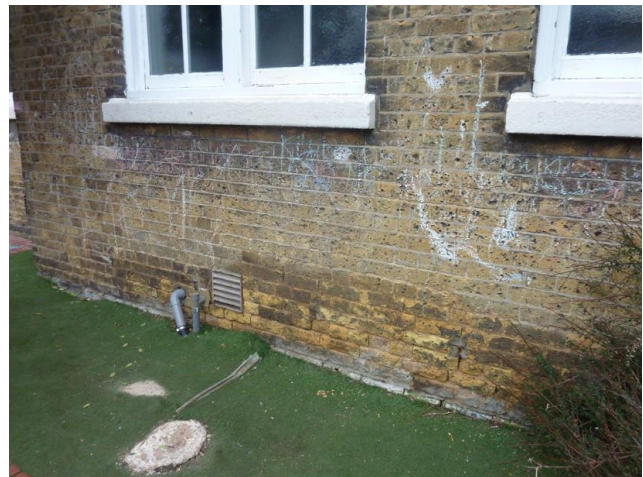
External walls are sound, although there are several items of repairs required to prevent further deterioration. The external walls to the property are generally constructed with 338mm yellow London stock solid brickwork. Red stock gauged arches have been provided to windows, mainly at first floor level. Isolated damage has been caused to the leading edge of the projecting stone corbels and requires specialist repair. Isolated staining has occurred to the brickwork, notably from leakage of rainwater goods.

To all elevations, there are isolated defective bricks, possibly the result of frost action. We recommend that all defective bricks are carefully cut out and replaced, to ensure that further deterioration of the brickwork does not occur.

To all elevations, there are isolated areas of defective pointing. We recommend that all pointing is carefully raked out and replaced, to ensure that further deterioration of the brickwork does not occur.

These patches would benefit with a clean. Fracturing to the cills should be pointed in. Further vegetation is growing close to other windows on the same elevation. Again, we recommend removal to ensure no future damage to the building.

Our recommendation would be to undertake repair works as outlined.

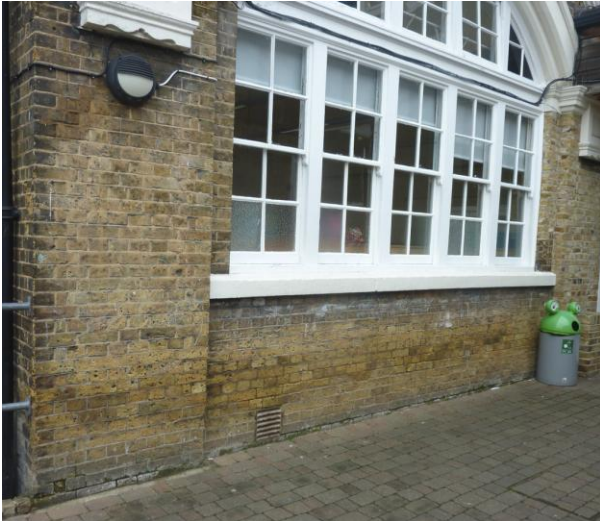
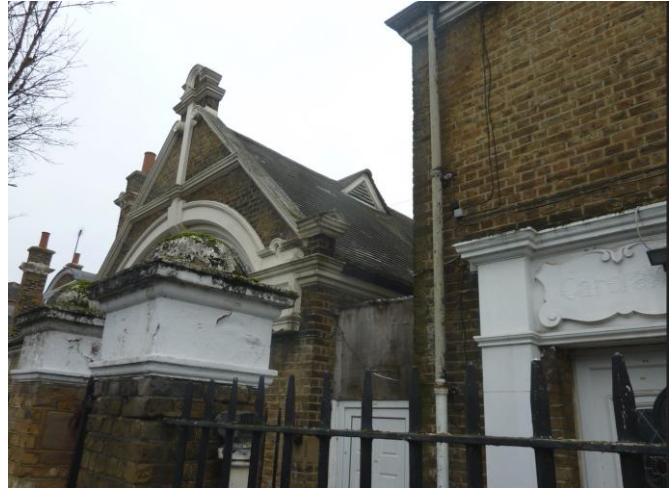
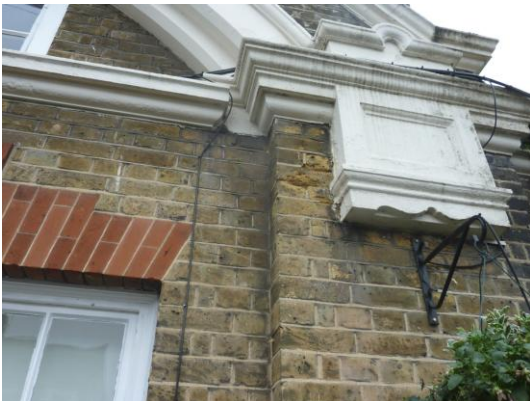
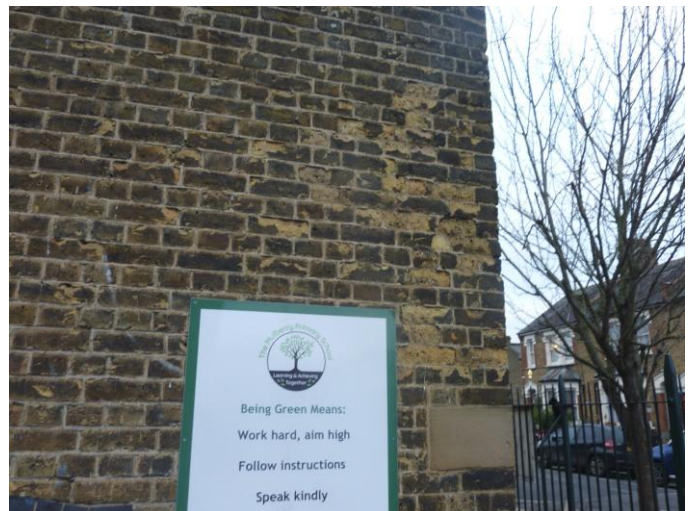
Heavy vegetation growth is evident which needs to be removed and is likely to have damaged the brick and stonework. There are some larger trees/plants in this location which should also be removed to prevent further damage to the building. We recommend allowance made at this stage for provisional repairs.

Isolated staining has occurred to the brickwork, particularly to the front elevation notably from leakage of rainwater goods, vegetation growth and leaking external plumbing. These patches would benefit with a clean. Ivy and other plant growth has also occurred on the front elevation. This should be removed and the plants killed as ivy growth can damage the face of the brickwork.

Alterations have been undertaken to the left-hand gabled projection to the western elevation, to form a new combined window and door opening. New brick reveals have been provided with a flat concrete roof, lined in probably leadwork. The covering required redressing. There does not appear to be an upstand with the adjoining brickwork. We also recommend that a proper lead upstand and flashing be provided. Electrical cabling on the roof will need to be moved and repositioned.

To all elevations, there are isolated defective bricks, possibly the result of frost action. We recommend that all defective bricks are carefully cut out and replaced, to ensure that further deterioration of the brickwork does not occur

To all elevations, there are isolated areas of defective pointing. We recommend that all pointing is carefully raked out and replaced, to ensure that further deterioration of the brickwork does not occur.

There are several old fixings, redundant services etc., fixed to the elevations, which should be removed and made good.

Our recommendation would be to undertake repair works as outlined.

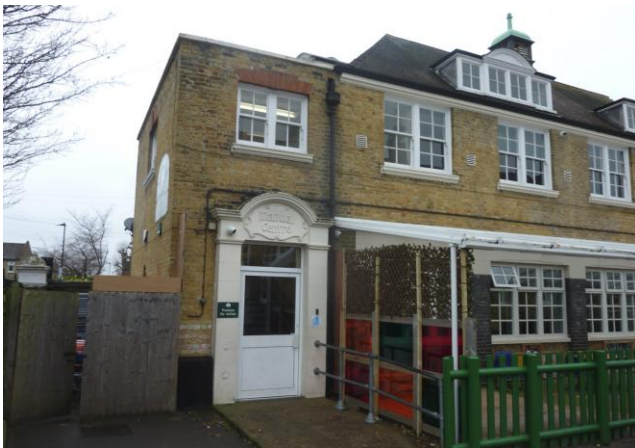
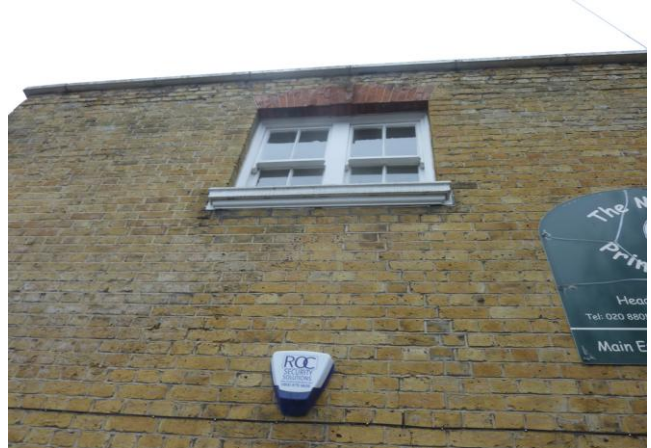
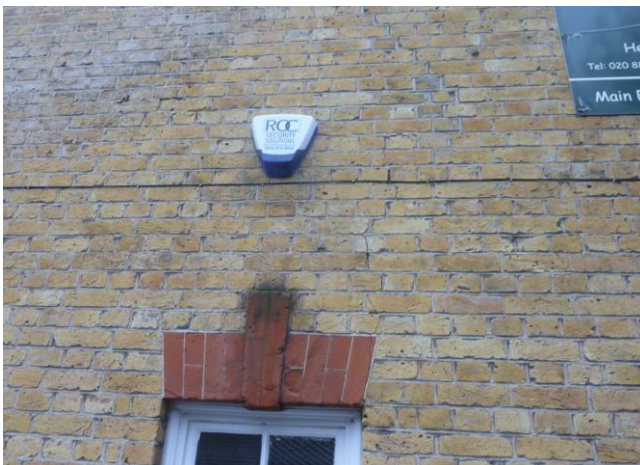
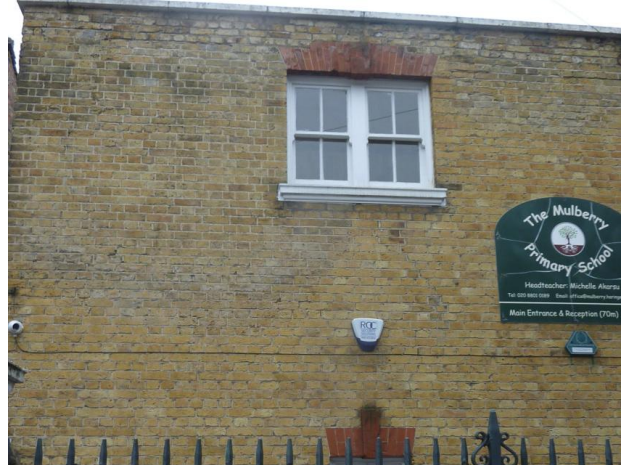
External walls are mainly sound, although there are items of repairs required to prevent further deterioration. The rear wall to the southern side facing the adjoining building appears poor and requires replacement of spalled bricks and repointing.

The red stock arch to the first-floor window to the eastern elevation is of poor quality. The surface of the bricks has spalled and the pointing is poor. Repairs have been undertaken in the past but have failed. We are of the opinion that this arch should be rebuilt to match existing.

To the lower window east elevation, 1nr brick is damaged and should be repaired with a matching brick.

A fracture has occurred to the eastern elevation brickwork, between the head of the ground floor window, extending to the cill of the window above. This fracture is historic and we suspect further significant movement unlikely. The fracture should be pointed in.

Most of the rear south elevation facing the adjoining property was only visible from the drone. However, we noted poor pointing and several spalled bricks. We recommend an allowance is included for cutting out and

To the front elevation above there is a red stock arch, which is of poor quality. Repairs have been undertaken in the past to a poor standard. The surface of several bricks has spalled and the pointing is poor. The defective bricks should be repaired and the arch repointed.

To all elevations, there are isolated areas of defective pointing. We recommend that all pointing is carefully raked out and replaced, to ensure that further deterioration of the brickwork does not occur. To the rear southwestern corner, there is dead plant growth attached to the wall, which should be removed and made good.

replacing defective bricks as required. In addition, it would be prudent to allow for the entire repointing of this rear elevation.

Our recommendation would be to undertake repair works as outlined.

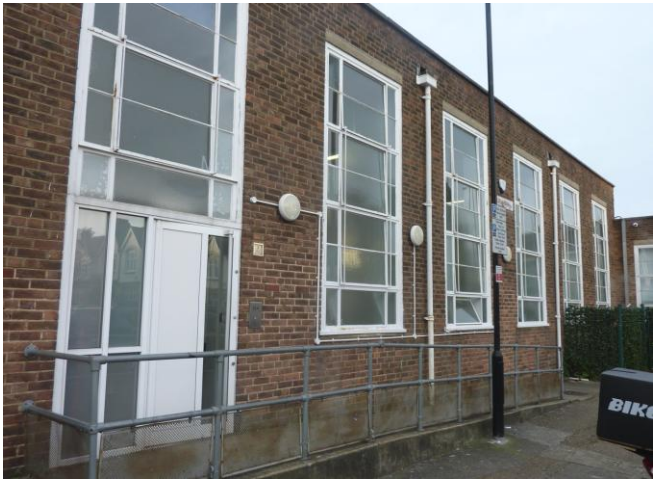
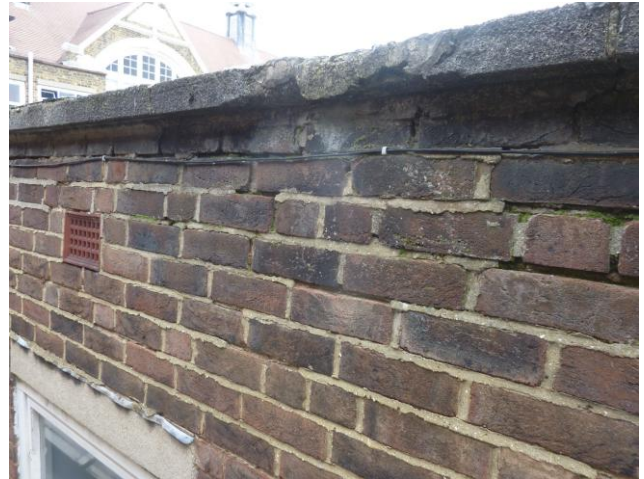
To all elevations, there are isolated defective bricks, possibly the result of frost action. We recommend that all defective bricks are carefully cut out and replaced, to ensure that further deterioration of the brickwork does not occur

To all elevations, there are areas of defective pointing. We recommend that all pointing is carefully raked out and replaced, to ensure that further deterioration of the brickwork does not occur.

Our recommendation would be to undertake repair works as outlined.

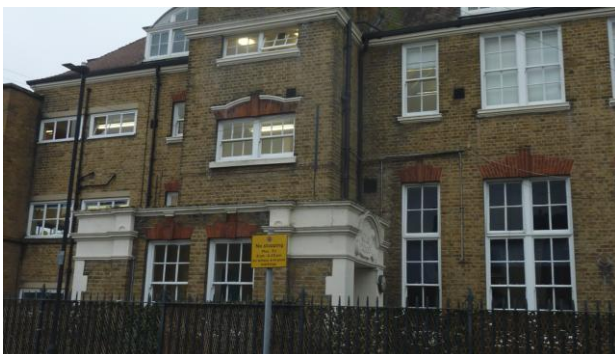
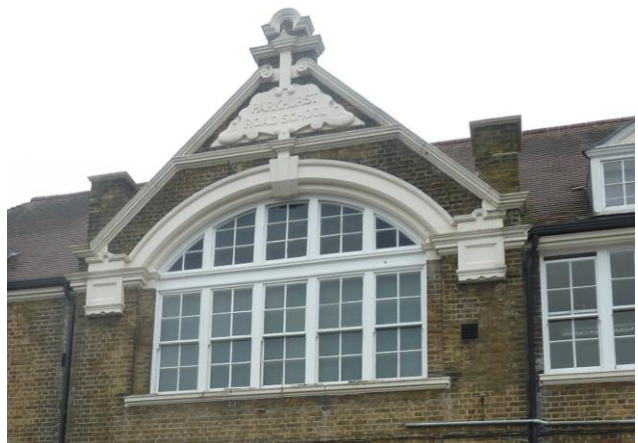
To the main entrance, there is a stone surround and ornate integral signage above the door, decorated. Surface damage caused by old fixings require making good. The upper arch is heavily covered in moss, and requires cleaning off, prior to decoration.

To the main entrances to the eastern side there is a stone surrounds and ornate integral signage above the door, decorated. Surface damage caused by old fixings require making good. The upper arch is heavily covered in moss, and requires cleaning off, prior to decoration. Minor pointing to open joints required.

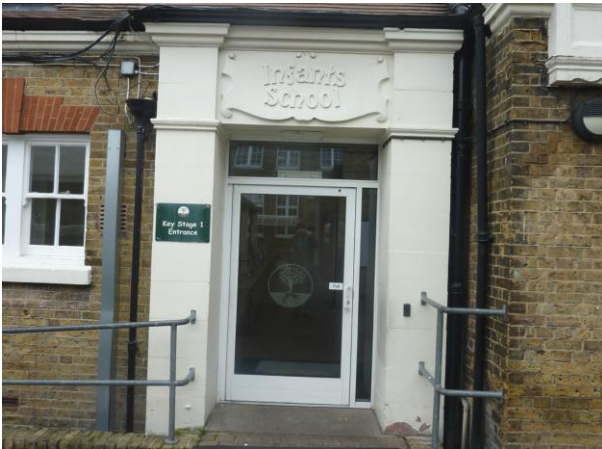
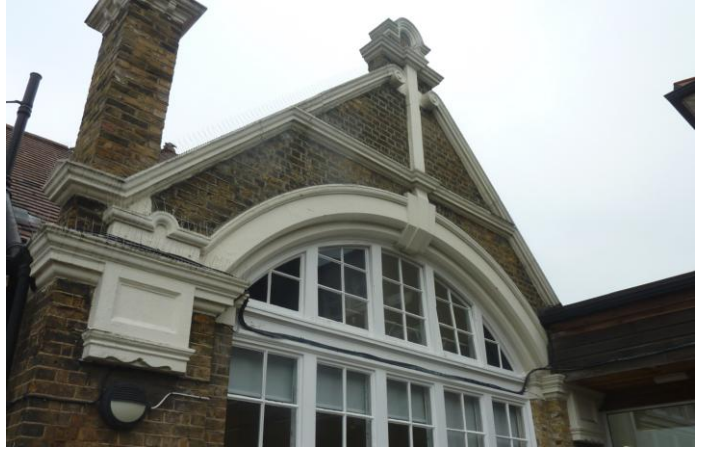
To the main entrance to the southern side accessed from the playground, there is a stone surround and ornate integral signage above the door, decorated. Surface damage caused at low level to the surface, which requires refacing, prior to decoration.

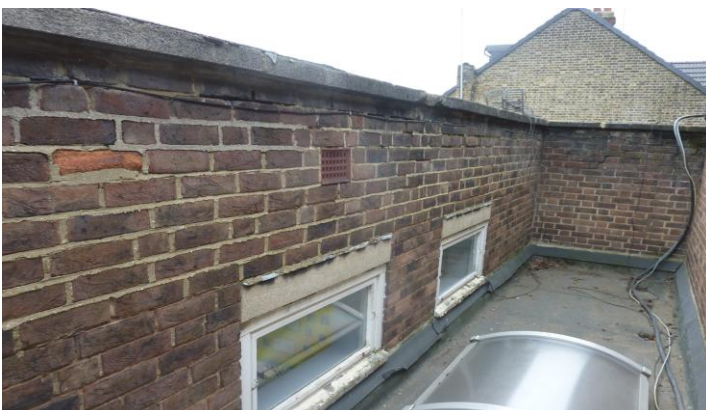
Evidence of defective pointing to the copings, copings are poor and should be removed and replaced. Expansion joints have not been provided, and we recommend that expansion joint be provided. In conjunction with roof replacement, all copings should be removed and re bedded on a new damp proof course.

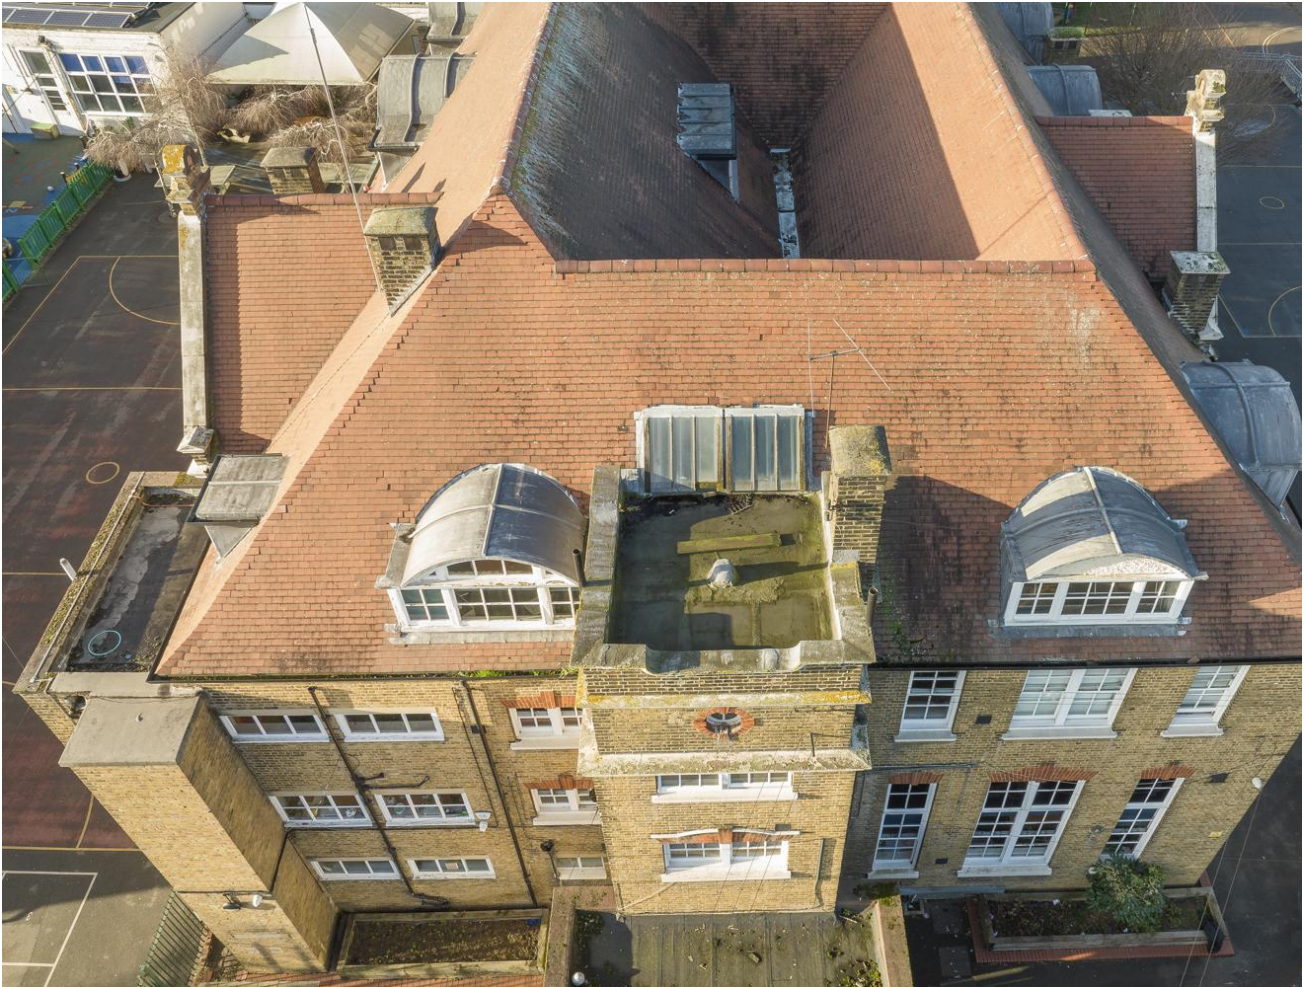
Main roof- Block A

In summary the roof and associated details are reaching the end of useful life.

We are seeking permission to repair the roof by removing broken tiles and replace with new. This will include the general repair/renewal of rainwater goods and associated roof details as noted above.

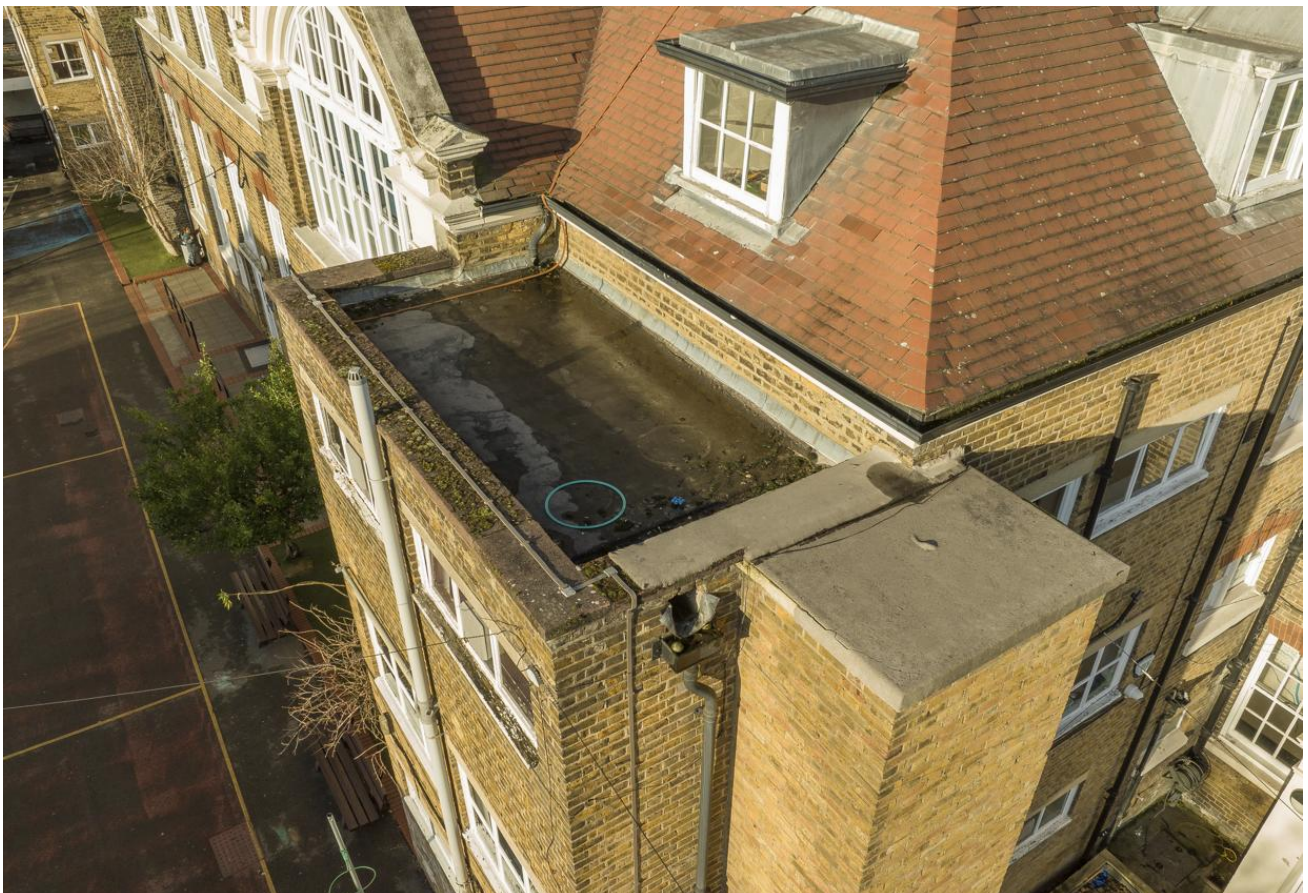
There is 1nr cast iron hopper and downpipe. There is evidence of surface rusting and joint leakage, and the downpipe was blocked at the time of inspection.

We are seeking permission to replace the roof and all associated details and upgrade the thermal performance to at least the latest building regulations. The downpipe and hopper should be replaced. The lightning conductor will need removal and reinstatement.

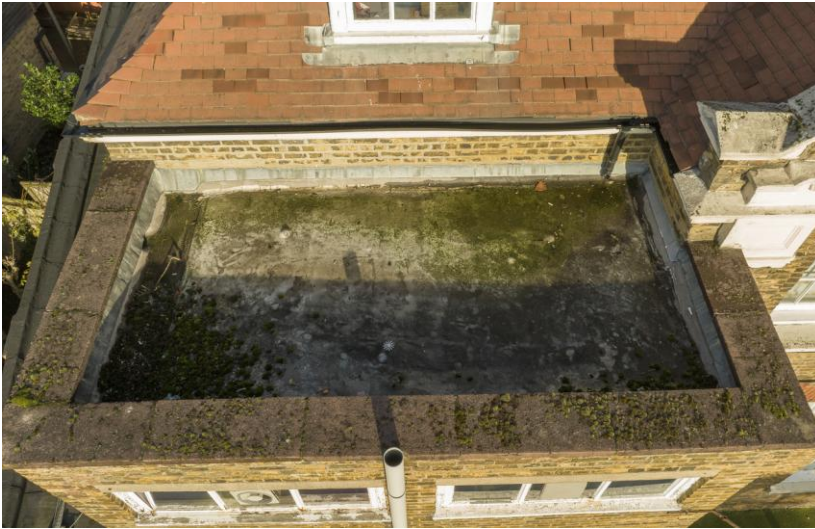
This roof is flat and covered with asphalt with asphalt dressed up the perimeter upstands and with lead flashings. Where inspected, the roof covering is of some age. Water retention and moss staining, suggesting poor falls to the rainwater outlet. The asphalt has blistered and cracked. Past repairs and plant growth. There was no evidence of water penetration below this roof at the time of inspection. We cannot confirm if the roof is insulated.

We are seeking permission to replace the roof and all associated details and upgrade the thermal performance to at least the latest building regulations. The downpipe and hopper should be replaced.

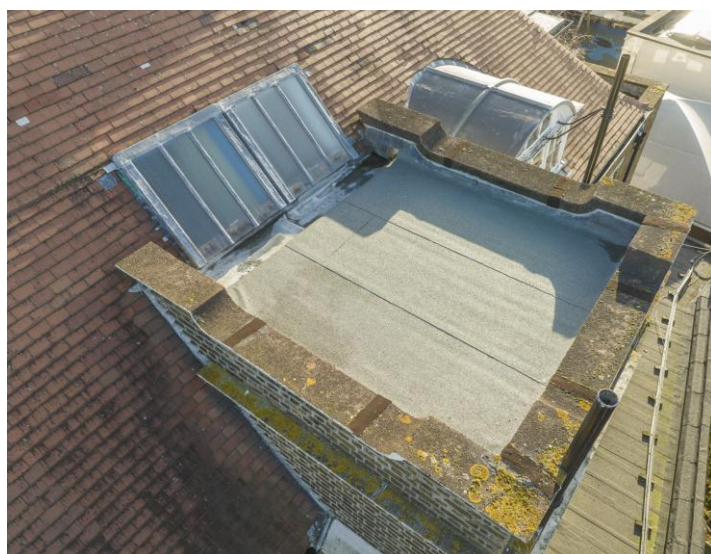
appears a temporary repair where inspected. Exposed leadwork is of considerable age. We cannot confirm if the roof is insulated. This roof has reached the end of useful life and requires replacement. Rainwater discharges through a chute onto a lower lead roof shared with the adjoining dormer projection and then into what appears an aluminium gutter and downpipe, discharging onto a lower roof.

The roof covering is poorly installed and appears a temporary repair. We are seeing permission to replace the roof and all associated details and upgrade the thermal performance to at least the latest building regulation. The downpipe and gutter should be replaced.

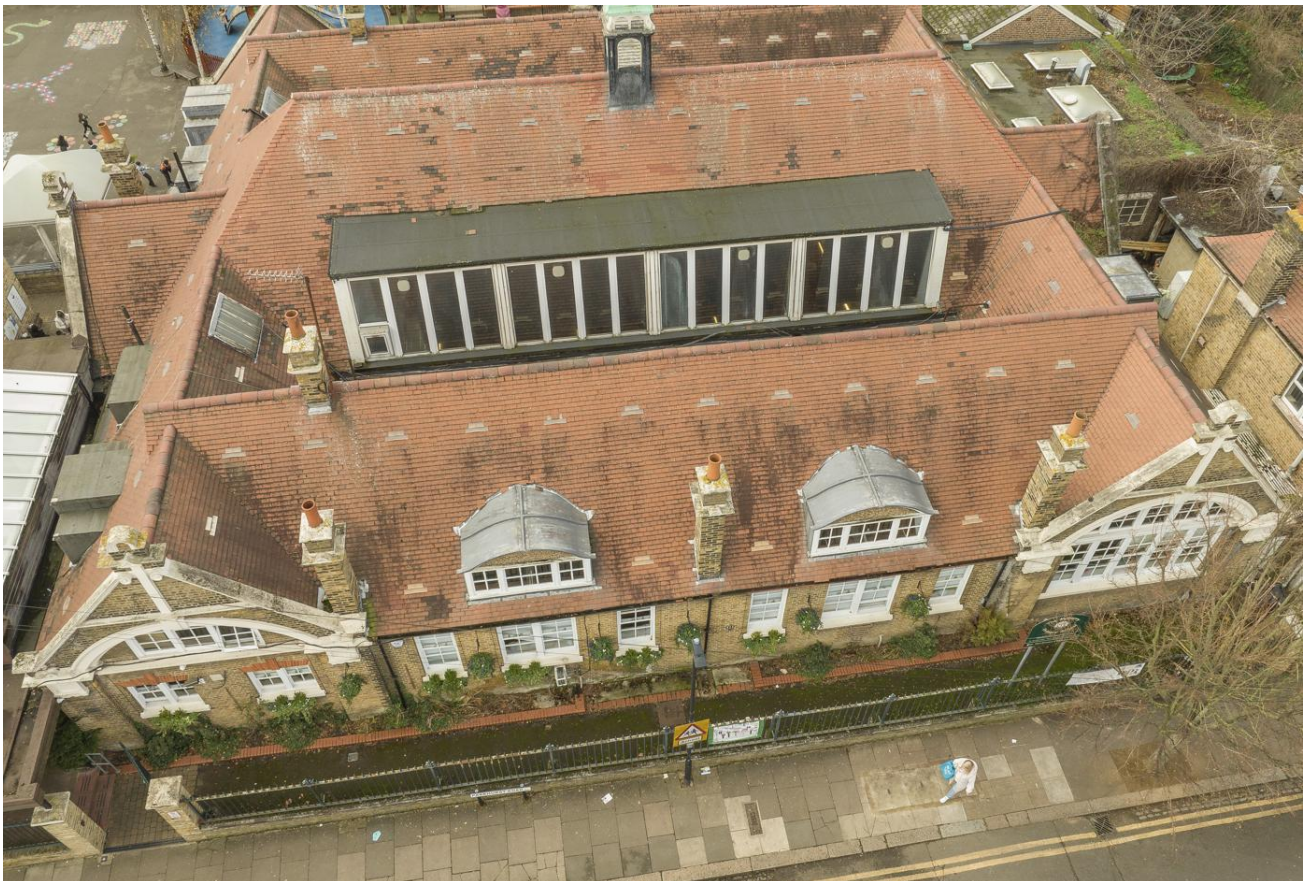
In summary the roof and associated details have reached the end of economic useful life.

We are seeking permission to repair the roof by removing broken tiles and replace with new. This will include the repair/renewal of internal valley gutters to dormer windows and general repair/renewal of rainwater goods and associated roof details as noted above.

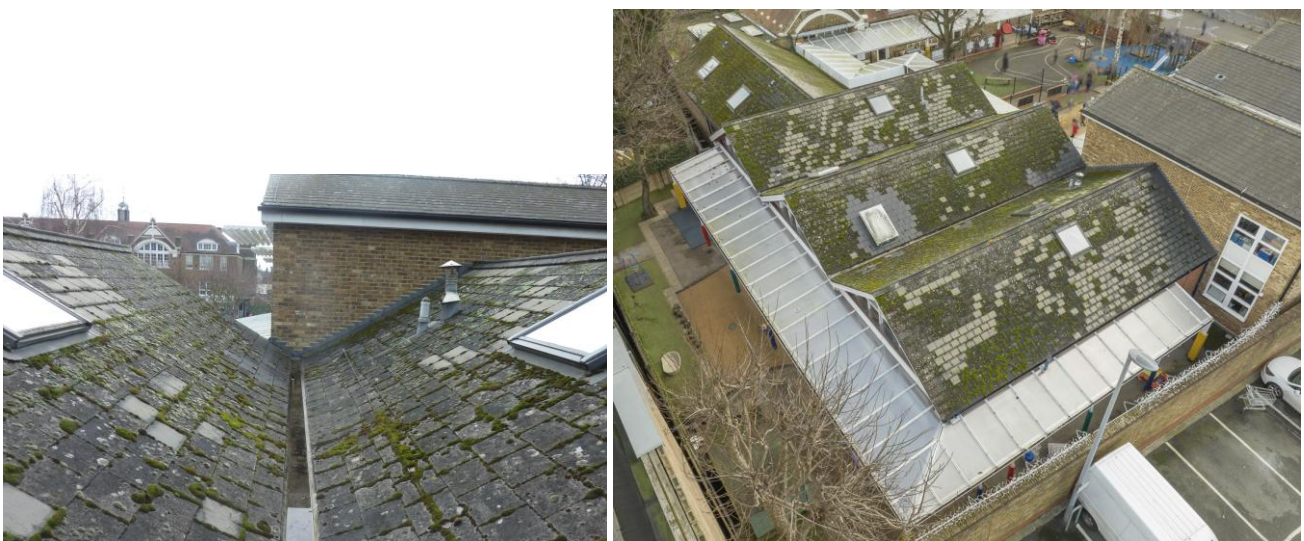
There is a section of aluminium powder coated and pvc guttering and downpipes at low level to the southern side, fixed to timber fascia and guttering. There is evidence of poor falls, joint leakage and blockage. These should be removed, overhauled and repositioned. The soffit and fascia are decayed in two areas, and these should be replaced in uPVC in conjunction with roof repair works.

We are seeking permission to repair the roof by removing broken slates and replace with new. This will include the repair/renewal of internal valley gutters and general repair/renewal of rainwater goods and associated roof details as noted above.

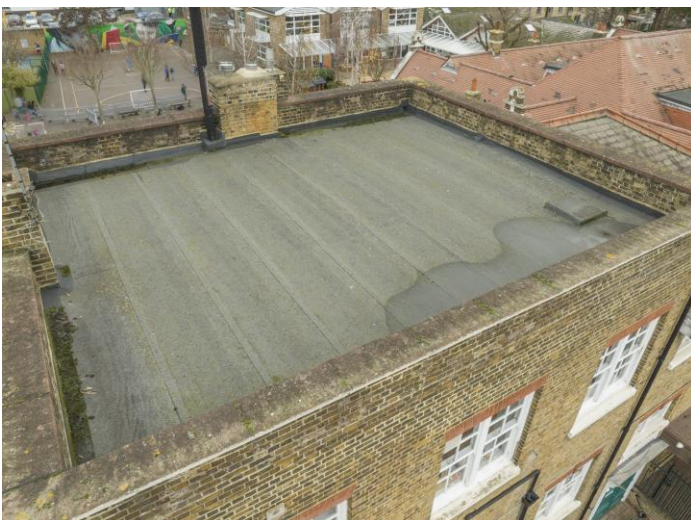
Although not significantly leaking at the time of our inspection, we suspect that this roof is of some age and will have a maximum life expectancy of 5 years.

We are seeking permission to overlay the roof and upgrade the thermal performance to at least the latest building regulations. The downpipe and hopper will be overhauled and retained.

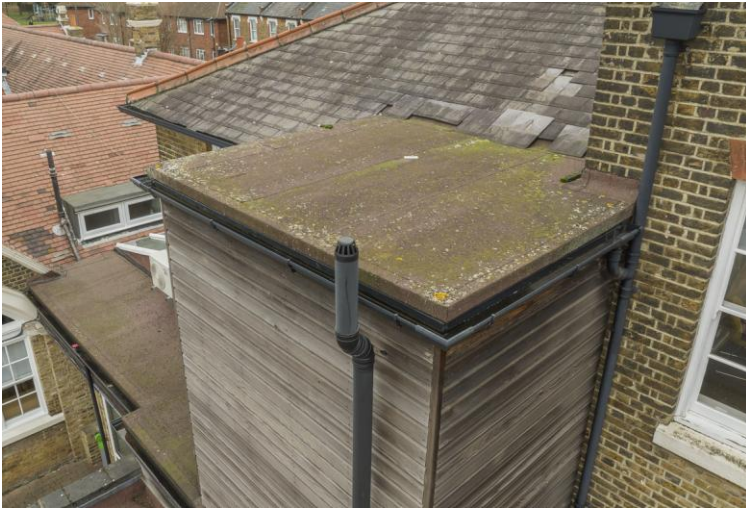
We suspect that this roof is of some age and has been possibly leaking which requires further inspection. If well maintained may last another 5-10years, but we cannot guarantee this.

We are seeking permission to replace the roof and all associated details and upgrade the thermal performance to at least the latest building regulations. The downpipe and hopper should be overhauled and retained.

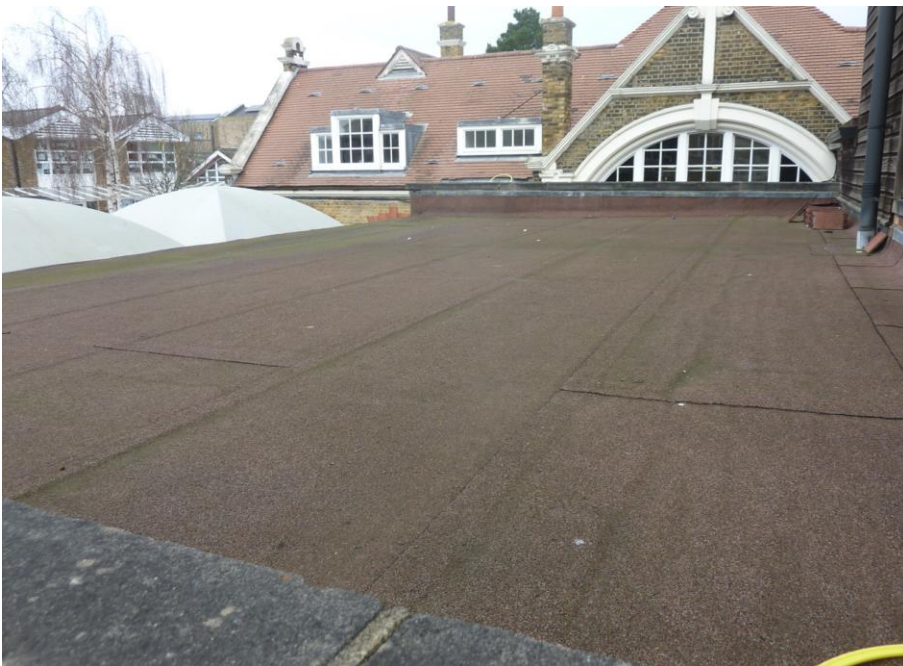
We suspect that this roof is of some age. If well maintained may last another 5-10 years, but we cannot guarantee this.

We are seeking permission to replace the roof and all associated details and upgrade the thermal performance to at least the latest building regulations. The gutter and downpipe should be overhauled and retained.

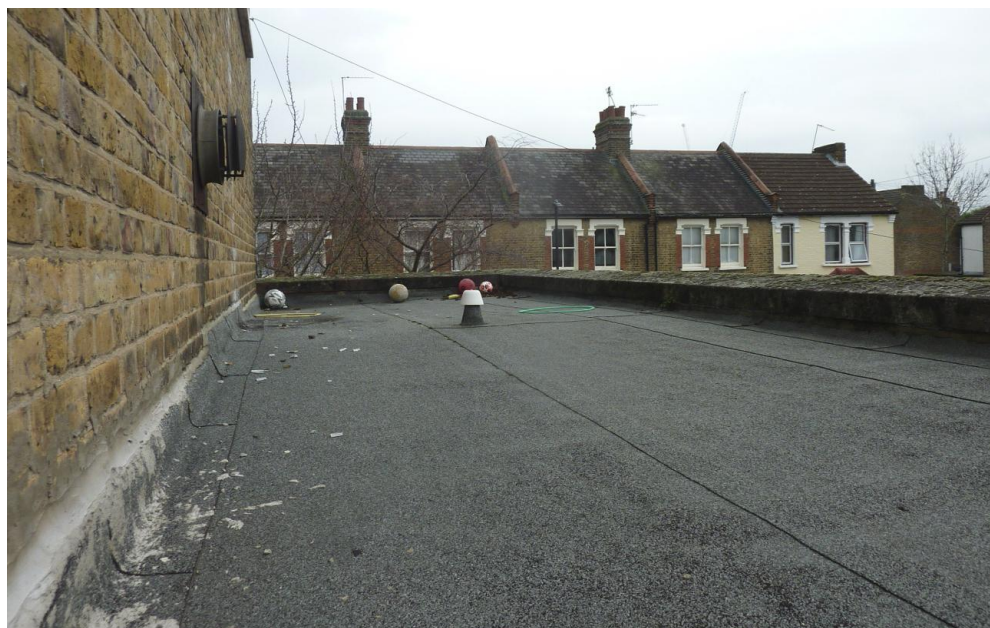
This roof is flat and covered with mineral felt with felt upstands dressed up the perimeter upstands. The upstands are of limited height below adjoining windows, that will lead to early deterioration. We suspect that this roof is in excess of 10 years old. Water retention is evident, suggesting poor falls to the rainwater outlets.

We are seeking permission to overlay the roof and upgrade all associated details including upgrading the thermal performance to at least the latest building regulations. The downpipes and hoppers will be repaired/renewed.
