# Site Investigation Report

191036.1.USI

Auger were commissioned by Sedgwick International UK to undertake a site investigation and CCTV inspection of the underground drainage within the area of concern (AOC) at the property.

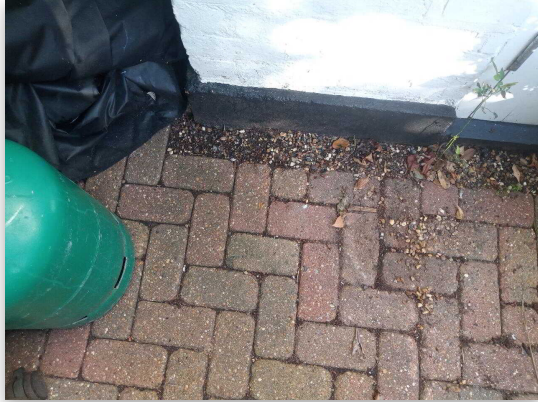
Fig 1.1: Trial Hole 1 Location

Within Trial hole 1 we revealed the footing and augered to the required depth (3m) in the proposed location. We took the requested soil and root samples. These measurements are shown in Trial hole log 1 below.

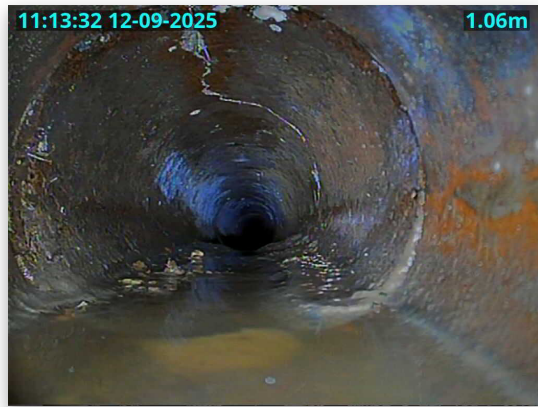
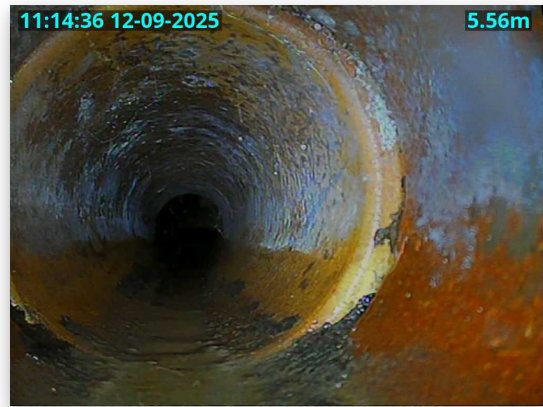
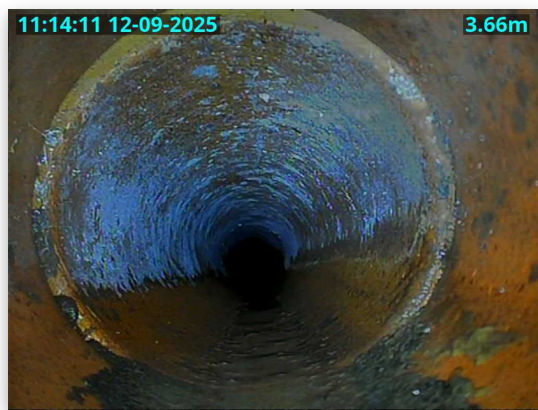
Our survey of line 4 revealed root ingress, joint displacements and fractures within the 6.3m of pipework between the 2 manholes. We had found scale within the line but had removed this whilst on site.

Fig 2.1: Line 4.

Fig 2.2: Line 4.

Fig 2.3: Line 4.

Install 6.3m of 100mm liner directly downstream of MH1 to MH3.

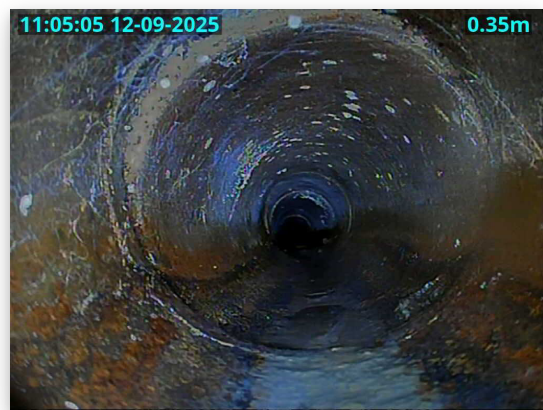
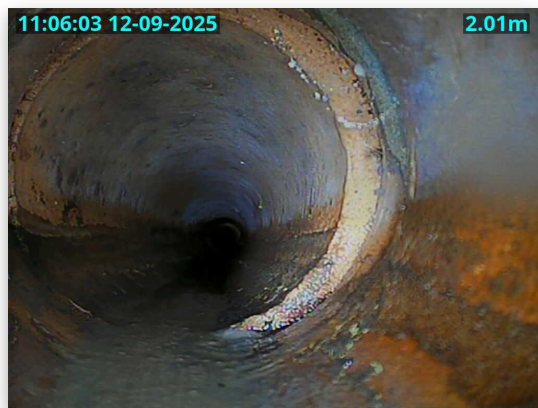
Our survey of line 2 revealed root ingress, joint displacements and fractures within the line. This included a fractured branch connection serving the SWG in the 3.5m run of pipework between the 2 manholes.

Fig 2.4: Line 2.

Fig 2.5: Line 2.

Install 3.5m of 100mm liner directly upstream of MH1 to MH2, covering over the defective branch connection.

Sonde, excavate and replace 1m of 100mm pipework including a the defective SWG branch connection approximately 0.8m upstream of MH1 at a depth no greater than 1.0m through block paving.
