# Schedule of Condition

Queen Street  
Tottenham  
London  
N17 8HZ

February 2026

**Reference** P2023-0756

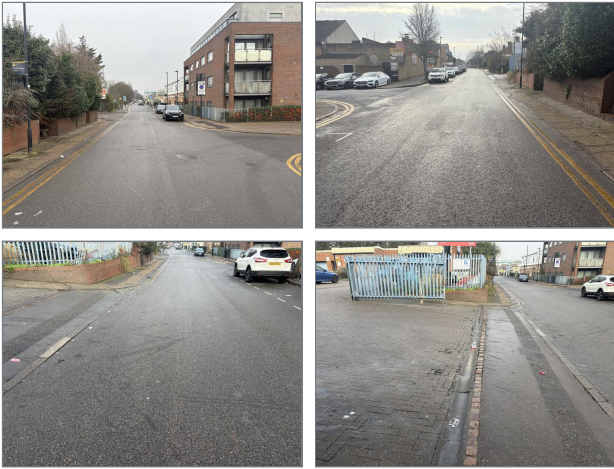
| Location | Element | Condition | Photographs | Photo No. |
|---|---|---|---|---|
| Zone 1 | Road | Entrance to Frontier Works is heavily scarred and drainage channel is significantly damaged and sunken. | | Photos [ 4 - 7 ] |

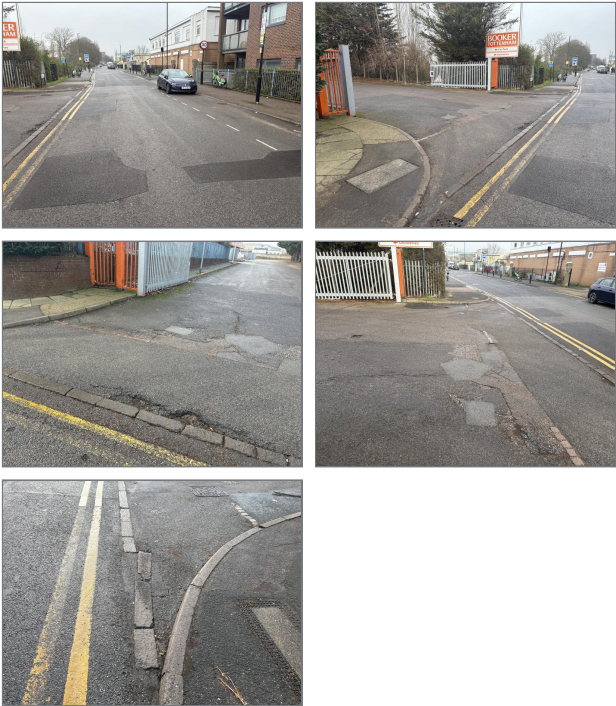
| Location | Element | Condition | Photographs | Photo No. |
|---|---|---|---|---|
| Zone 2 | Road | Cracked, rucked, and missing in part at entrance to retail park.<br>Damaged perimeter edging.<br>Patch repairs throughout. | | Photos [ 19 - 23 ] |

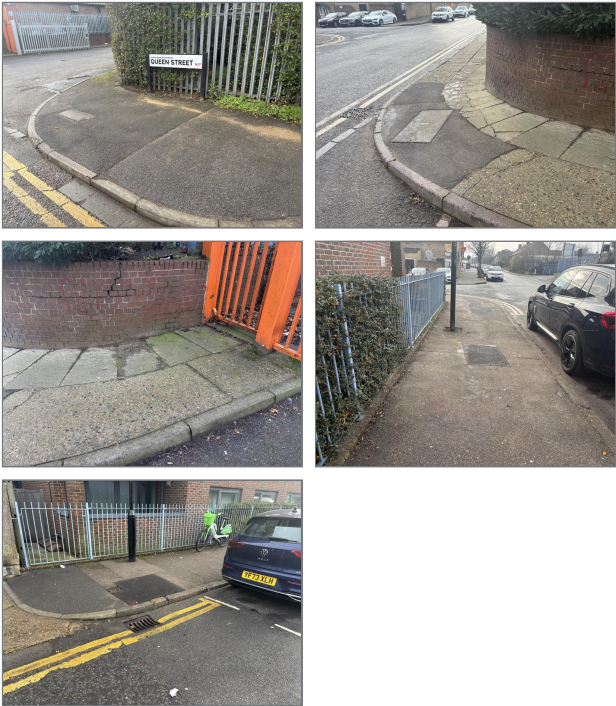
| Location | Element | Condition | Photographs | Photo No. |
|---|---|---|---|---|
| Zone 2 | Paving | Soiled throughout.<br>Kerbing damaged throughout.<br>Patch repaired throughout. | | Photos [ 24 - 28 ] |

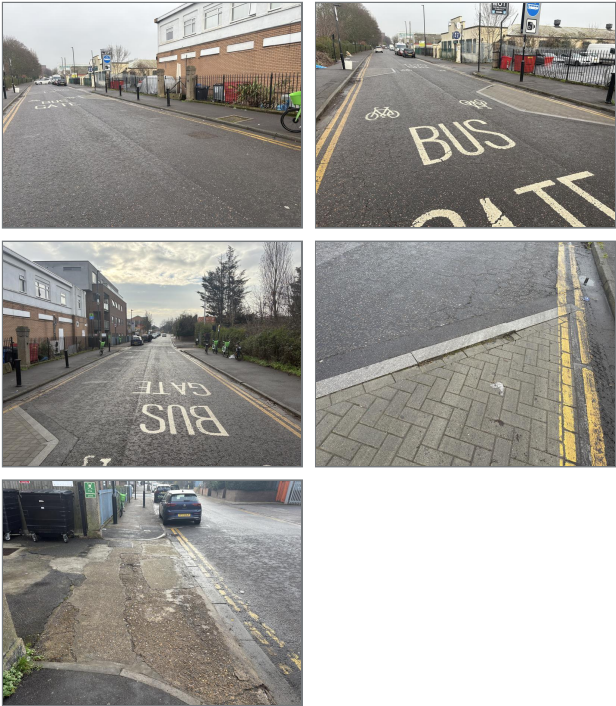
| Location | Element | Condition | Photographs | Photo No. |
|---|---|---|---|---|
| Zone 3 | Road | Concrete driveway is heavily cracked and scarred.<br>Edging to brick paviors is rucked. | | Photos [ 35 - 39 ] |

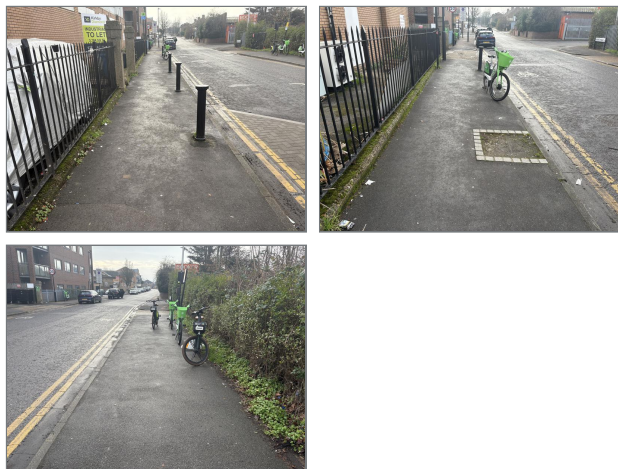
| Location | Element | Condition | Photographs | Photo No. |
|---|---|---|---|---|
| Zone 3 | Paving | No significant defects noted. | | Photos [ 40 - 42 ] |

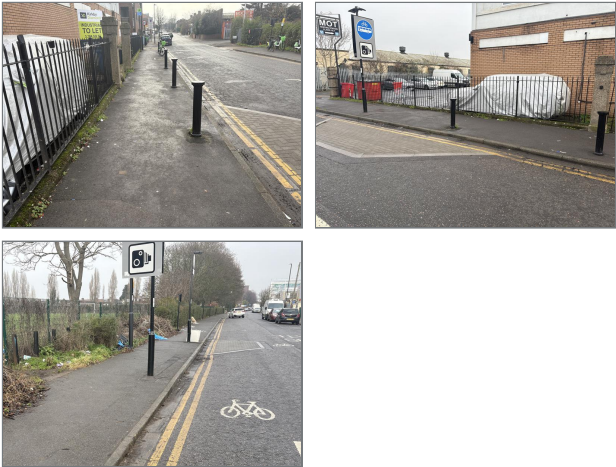
| Location | Element | Condition | Photographs | Photo No. |
|---|---|---|---|---|
| Zone 3 | Street Lights and Bollards | Scratched and scuffed throughout.<br>No significant defects. | The photographs show various street infrastructure. The top-left photo shows a row of black bollards along a sidewalk next to a black metal fence. The top-right photo shows a bollard near a building with a white tarp-covered object. The bottom-left photo shows a bollard next to a road with a bicycle symbol painted on it. | Photos [ 44 - 46 ] |

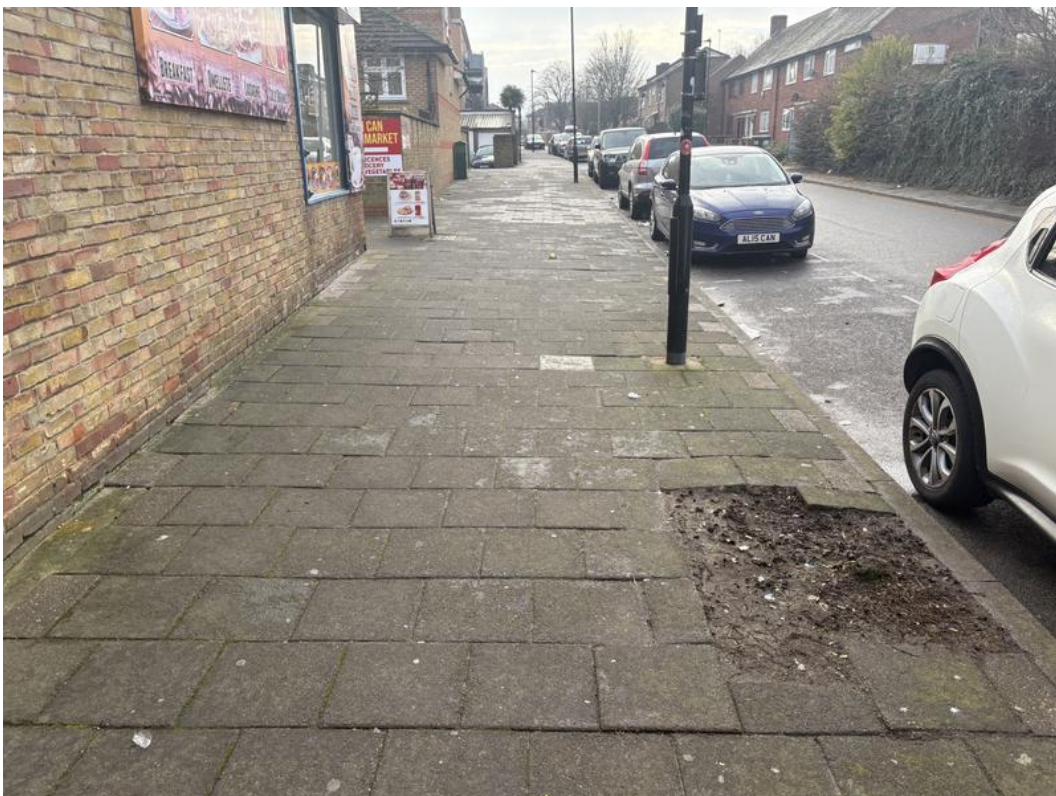
Photograph 8

| Location | Element | Condition | Photographs | Photo No. |
|---|---|---|---|---|
| Zone 1 | Paving | Cracked and undulating slabs throughout.<br>Concrete scarred, cracked, and missing in part.<br>Isolated patch repairs. | | Photos [ 8 - 12 ] |

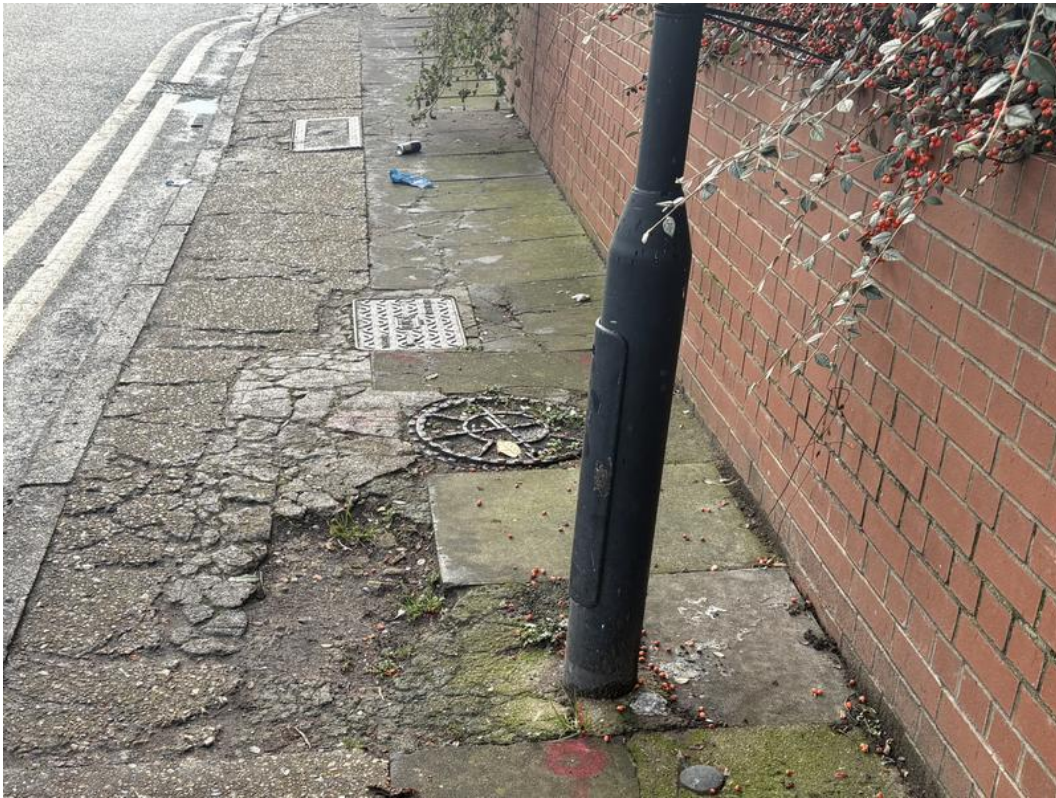
Photograph 13

| Location | Element | Condition | Photographs | Photo No. |
|---|---|---|---|---|
| Zone 1 | Drainage | Blocked to front of Frontier Yards. | | Photo [ 13 ] |

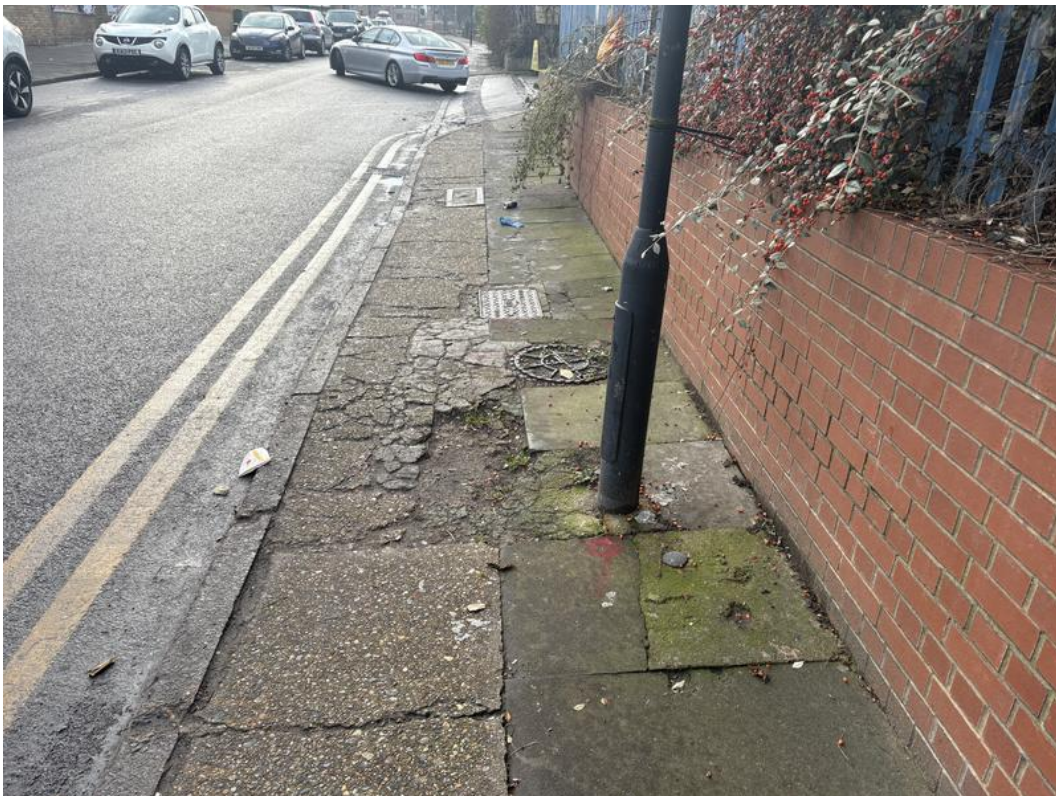
Photograph 14

| Location | Element | Condition | Photographs | Photo No. |
|---|---|---|---|---|
| Zone 1 | Street Lights and Bollards | Scratched and scuffed throughout.<br>No significant defects. | | Photos [ 14 - 16 ] |
