# Cooke Fawcett Architects

## 28 Wood Lane, N6 5UB Condition Survey-Rev A (Windows Only) 23.03.2025

CF\_225\_REP\_Condition-Survey-RevA

## 5. Windows

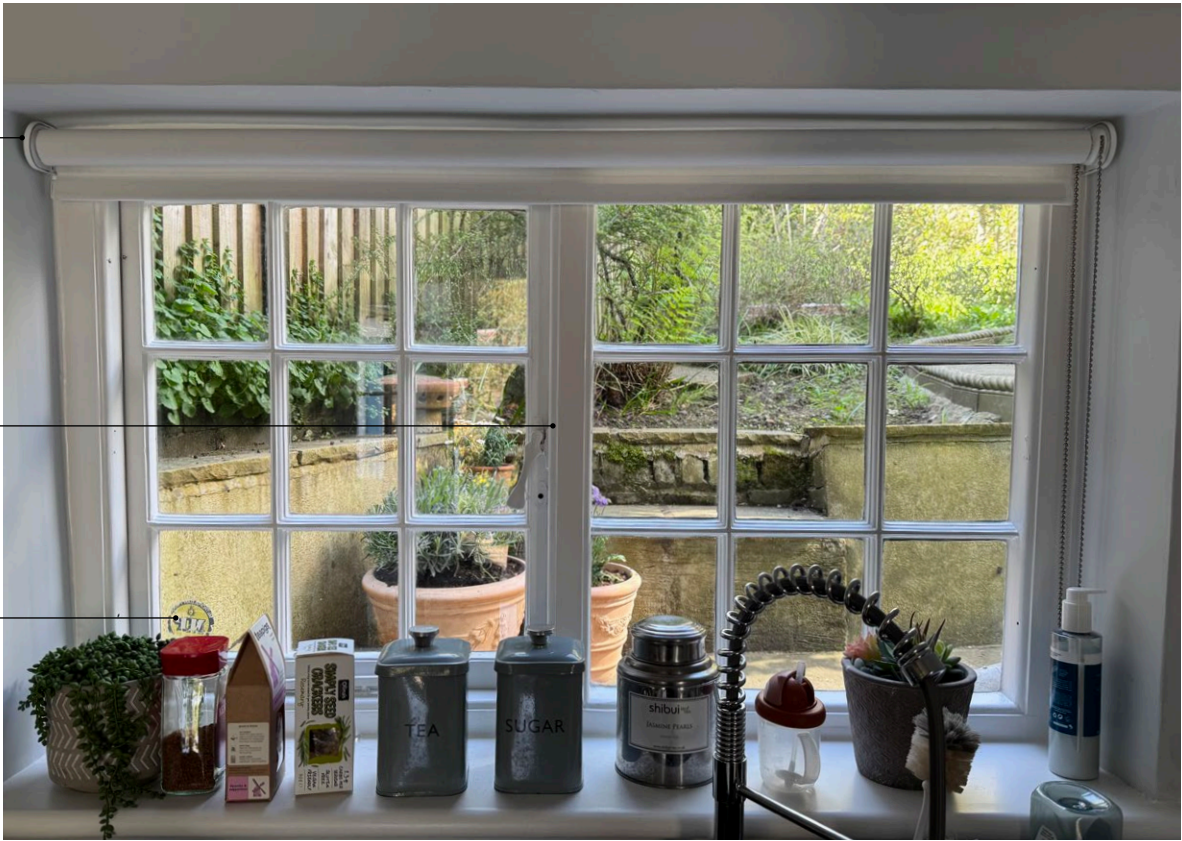
Interior

in good condition, however in this instance good condition combined with the fact that this is not a period timber profile, indicates that this window has been replaced recently -likely at the point that original crittal windows were replaced with timber

Non-original glass

Screw marks present on frame

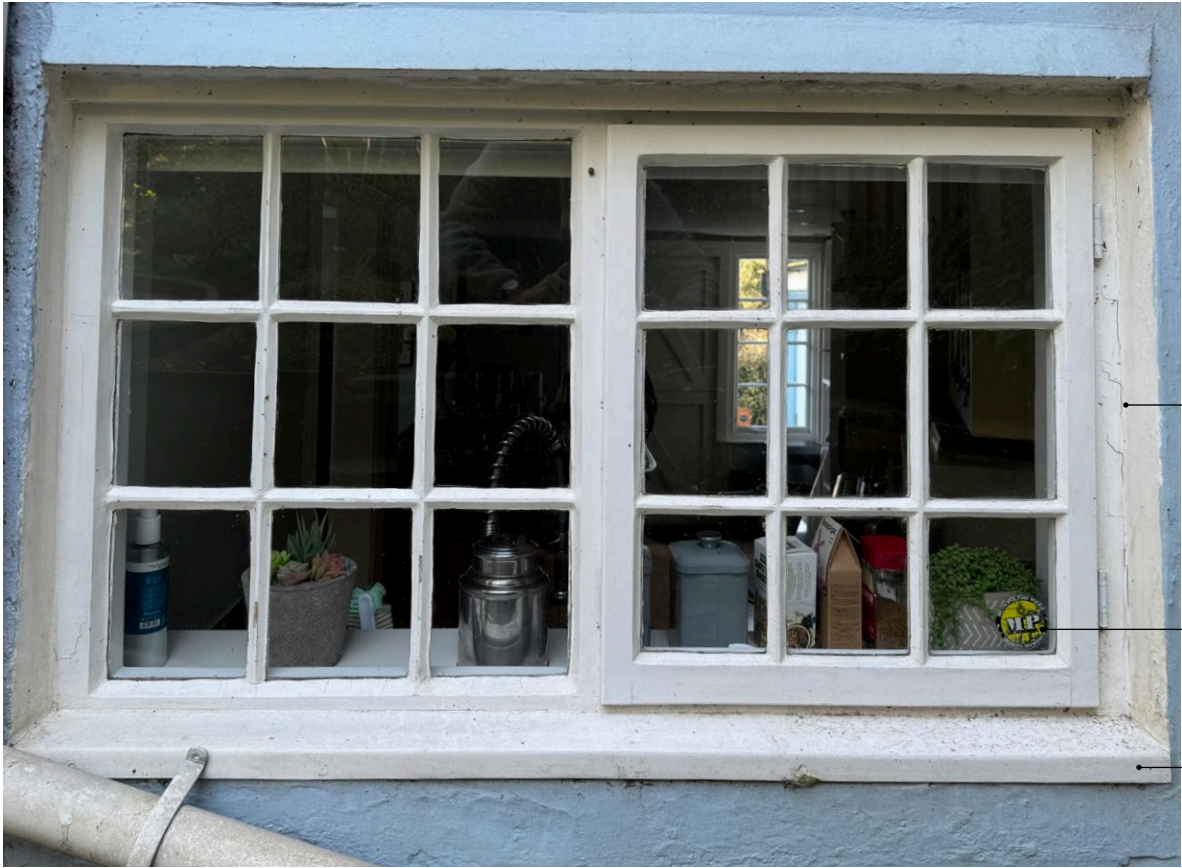
Exterior

Signs of some weathering - paint flaking/cracking on window frames and on brick mould.

Cill and frame in relatively good condition

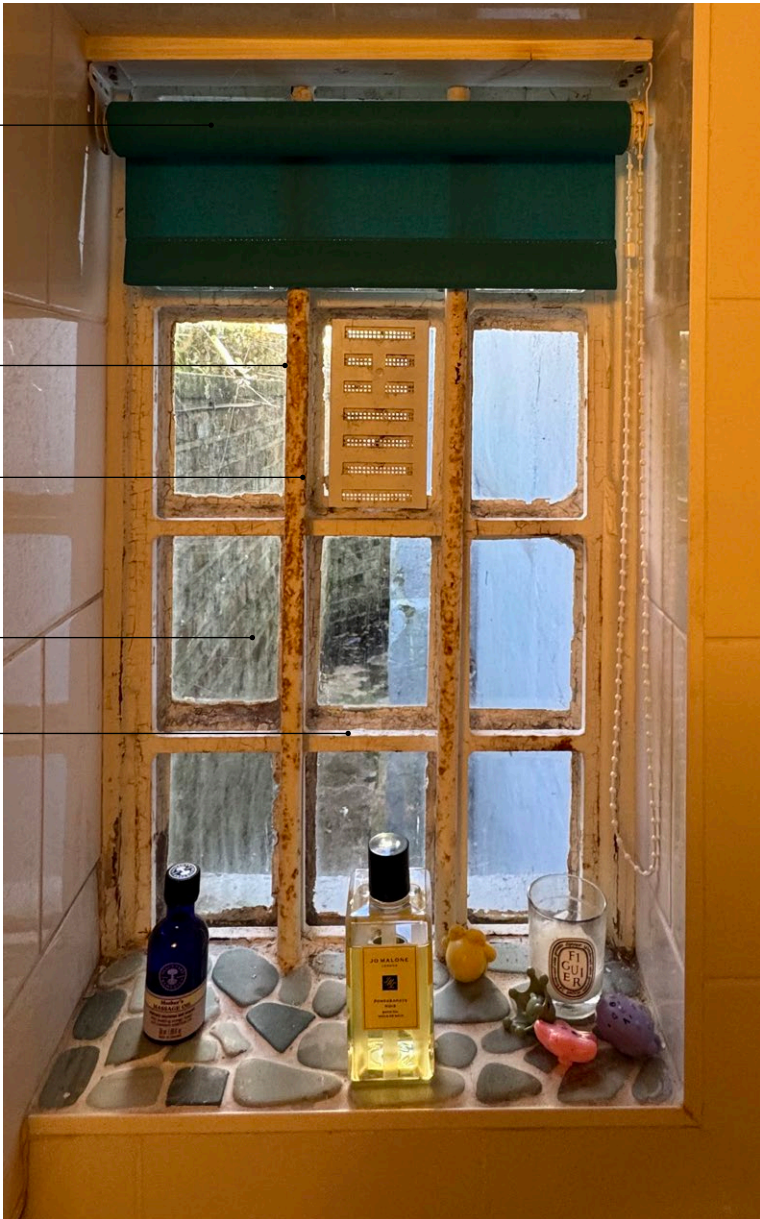
Interior

| Element | Description | Condition |
|---|---|---|
| Internal | -Crittall casement window with 12 panes<br>-Privacy blind fitted above frame<br>-Security bars fitted to interior<br>-Vent fitted to centre pane after 2014 works | Window is in very poor overall condition with significant flaking, rotting and rusting. Modern addition of security bars has extensive rust and degradation. The window is no longer operable. |

Crack and hole in glass pane

Extensive rust on security bars. Later addition

No longer operable

Very poor overall condition

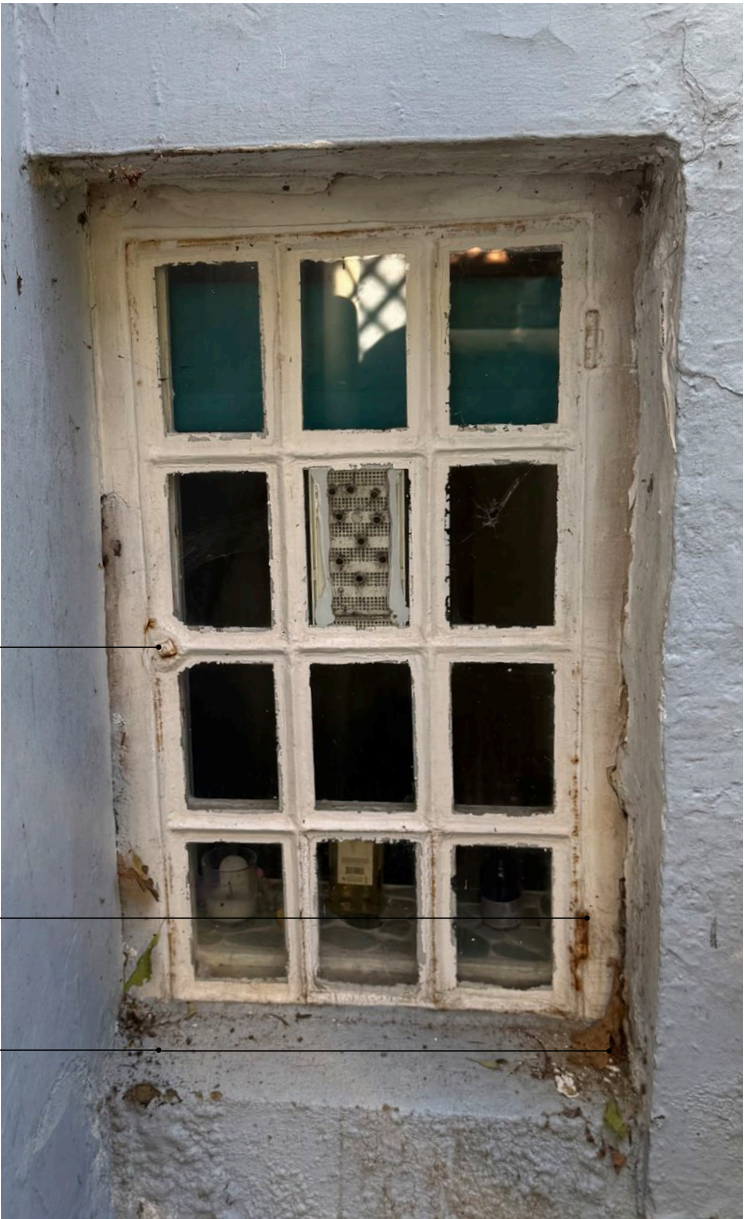
Exterior

| Element | Description | Condition |
|---|---|---|
| External | -Deep recessed single-paned casement window with metal frame | Very poor condition externally. Missing ironmongery and evidence of rotting, paint flaking on the frame and around. |

Handle missing and hinges no operable

Significant rusting of frame evident

External rotting and paint flaking

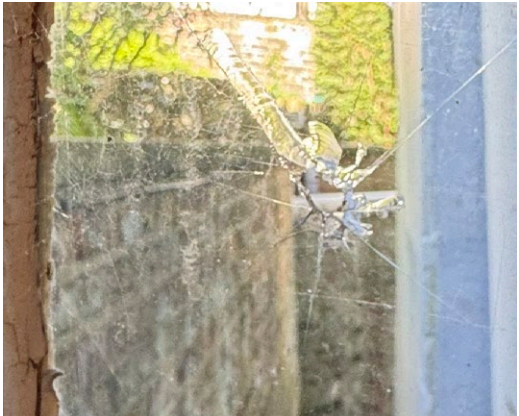
Crack and hole evident in one glass pane

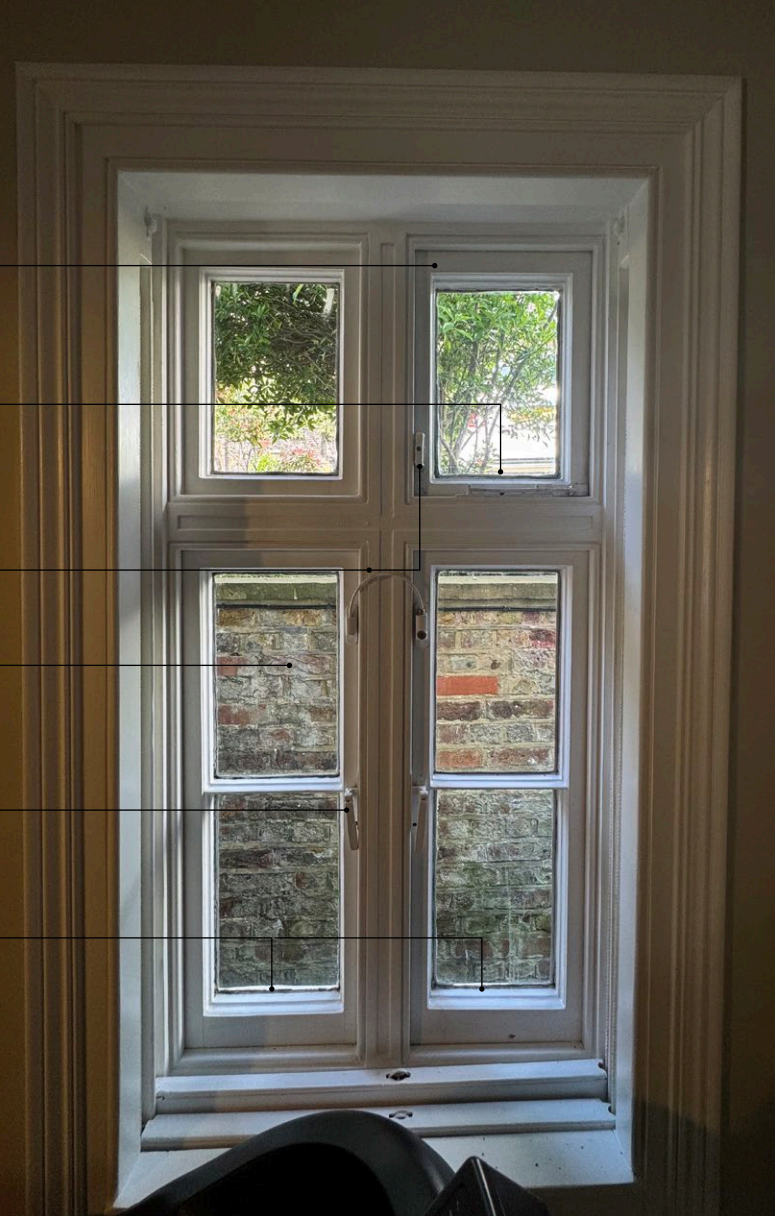
Interior

| Element | Description | Condition |
|---|---|---|
| Internal | -Timber casement window with 6-pane configuration<br>-Three casements are operable with fixed top left panel<br>-Vertical sliding shutter panels recessed into window<br>-Modern wired lock added and fixed to internal frames | Window frame is in good condition but some signs of black mould and rot in casement units.<br><br>The glass panes are a combination of original and new glass.<br><br>Poor air-tightness around junctions -top right casement does not fully close . |

Window stay rusting and not operable

Steel handles loose

Signs of black mould on bottom rail of sills

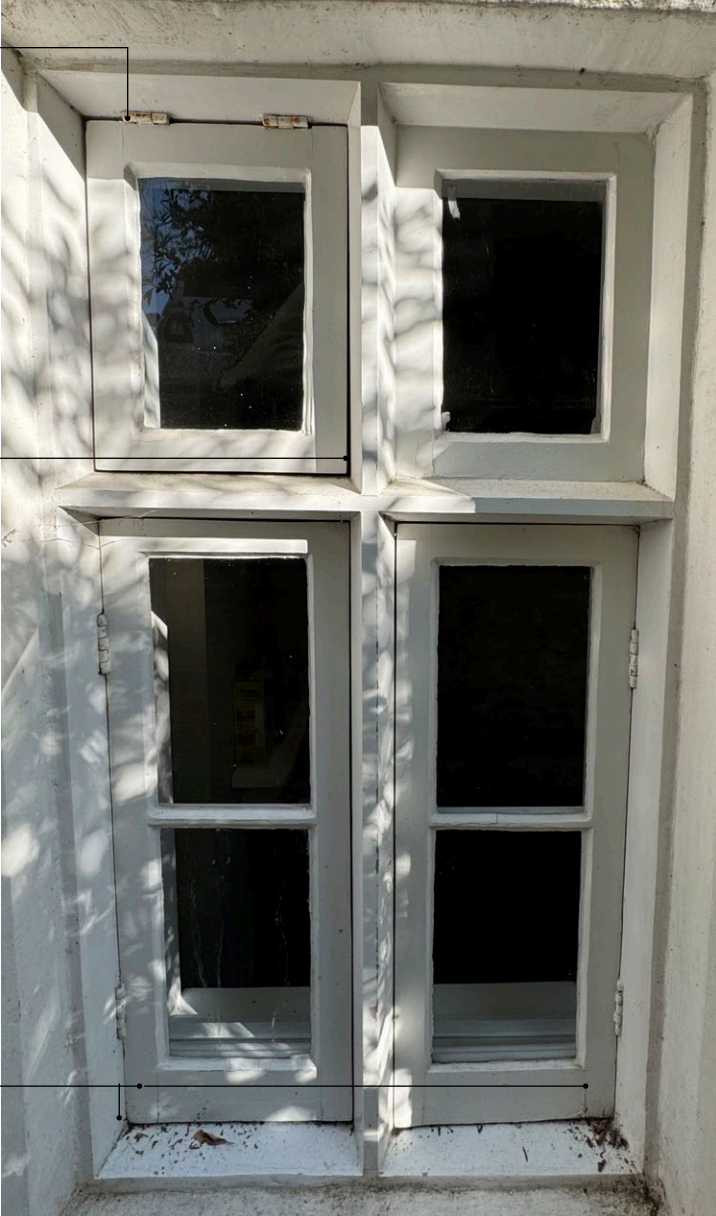
Exterior

| Element | Description | Condition |
|---|---|---|
| External | -Timber casement window with 6-pane configuration | Frame and cill in good condition needed some re decoration. There are signs of flaking on paint and hinges on operable panels rusting. |

Hinges on operable unit rusting

Gaps in air tightness

Signs of cracking and possible timber decay

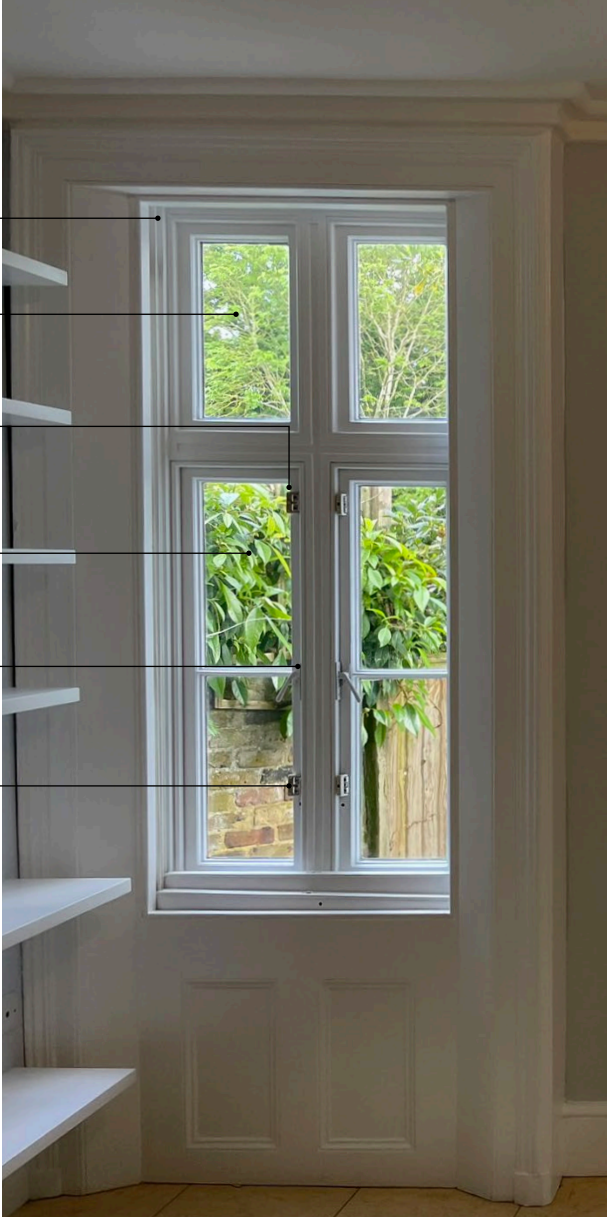
Interior

| Element | Description | Condition |
|---|---|---|
| Internal | <div>-Timber casement window with 6-pane configuration</div> <div>-Two lower panels operable, two higher panels fixed</div> <div>-Vertical shutters recessed into decorative timber casing below</div> | <div>Window frames show some signs of cracking on joints and corners with potential timber decay, otherwise in relatively good condition. Modern fitted locks have been fixed to the casements.</div> <div>The glass panes are a combination of original and new glass.</div> <div>There is evidence showing floor tiles covering decorative wood casing extending below floor level.</div> |

- Paint cracking on joints and corners
- Glass panes in good condition
- Modern security -fitted locks addition fixed to the casement units
- Glass panes mix of original and new
- Steel handle painted over poorly with chips and flaking of paintwork
- Modern security -fitted locks addition fixed to the casement units

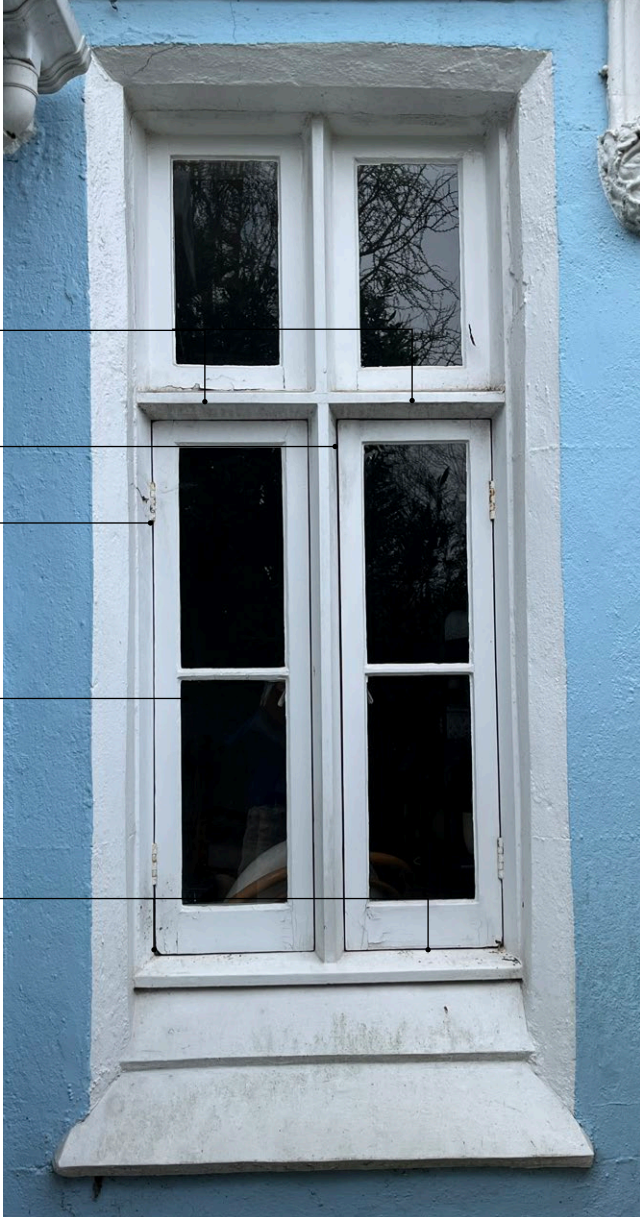
Exterior

| Element | Description | Condition |
|---|---|---|
| External | <div>-Timber casement window with 6-pane configuration</div> <div>-Casement window frames painted white</div> <div>-Angled recess into masonry wall painted white</div> | <div>External frames show signs of peeling paint and potential timber decay.</div> <div>Damage to cill caused by incorrect paint and water causing the paint to crack/burst exposing the timber.</div> |

- Signs of peeling paint and potential timber decay
- Poor air-tightness
- Metal hinges painted over but rust coming through
- Both casements operable
- Signs of peeling paint and potential timber decay

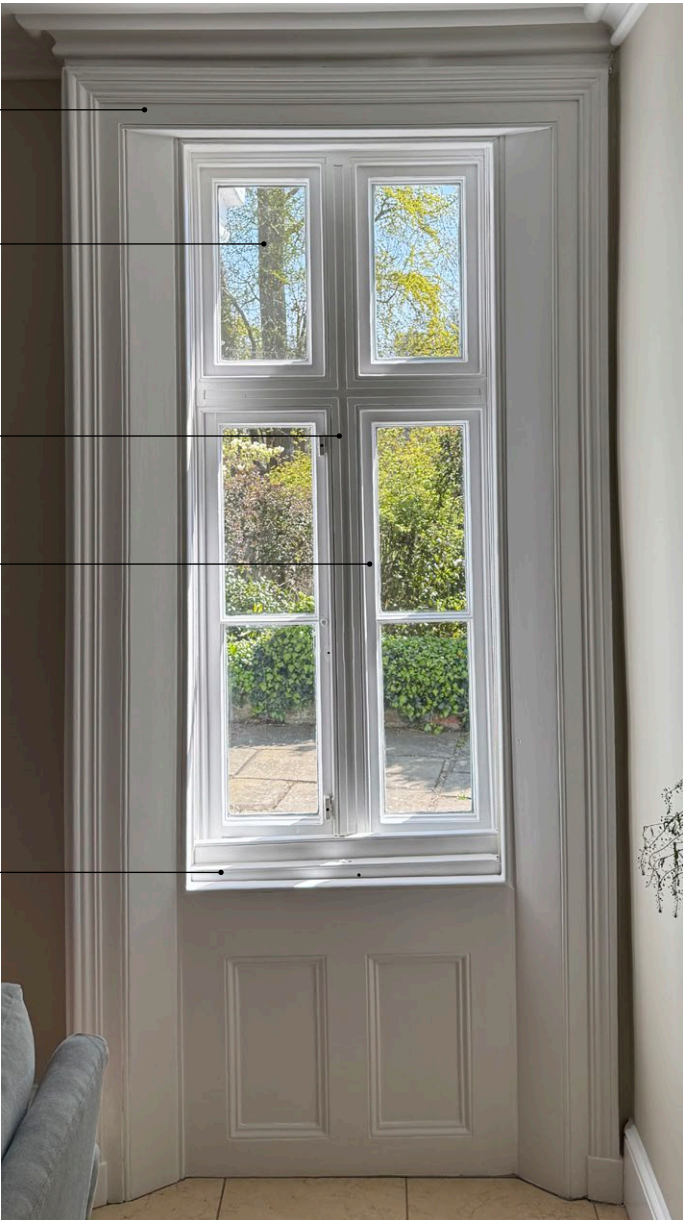
Interior

| Element | Description | Condition |
|---|---|---|
| Internal | -Timber casement window with 6-pane configuration<br>-Vertical shutters recessed into decorative timber casing below<br>-One operable casement window | Window is in average condition with one of the casement units sealed shut, modern security additions. There are signs of paint cracking on joins and corners. Lady birds and other small insects present.<br><br>Glass is in good condition. |

Handle missing on single operable casement

Vertical slider operable. 20cm discrepancy between bottom of timber shutter casing and floor level

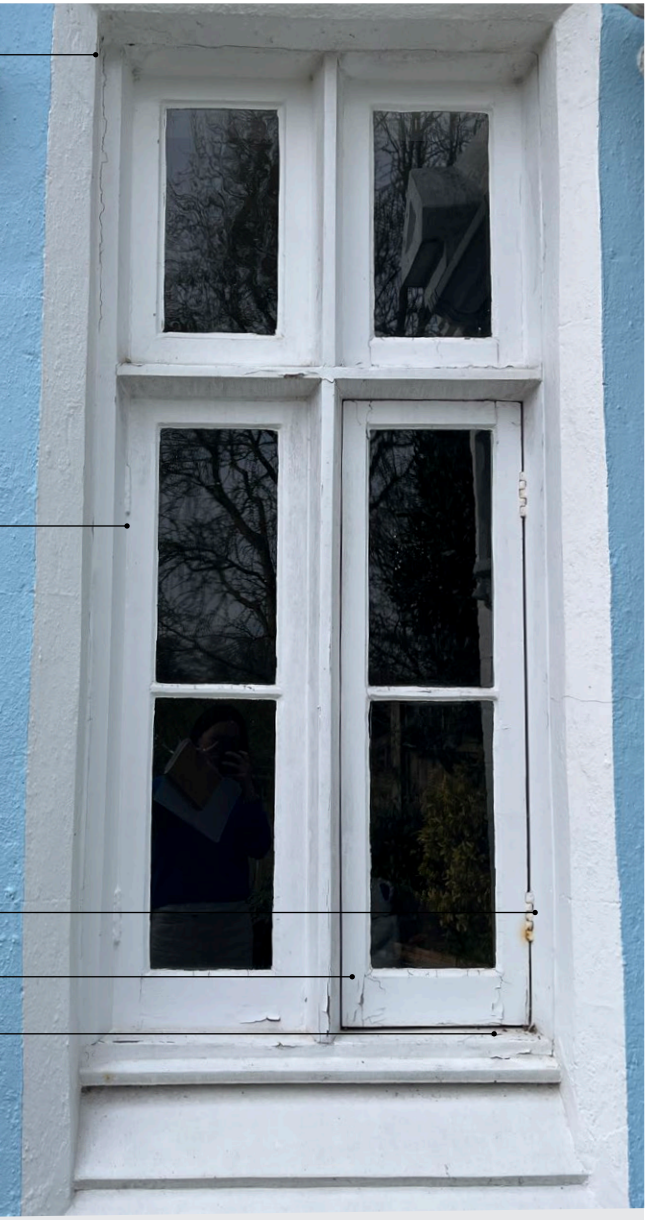
Exterior

| Element | Description | Condition |
|---|---|---|
| External | -Timber casement window with 6-pane configuration<br>-Casement window frames painted white<br>-Angled recess into masonry wall painted white | Frame is in relatively good condition but significant splits and woodwork rot in the cill. Gaps around operable casement evidences the poor air tightness of the window.<br><br>Damage to cill caused by incorrect paint and water causing the paint to crack/burst exposing the timber. |

Paintwork flaking and cracking on joins and corners

Metal hinges painted over but rust coming through

Poor air-tightness

Significant cracking and potentially timber decay in corner of cill -

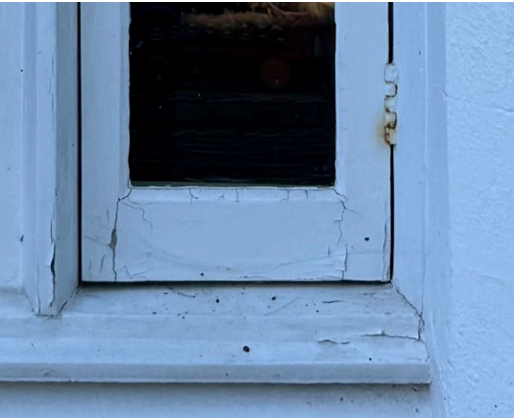
Significant splits and cracking of paintwork, woodwork rotting, white painted hinges rusting

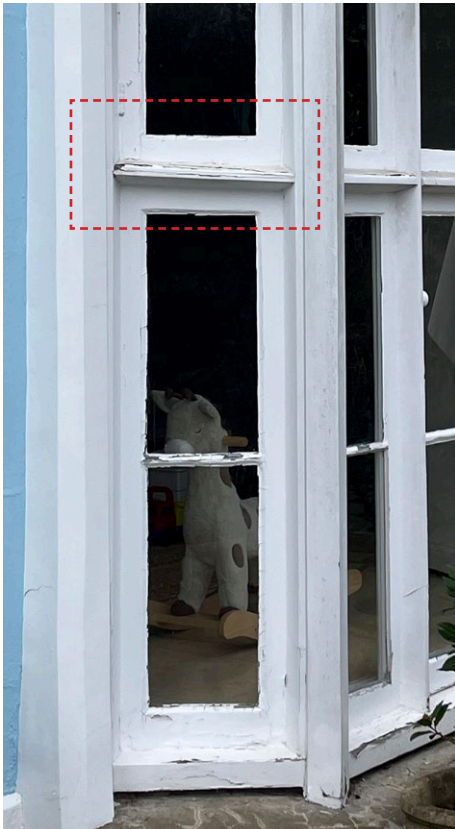
Damage to post and cill

Poor external condition

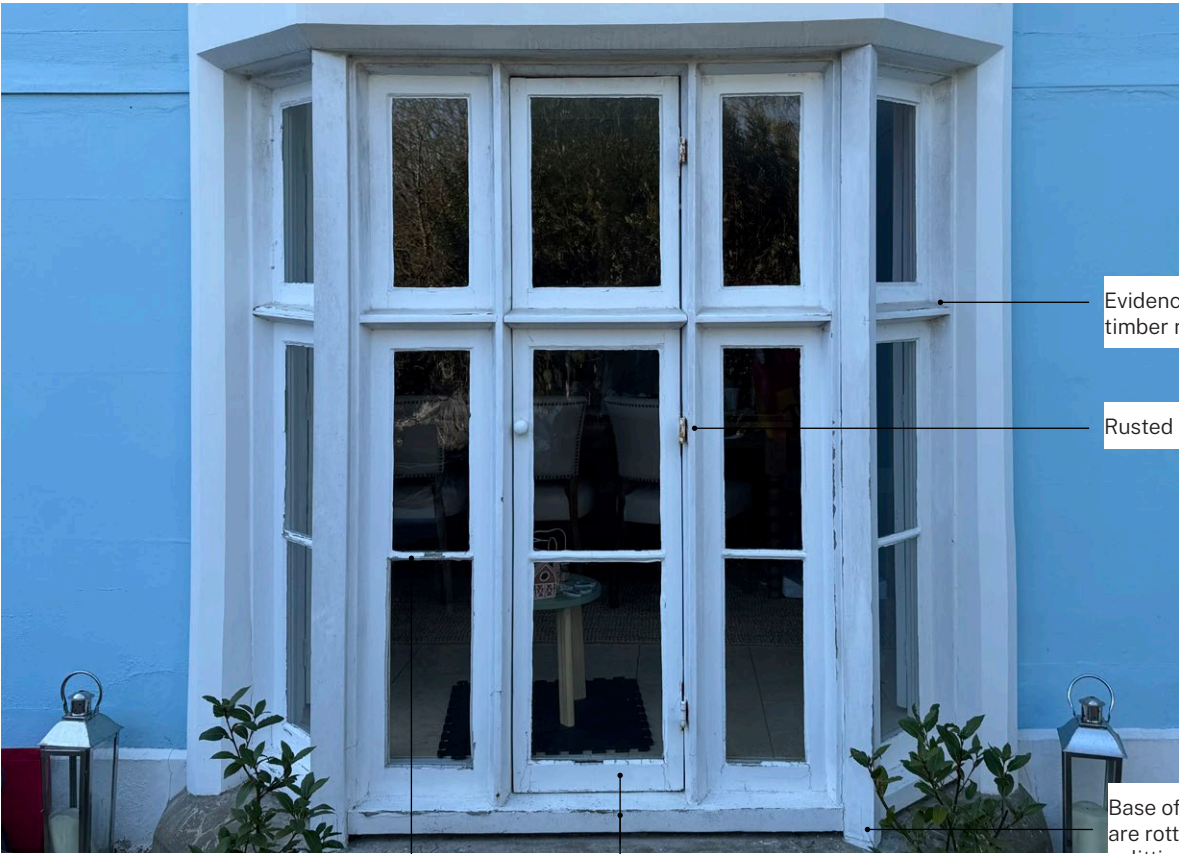
Exterior

| Element | Description | Condition |
|---|---|---|
| External | <div>-Canted bay window with triple casement central bay. Timber frames painted white</div> | <div>Frame, structural posts and cill need immediate attention. Damage from subsidence evident.</div> <div>The base of the structural posts are rotting and collapsing from the pressure of the bay windows sinking.</div> <div>Damage to cill caused by incorrect paint and water causing the paint to crack/burst exposing the timber.</div> |

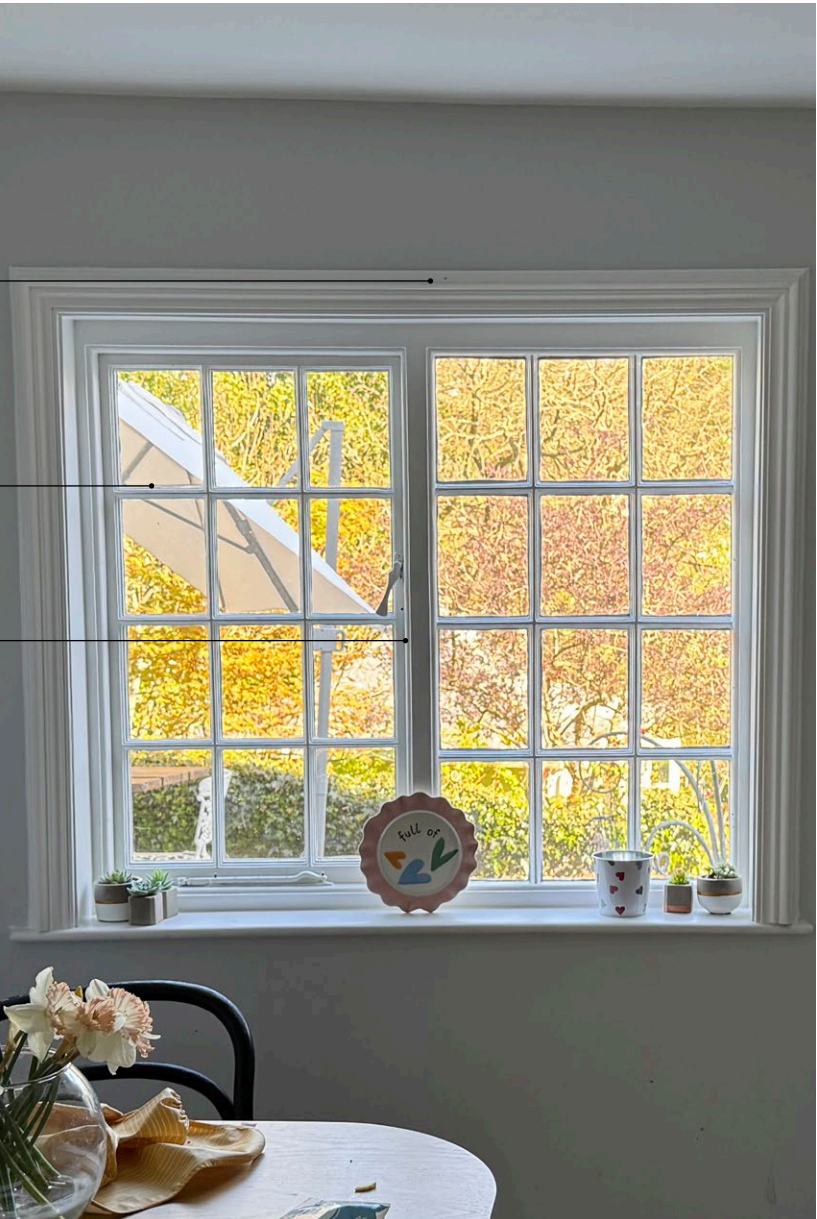
Interior

| Element | Description | Condition |
|---|---|---|
| Internal | -Timber-framed, double-casement window with 12-pane configuration per casement.<br>-One casement is operable | The style and frame moulding profile indicates that the timber frame window is a replacement of an original crittal window.<br><br>Glass is new.<br><br>The window is in generally good condition. |

Non-original glass

in good condition, however in this instance good condition combined with the fact that this is not a period timber profile, indicates that this window has been replaced recently -likely at the point that original crittal windows were replaced with timber

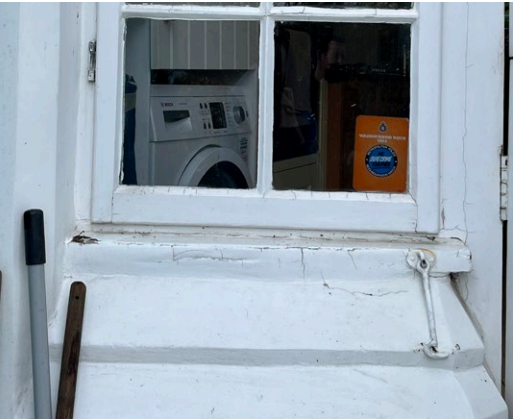
Cracks and chips in paintwork around frame and sill. Modern hinge on higher portion of stable door

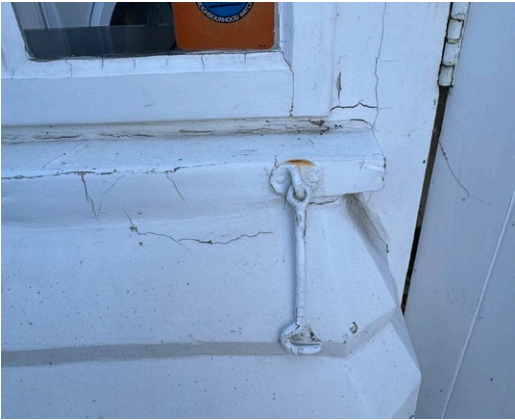
Rusting latch no longer usable alongside cracking and rotting of timber above sill

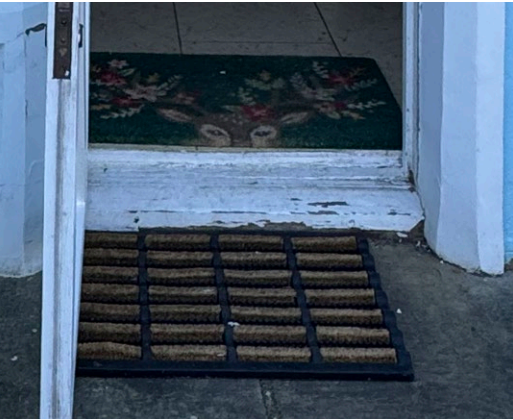
Significant scuff marks, chips and cracking to threshold timber on door

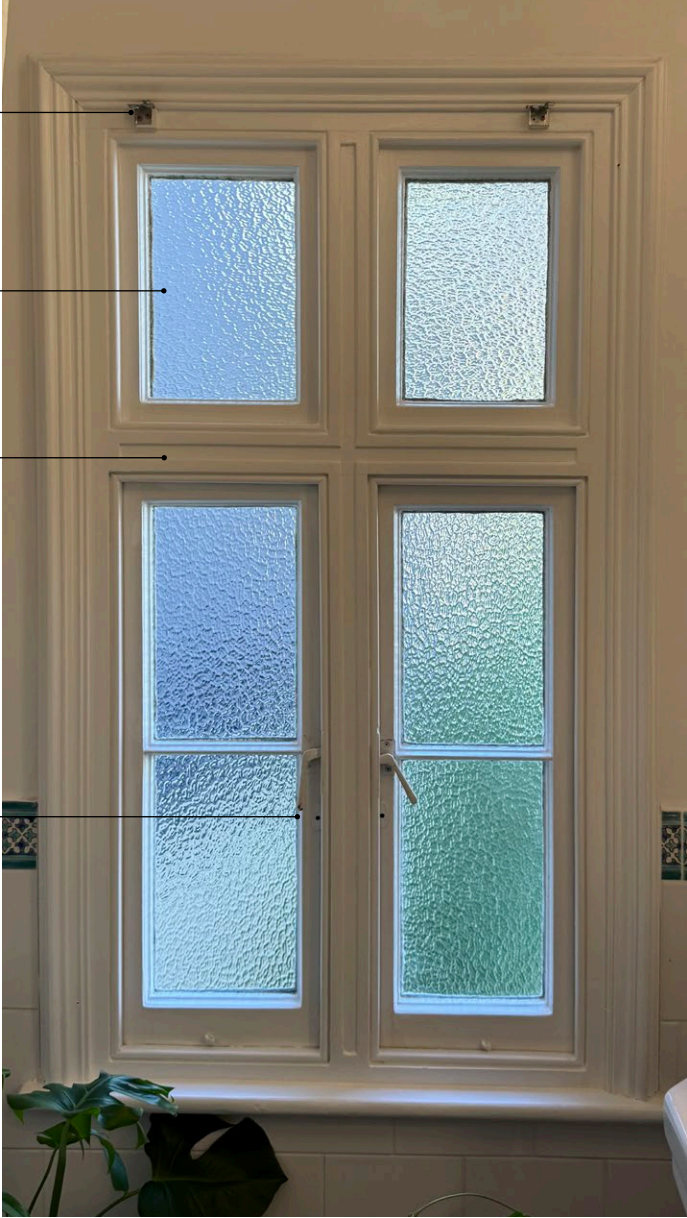
Interior

| Element | Description | Condition |
|---|---|---|
| Internal | <div>-Timber casement window with 6-pane configuration</div> <div>-Two lower casements operable, two higher casements fixed</div> <div>-One operable casement window</div> <div>-Textured glass panels for privacy</div> | Window and frame are in good condition. Original glass has been replaced with obscured glass with a locking system |

Some cracking in paintwork but overall good condition

Locking system

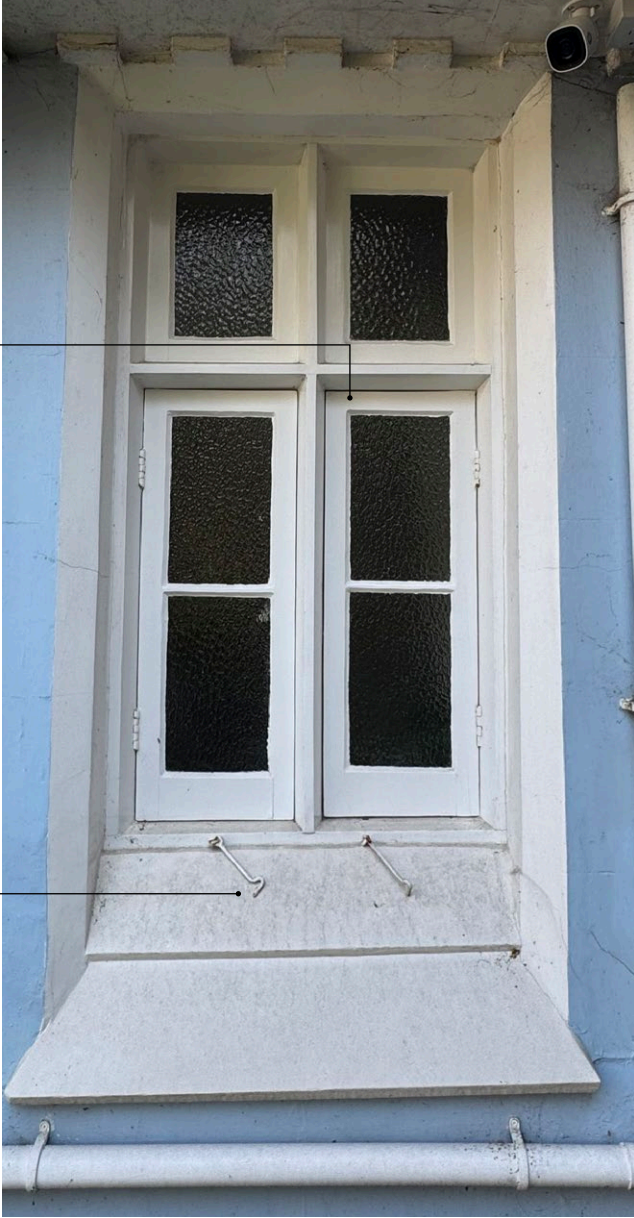
Exterior

| Element | Description | Condition |
|---|---|---|
| External | <div>-Timber casement window with 6-pane configuration</div> <div>-Casement window frames painted white</div> <div>-Angled recess into masonry wall painted white</div> <div>-External latches fixed to bottom rail of sill</div> | There are minor signs of weathering but frames and cill are in generally good condition. |

Some wear and splitting in paintwork around frames, particularly around corners and joins

Build up of dirt on decorative plaster moulding

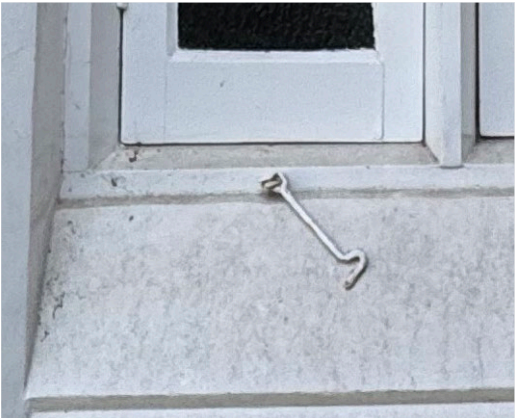
External latch and build up of dirt on decorative plaster mouldings, signs of paintwork cracking

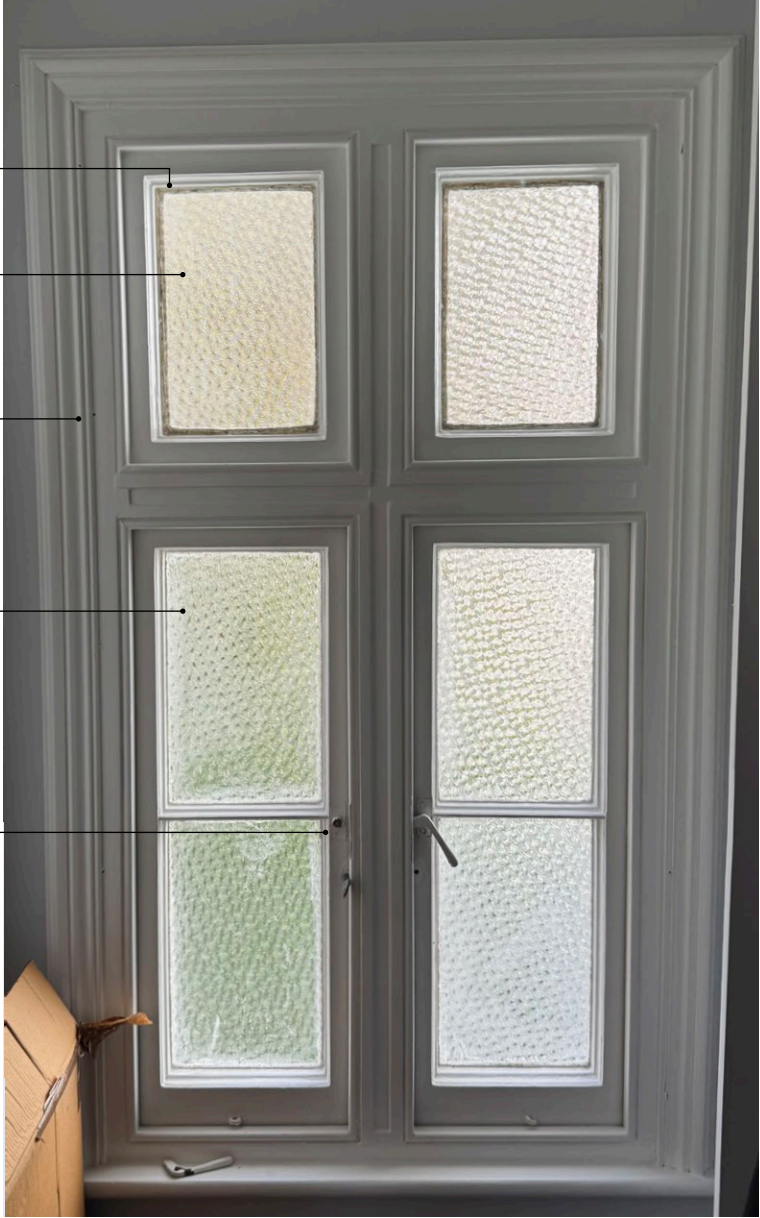
Interior

Handle broken on left casement

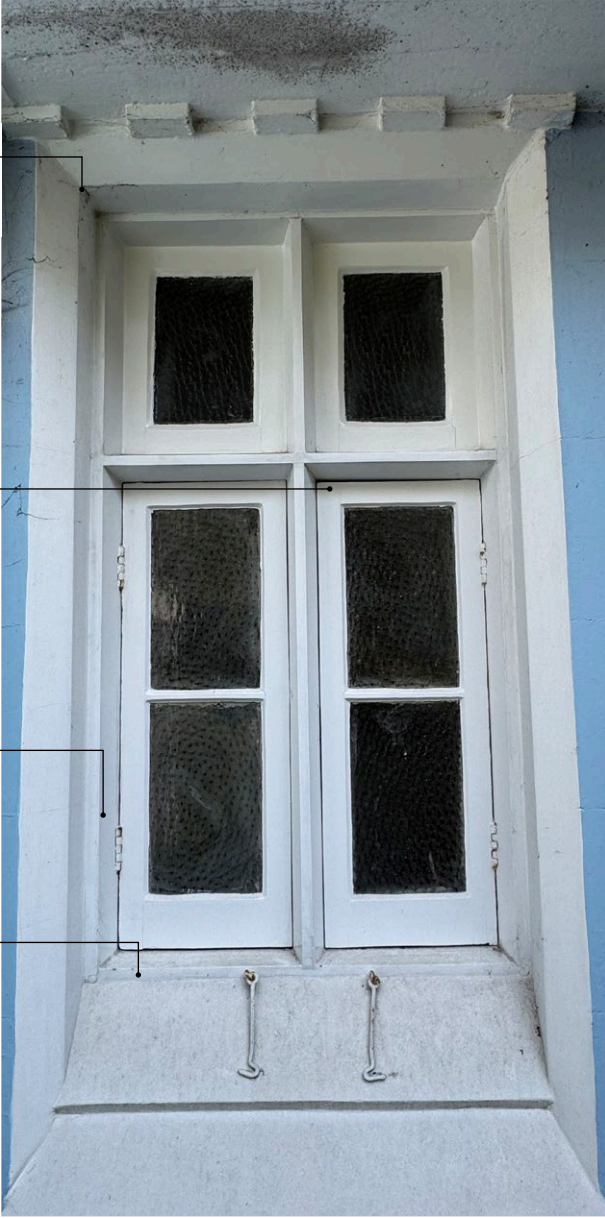
Exterior

Early signs of cracking and splitting in paintwork

Build up of dirt on decorative plaster moulding

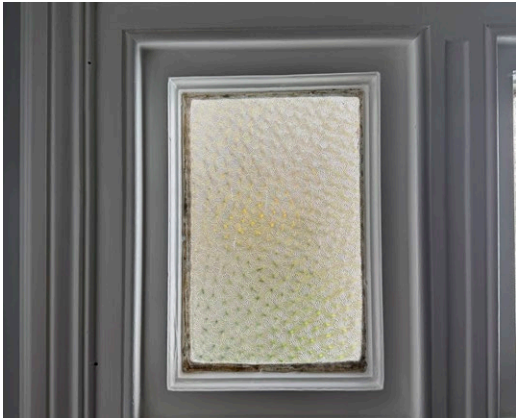
Screw/nail marks to left of glass pane, early signs of black mould along frame

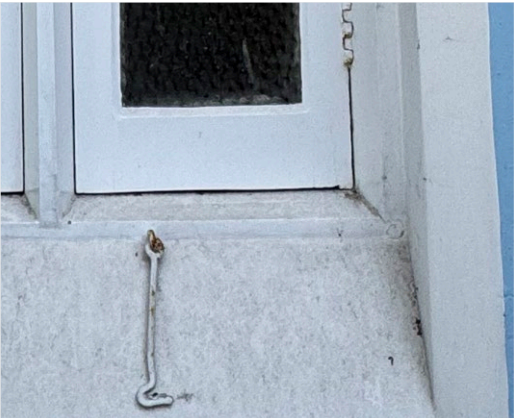
Dirt build up and weathering on decorative moulding below sill, rusting present on hinges and latches

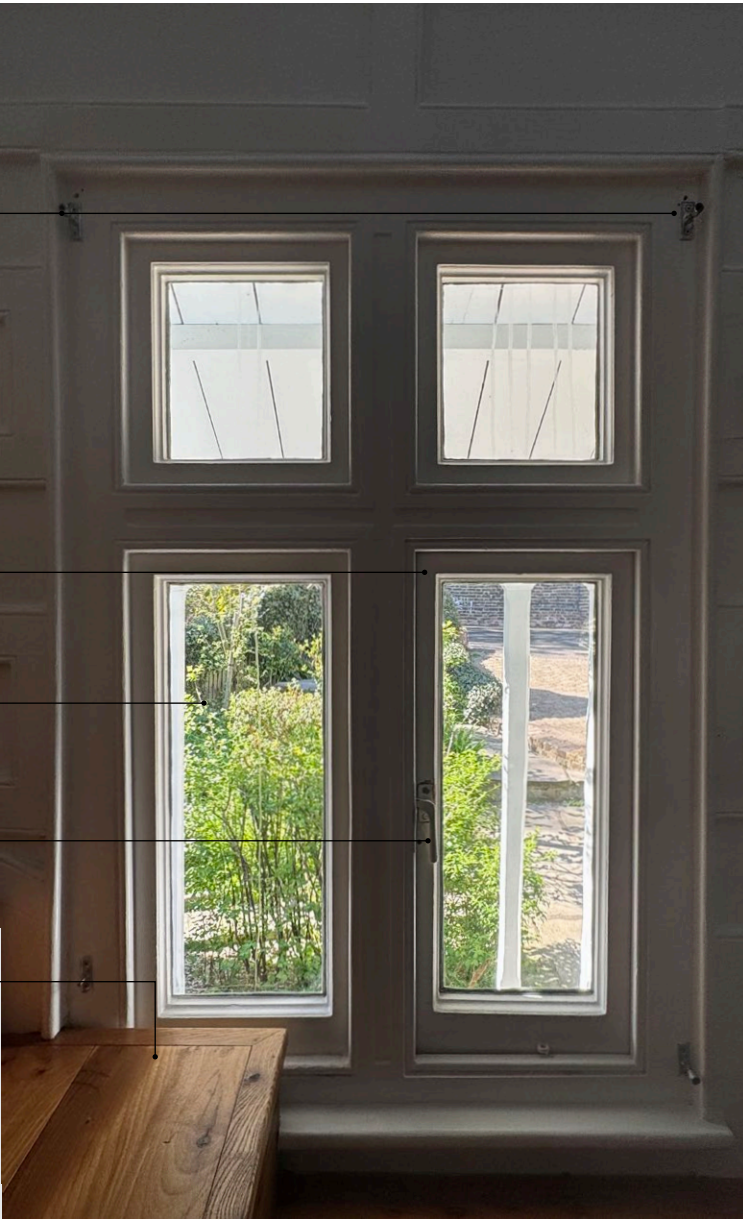
Interior

Stair overlaps and cuts directly into the bottom sill and frame

Window doesn't fully close/seal

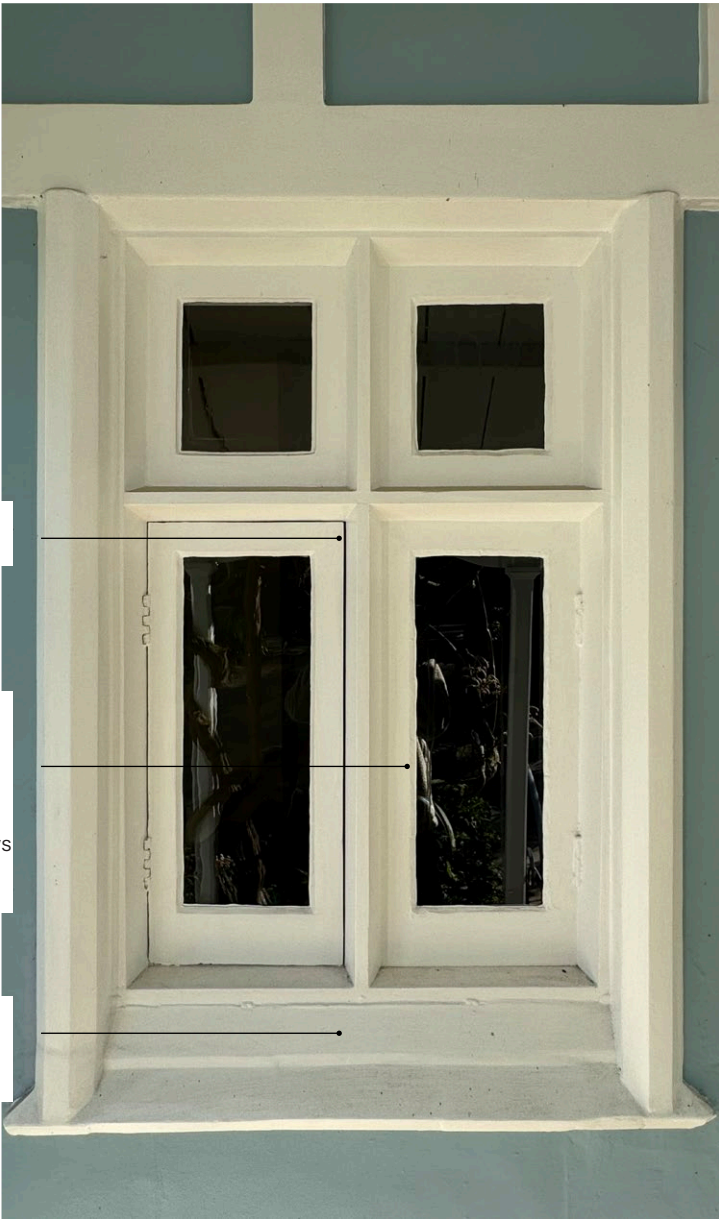
Exterior

Overall good condition frame and cill

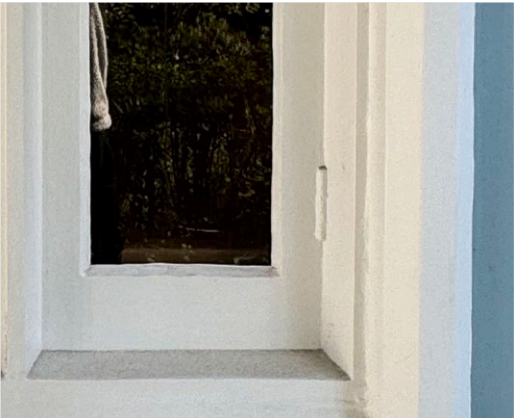
Hinges painted over to seal window casement

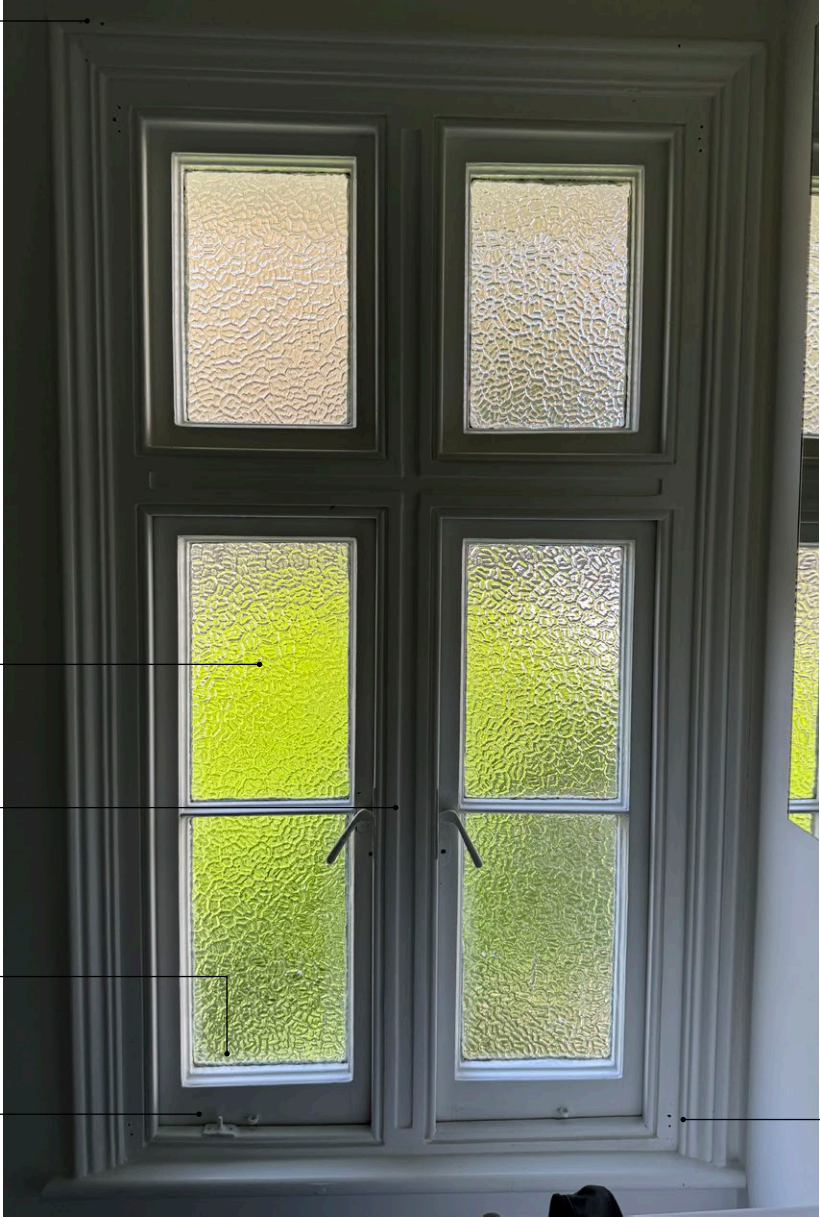
Interior

Window stay not present, windows cannot be fixed open in fixed location

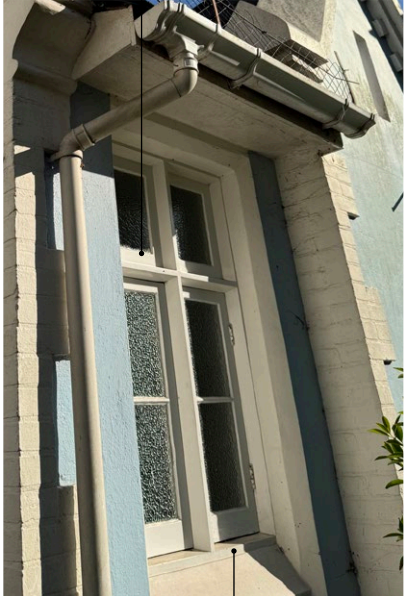
Exterior

Some signs of cracks and splits in paintwork, general condition is good

Minimal weathering and dirt build up on white moulding below sill bottom rail

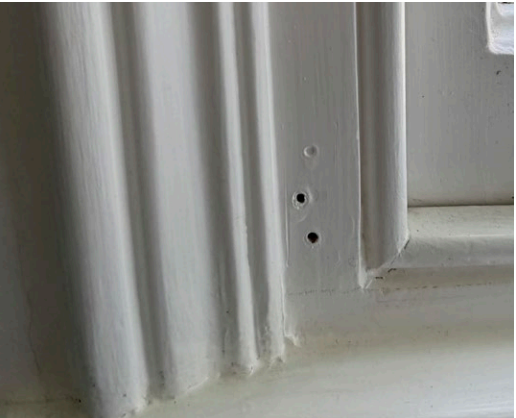
Screw marks/holes in frame

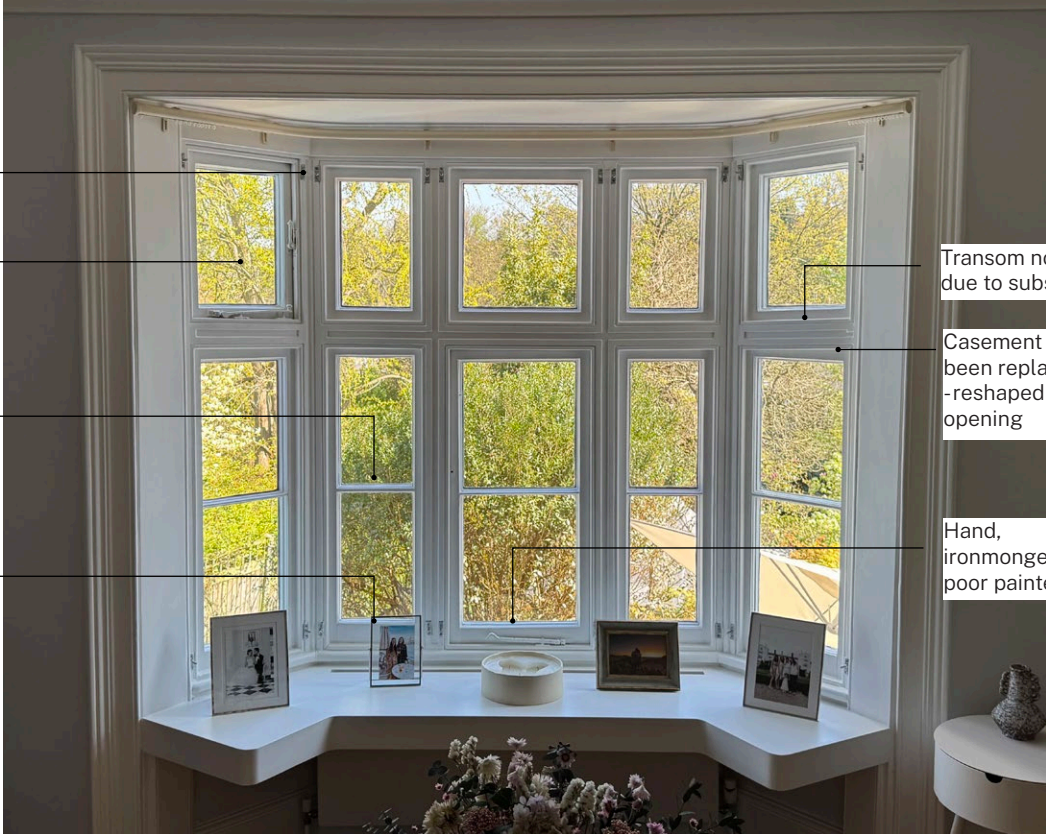
Interior

Evidence of cracking and rotting in timber frame and paintwork

Evidence casement has been replaced - reshaped to accomodate skewed frame
