# Cooke Fawcett Architects

## 28 Wood Lane, N6 5UB Condition Survey-Rev A (Windows Only) 23.03.2025

CF\_225\_REP\_Condition-Survey-RevA

## 5. Windows

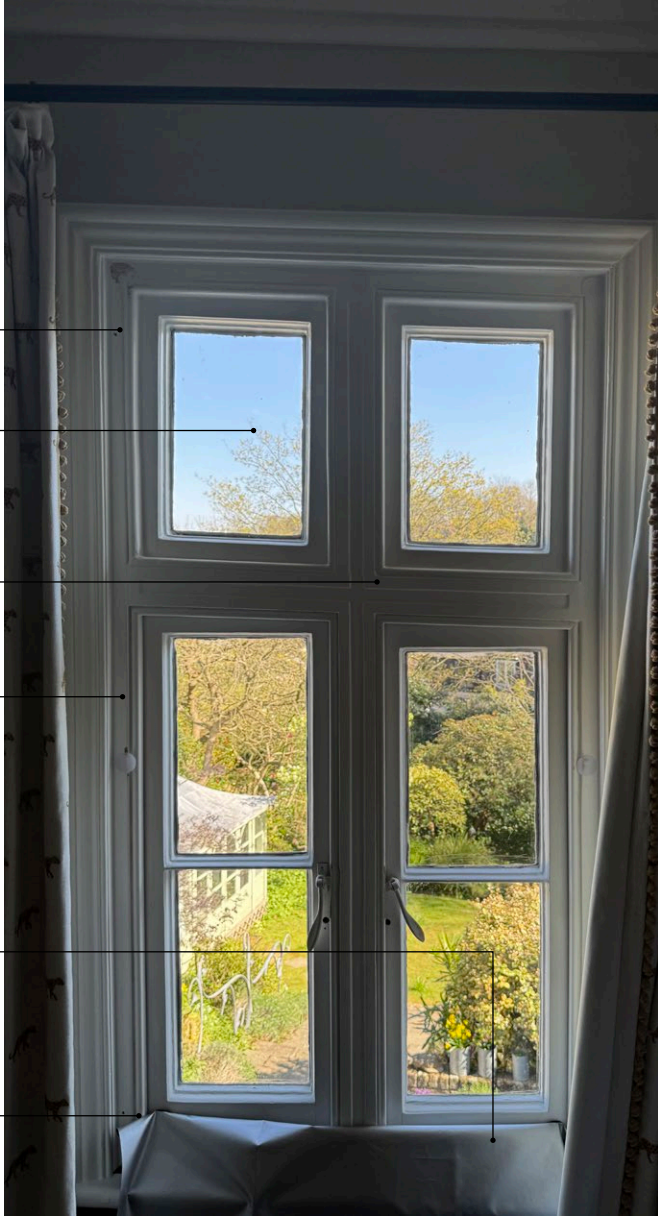
Interior

Previous screw marks/holes left in frame

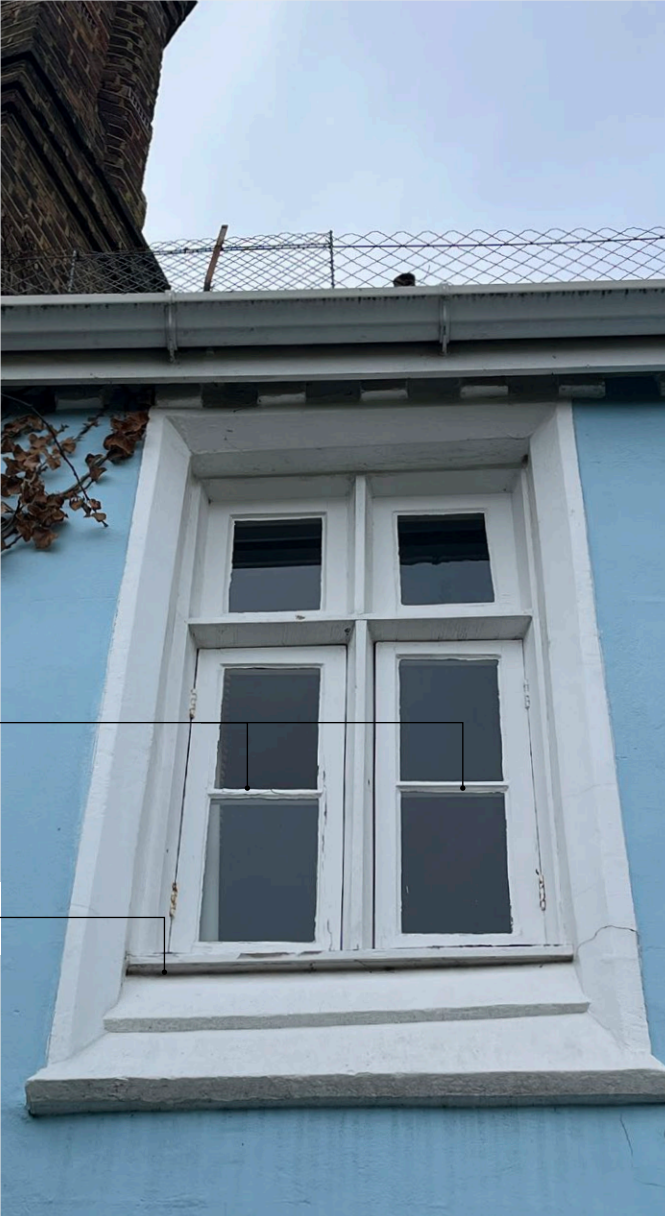
Exterior

Signs of splitting and cracking

Cill in poor condition

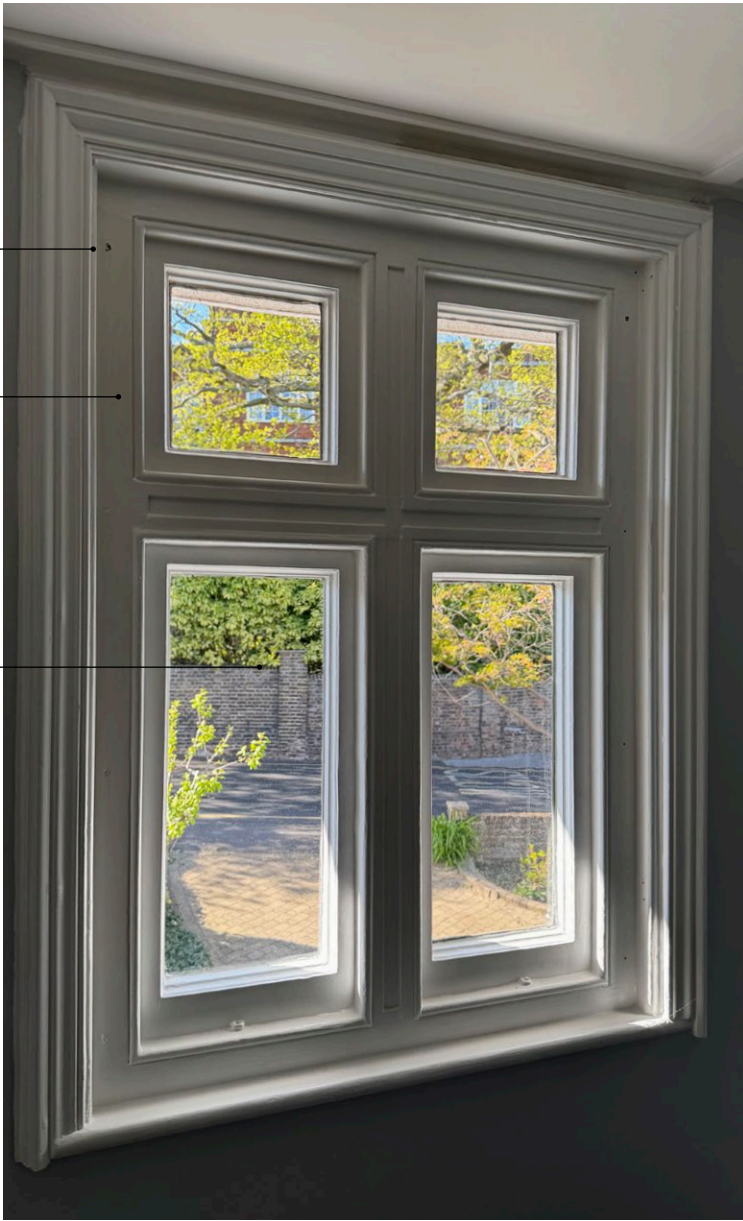
Interior

| Element | Description | Condition |
|---|---|---|
| Internal | -Timber casement window with 4-pane configuration<br>-All casements are fixed and not operable | Window in good condition with some previous screw marks visible. |

The glass panes are a  
combination of original  
and new glass

Signs of splits and  
cracks in paintwork on  
frame

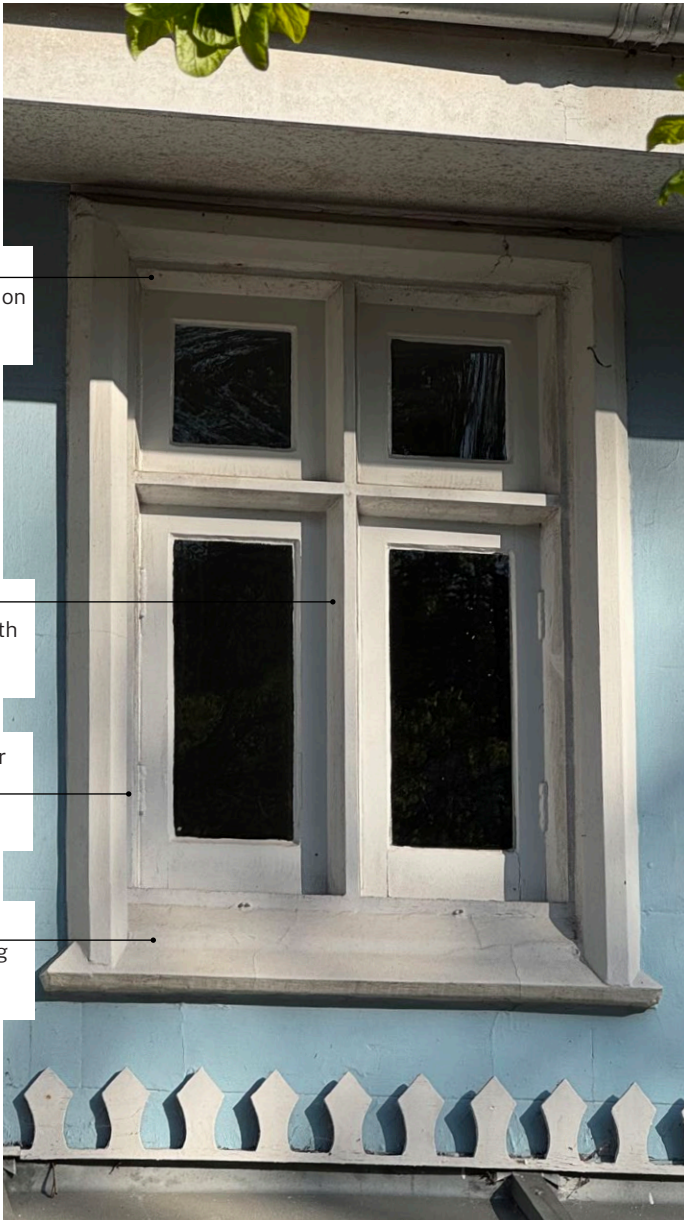
Exterior

Splits and cracks in  
decorative moulding

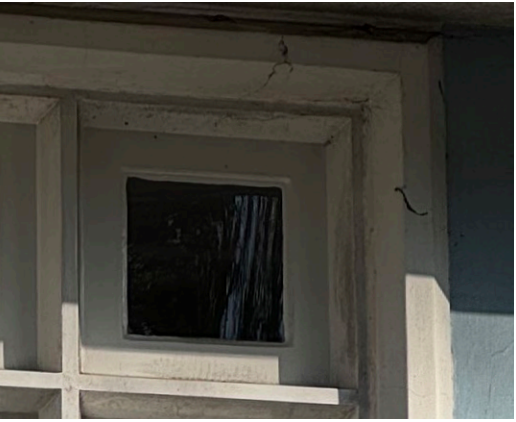
Splits and cracks in decorative moulding

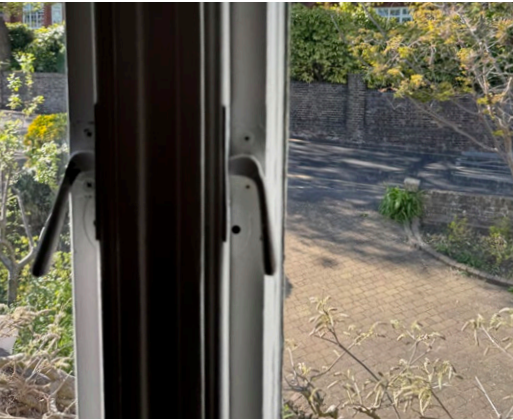
Handle loose

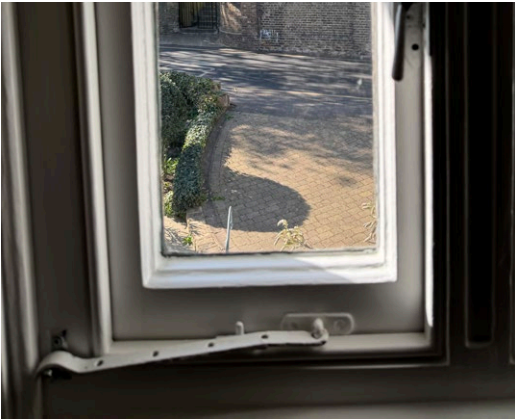
Window stay too large for casement size

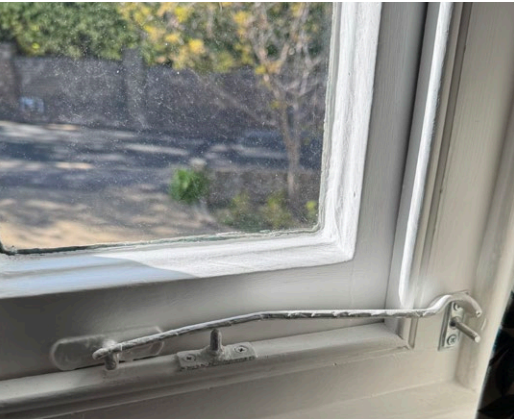
Window stay too large for casement size and poorly painted

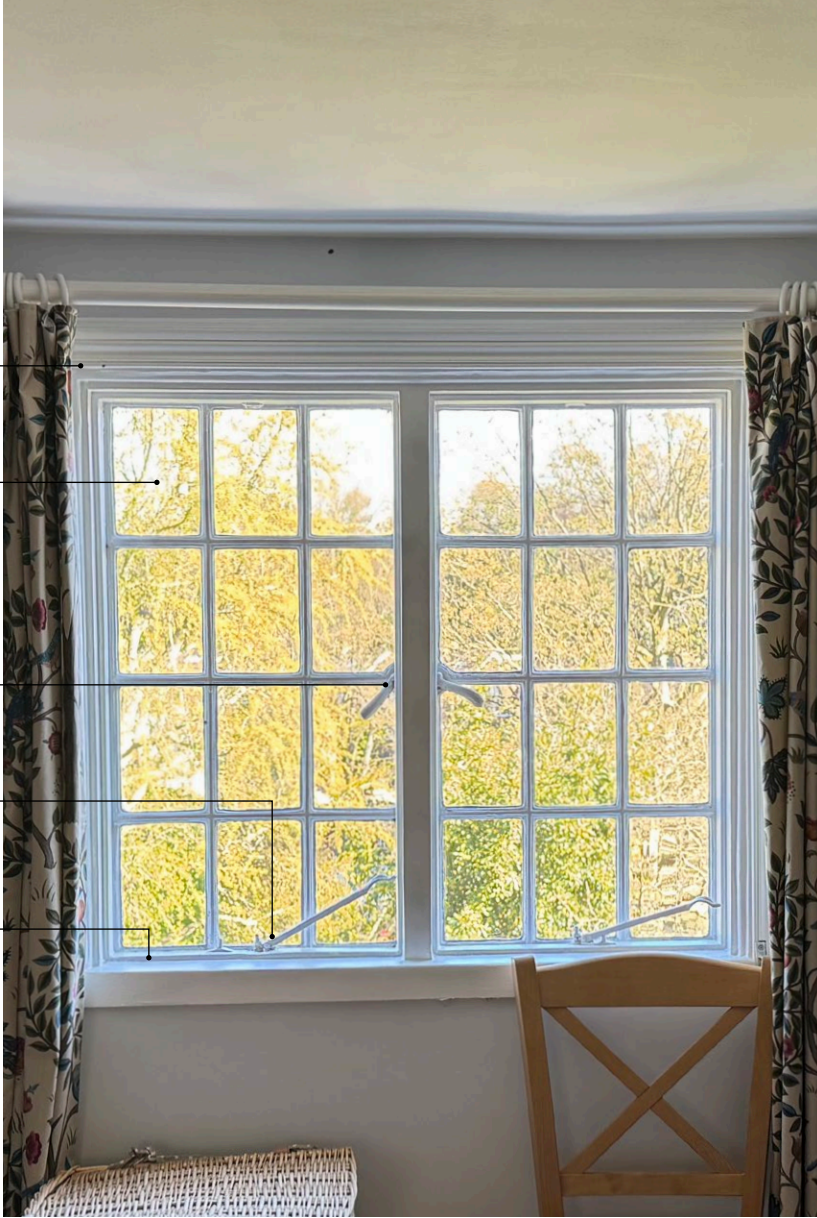
Interior

- Evidence of ladybirds around frame
- Non-original glass. No evidence of imperfections or bubbles
- Significant/advanced rotting around lock/handle
- Signs of rotting on timber outer frame
- Holes in window stays painted over therefore not operable. Casements cannot be fixed open
- Build up of black mould on bottom rail of sills

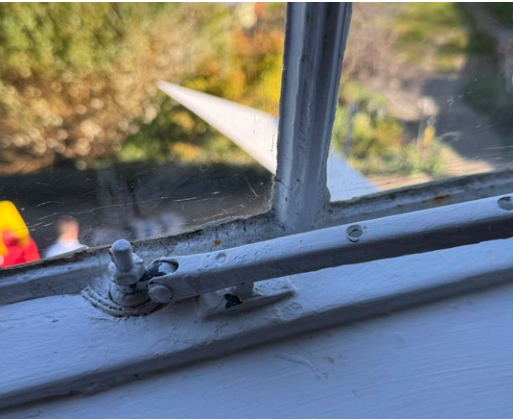
Holes in window stays painted over therefore not fully operable.

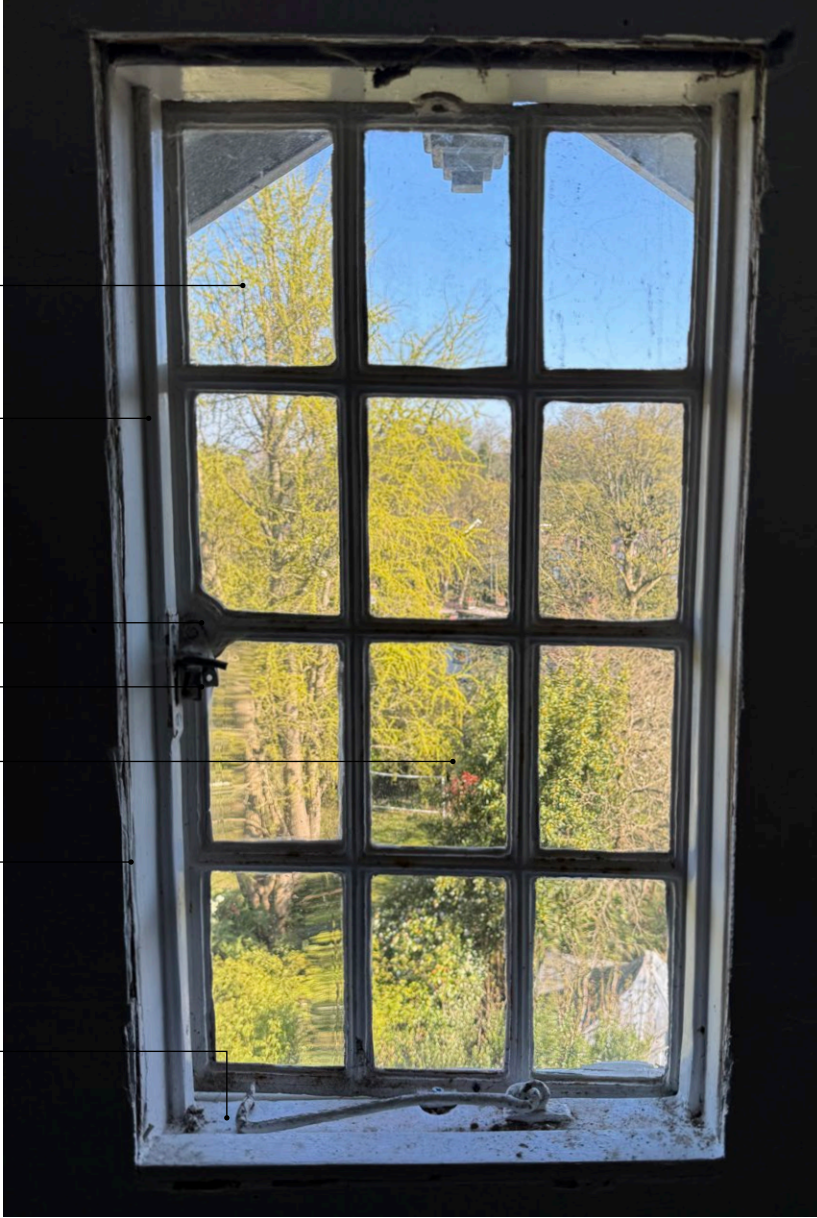
Interior

- Non-original glass. No evidence of imperfections or bubbles
- Significant rotting and rusting of steel frame
- Significant/advanced rotting around lock/handle & Ironmongery severely weathered
- Window casement screwed shut - not
- Hole in glass pane
- Signs of rotting on timber outer frame
- Significant cracking, build up of dirt along bottom rail of frame  
Build up of black mould on bottom rail of cills

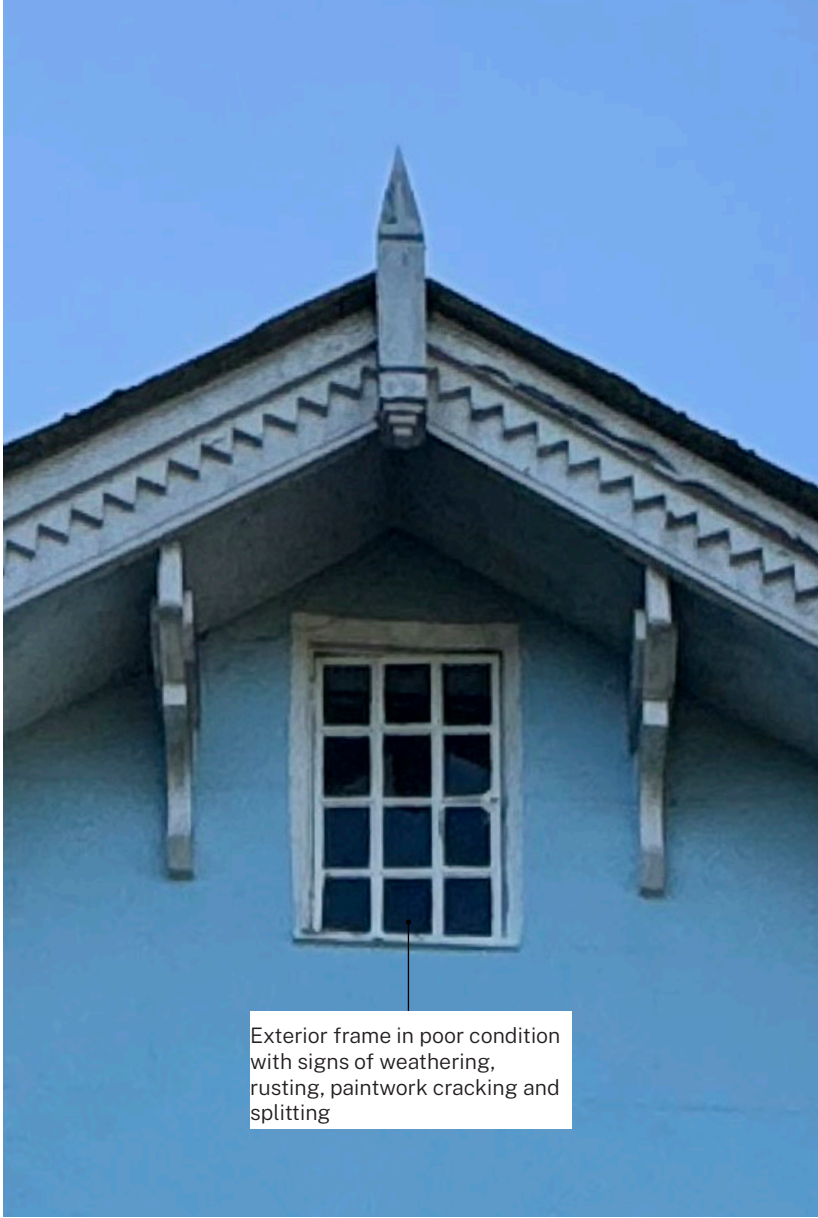
Exterior frame in poor condition with signs of weathering, rusting, paintwork cracking and splitting

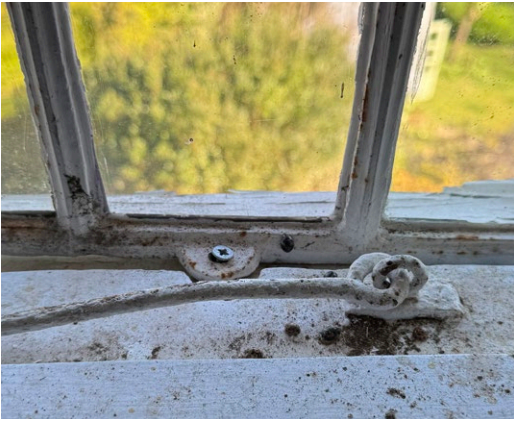
Build up of dirt, black mould and rusting, evidence of ladybirds and fixing screwed shut

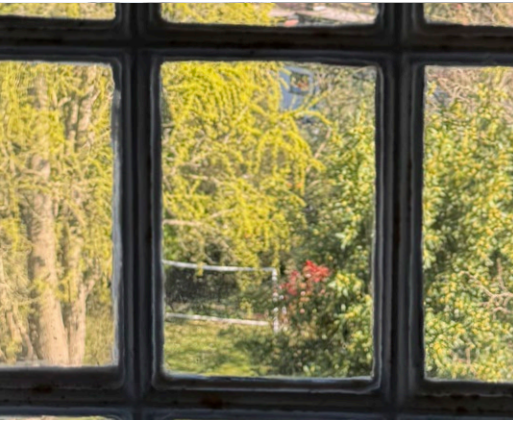
Broken window pane with hole to exterior

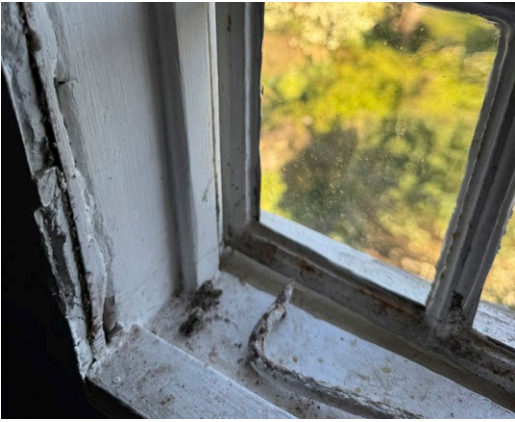
Signs of dirt, rotting and rusting of steel elements

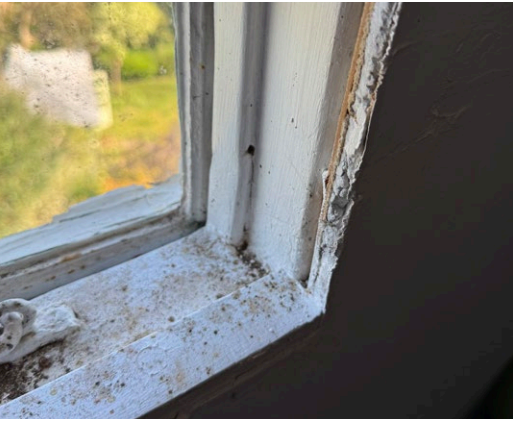
General poor condition around frame, flaking can be seen on exterior sill
