# Arboricultural Appraisal Report

## Subsidence Damage Investigation at:

37 Park Avenue South  
Hornsey  
London  
N8 8LU

| REPORT DATE: | 17/12/2020 |

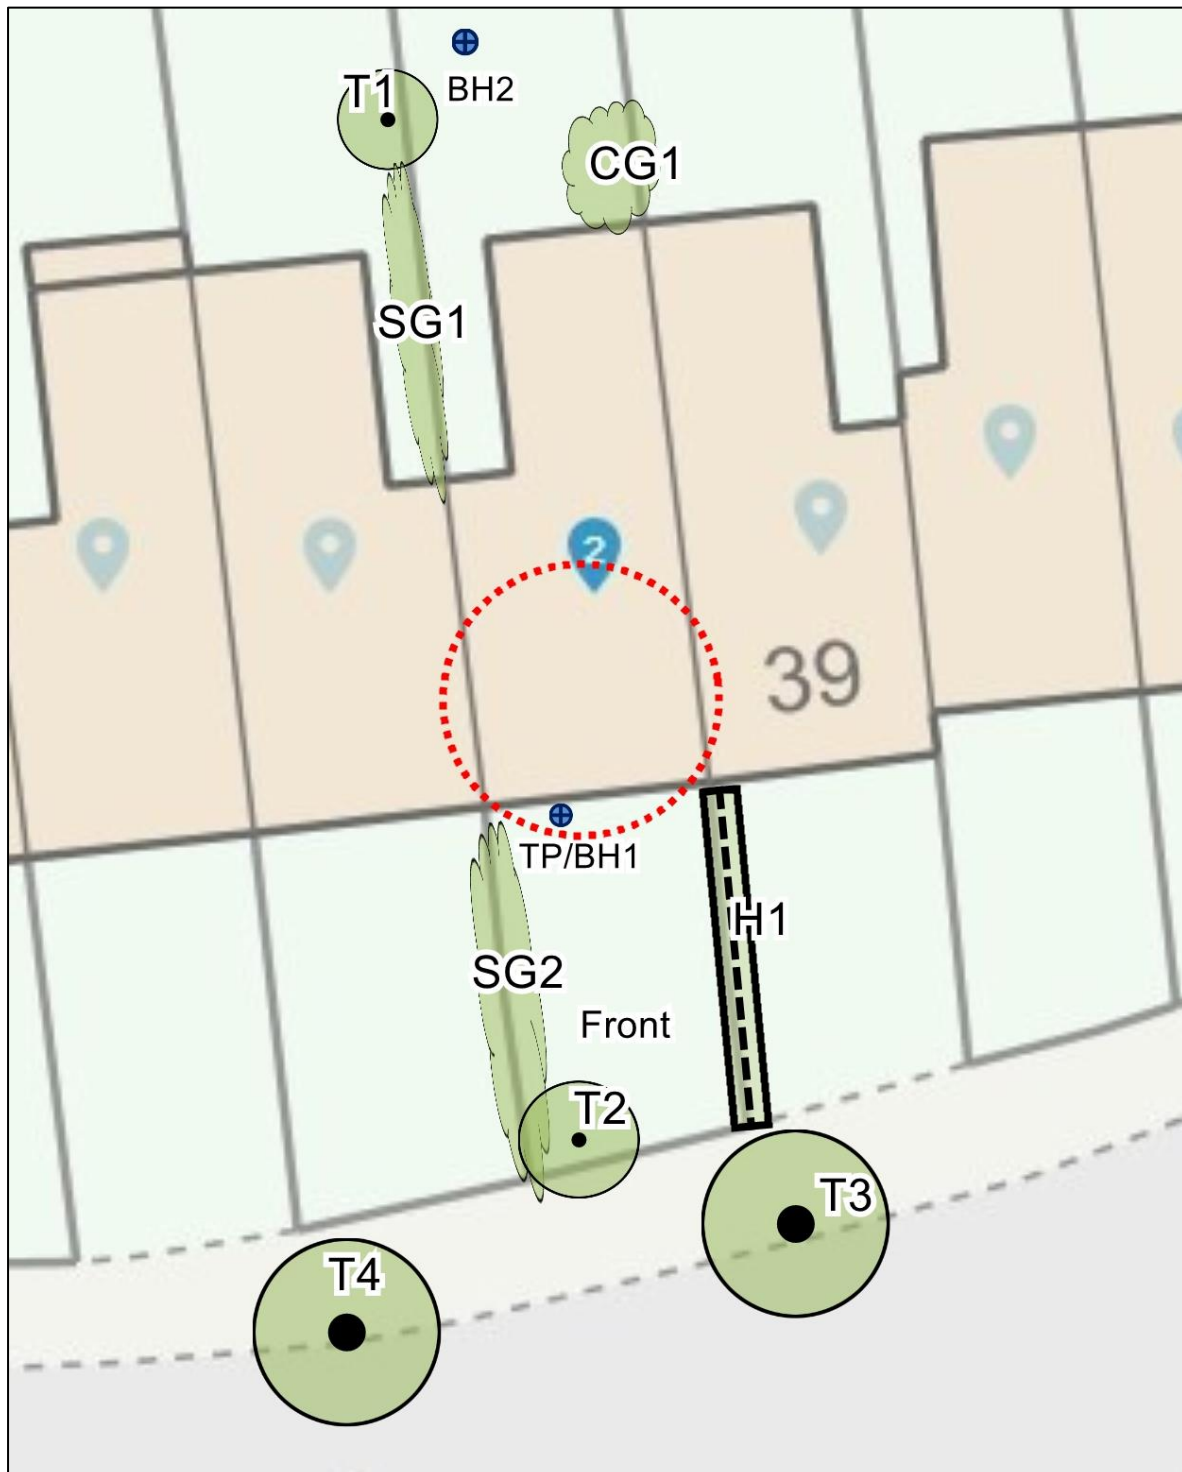
## Site Plan

Our survey has therefore identified vegetation within influencing distance of the building with a current potential to influence soil volumes below foundation level the most significant of which in relation to the current damage is T2 Cypress combined with nearby shrubs of SG2 group. There is also a potential influence from the Local Authority owned T3 and T4 London Planes however this is equivocal at present.

Approximate areas of damage

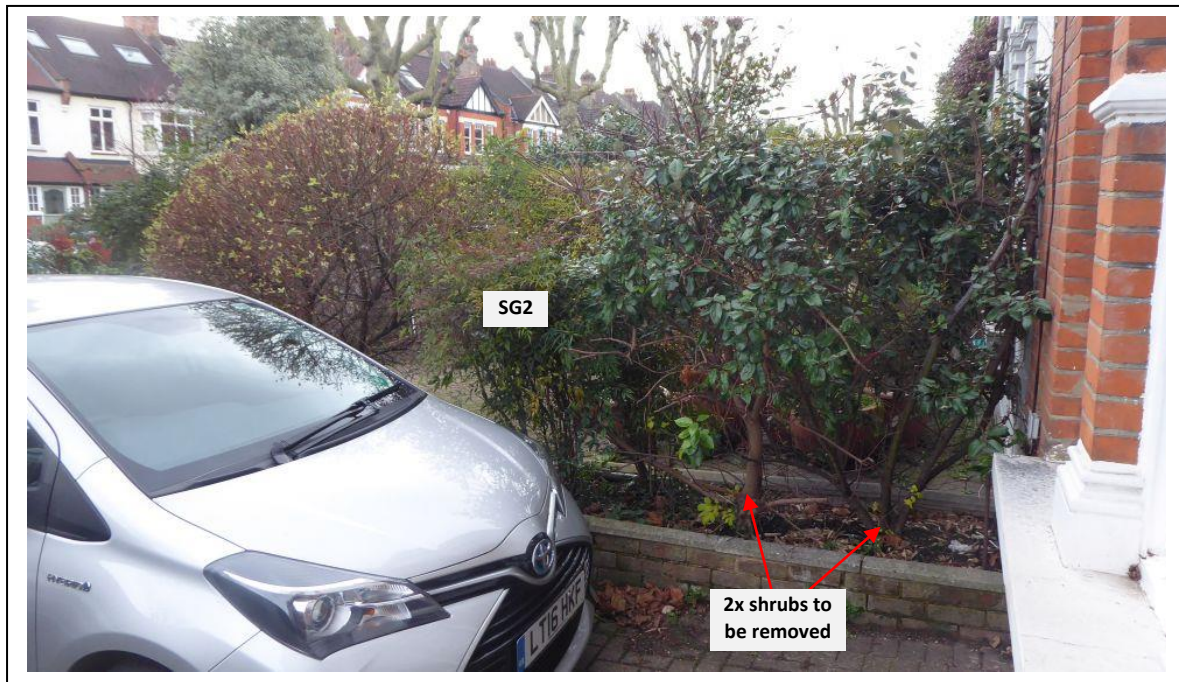
Based on the technical reports currently available, engineering opinion and our own site assessment we conclude the damage is consistent with shrinkage of the clay subsoil related to moisture abstraction by vegetation. Having considered the information currently available, it is our opinion that T2 Cypress combined with nearby shrubs of SG2 group are the likely principal cause of the current subsidence damage.

| Tree No. | Species | Ht (m) | Dia (mm) | Crown Spread (m) | Dist. to building (m) | Age Classification | Ownership |
|---|---|---|---|---|---|---|---|
| SG2 | Mixed spp. group of mostly Euonymus, Jasmine and Bottlebrush | 2.0 | 60 | 2.0 | 0.5 | Younger than Property | Joint Boundary Policy Holder & 35 Park Avenue South N8 8LU |

View of SG2 group with shrubs to be removed annotated

| Tree No. | Species | Ht (m) | Dia (mm) | Crown Spread (m) | Dist. to building (m) | Age Classification | Ownership |
|---|---|---|---|---|---|---|---|
| Recommendation | | Remove (fell) all within 1.5m of the building to near ground level and treat stumps to inhibit regrowth. | | | | | |

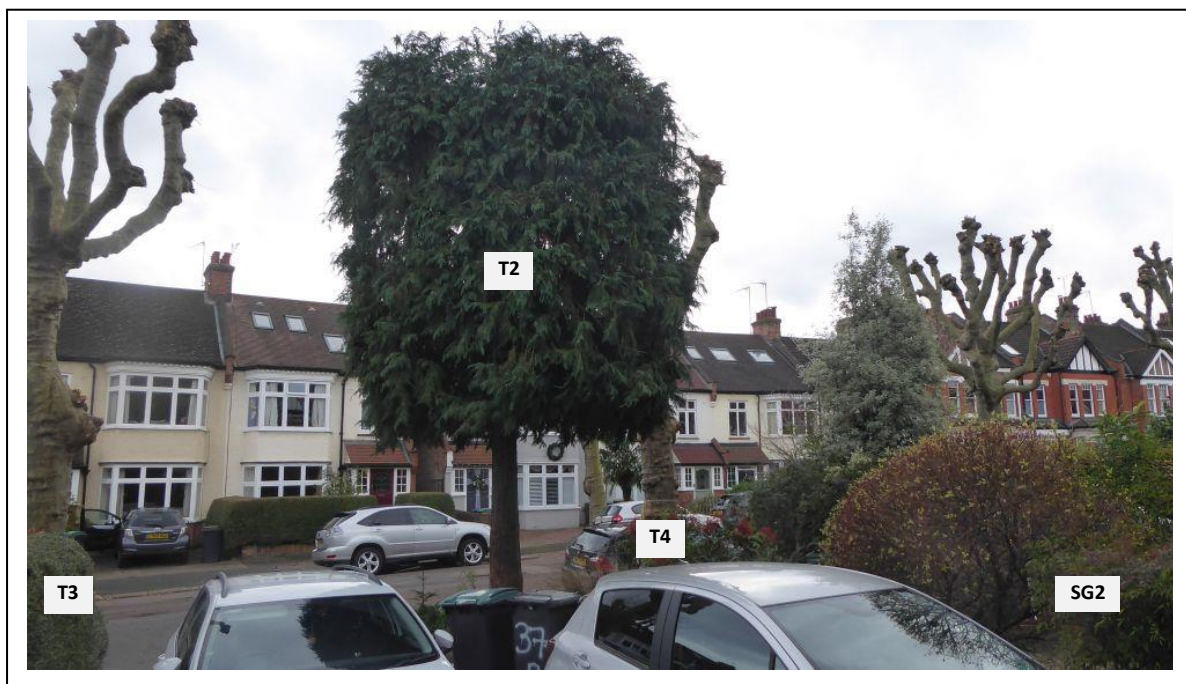
| Tree No. | Species | Ht (m) | Dia (mm) | Crown Spread (m) | Dist. to building (m) | Age Classification | Ownership |
|---|---|---|---|---|---|---|---|
| T2 | Cypress | 6.5 | 320 | 3.0 | 8.2 | Younger than Property | Policy Holder |

View of T2 Cypress with SG2 group visible to right of frame and T3 and T4 London planes visible to rear

| Tree No. | Species | Ht (m) | Dia (mm) | Crown Spread (m) | Dist. to building (m) | Age Classification | Ownership |
|---|---|---|---|---|---|---|---|
| Recommendation | | Remove (fell) to near ground level and treat stump to inhibit regrowth. | | | | | |

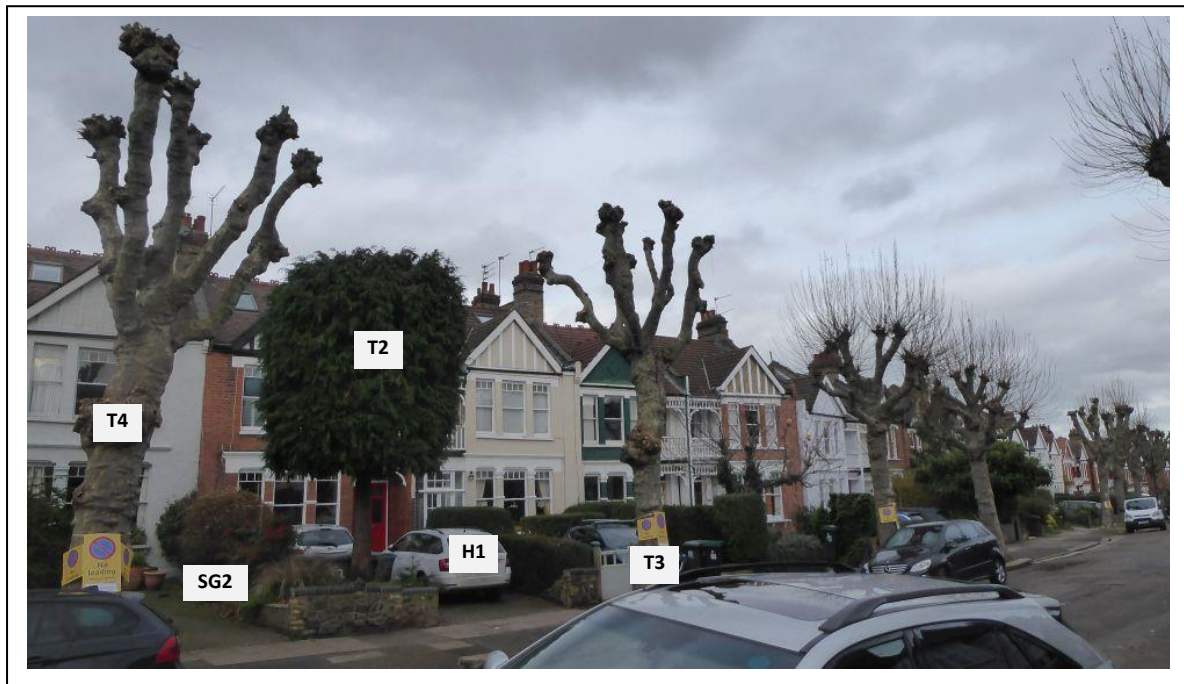
| Tree No. | Species | Ht (m) | Dia (mm) | Crown Spread (m) | Dist. to building (m) | Age Classification | Ownership |
|---|---|---|---|---|---|---|---|
| T3 | Plane (London) | 7.5 | 560 | 4.5 | 11.1 | Younger than Property | Local Authority |
| T4 | Plane (London) | 8.0 | 610 | 4.0 | 12.7 | Younger than Property | Local Authority |

| Tree No. | Species | Ht (m) | Dia (mm) | Crown Spread (m) | Dist. to building (m) | Age Classification | Ownership |
|---|---|---|---|---|---|---|---|
| H1 | Lonicera hedge | 2.0 | 20 Ms * | 1.5 | 1.7 | Younger than Property | Joint Boundary Policy Holder & 39 Park Avenue South N8 8LU |

Overview of T2 Cypress, T3 and T4 London planes with SG2 group and H1 hedgerow visible beyond

| Tree No. | Species | Ht (m) | Dia (mm) | Crown Spread (m) | Dist. to building (m) | Age Classification | Ownership |
|---|---|---|---|---|---|---|---|
| Recommendation | | No works required at present (subject to review if movement persists). | | | | | |

| Tree No. | Species | Ht (m) | Dia (mm) | Crown Spread (m) | Dist. to building (m) | Age Classification | Ownership |
|---|---|---|---|---|---|---|---|
| Recommendation | | Maintain broadly at no more than current dimensions by periodic pruning. | | | | | |
