## SITE INVESTIGATION FACTUAL REPORT

Report No: 772537  
Client: Crawford Claims Management  
Site: 37 Park Avenue South, Hornsey

Client Ref: SU2003259  
Date of Visit: 21/10/2020

# Drainage Layout Plan

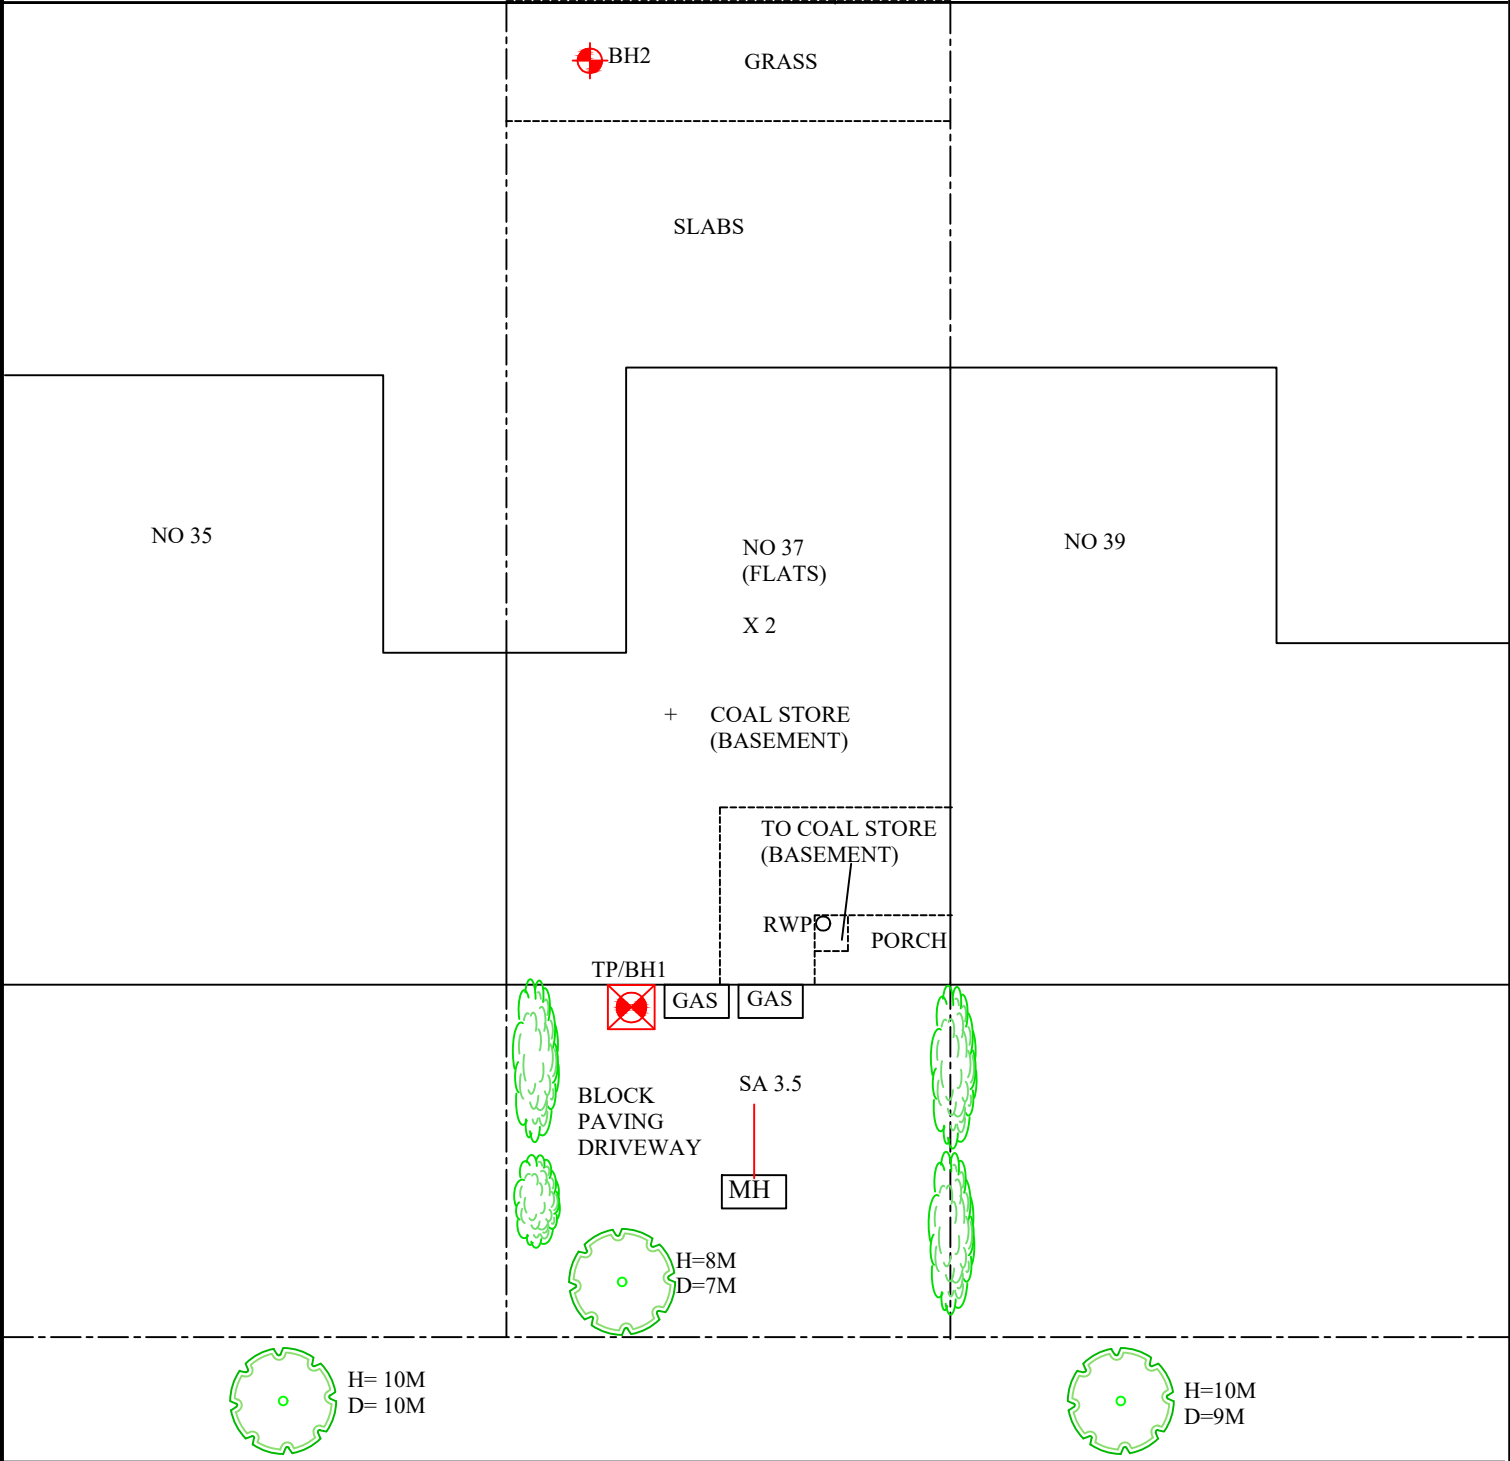
TP moved to left of original location due to buried services  
No recommendations required to the private drainage surveyed.

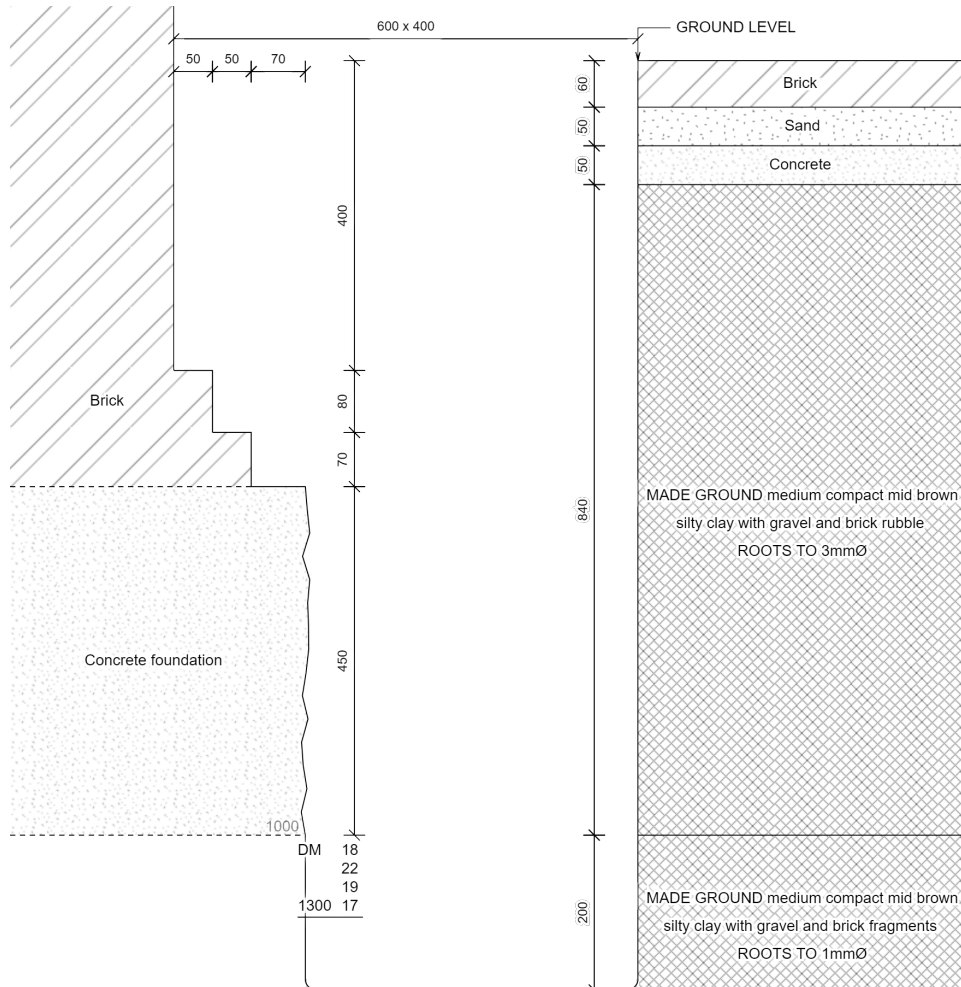
TRIAL PIT REF: TP1

TP moved 1.5m left of original location due to buried services.
