### **INSURANCE CLAIM: ENGINEERING APPRAISAL REPORT**

Out Ref: 10828336

Address of Insured: 10 Rosebery Road, LONDON, N10 2LH

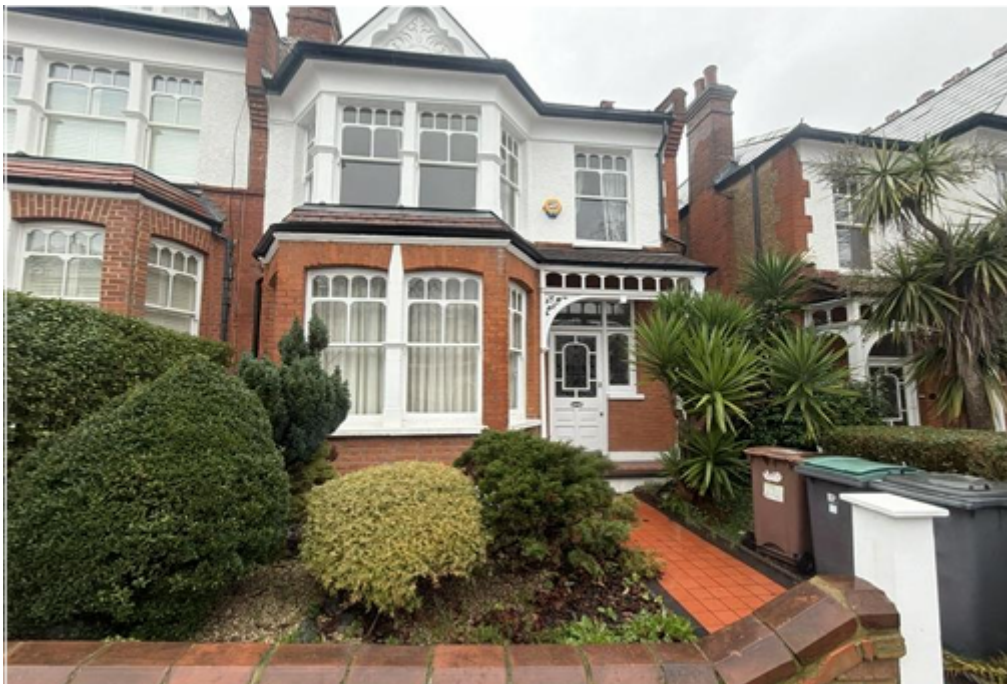
The claim is concerned with damage affecting the front bay window and associated internal areas. All references to orientation are made facing the front elevation of the property.

| Description and Mechanism | The principal damage affects the front bay window structure and associated internal finishes. Damage presents predominantly as tapered cracking to external masonry and corresponding internal cracking. |
| Significance | The level of damage is moderate, and is classified as category 3 in accordance with BRE Digest 251 - Assessment of damage in low-rise buildings.. |
