# Defect Advisory Report

93 Mountview Road  
London N4 4JA

28 July 2022

EKA220563

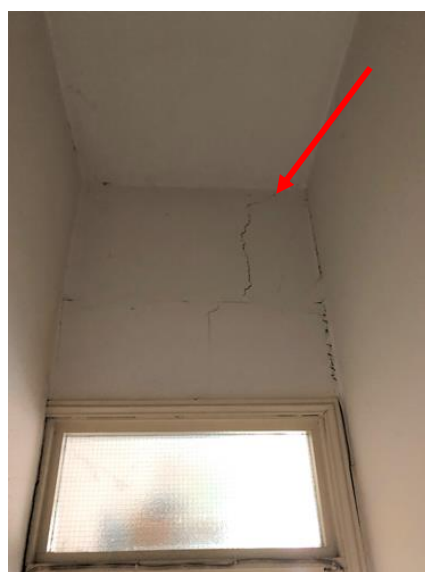
Photo 4: Fine vertical cracks above entrance to front bedroom

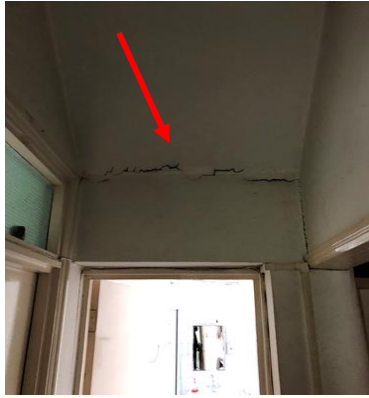
Photo 5: Horizontal cracking across top of entrance to rear bathroom

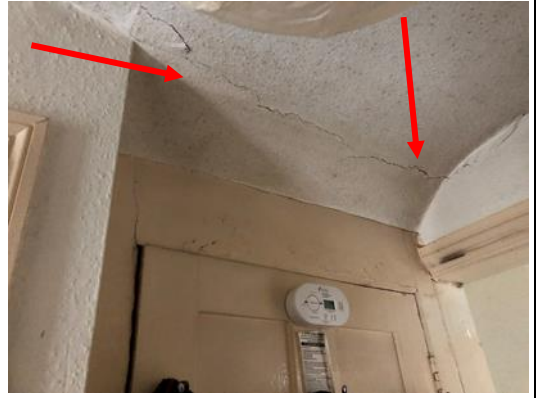
Photo 6: Fine horizontal cracks above entrance to Cellar

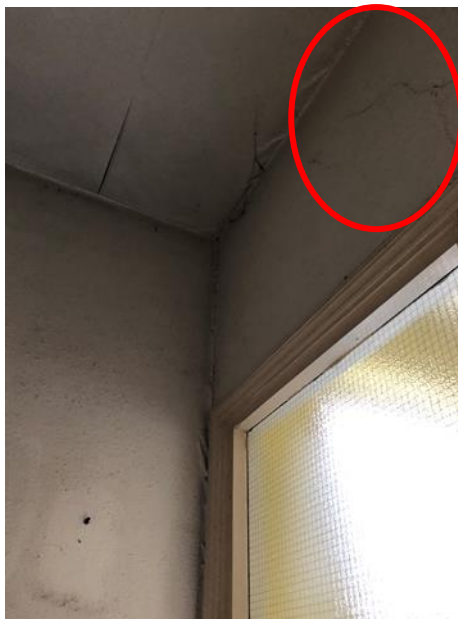
Photo 7: Fine diagonal cracks above entrance to kitchen

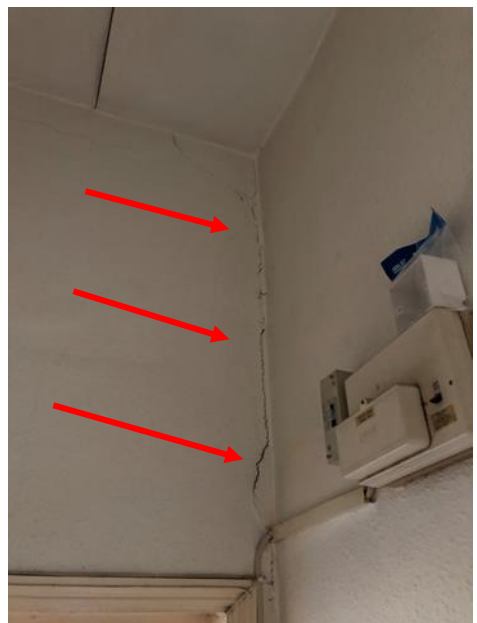
Photo 8: Vertical cracks above entrance to living room

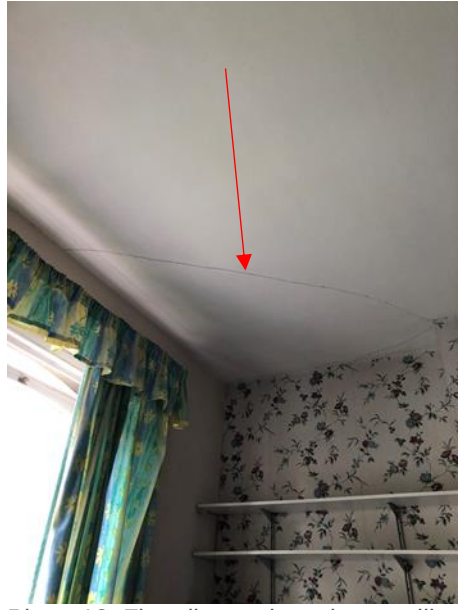
Photo 10: Fine diagonal cracks to ceiling / front elevation

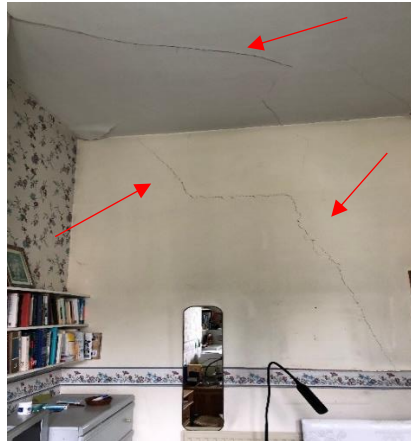
Photo 11: Diagonal fine cracks to partition with bedroom 2

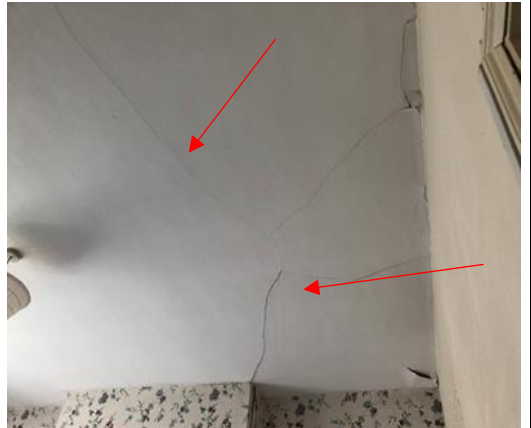
Photo 12: Crazed fine cracks to ceiling / rear of room

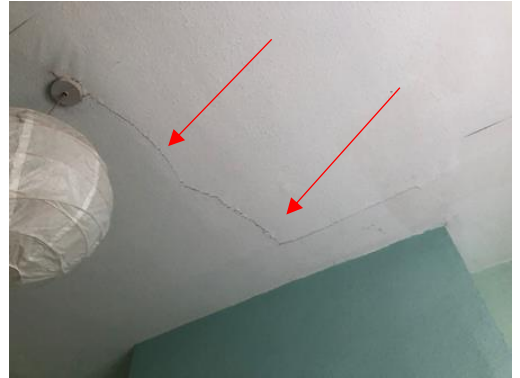
Photo 14: Fine cracks to ceiling

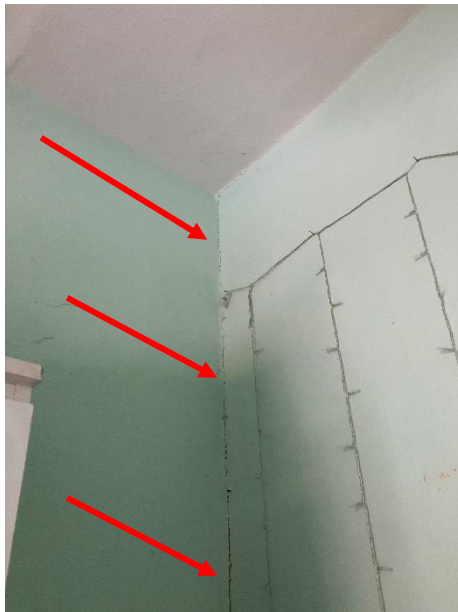
Photo 15: Fine vertical cracks to rear wall / partition with front bedroom

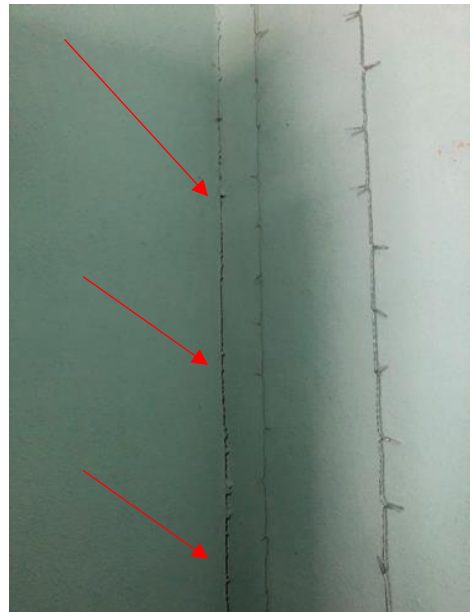
Photo 16: Closer view of the same area

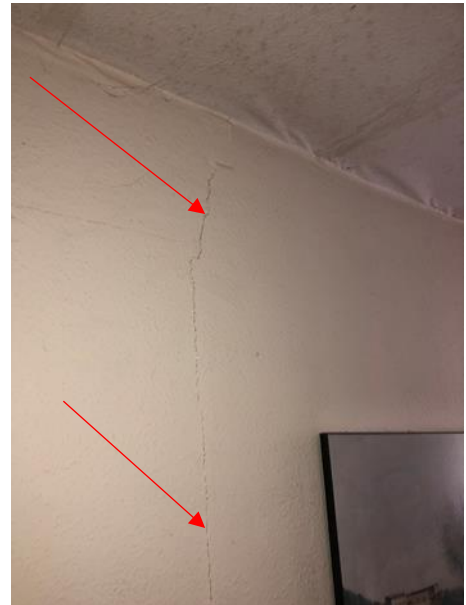
Photo 18: Vertical fine cracks to partition with bathroom

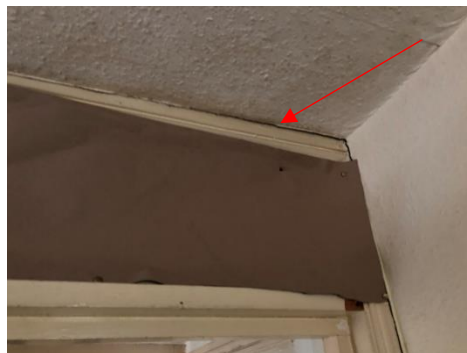
Photo 19: Separation cracks above door

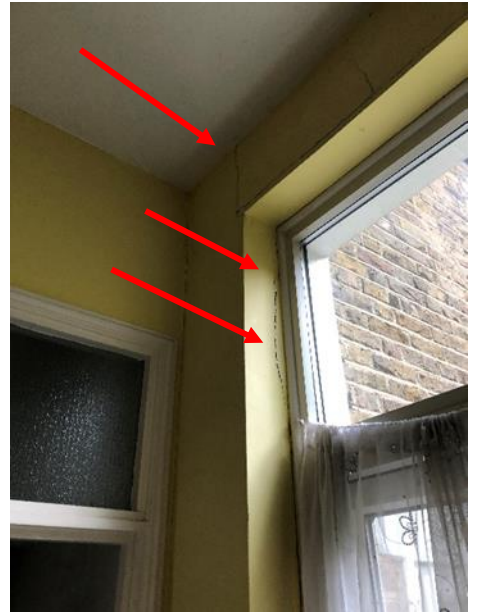
Photo 20: Vertical fine cracks above door & surround to garden

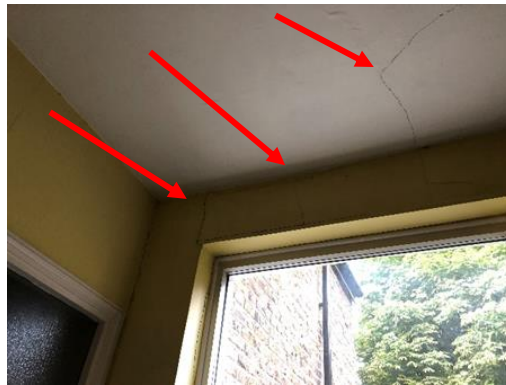
Photo 21: Close up view of cracks

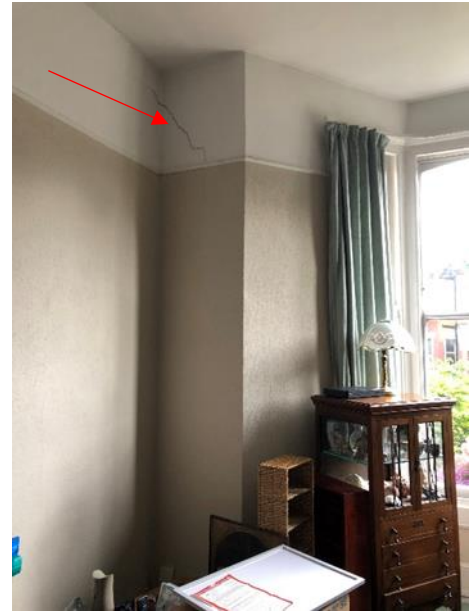
Photo 21: Close up view of fine diagonal and horizontal cracking / left hand side of bay window

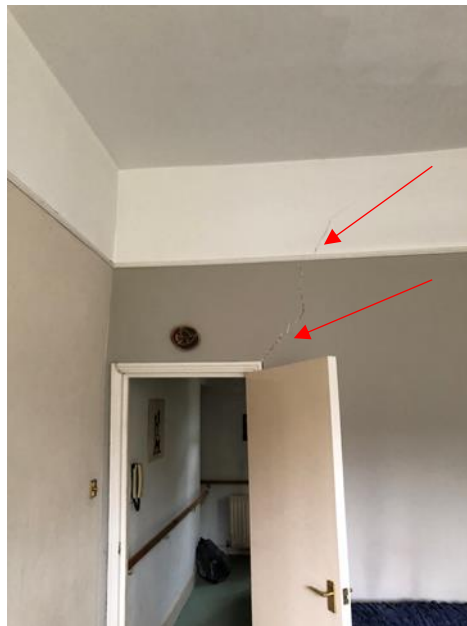
Photo 22: Fine diagonal crack above entrance door

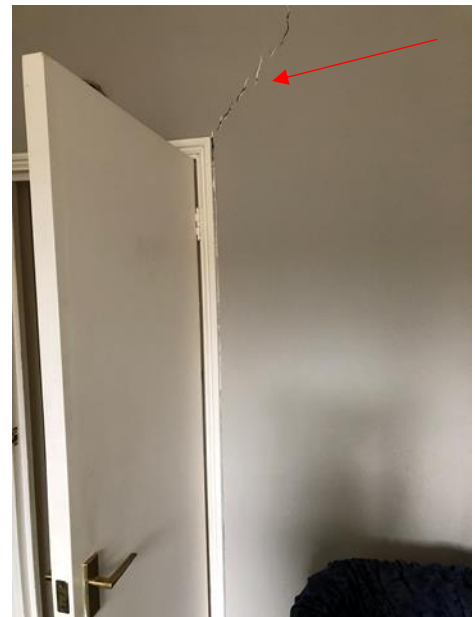
Photo 23: Close up view of diagonal crack above entrance door

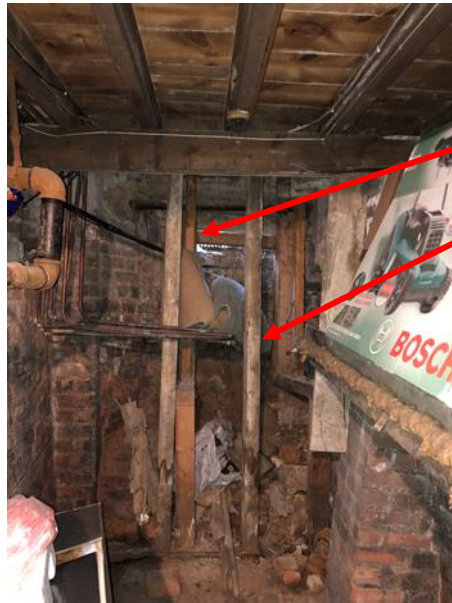
The front external steps and porch appear to have visibly shifted, with cracks appearing over the years. A local builder rebuilt the steps, installing wooden props in the cellar area beneath the steps, in order to provide temporary support. However, we were advised these have been in situ for some years.

Temporary wooden props installed to stabilise front elevation steps.

Photo 24: Area beneath front elevation/ steps

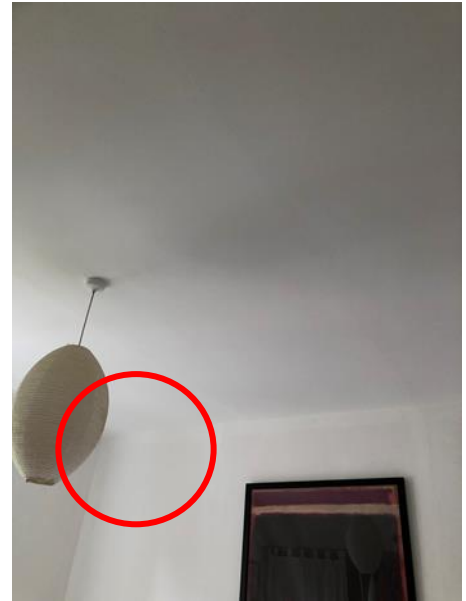
Photo 26: Area of vertical and diagonal hairline and fine cracks to flank wall

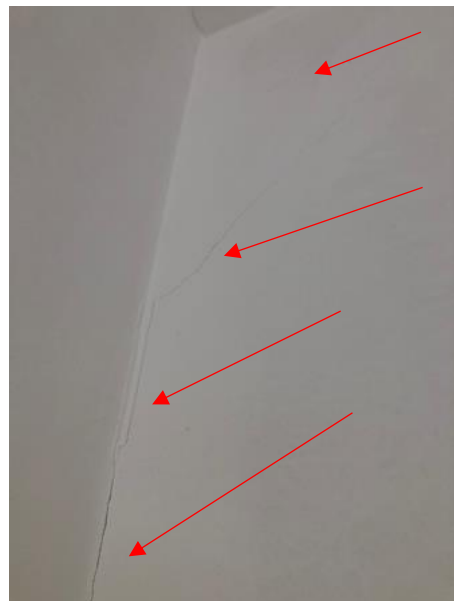
Photo 27: Closer view of hairline and fine cracks

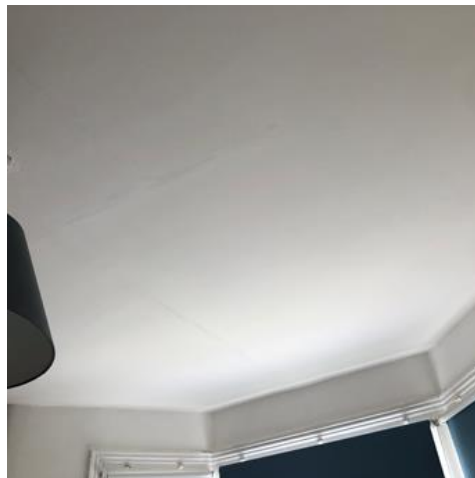
Photo 30: General cracks to ceiling throughout

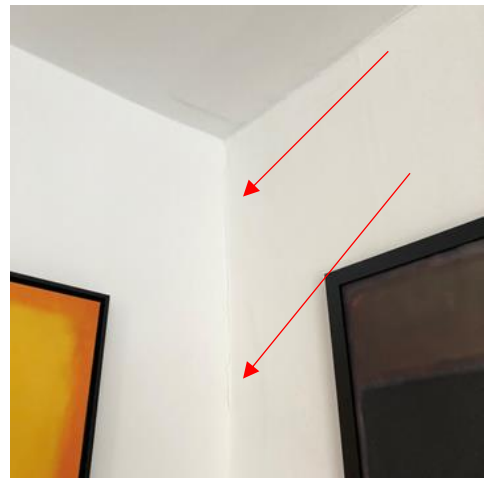
Photo 31: Hairline cracks to corner of partition wall with bathroom/flank wall

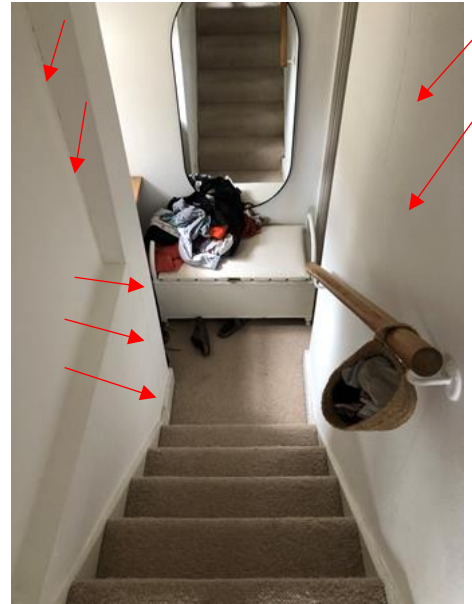
Photo 33: Overview of stairs leading to bathroom and kitchen to rear. Fine cracks to both sides of stairwell

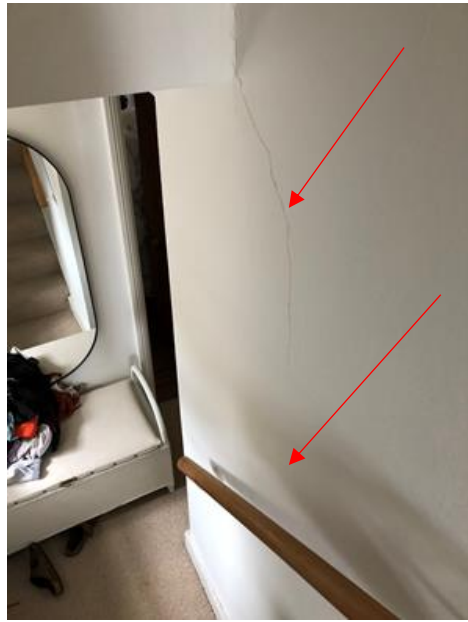
Photo 34: Closer view of fine vertical crack

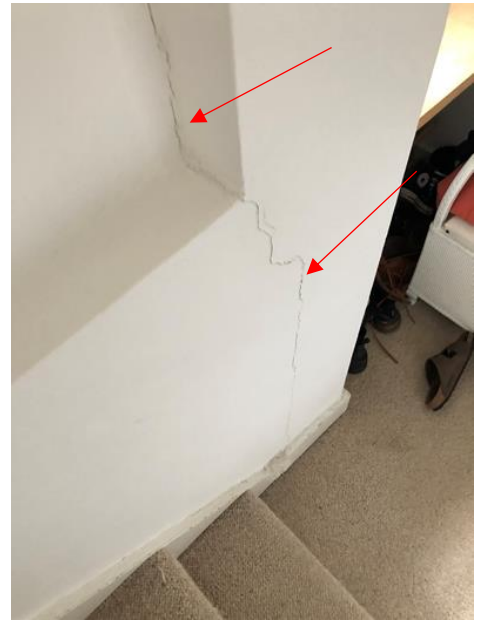
Photo 35: Closer view of vertical cracks to left hand side

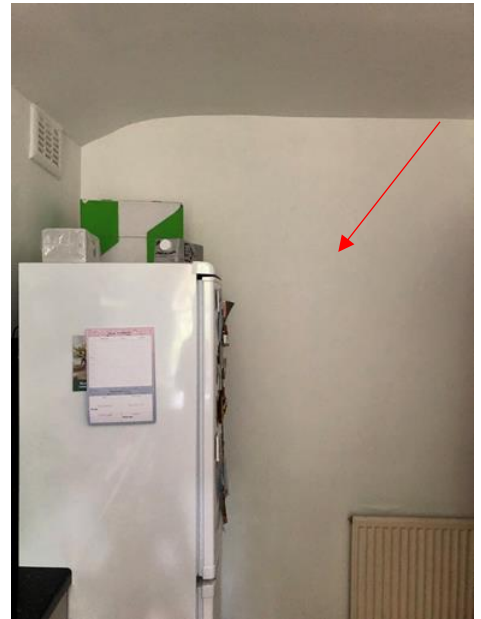
Photo 37: Minor vertical hairline crack to partition with communal area

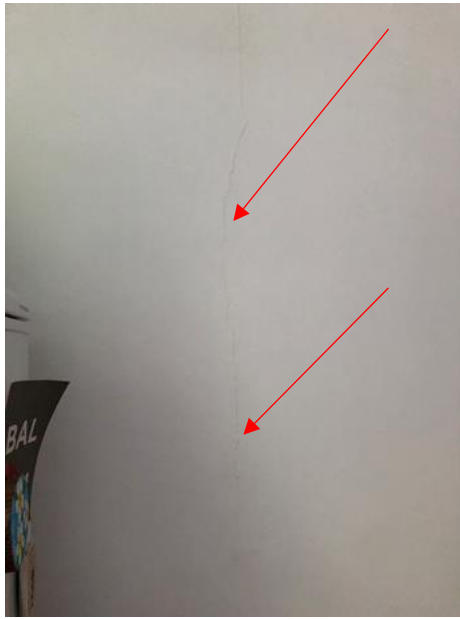
Photo 38: Closer view of hairline crack to right hand side of fridge

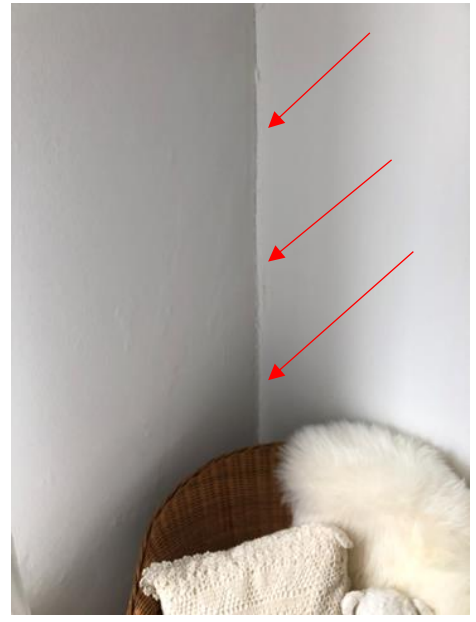
Photo 40: Vertical hairline crack to left hand side of window

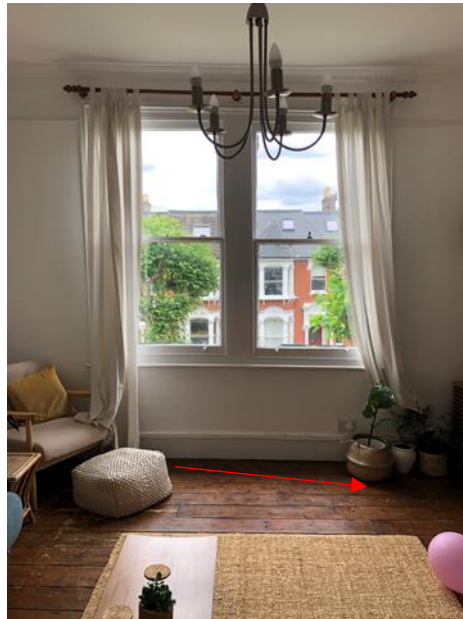
Photo 41: Overview of living room, floor noted as sloping left to right

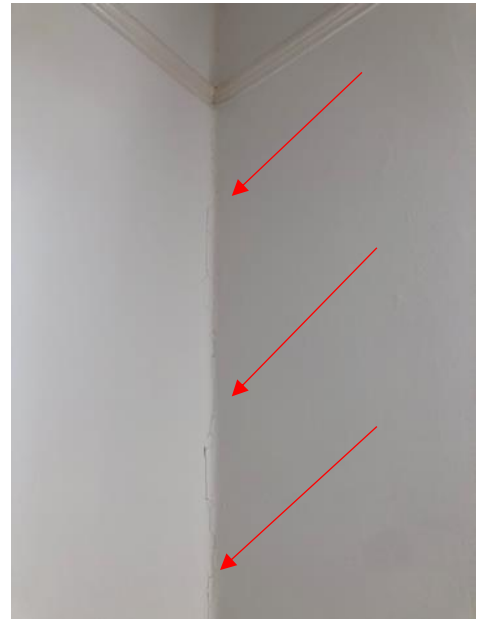
Photo 42: Fine cracks running from ceiling to low level left hand side of window

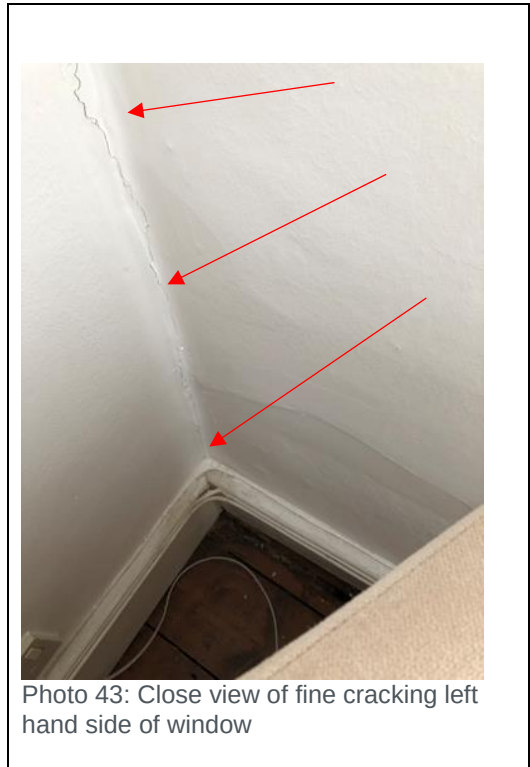
Photo 43: Close view of fine cracking left hand side of window

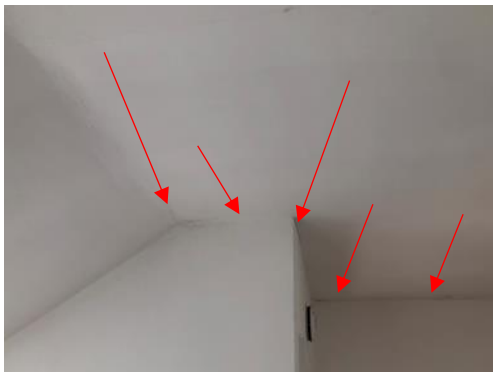
Photo 47: Fine cracking to junction of ceiling/walls throughout stairs, half landing and landing

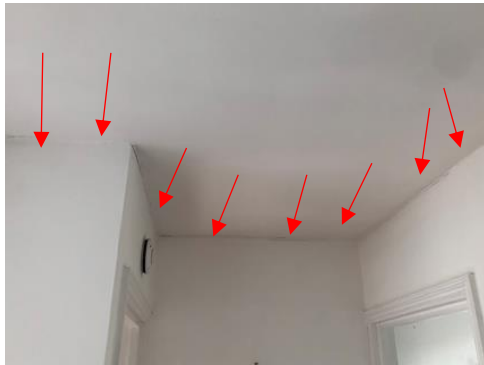
Photo 48: Fine cracking throughout

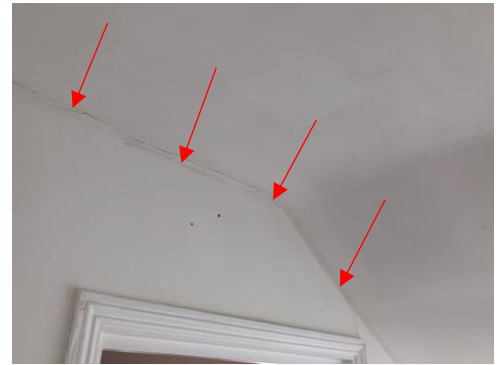
Photo 49: Close view of fine horizontal cracks above door to living room

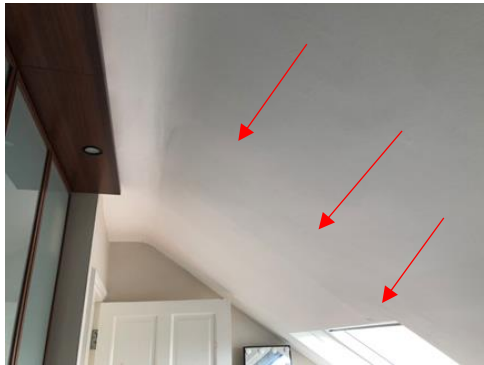
Photo 50: Overview of ceiling with general hairline cracks to boards

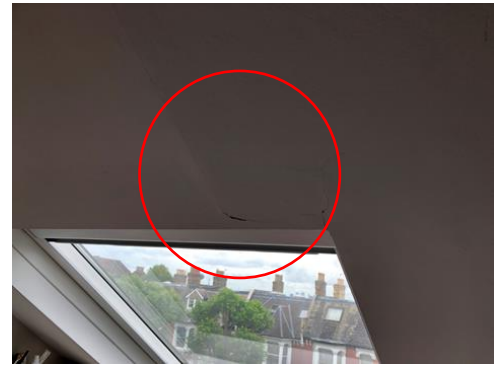
Photo 51: Closer view of hairline cracks above window, opposite entrance door

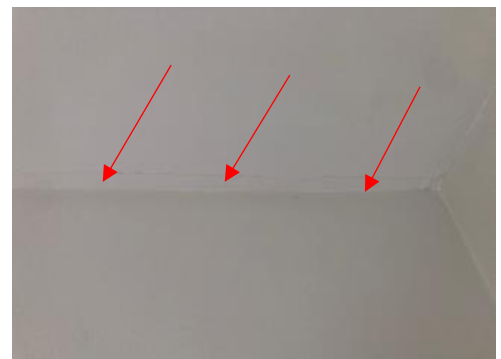
Photo 53: Fine horizontal cracking to ceiling

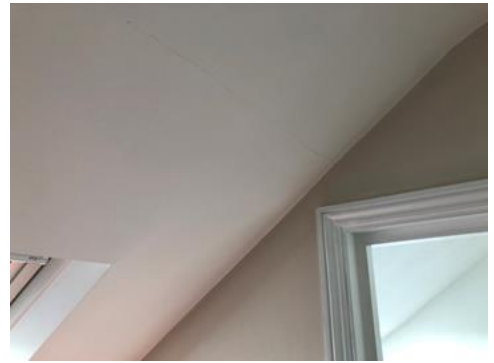
Photo 55: Fine cracks to ceiling plasterboard

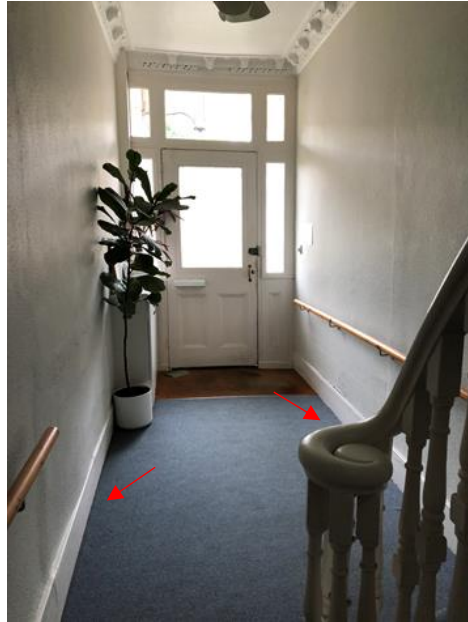
Photo 56: Overview of communal entrance, sloping flooring as shown by arrows

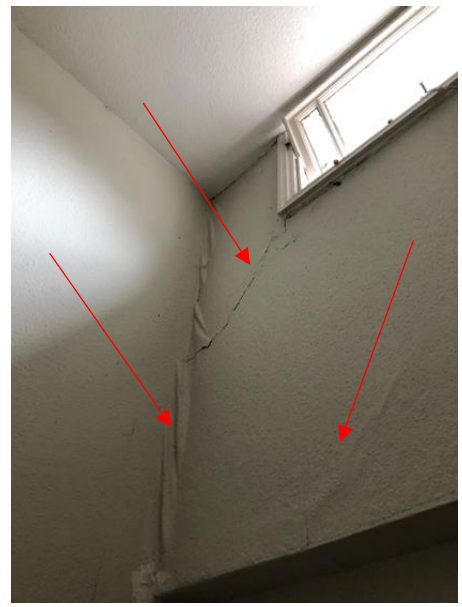
Photo 59: Closer view of diagonal cracks beneath paper and rippling to wallpaper

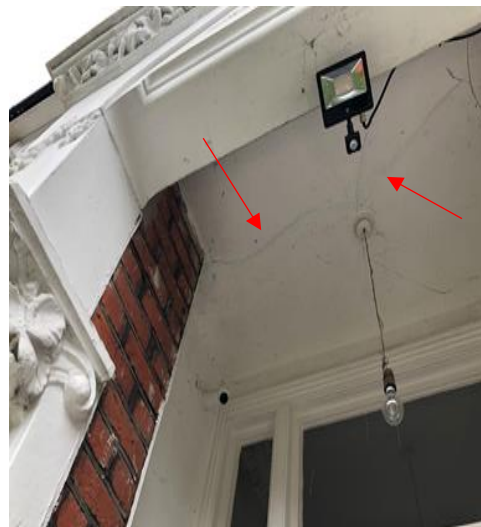
Photo 62: Porch ceiling – crazed cracking

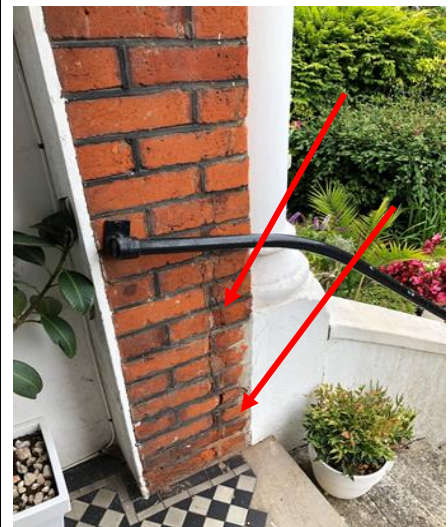
Photo 63: Stepped cracks to brickwork

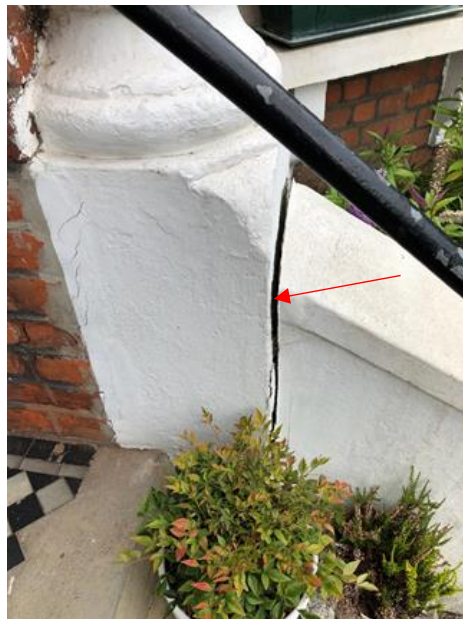
Photo 64: Gap to top top of stairs

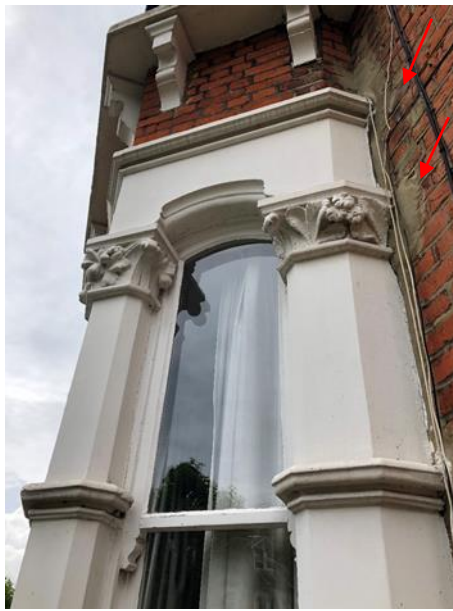
Photo 68: Patch repairs

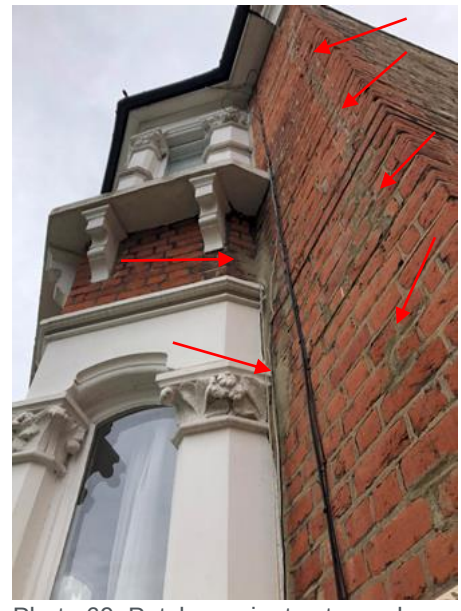
Photo 69: Patch repairs to stepped cracking

To front elevation, historic stepped crack repairs running vertically, to left hand side and right hand side of first floor bay window were noted.

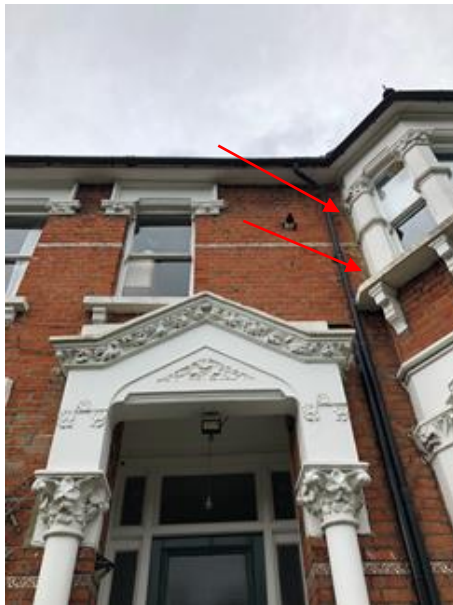
Photo 70: Patch repairs

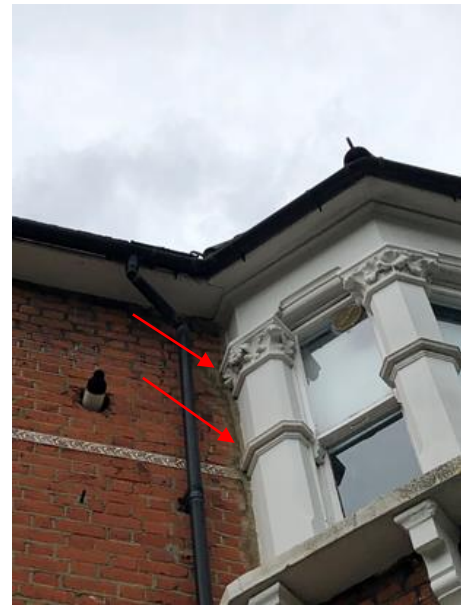
Photo 71: Closer view of patch repair

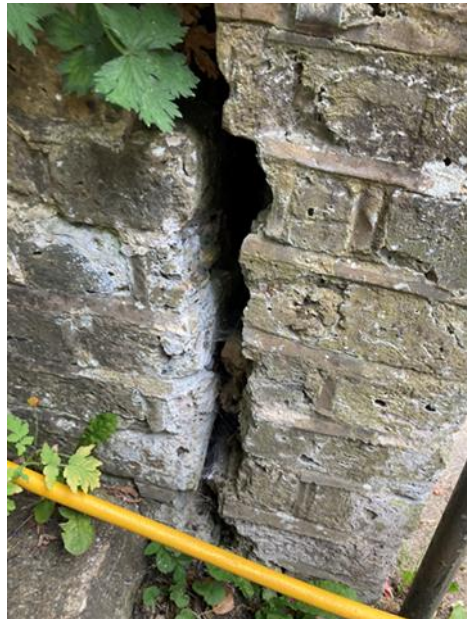
Photo 74: Opened up crack to garden wall - Area 1

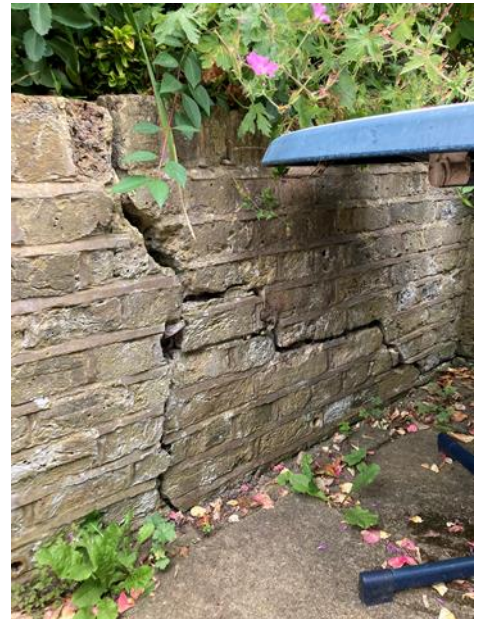
Photo 75: Stepped opened up cracking to garden wall – Area 2

The rear garden and patio areas have also been affected, with stepped cracking to garden wall and sloping flagstones, close to building proximity.

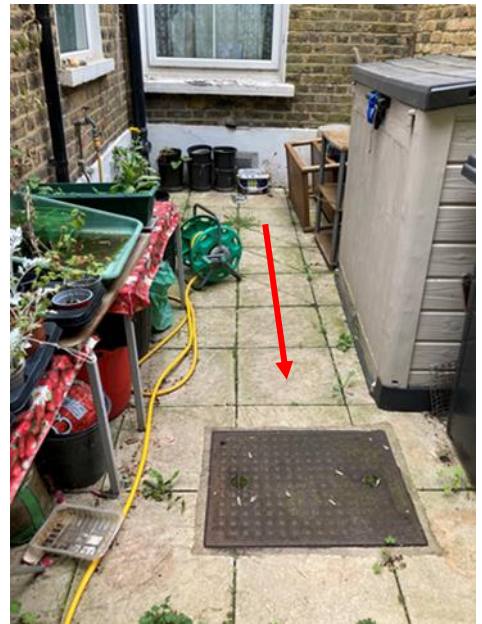
Photo 79: Rear patio area – floor slanting
