## Addendum Arboricultural Report

### Subsidence Damage Investigation at:

93 Mount View Road  
London  
N4 4JA

| MWA REF: | SUB230517-13156Rev02 |

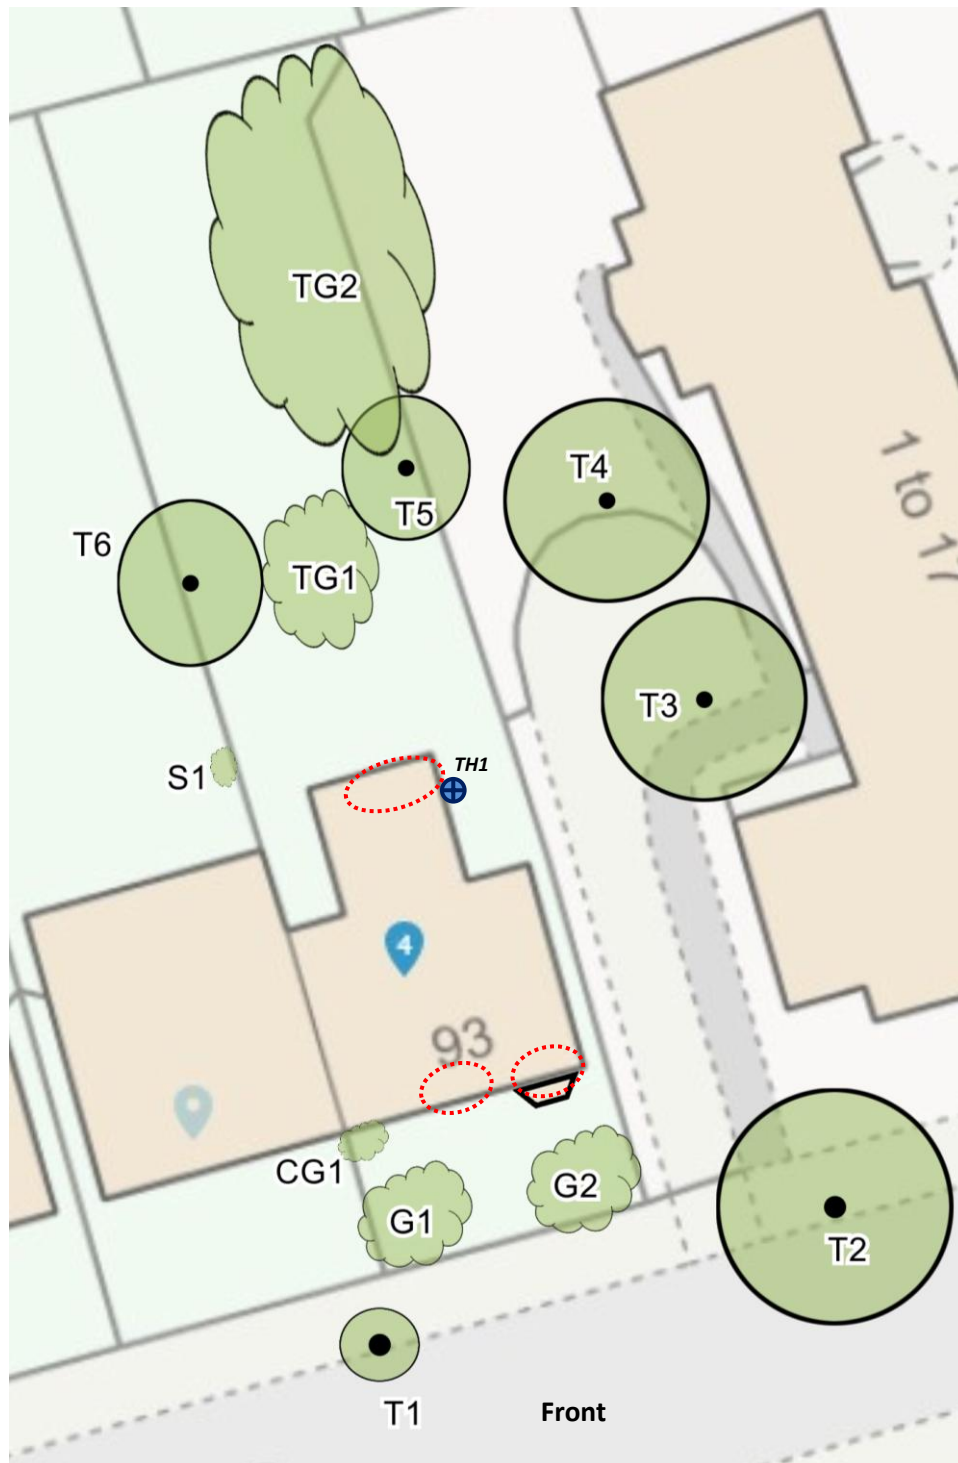
**Site Plan**

Approximate areas of damage

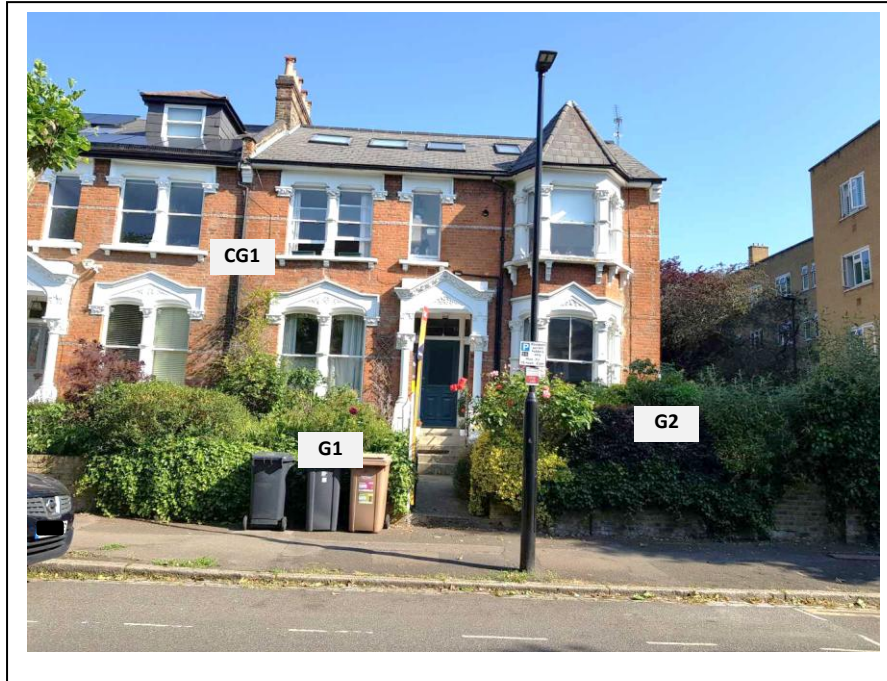
View of property from front

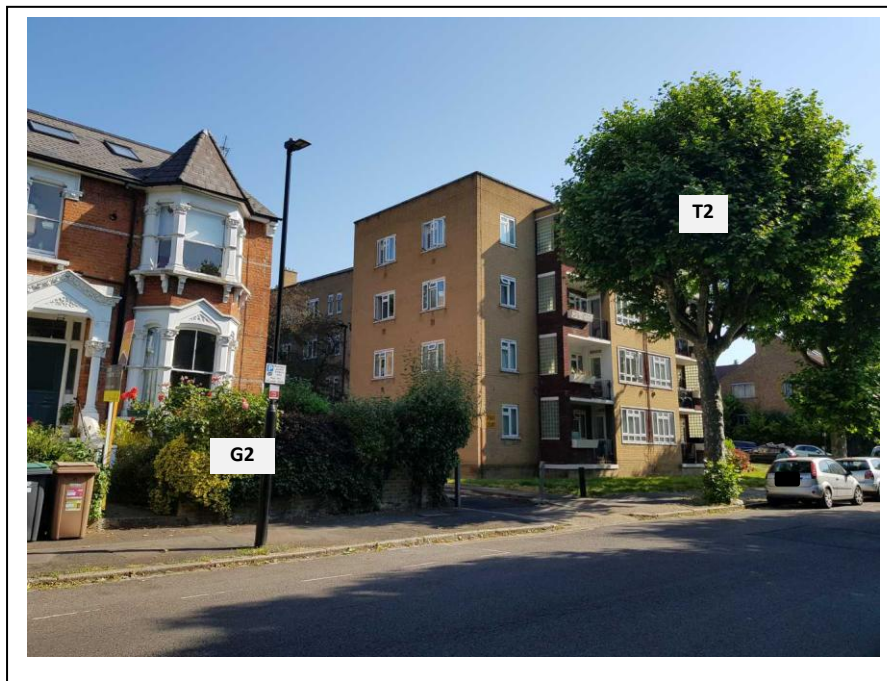
View of T2 from front of property

| Tree No. | Species | Ht. (m) | Dia. (mm) | Crown Spread (m) | Dist. to building (m) | Age Classification | Ownership |
|---|---|---|---|---|---|---|---|
| Recommendation | | Pollard at 6m. Prune on a triennial cycle to maintain at broadly reduced dimensions.<br><b>Initial works completed. Repetition required as per recommendation.</b> | | | | | |

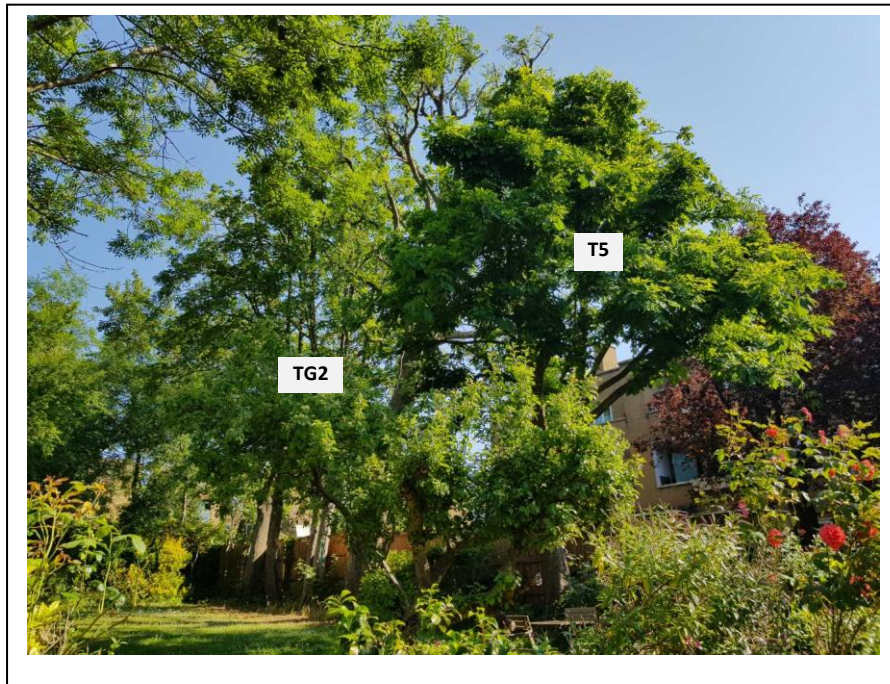
Roots were observed to a depth of 900mm bgl in TH1 and recovered samples have been identified (using anatomical analysis) as *Hedera spp.* or *Fatsia spp.* and probably *Aesculus spp.*, the origin of which will be ivy in the rear garden and T5 respectively. It is however unlikely that the ivy will have sufficient leaf volume to influence the soils below the foundations to a significant degree, leaving T5 as the most likely influence.

In our initial report we recommended that in order to address movement to the rear, T5 and TG2 should be reduced and we understand works to have been completed only for T5, with TG2 not managed.

View of TG2 and T5 from rear of conservatory

If an arboricultural solution is to be implemented to mitigate the ongoing movement, we recommend that T5 and T6 are removed and previously recommended reduction of TG2 is also conducted.

| Tree No. | Species | Ht. (m) | Dia. (mm) | Crown Spread (m) | Dist. to building (m) | Age Classification | Ownership |
|---|---|---|---|---|---|---|---|
| Recommendation | | <b>Initial recommendation:</b> Reduce height and crown spread to 6m. Prune on a triennial cycle to maintain at broadly reduced dimensions.<br><b>Revised recommendation:</b> Remove (fell) to near ground level and treat stump to inhibit regrowth. | | | | | |
| Recommendation | | Pollard at 8m. Prune on a triennial cycle to maintain at broadly reduced dimensions. | | | | | |

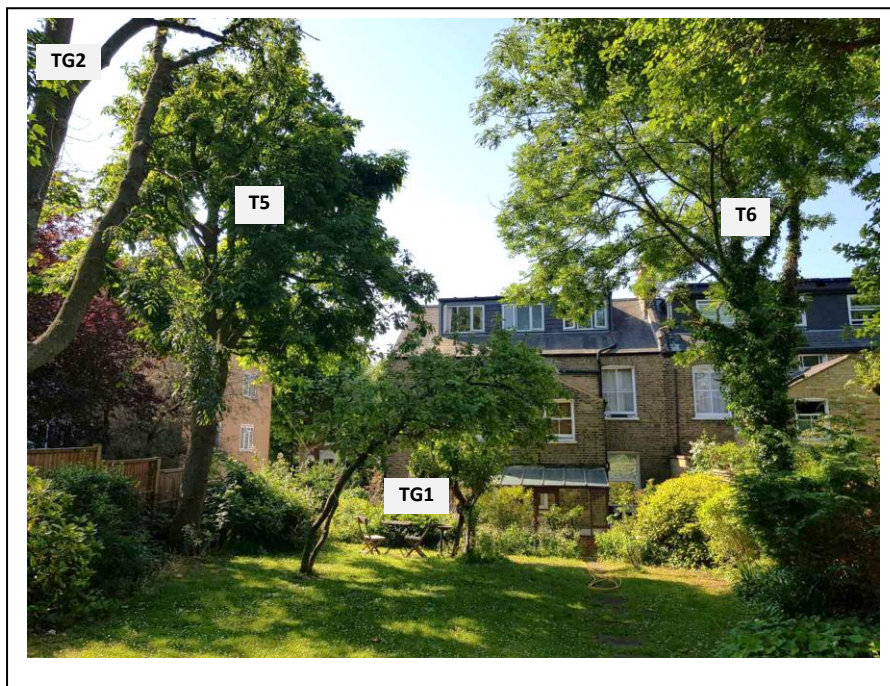
View of dwelling from rear
