# GeoShield Verification Report 1

GEO105182

Cranford House,  
100 Woodside Avenue,  
Haringey,  
LONDON  
N10 3JA

Block C - Slab, gridlines 13-15/Q-T

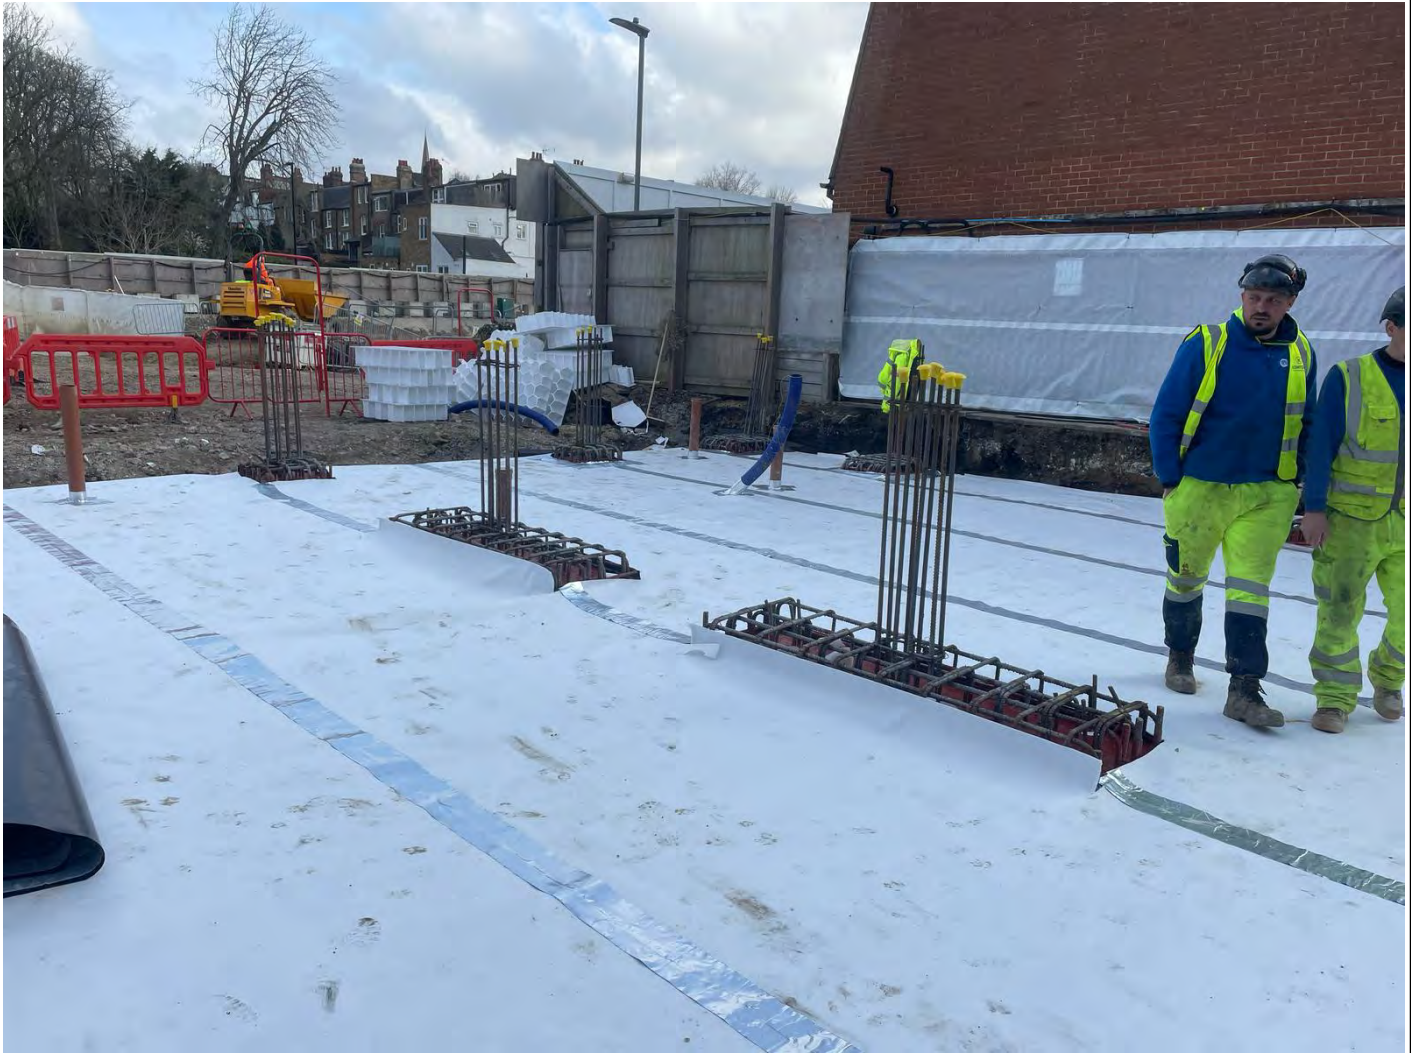
The photograph above displays an overview of the slab section in Block C where today's verification inspection took place on site.

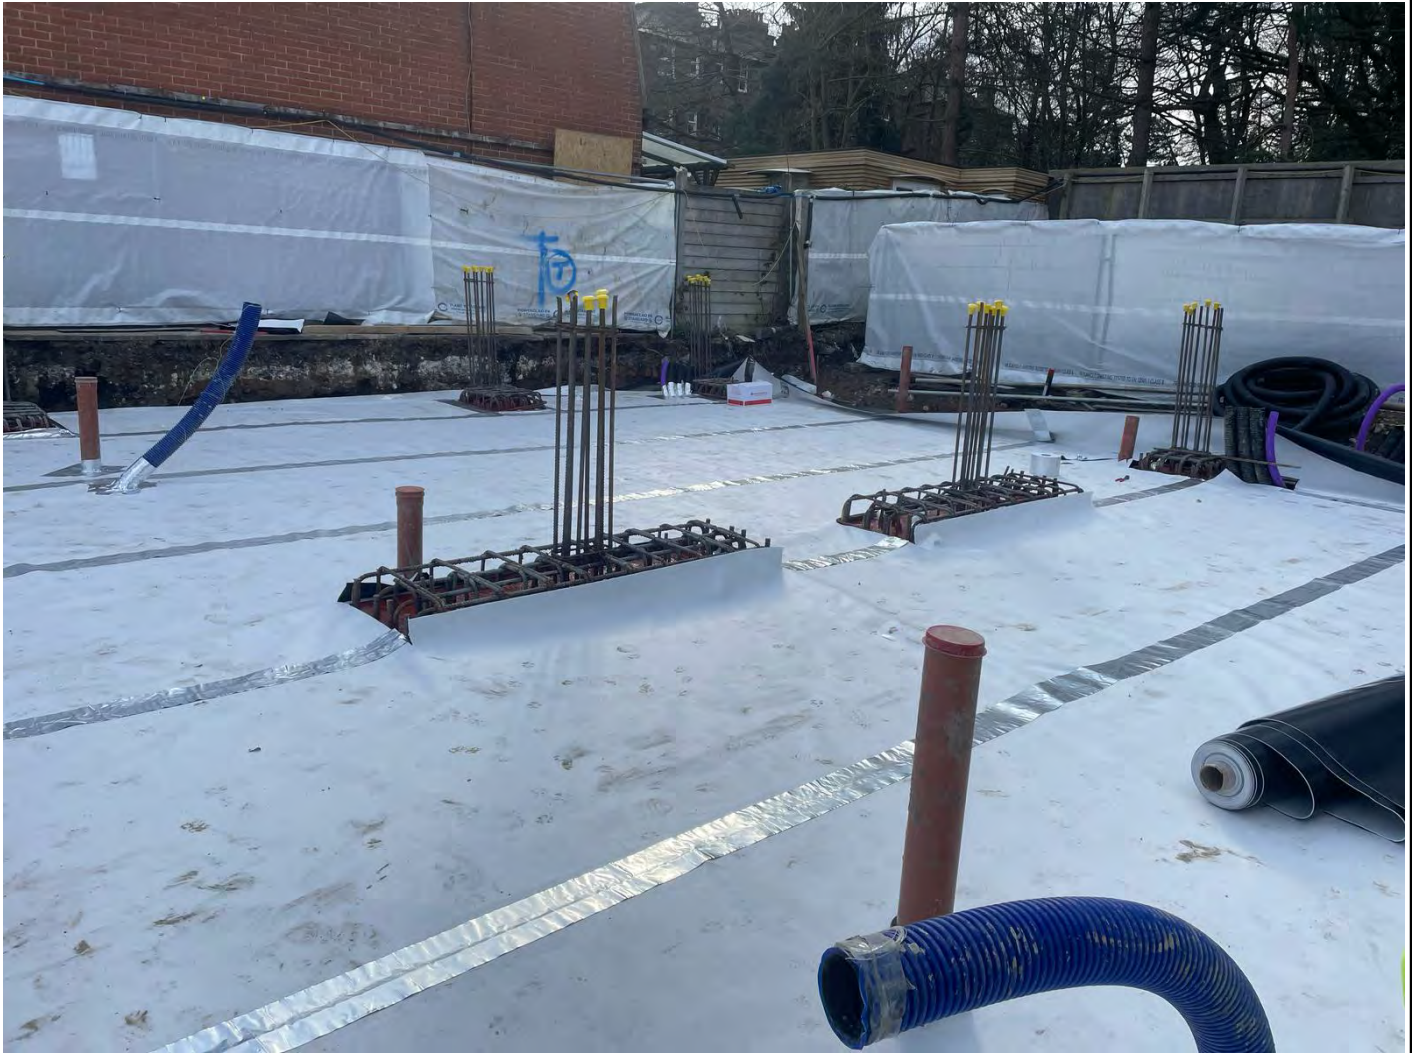
The photograph above displays an overview of the slab section in Block C where today's verification inspection took place on site.

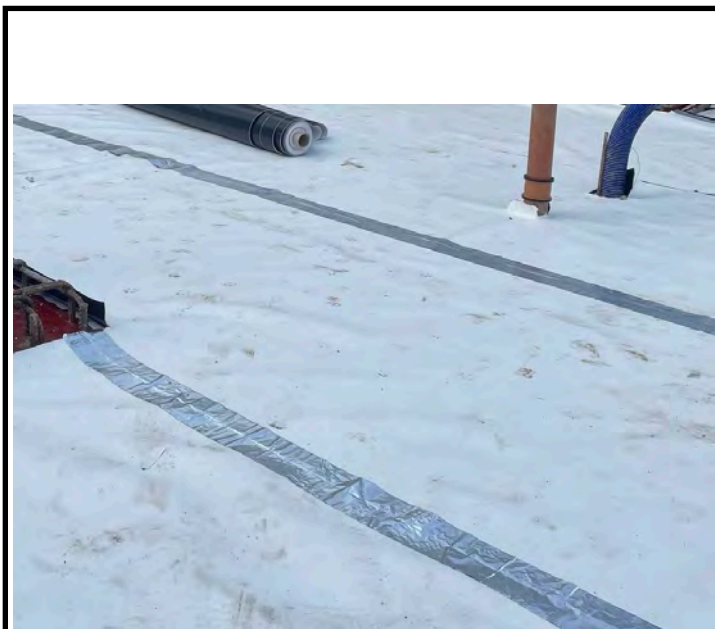
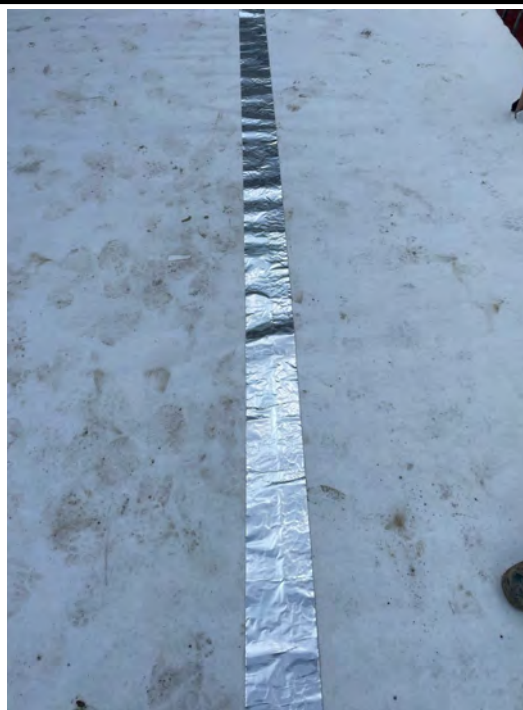
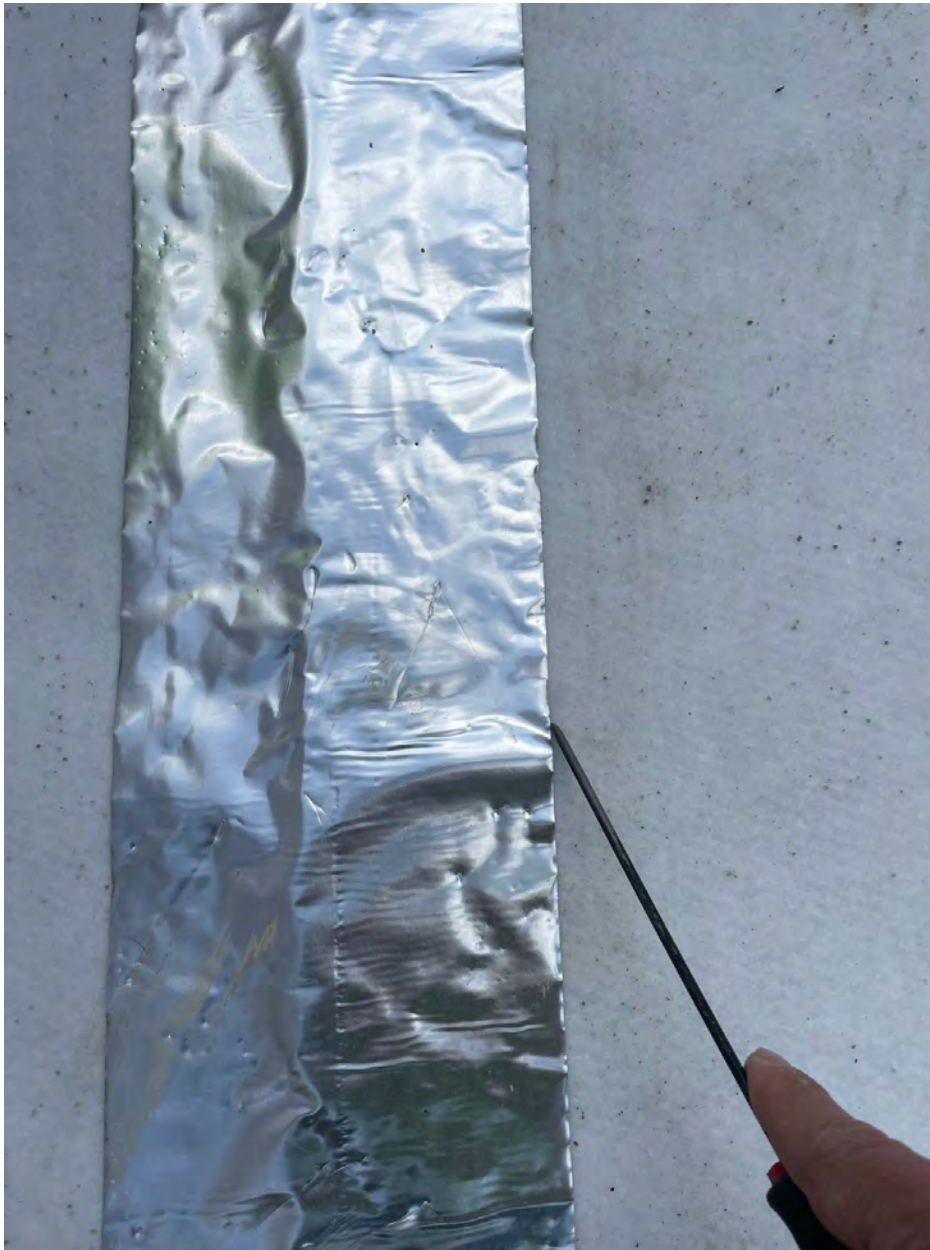
## VERIFICATION ITEM ONE

Premcrete CombiSeal Plus Gas Barrier has been installed across the footprint of a slab section within Block C, gridlines referenced. The Premcrete CombiSeal Plus Gas Barrier has been lined upon a smooth insulated substrate, minimising any damages occurring from beneath the membrane. A substantial overhang has

been left around the perimeter to enable sufficient overlapping during further works at a later date. All overlaps between the adjacent sheets of Premcrete CombiSeal Plus Gas Barrier have been sealed via the preformed adhesive zip lap joints, with Premcrete CombiSeal Tape applied over the top of the lap joints. Adequate heat and

rolled pressure have been applied where necessary, creating a gas resistant seal. Thorough visual inspections, supported by mechanical point stress testing, also known as pick and probe testing, conducted upon the sealed overlaps of the Premcrete CombiSeal Plus Gas Barrier identified no faults or defects.

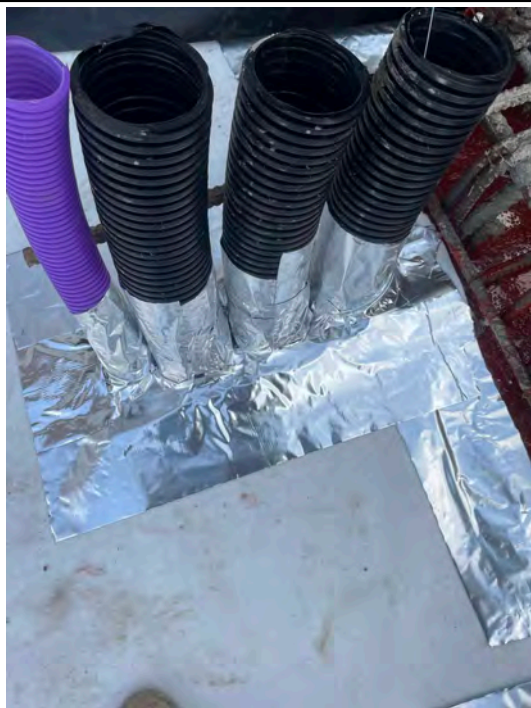
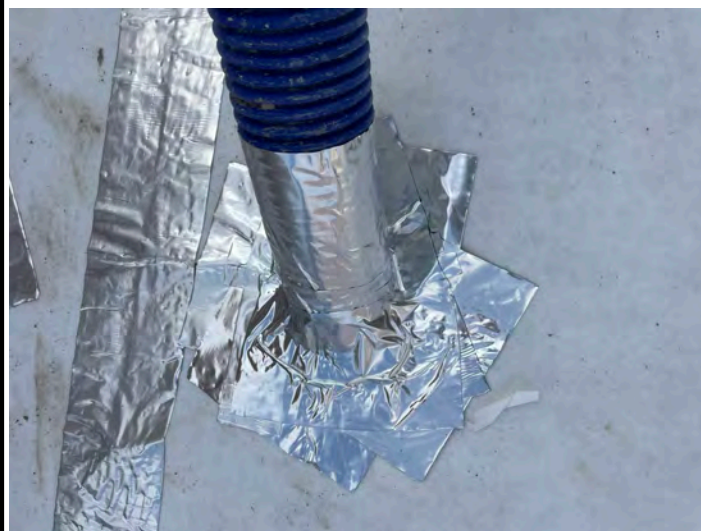
## VERIFICATION ITEM TWO

Throughout the Premcrete CombiSeal Plus Gas Barrier installation, a number of pipe penetrations required sealing. The Premcrete CombiSeal Plus Gas Barrier has been cut tightly around each individual pipe penetration, with Premcrete HCR Butyl Tape placed beneath the membrane to secure in place, which is a double sided

butyl tape. The Premcrete CombiSeal Plus Gas Barrier has been terminated upon the pipe penetrations using strips of Premcrete CombiSeal Tape placed intricately up the neck of the pipe and around the base, onto the Premcrete Combi-Seal Plus Gas Barrier. Thorough mechanical point stress testing of the pipes identified no faults.

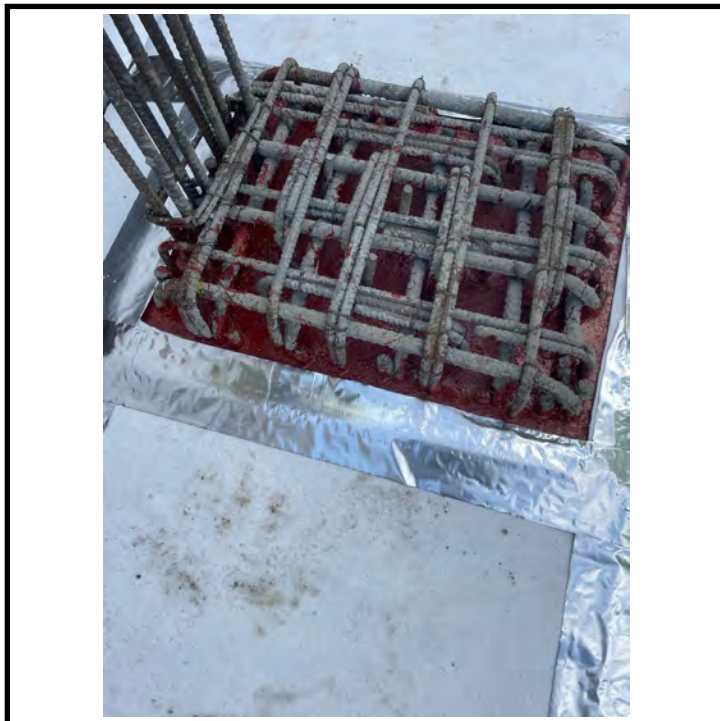
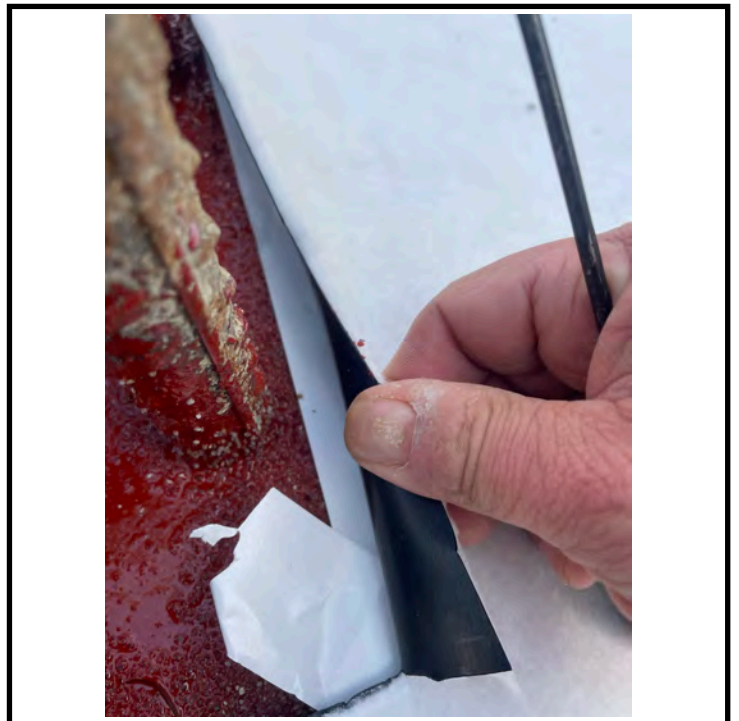
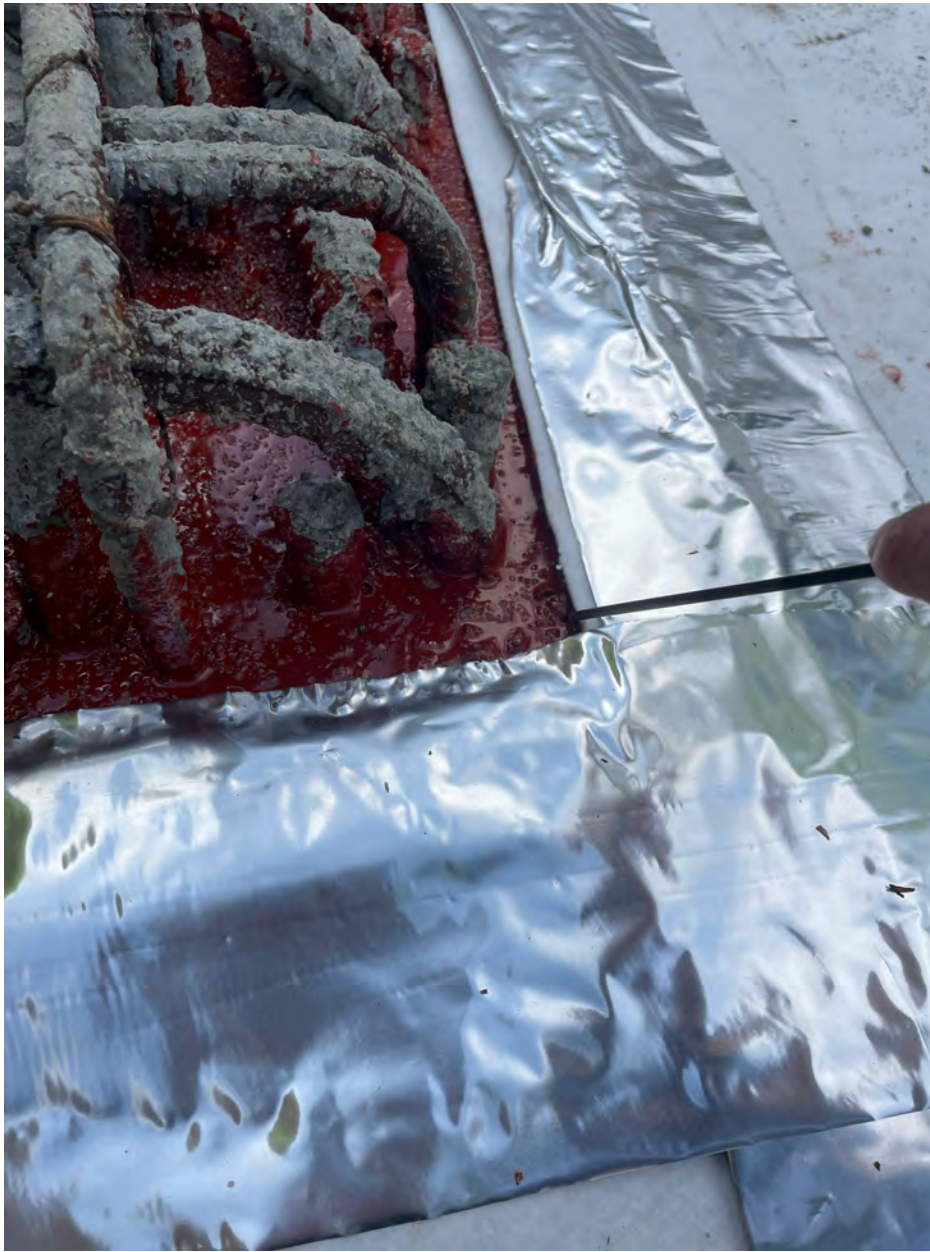
## VERIFICATION ITEM THREE

Throughout the installation to the slab area within Block C, a number of pile columns required sealing. The primary seal of the pile columns is the application of Premcrete Hydroprufe LG, which is a liquid gas membrane. The Hydroprufe LG has been applied across the entirety of the pile columns and returned partially up each

individual steel rebar. The Premcrete Hydroprufe LG has been left to cure prior to the installation of the Premcrete CombiSeal Plus Gas Barrier. Once cured, Premcrete HCR Butyl Tape is implemented around the perimeter of the pile columns, with the Premcrete CombiSeal Plus Gas Barrier lapping onto the Premcrete HCR

Butyl Tape. Premcrete Metal Washer Fixings have been implemented to secure the Premcrete CombiSeal Plus Gas Barrier in place, ensuring that these have gone through the Premcrete HCR Butyl Tape. Strips of Premcrete CombiSeal Tape complete the termination upon the pile columns. Thorough visual inspections, supported by mechanical point stress testing conducted upon all pile columns identified no faults.

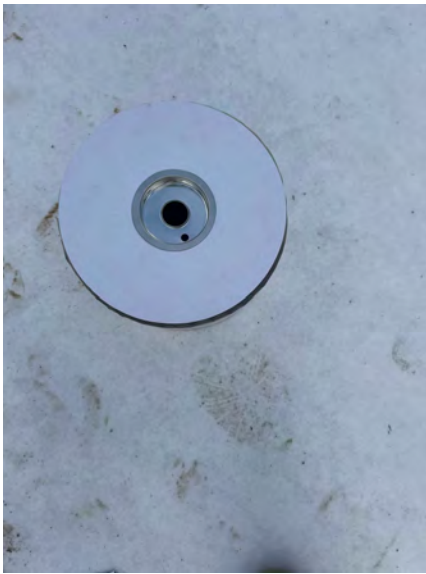
Premcrete Metal Washer Fixings used to secure the membrane in place around pile columns.

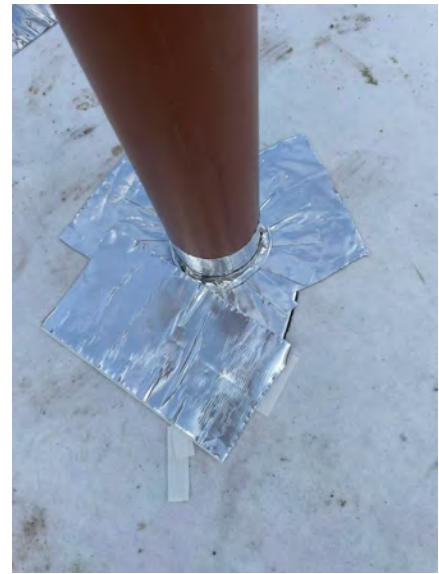
A pipe penetration sealed with Premcrete CombiSeal Tape.

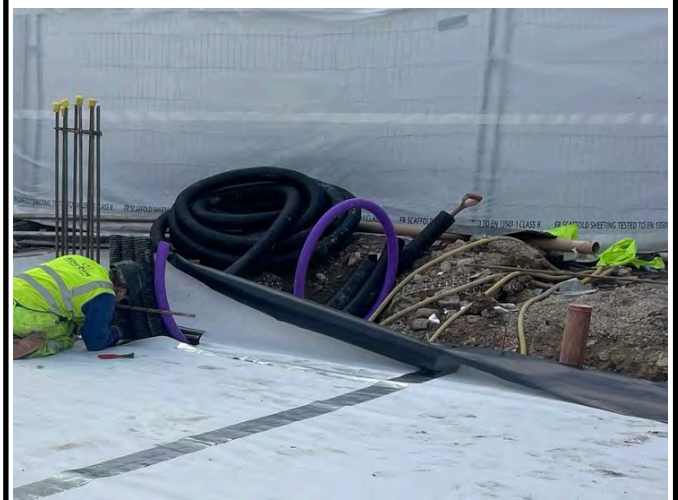
A sufficient overhang left around the perimeter in preparation for further works at a later date.
