## SITE INVESTIGATION FACTUAL REPORT

Report No: 006213

Client: Sedgwick International UK

Site Address: 19 Wellfield Avenue, N10 2EA

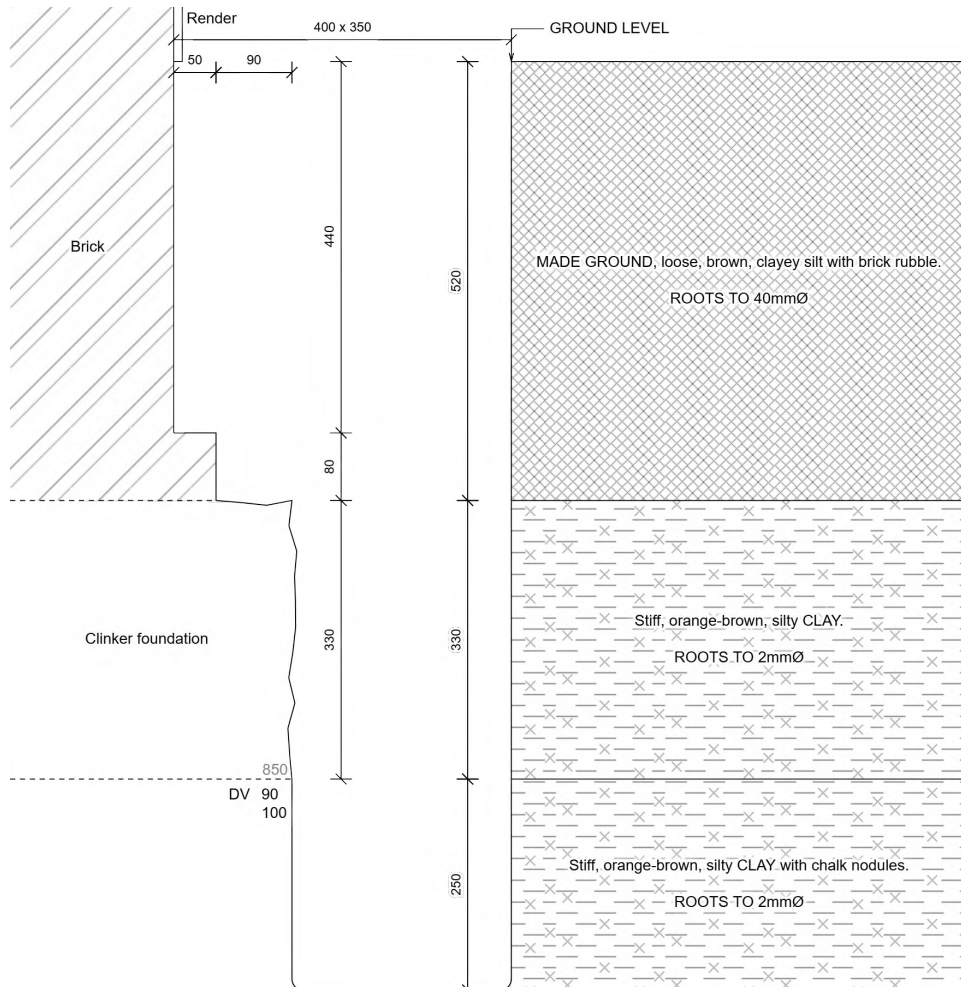
REPORT NUMBER: C5016741 / 383080.1.1.1  
TRIAL PIT REF: TP1  
CLIENT: Sedgwick International UK  
JOB NO: SI-006213  
EXCAVATION METHOD: Hand tools

For Strata below 1100mm see Bore Hole log
