# GeoShield Verification Report 5

GEO105182

Cranford House,  
100 Woodside Avenue,  
Haringey,  
LONDON  
N10 3JA

Block A, Slab Section - Full Line Out

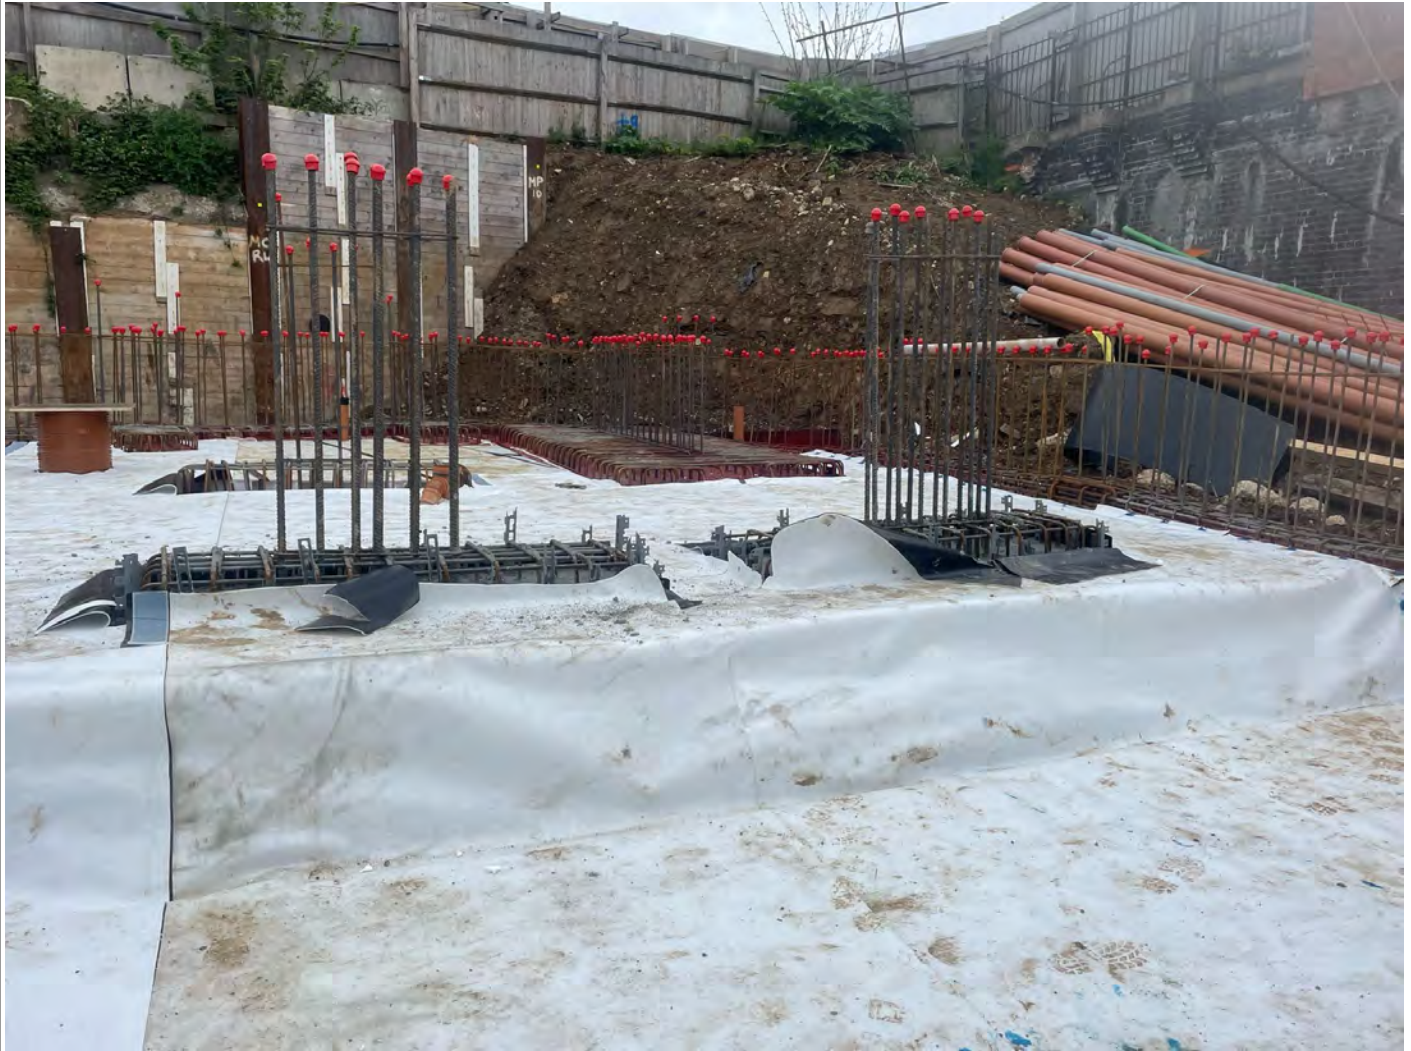
The photograph above displays an overview of the slab section in Block A where today's verification inspection took place on site.

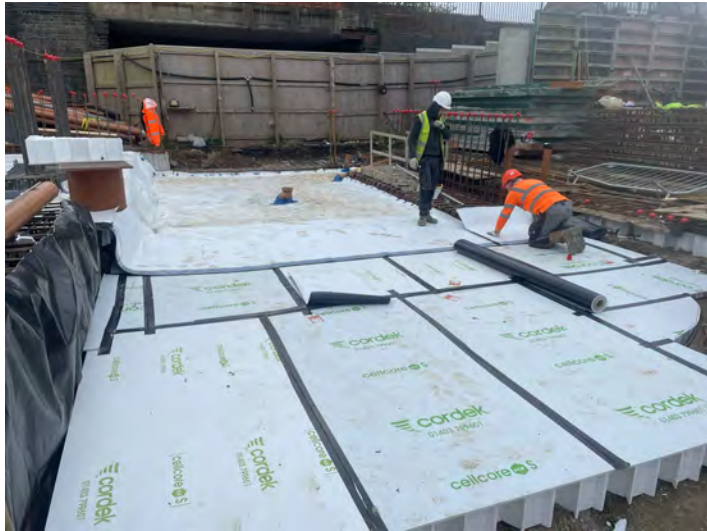
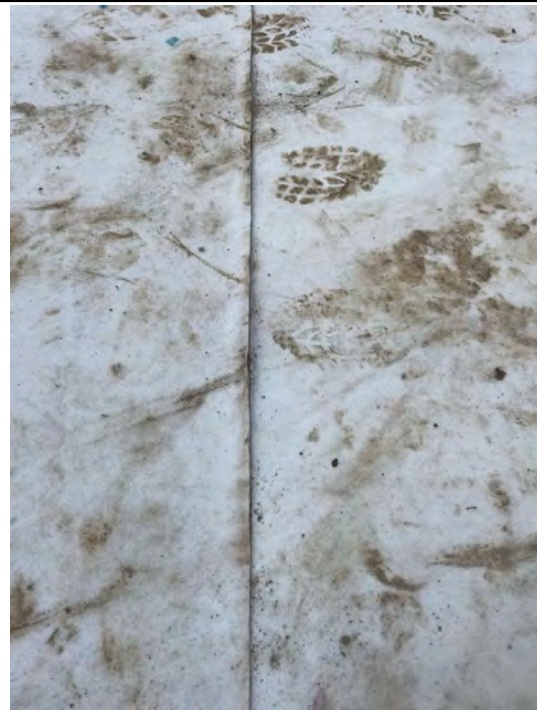
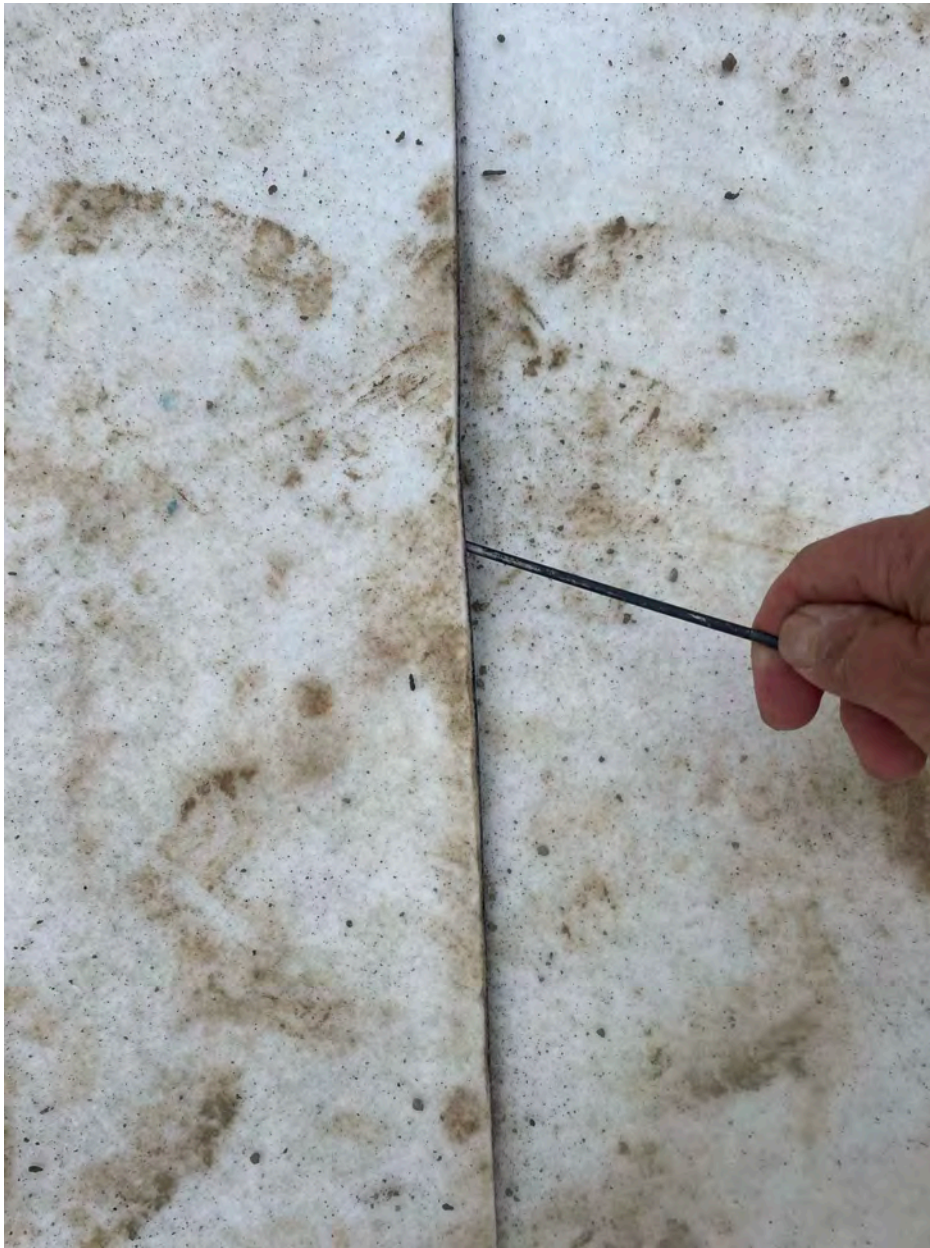
## VERIFICATION ITEM ONE

Premcrete CombiSeal Plus Gas Barrier has been installed across the footprint of a slab section within Block A. The Premcrete CombiSeal Plus Gas Barrier has been lined upon a Cordek Ventform, minimising any damages occurring from beneath the membrane. A sufficient overhang has been left around the perimeter in

preparation for future works at a later date. All overlaps between the adjacent sheets of Premcrete CombiSeal Plus Gas Barrier have been sealed via the preformed adhesive zip lap joints, or alternatively Premcrete CombiSeal Tape from beneath. Adequate pressure has been applied where necessary, creating a gas

resistant seal.

Thorough visual inspections, supported by mechanical point stress testing, also known as pick and probe testing, conducted upon the sealed overlaps of the Premcrete CombiSeal Plus Gas Barrier identified no faults or defects.

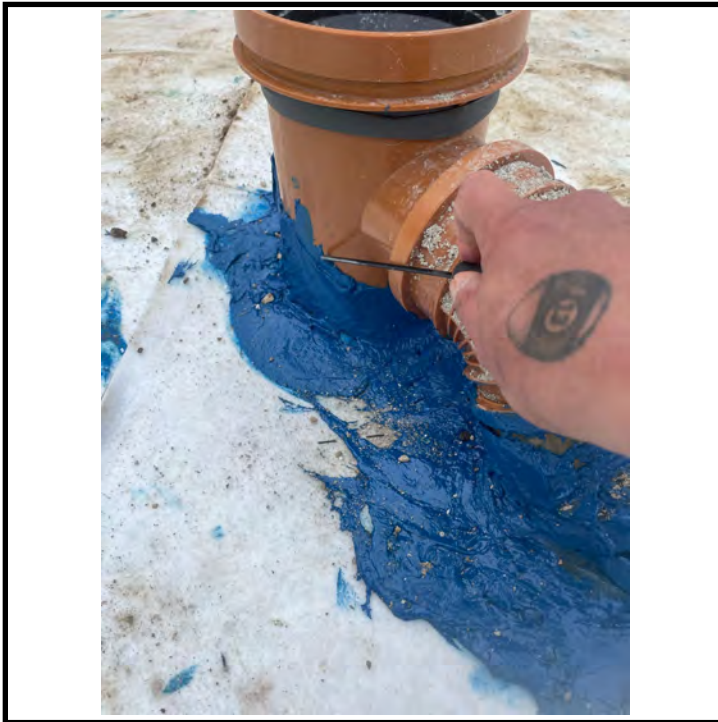
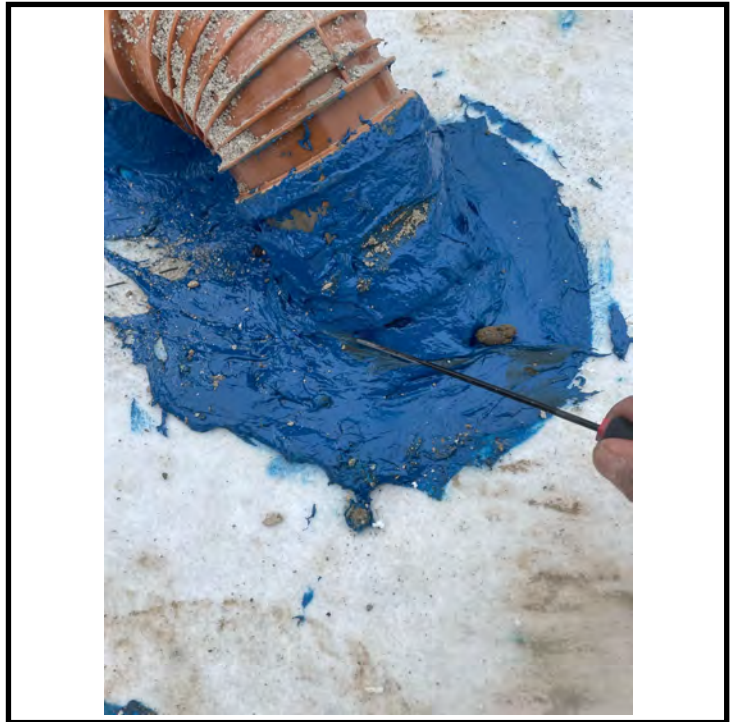
## VERIFICATION ITEM TWO

Throughout the Premcrete CombiSeal Plus Gas Barrier installation, a number of pipe penetrations required sealing. The Premcrete CombiSeal Plus Gas Barrier has been cut tightly around each individual pipe penetration, with Premcrete HCR Butyl Tape placed beneath the membrane to secure in place, which is a double sided

butyl tape. The Premcrete CombiSeal Plus Gas Barrier has been terminated upon the pipe penetrations using Twinseal Compound GR applied in a thick fillet up the neck of the pipe and around the base, onto the Premcrete Combi-Seal Plus Gas Barrier. Thorough mechanical point stress testing of the pipes identified no faults.

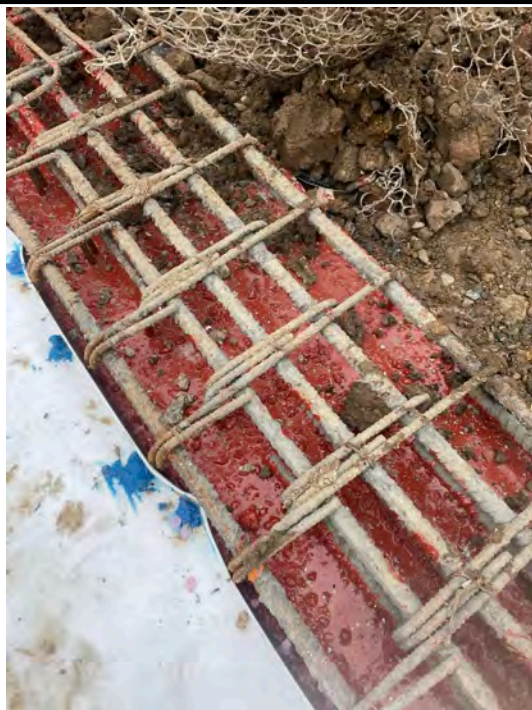
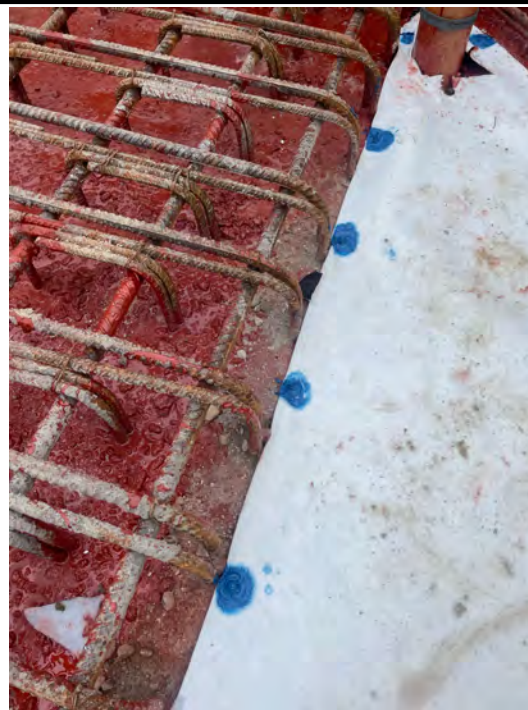
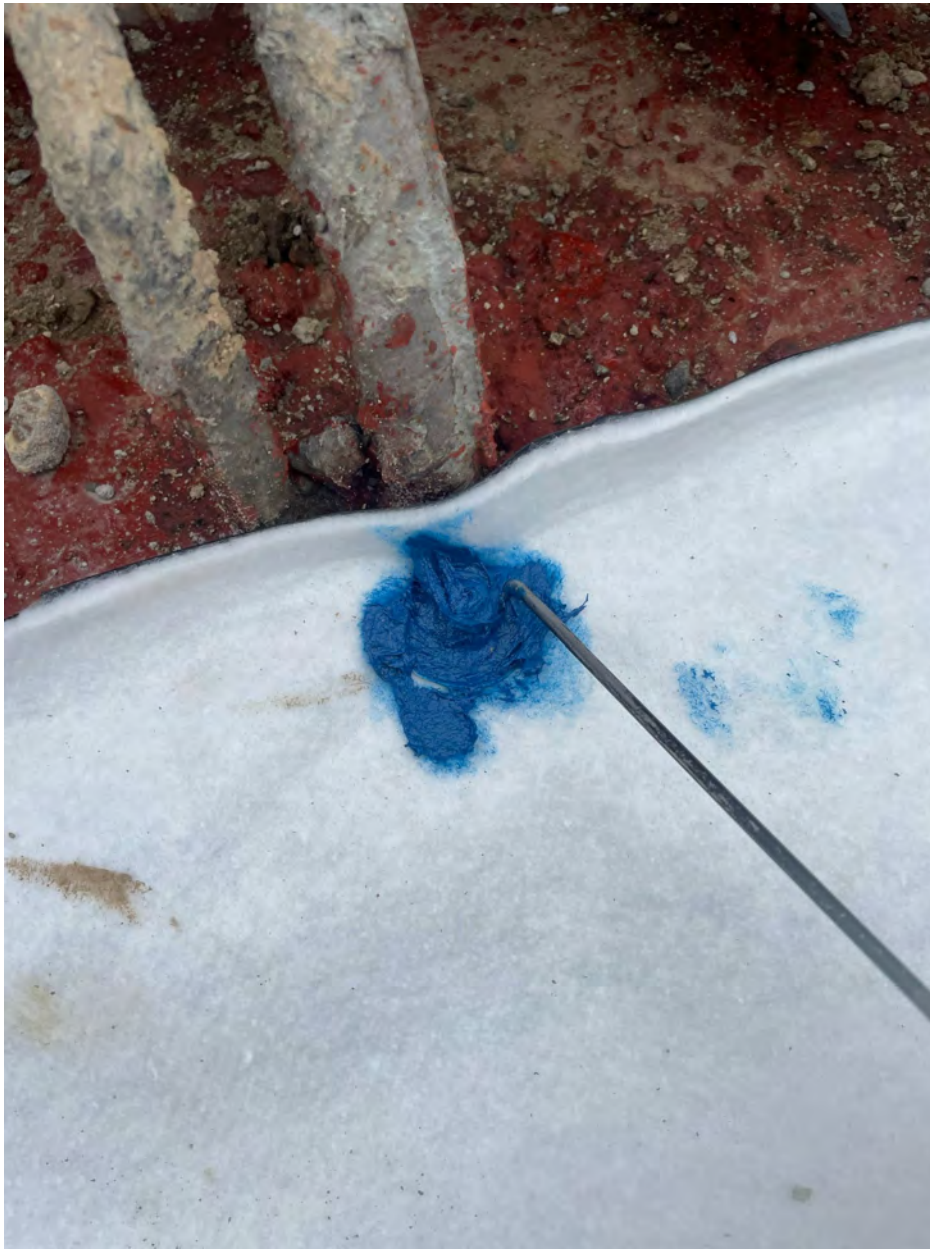
## VERIFICATION ITEM THREE

Throughout the installation to the slab area within Block A, a number of pile columns required sealing. The primary seal of the pile columns is the application of Premcrete Hydroprufe LG, which is a liquid gas membrane. The Hydroprufe LG has been applied across the entirety of the pile columns and returned partially up each

individual steel rebar. Once cured, Premcrete HCR Butyl Tape is implemented around the perimeter of the pile columns, with the Premcrete CombiSeal Plus Gas Barrier lapping onto the Premcrete HCR Butyl Tape. Premcrete Metal Washer Fixings have been implemented to secure the Premcrete CombiSeal Plus Gas

Barrier in place, ensuring that these have gone through the Premcrete HCR Butyl Tape. A fillet of Twinseal Compound GR applied over the Premcrete Metal Washer Fixings ensures a complete gas resistant seal is achieved throughout. Thorough visual inspections, supported by mechanical point stress testing conducted upon all pile columns identified no faults.

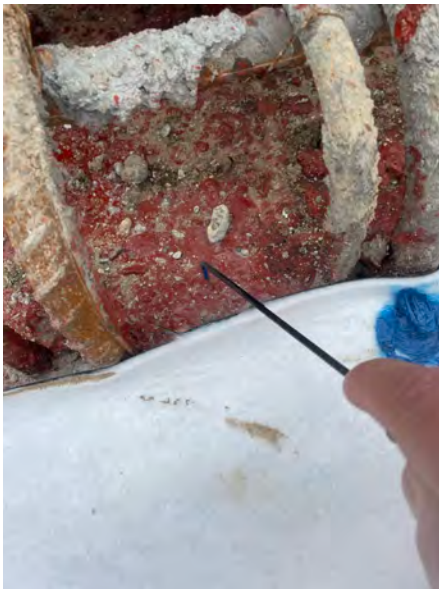
A mechanical point stress test being conducted upon a sealed pile column.

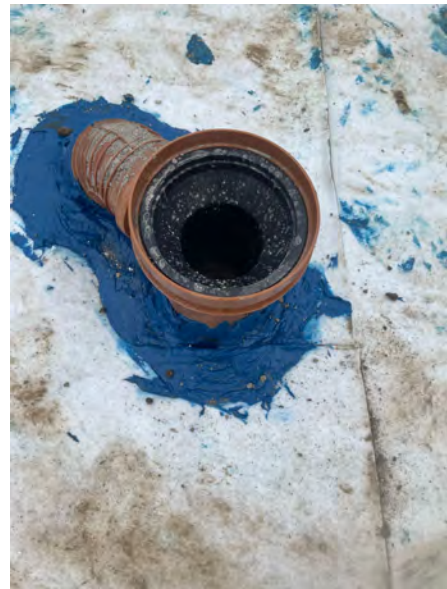
Typical pipe penetration detailing.

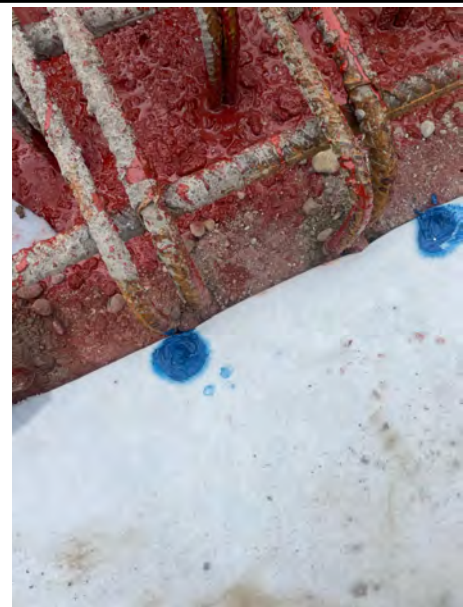
Premcrete Metal Washer Fixings around a pile column sealed with Twinseal Compound GR.
