# GeoShield Verification Report 3

GEO105182

Cranford House,  
100 Woodside Avenue,  
Haringey,  
LONDON  
N10 3JA

Block B - Slab, gridlines 6-9/G-J

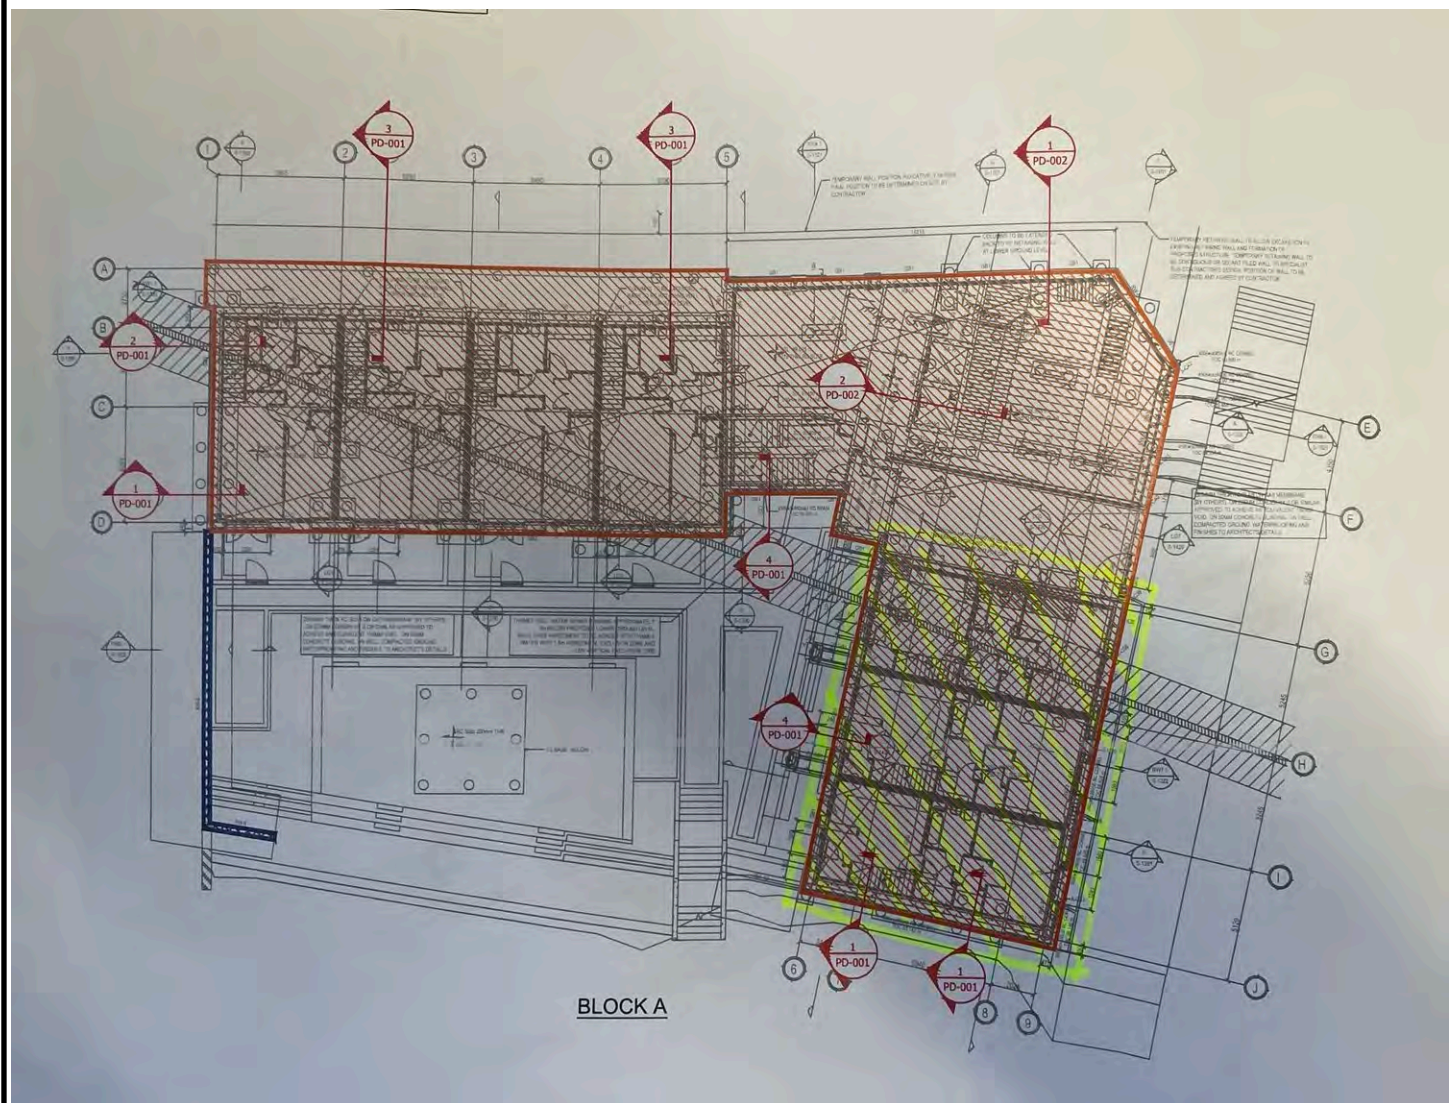
The photograph above shows a plan layout of the site. The area highlighted in yellow shows the slab section in Block B where the verification inspection took place on site today.

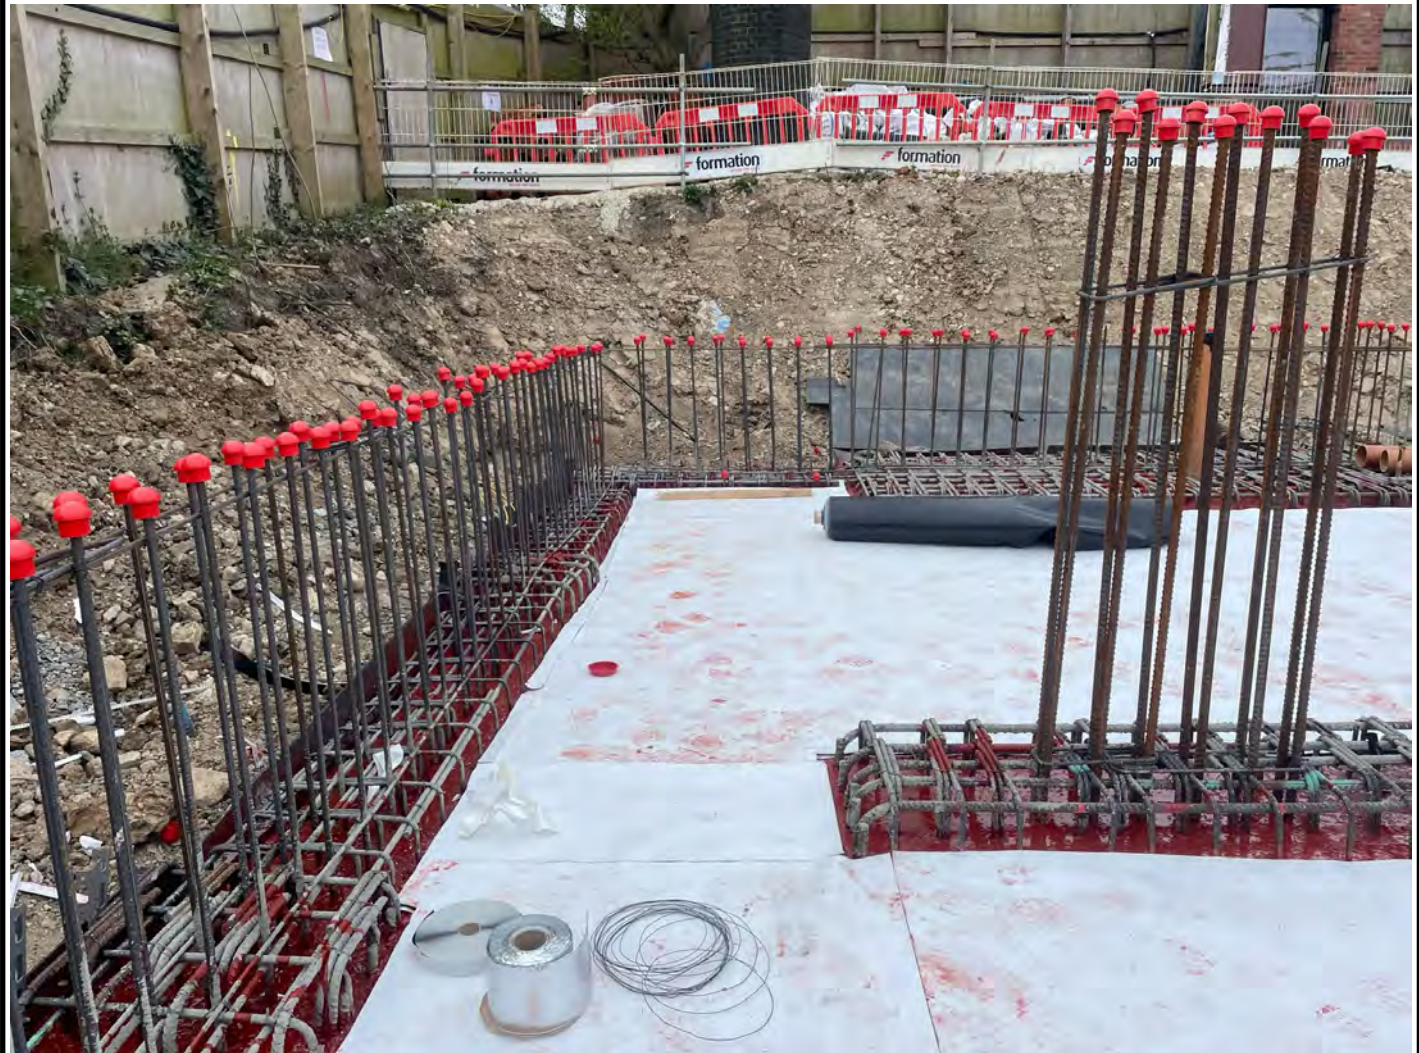
The photograph above displays an overview of the slab section in Block B where today's verification inspection took place on site.

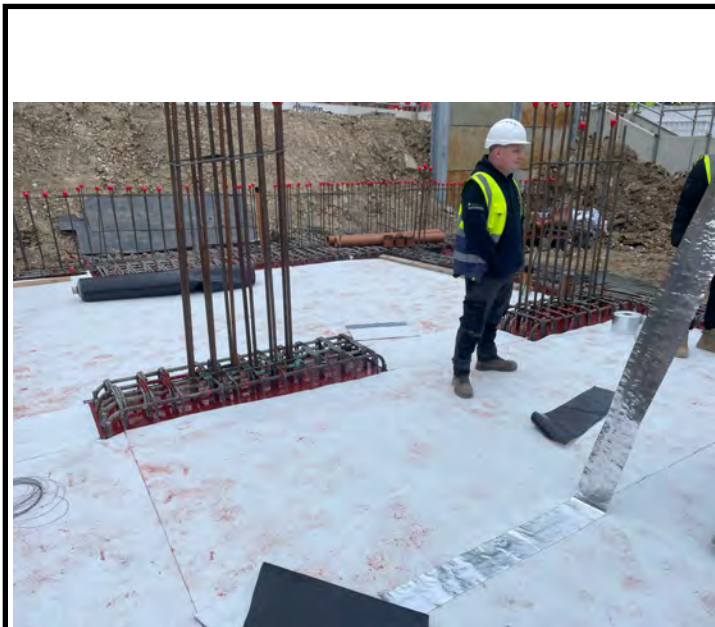
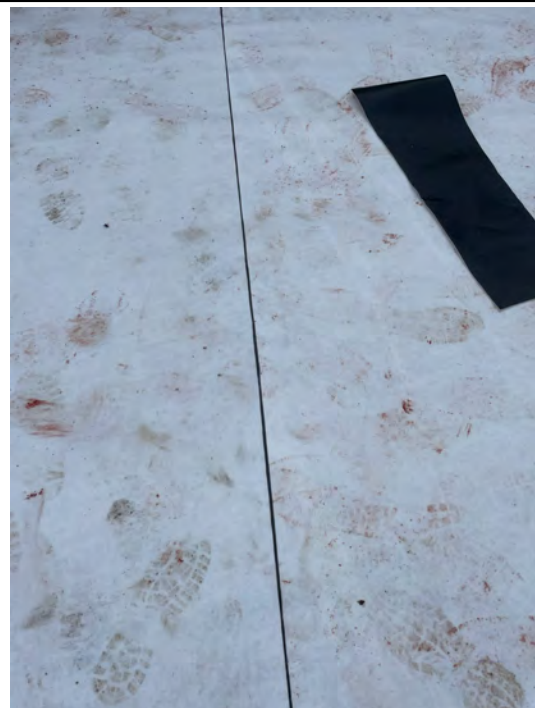
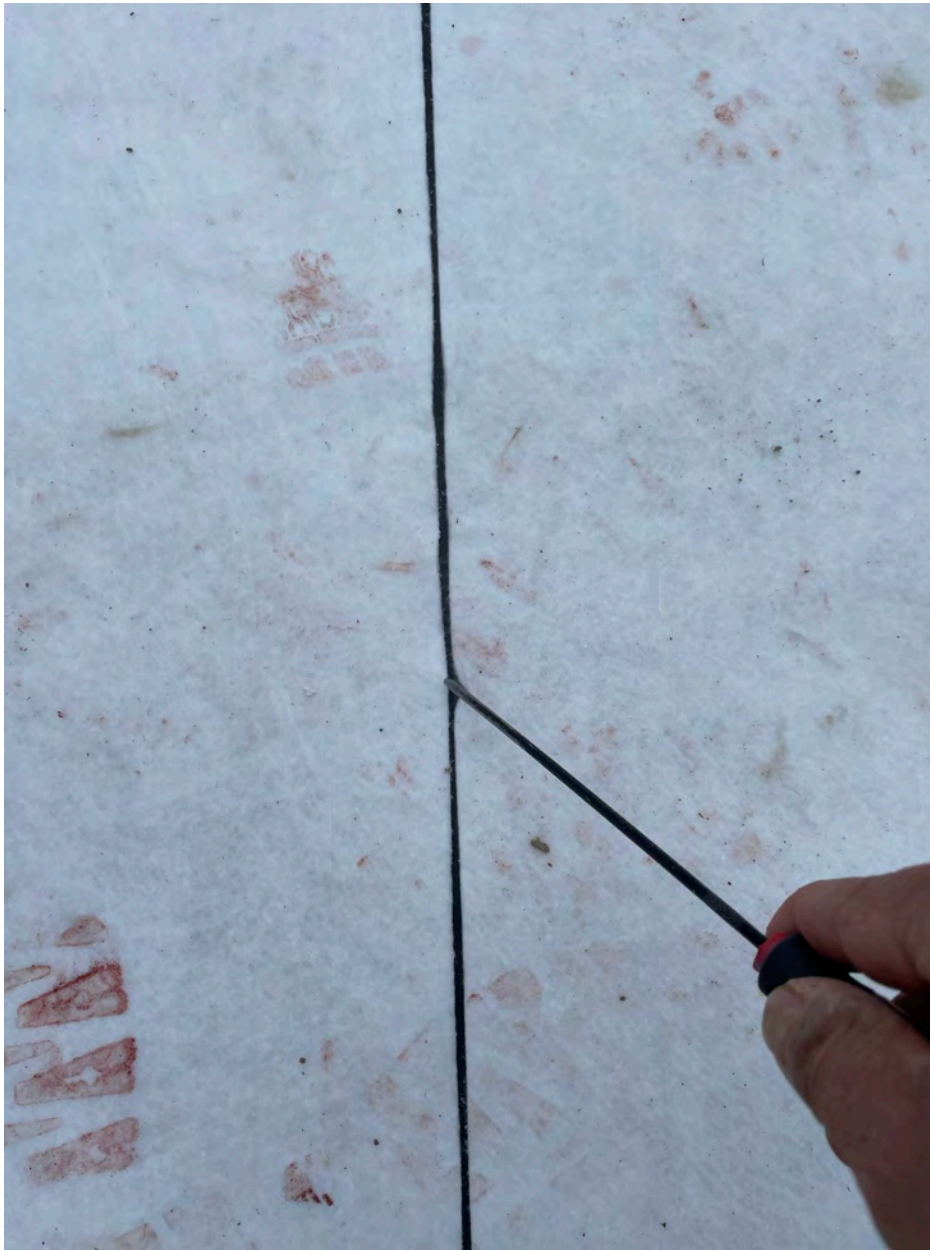
## VERIFICATION ITEM ONE

Premcrete CombiSeal Plus Gas Barrier has been installed across the footprint of a slab section within Block B, gridlines referenced. The Premcrete CombiSeal Plus Gas Barrier has been lined upon a smooth insulated substrate, minimising any damages occurring from beneath the membrane. A sufficient overhang has

been left around the perimeter in preparation for future works at a later date. All overlaps between the adjacent sheets of Premcrete CombiSeal Plus Gas Barrier have been sealed via the preformed adhesive zip lap joints, or alternatively Premcrete CombiSeal Tape from beneath. Some lap joints have been over-taped with

Premcrete CombiSeal Tape, although this is not required. Adequate heat and rolled pressure have been applied where necessary, creating a gas resistant seal. Thorough visual inspections, supported by mechanical point stress testing, also known as pick and probe testing, conducted upon the sealed overlaps of the Premcrete CombiSeal Plus Gas Barrier identified no faults or defects.

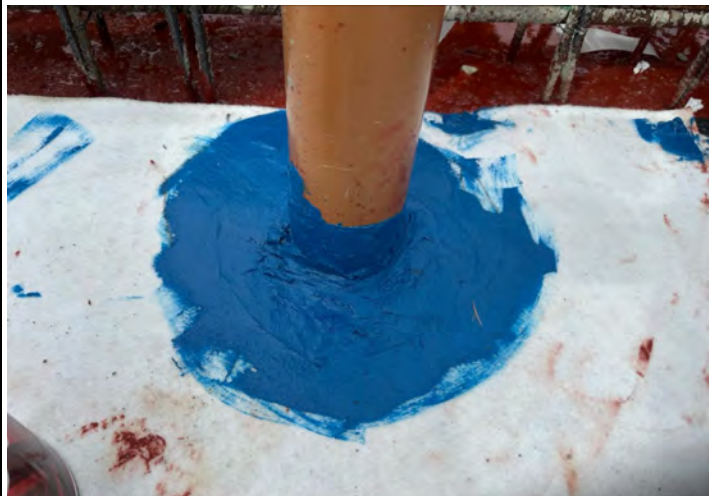
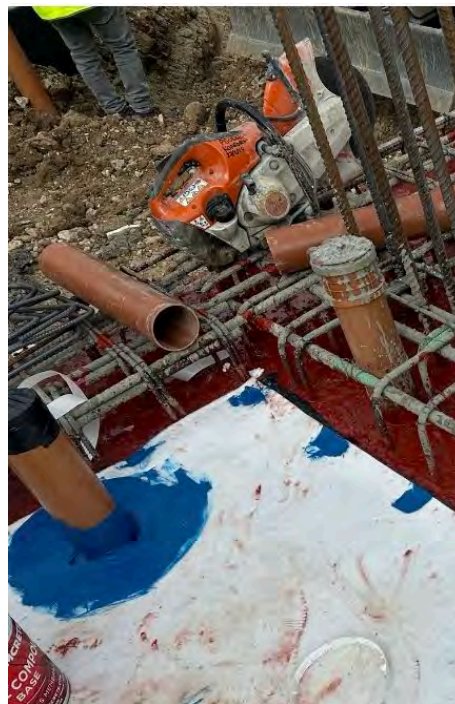
## VERIFICATION ITEM TWO

Throughout the Premcrete CombiSeal Plus Gas Barrier installation, a number of pipe penetrations required sealing. The Premcrete CombiSeal Plus Gas Barrier has been cut tightly around each individual pipe penetration, with Premcrete HCR Butyl Tape placed beneath the membrane to secure in place, which is a double sided

butyl tape. The Premcrete CombiSeal Plus Gas Barrier has been terminated upon the pipe penetrations using Twinseal Compound GR applied in a thick fillet up the neck of the pipe and around the base, onto the Premcrete Combi-Seal Plus Gas Barrier. Thorough mechanical point stress testing of the pipes identified no faults.

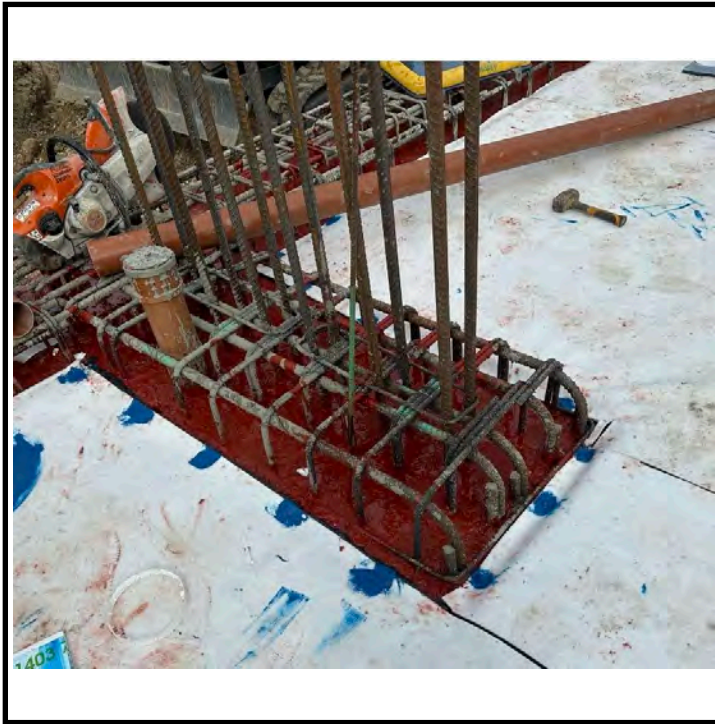
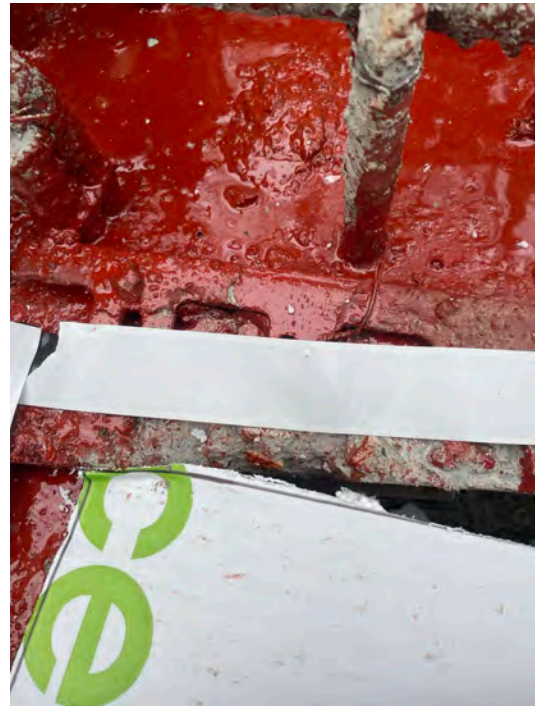
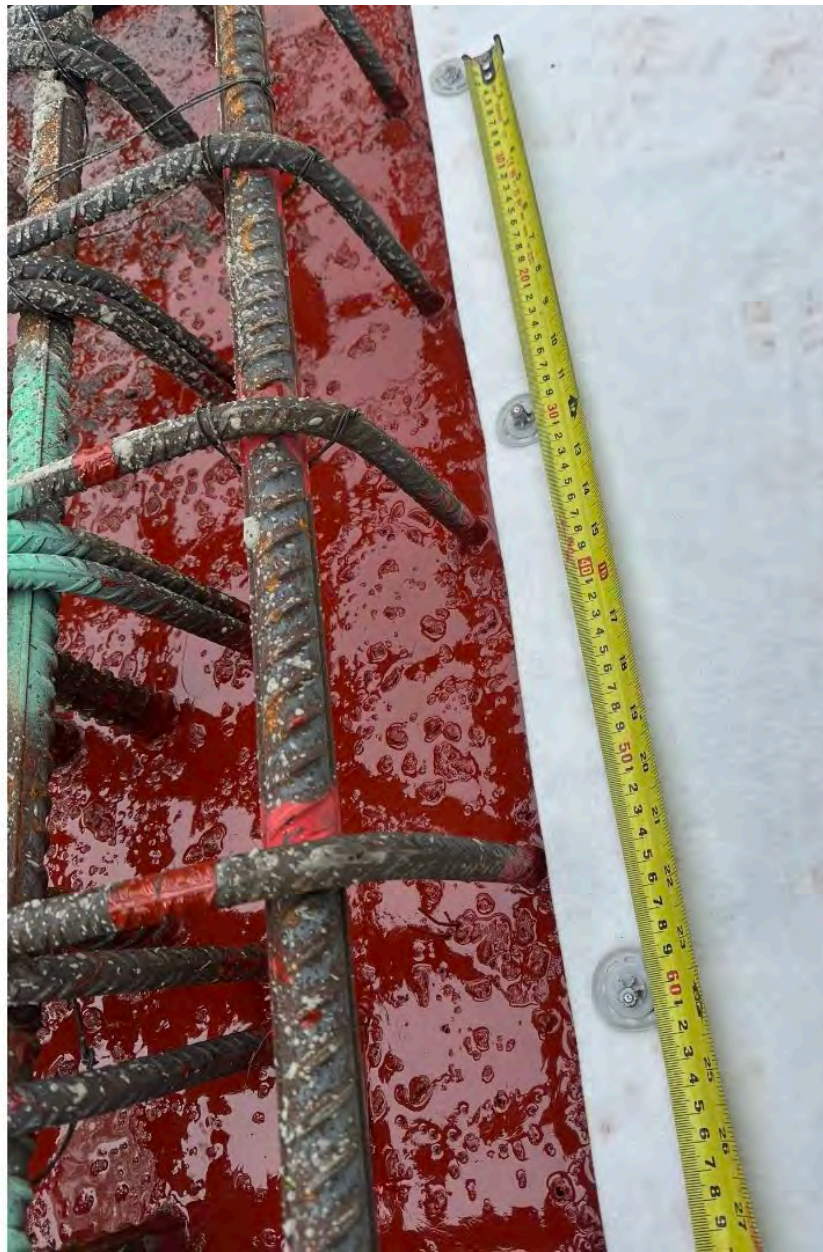
## VERIFICATION ITEM THREE

Throughout the installation to the slab area within Block B, a number of pile columns required sealing. The primary seal of the pile columns is the application of Premcrete Hydroprufe LG, which is a liquid gas membrane. The Hydroprufe LG has been applied across the entirety of the pile columns and returned partially up each

individual steel rebar. The Premcrete Hydroprufe LG has been left to cure prior to the installation of the Premcrete CombiSeal Plus Gas Barrier. Once cured, Premcrete HCR Butyl Tape is implemented around the perimeter of the pile columns, with the Premcrete CombiSeal Plus Gas Barrier lapping onto the Premcrete HCR

Butyl Tape. Premcrete Metal Washer Fixings have been implemented, ensuring these are equally spaced, to secure the Premcrete CombiSeal Plus Gas Barrier in place, ensuring that these have gone through the Premcrete HCR Butyl Tape. Thorough visual inspections, supported by mechanical point stress testing conducted upon all pile columns identified no faults.
