# PRELIMINARY ARBORICULTURAL REPORT

19 Wellfield Avenue, London N10 2EA

PRI Ref: 347875

Survey Date: 27-01-2026

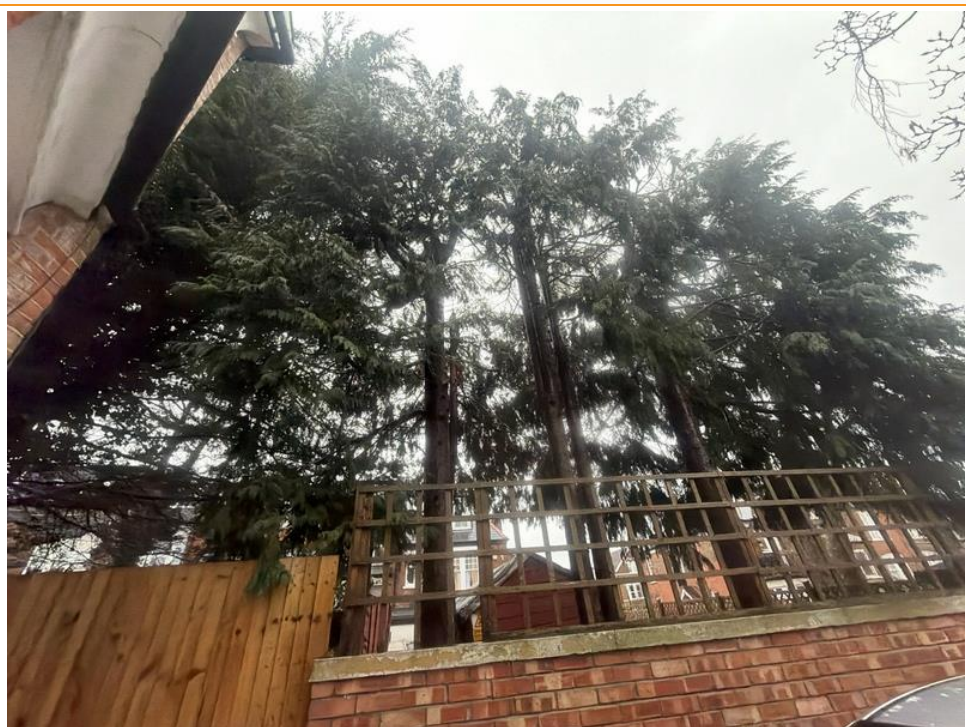
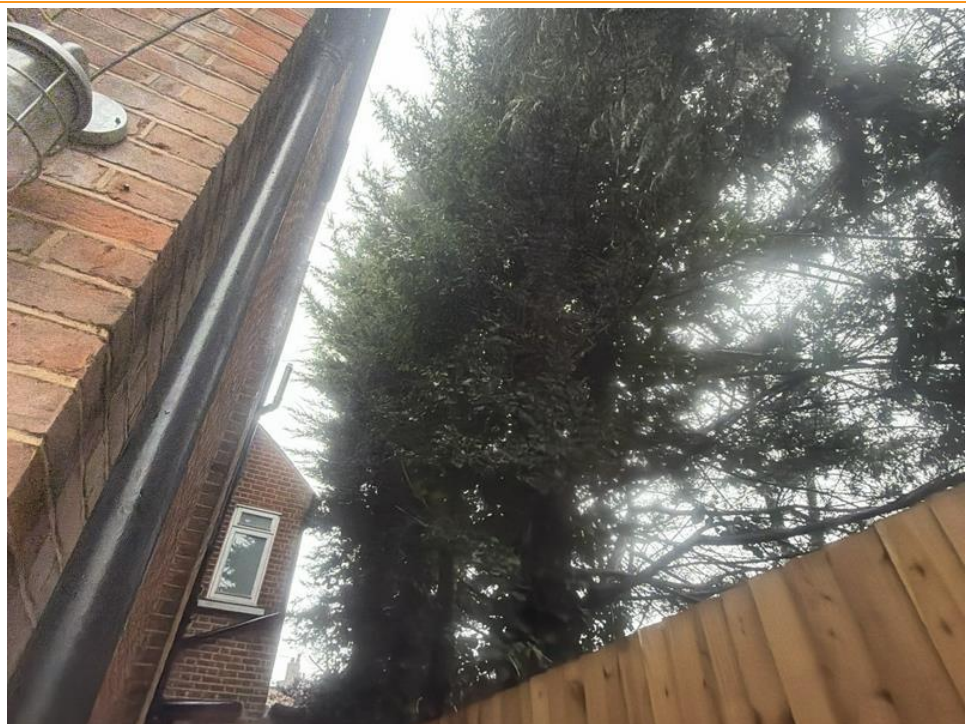
TG1 Cypress

| Tree No: | Common Name | Age Class | Condition | Height (m) | Crown Spread (m) | Stem diam. (mm) | No. of Stems | Dist to bldg. (m) | Roots Implicated | Pruning History | Recommendation | Tree Work Constraints | Notes | Owner address | Owner |
|---|---|---|---|---|---|---|---|---|---|---|---|---|---|---|---|
| TG1 | Cypress | Early Mature | Fair | 7.50 | 2.50 | 300 | 8 | 2.10 | Yes | Subject to historic crown reduction management. | Fell close to ground level (approx. 50mm) (conifer). | The third party may be responsible for works. Third party's | Estimated stem count and diameters. | 6 & 8 Muswell Road, London N10 2BH | P3P |

| Tree No: | Species | Works Required | CA | TPO | Ownership |
|---|---|---|---|---|---|
| TG1 | Cypress | Fell close to ground level (approx. 50mm) (conifer). | Yes | No | P3P |
