# Tree Condition Survey Report (VTA)

**Site:** Bright Horizons Crouch End Day Nursery and Preschool,  
113 Crouch Hill, London N8 9QN

**Client:** Bright Horizon

| <i>GC Document Reference</i> | J251238 | | |

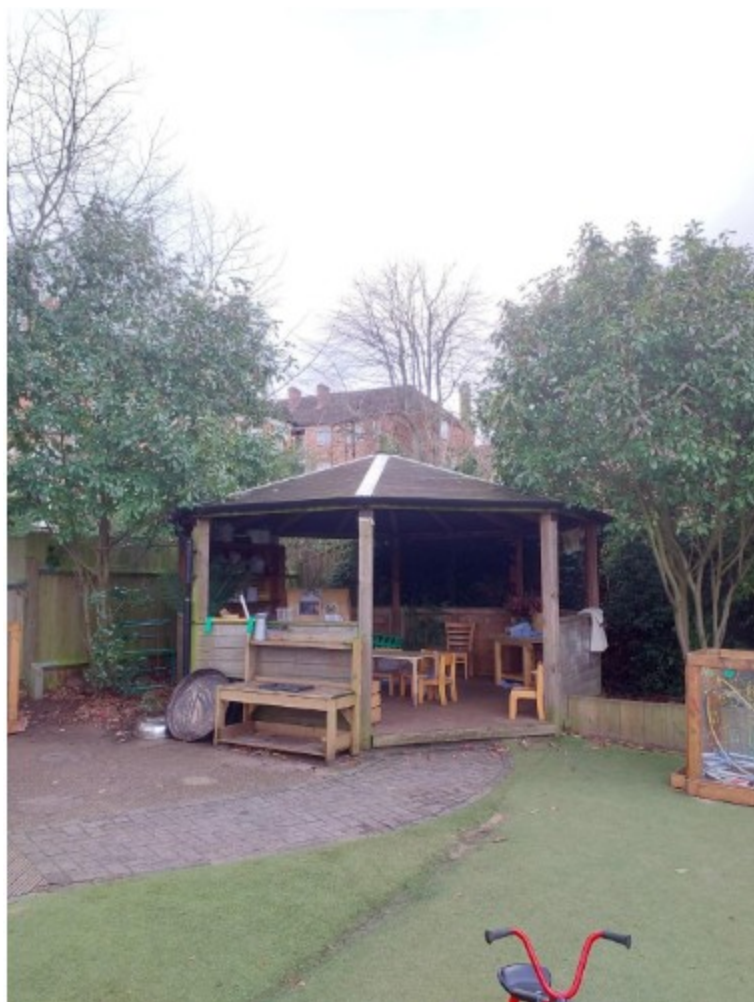
| Tree Group Survey Schedule | | | | | | | | | | | | | | | | | | | |
|---|---|---|---|---|---|---|---|---|---|---|---|---|---|---|---|---|---|---|---|
| 1 | | Mixed species | Mixed species | 5 | 0-5m | 0-150mm | Semi-mature | Good | Good | Mixed group of trees/shrubs. Foliage is encroaching onto shelter . | None Significant | Multi-Stem | Crown Close to Building | None Observed | None Observed | Fence, Playground | High | Good | Client |

| Tree / Group ID | Common Name | Work Task | Work Priority | Description | Tag No |
|---|---|---|---|---|---|
| G1 | Mixed species | Prune to Clear structure/wires/buildings by 1m | Within 6 - 12 Months | Prune to clear shelter. | |
