Drawings based on  
Hutton & Rostron  
Dry Rot / Survey Report

37 North Road, N6 - Lower Ground Floor  
Timber and Damp Condition Investigation

**37 North Road, N6 - Ground Floor**  
Timber and Damp Condition Investigation  
**Drawings as Existing**

**37 North Road, N6 - First Floor**  
Timber and Damp Condition Investigation

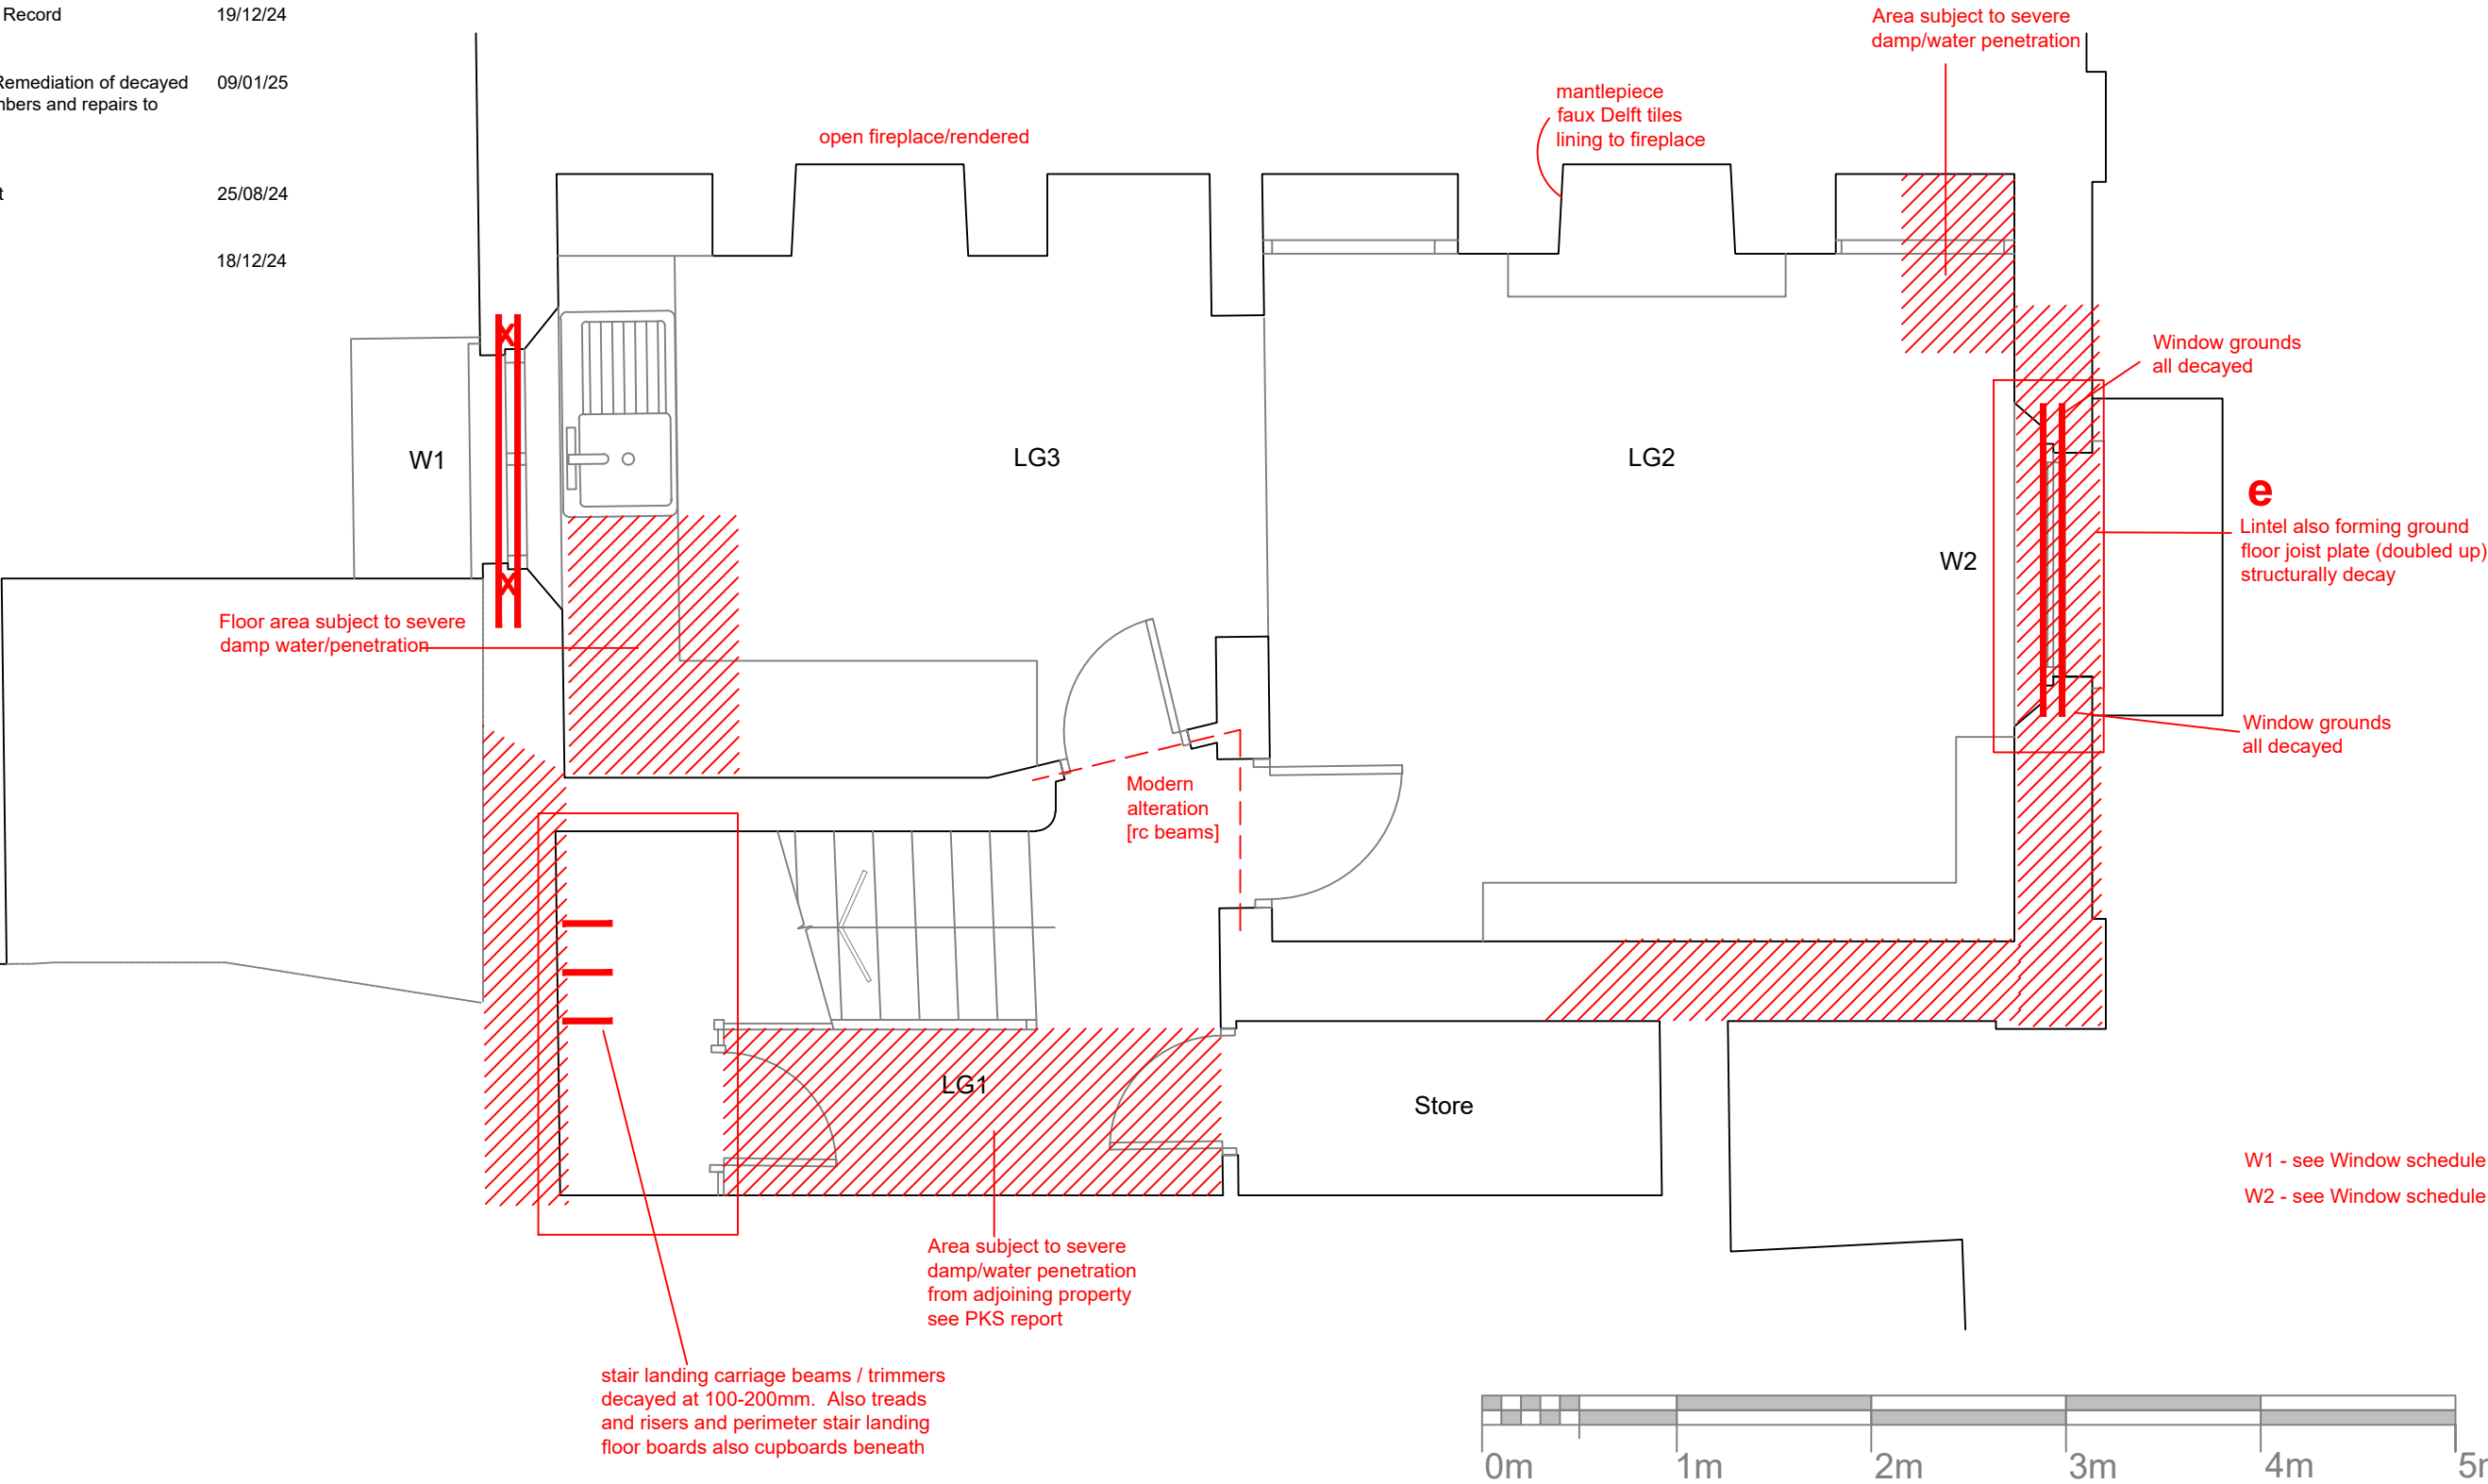
Ceilings:  
LG3 - plasterboard  
LG2 - plasterboard  
part lathe & plaster  
LG1 - plasterboard

Existing walls:  
Cementitious wall plaster  
Sirapite finish throughout  
LGF

LGF composition  
concrete [screed 50-70mm]  
Asphalt and vinyl tiles finish  
[see Initial Condition Survey  
H&R]

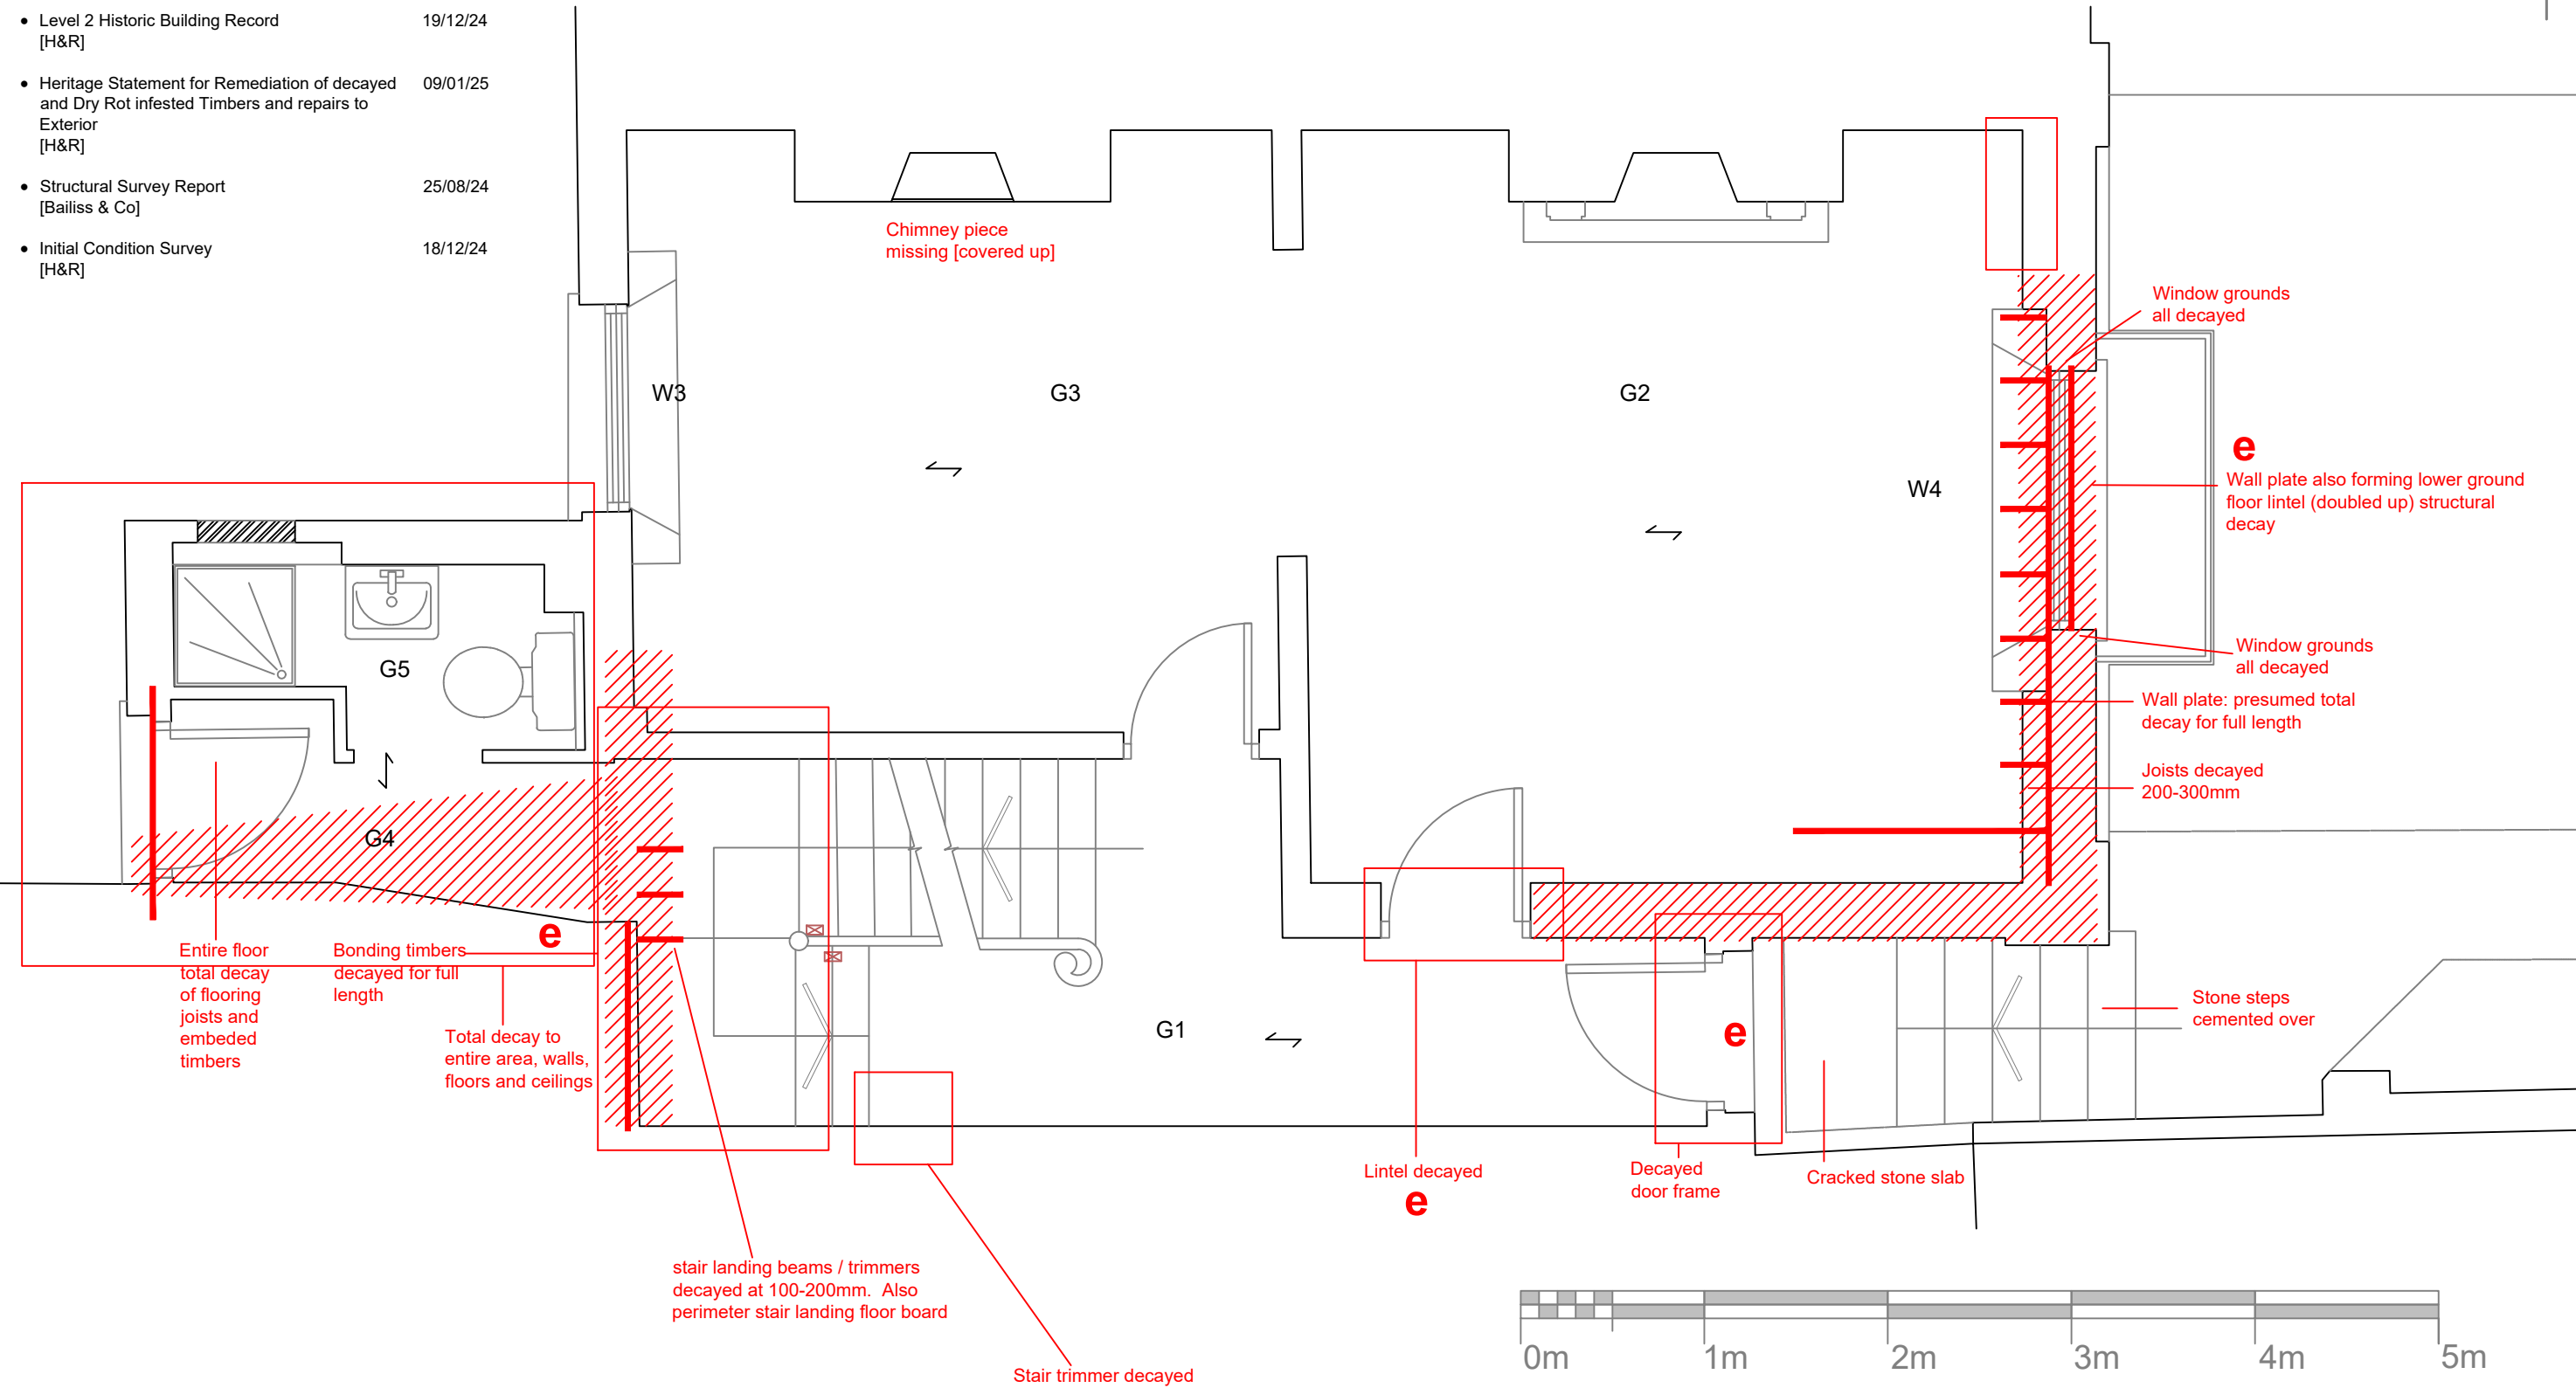
Ceilings:  
G1, G2, G3 - lathe & plaster

Existing walls:  
G4, G5 - plasterboard  
Stud walls - lathe & plaster  
On brickwork - lime plaster

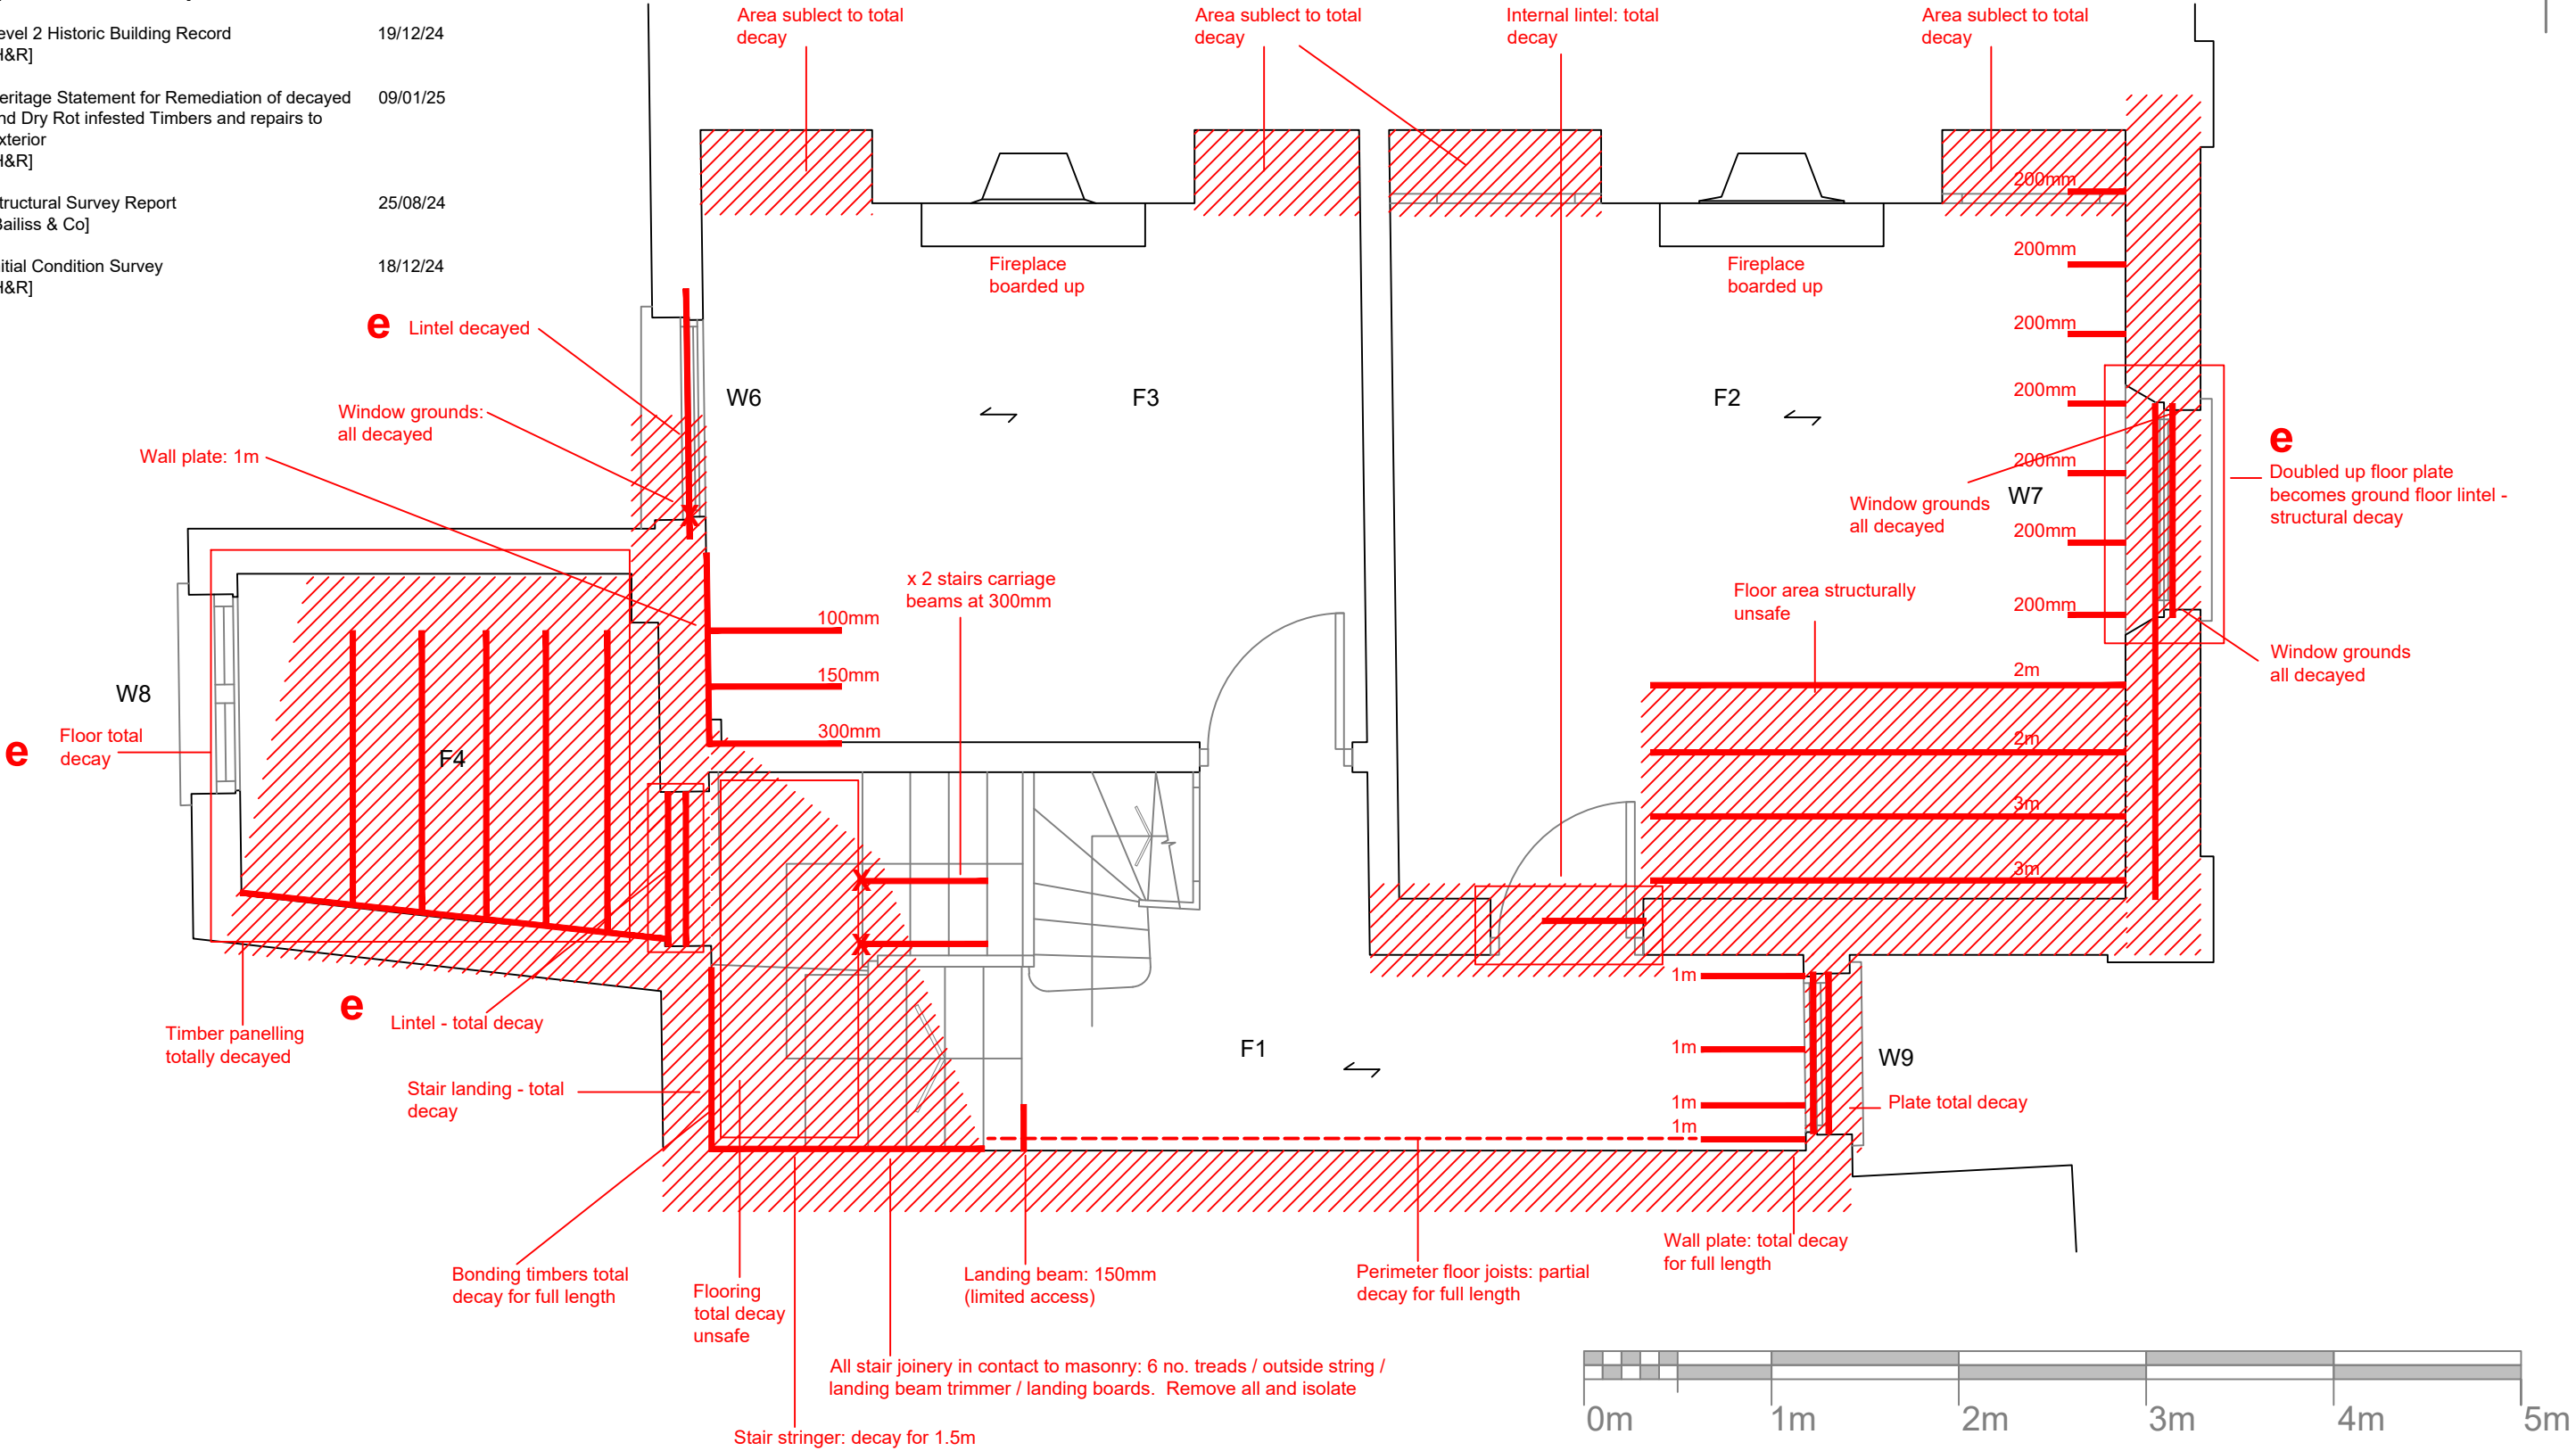
Ceilings:  
F1, F2, F3 - lathe & plaster

Existing walls:  
F4 - plasterboard  
Stud walls - lathe & plaster  
On brickwork - lime plaster

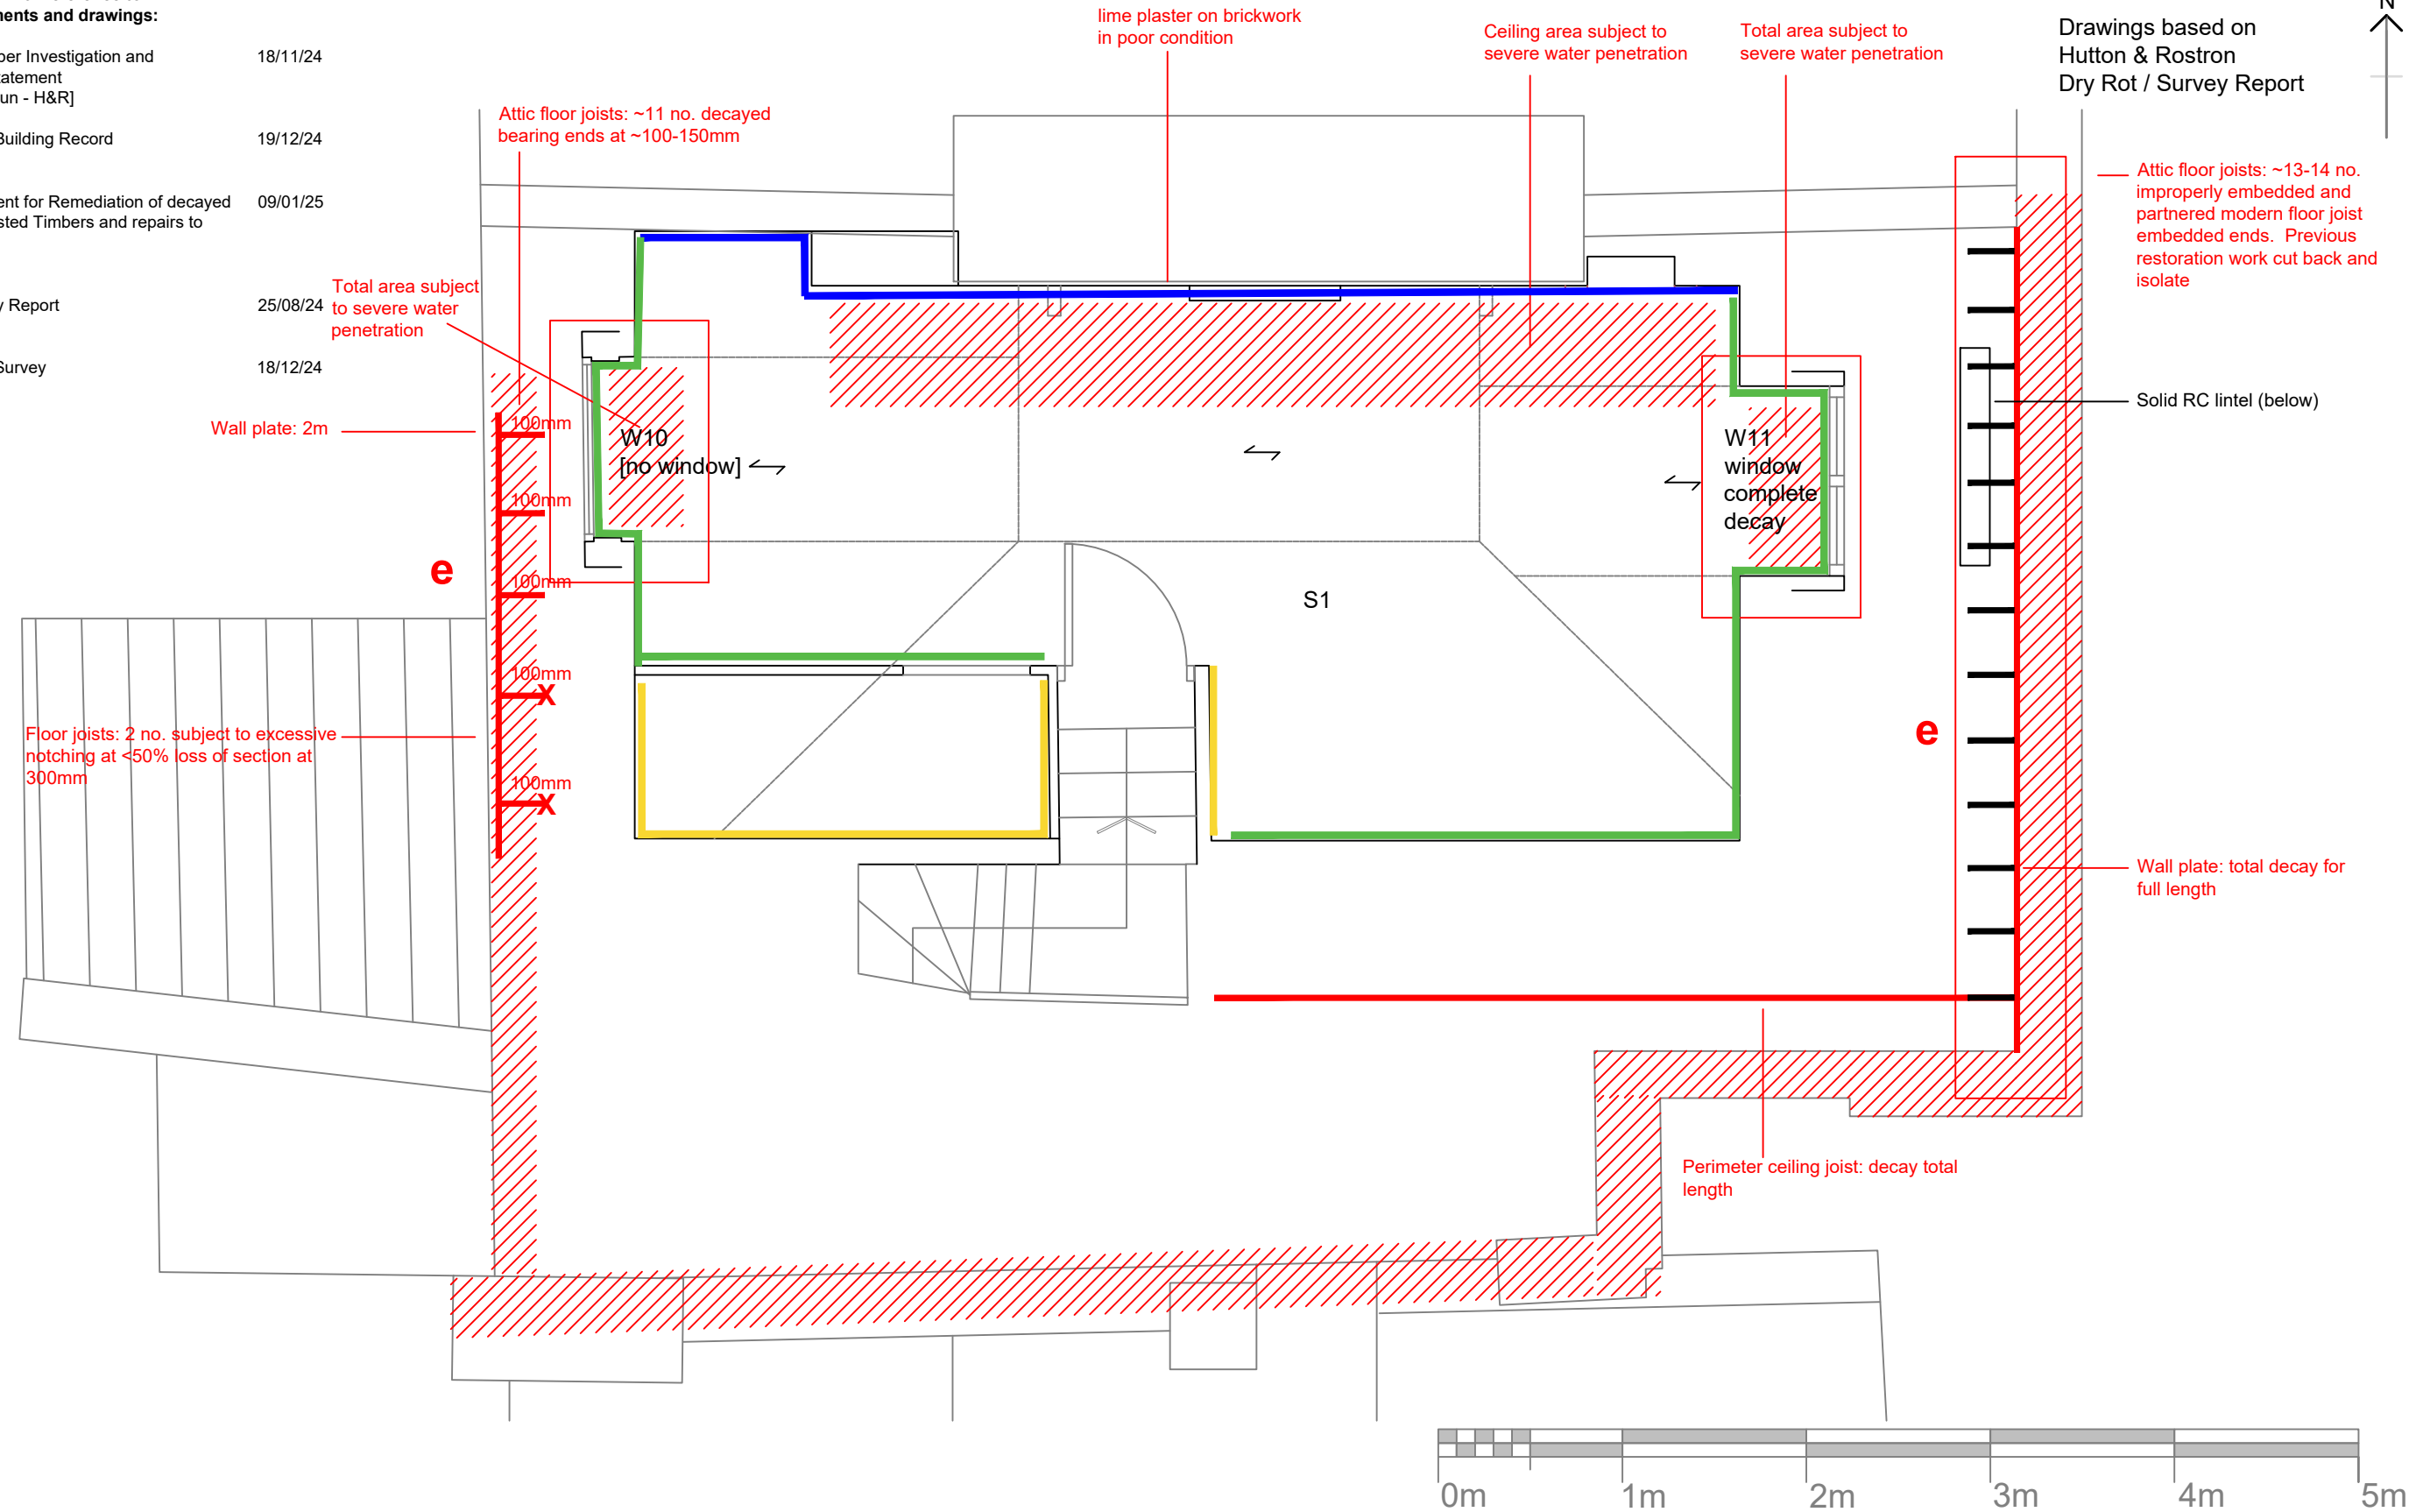
37 North Road, N6 - 2nd Floor  
Timber and Damp Condition Investigation

Ceilings:  
S1 - lathe & plaster partial  
ceiling collapse

- Existing walls:
- Studwork - lathe & plaster poor condition
  - On brickwork - lime plaster
  - T&G boarding

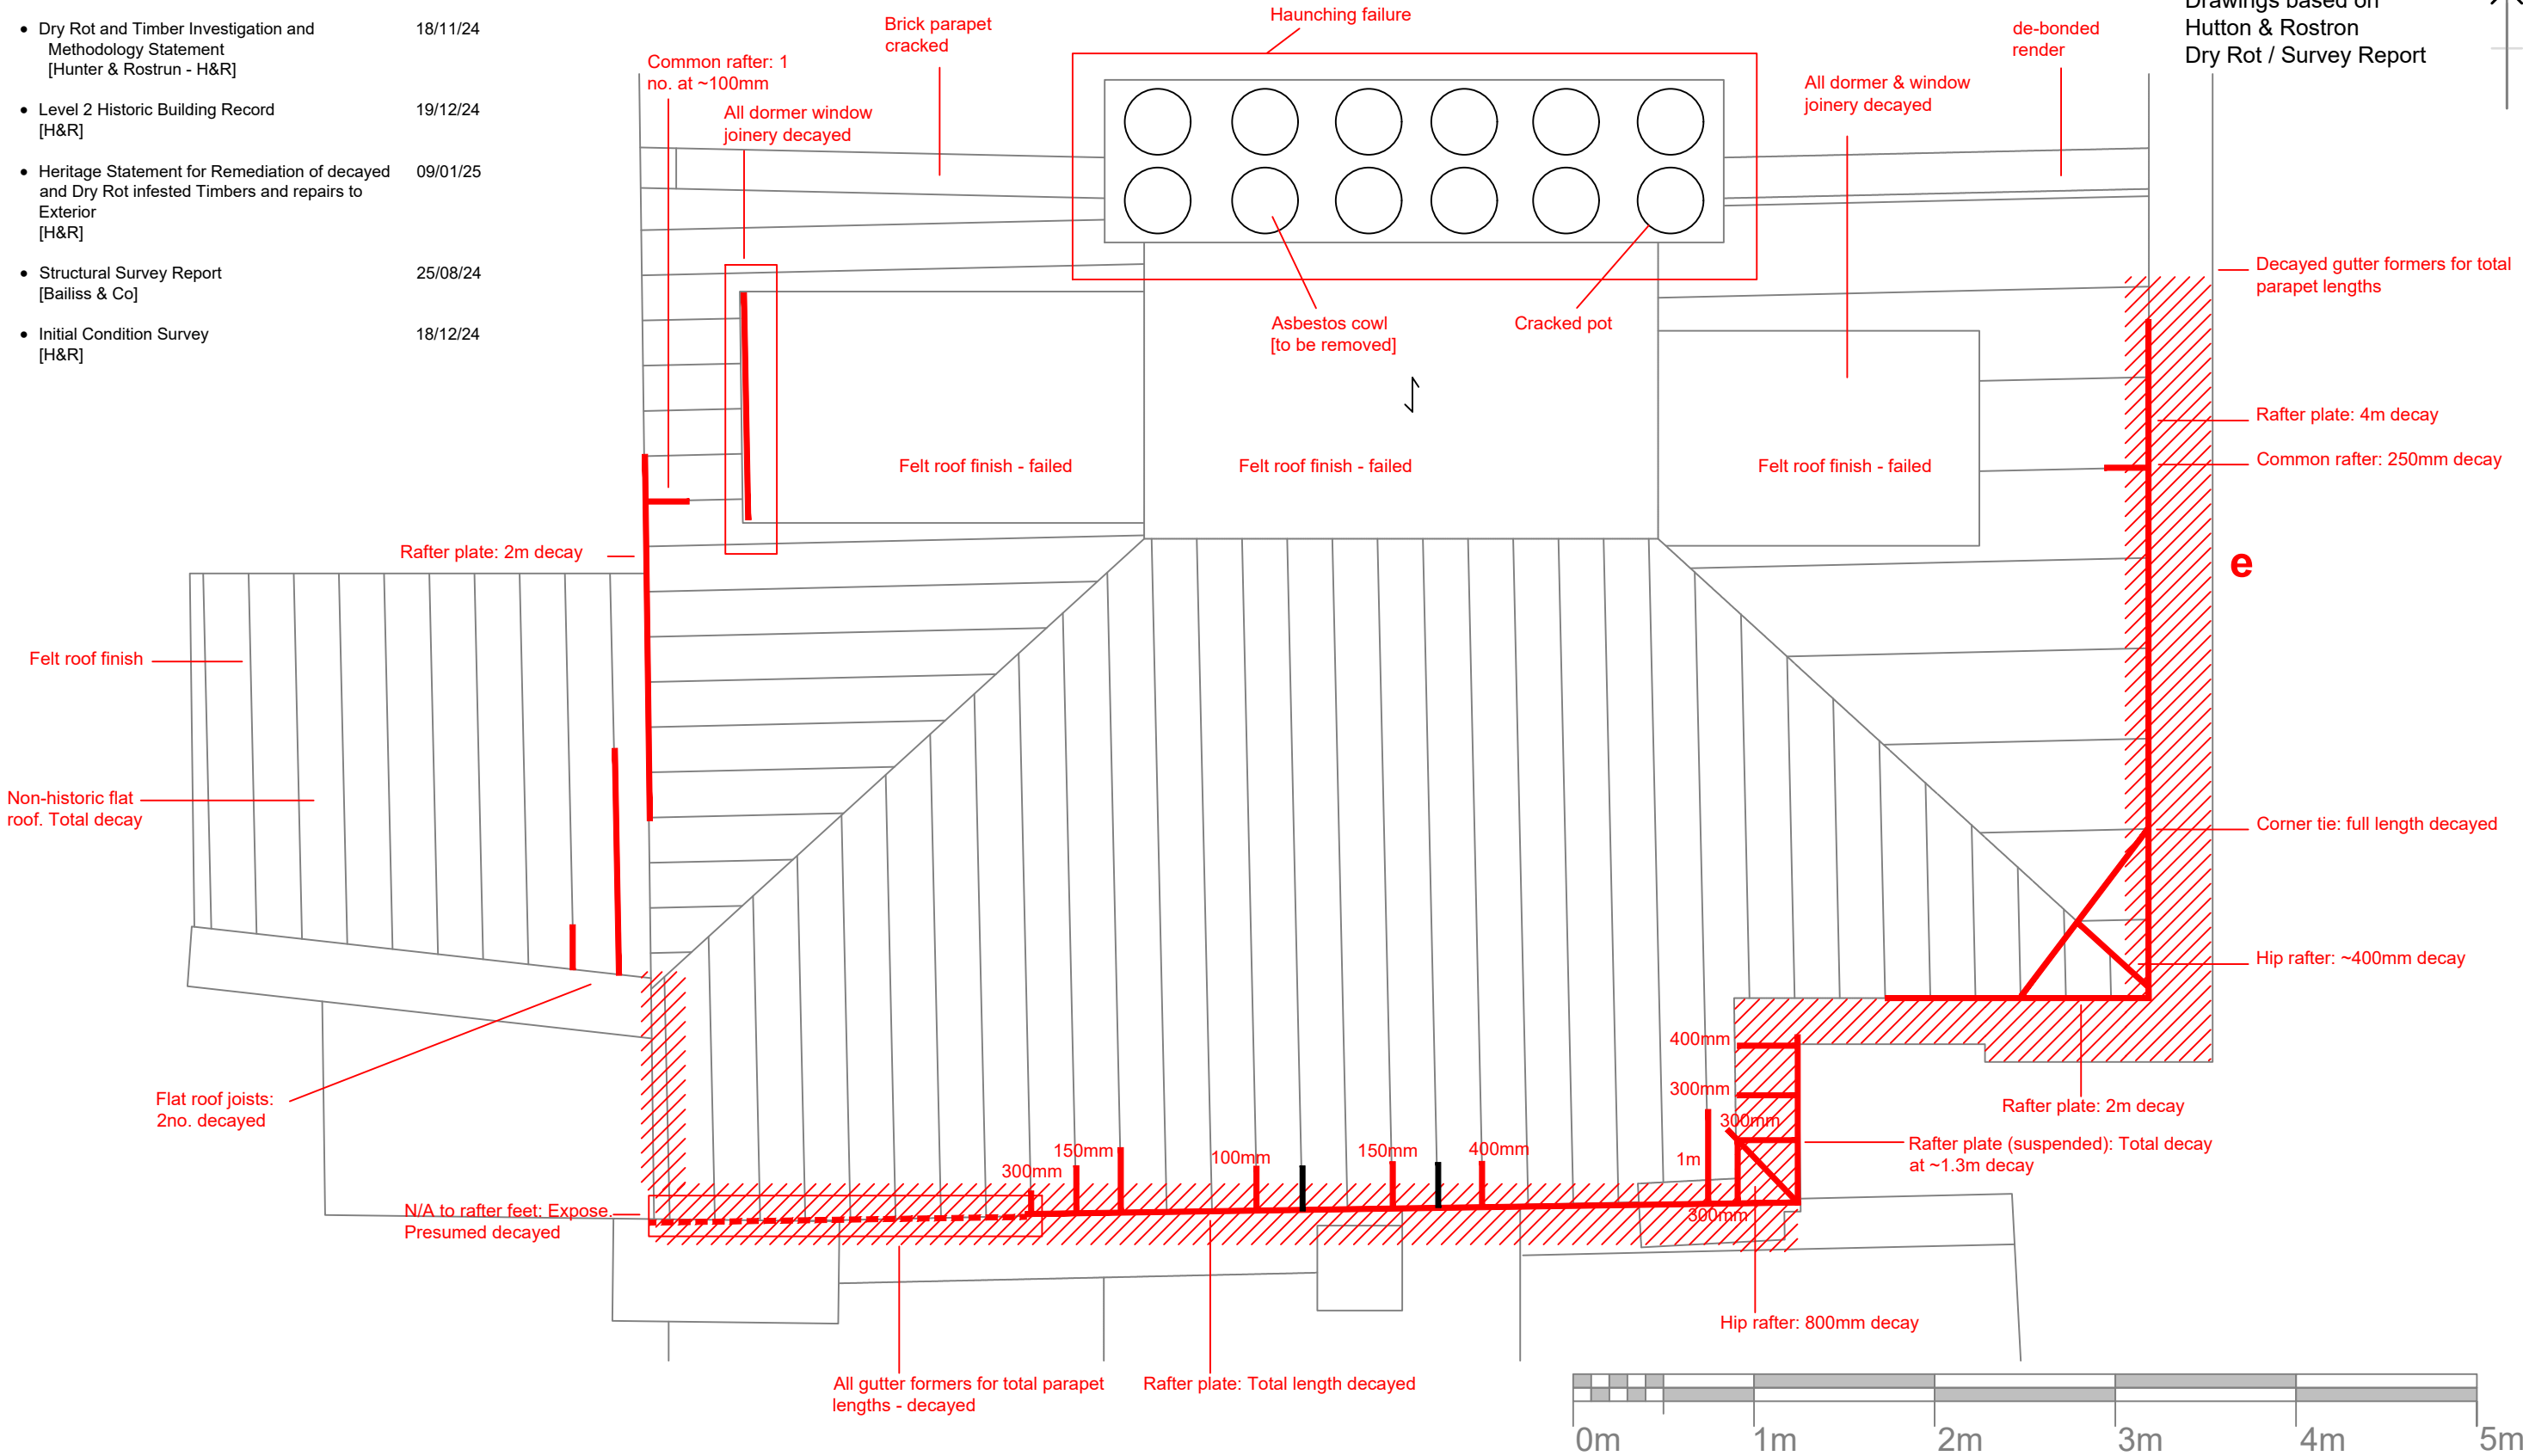
37 North Road, N6 - Roof  
Timber and Damp Condition Investigation

ROOF:  
Slopes - Spanish slates [poor quality modern]  
generally failed  
Flashings - lead generally failed part replaced with  
flashband in many places  
Valleys - lead [failed - incl gutter board]  
Gutters - pvc
