Drawings based on  
Hutton & Rostron  
Facade Masonry Report

37 North Road, N6 - Front (east) elevation  
Façade masonry condition investigation  
28 November 2024

Drawings as Existing

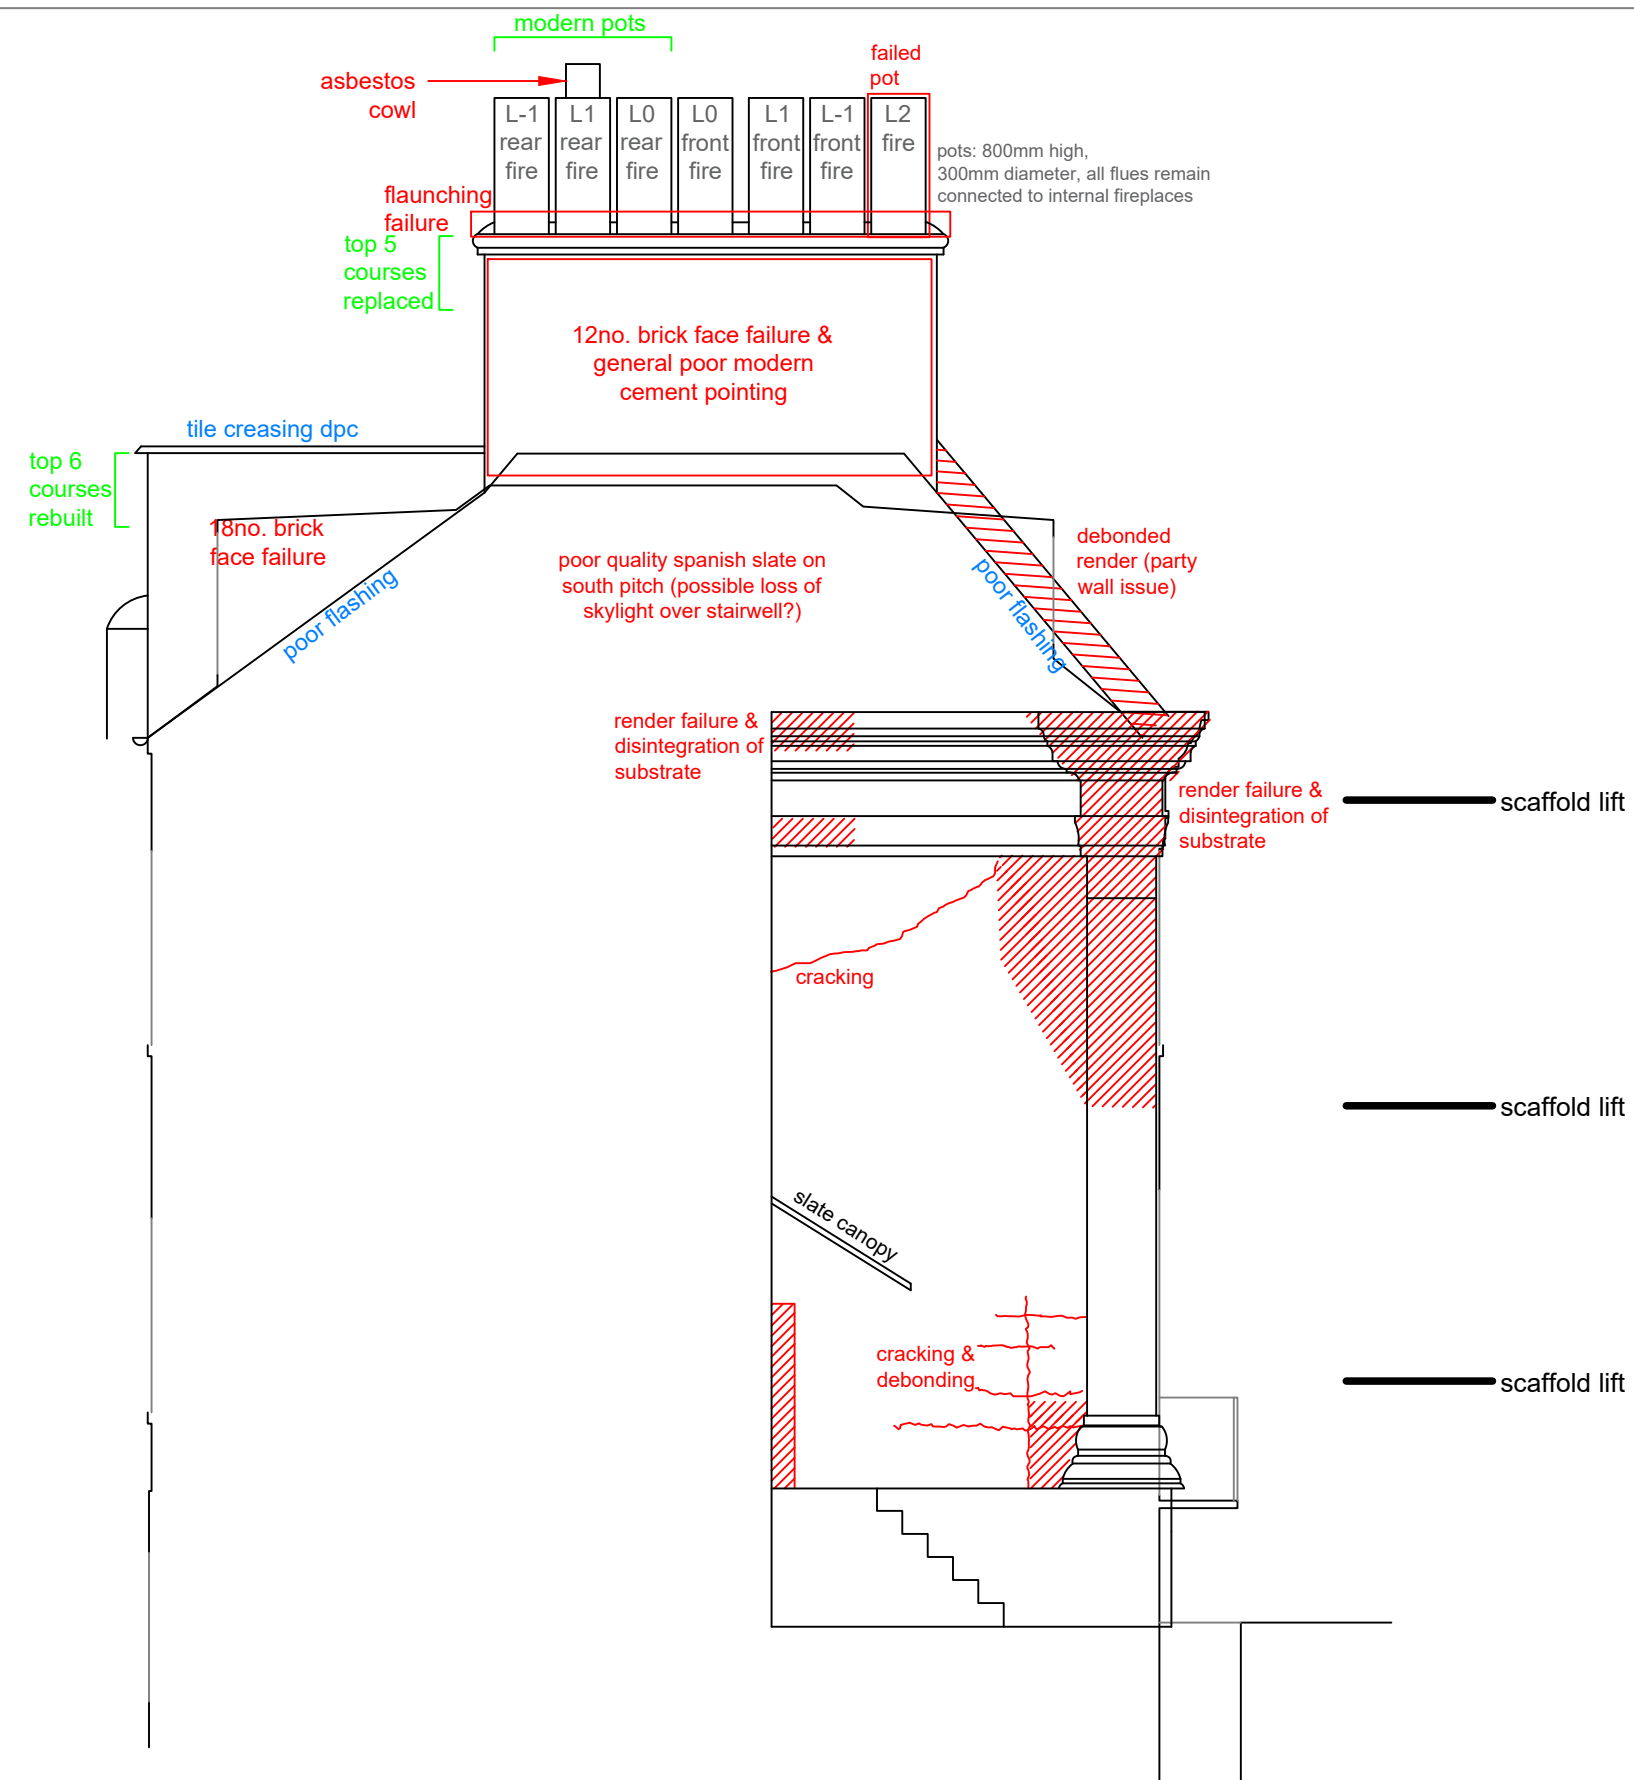
### 37 North Road, N6 - Front (east) elevation

Façade masonry condition investigation  
28 November 2024
