LOWER GROUND FLOOR PLAN

GROUND FLOOR PLAN

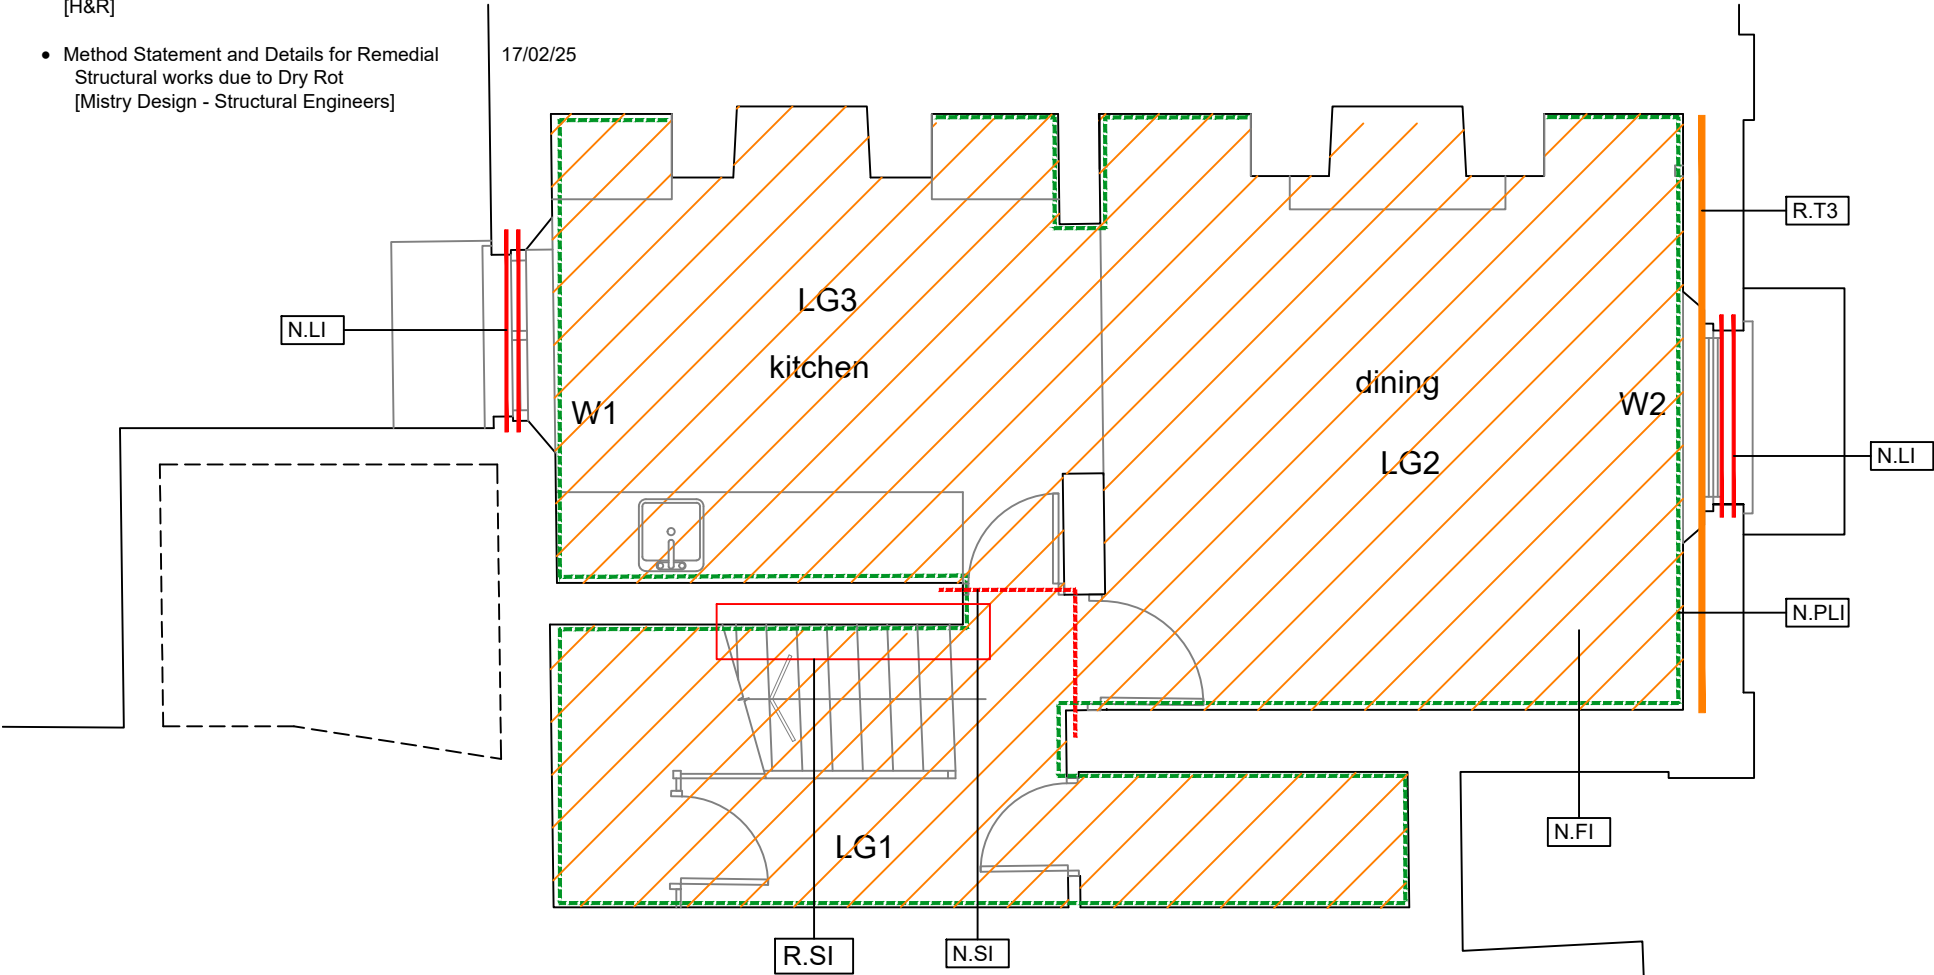
- N.LI** The wall is 325 thick, there is a brick arch on the external face and two timber lintels supporting the wall above. Carefully remove decayed timber lintel[s] and any loose brickwork. Prepare brickwork either side of window to receive new pre-cast rc lintel 100x140 mm. Dry pack or re-build brickwork as appropriate  
*See structural engineer's drawings 2505/01 [Mistry Design]*

- N.SI** Provide temporary support, remove rc lintel set at an obtuse angle and prepare brickwork to replace with 2 no 100x 150mm steel beams re-set at original orthographic position

- R.SI** Stairs LGF to GF, replace temporary support, remove landing and 4 steps, separate stringer from wall and protect with dpm. Replace 3 no carriage beams in matching species and dimensions. Selecting re-claimed timber boards replace decayed steps, risers and stringer [where decayed] *See drg ref: Greenhatch survey dwg*

- R.T3** Most of the wall plates and embedded bond timbers are decayed by dry rot. Provide temporary support of the joists where the wall plate is to be removed. Brick-up in matching bricks in lime mortar  
*See materials specification precommencement Condition 3 D*

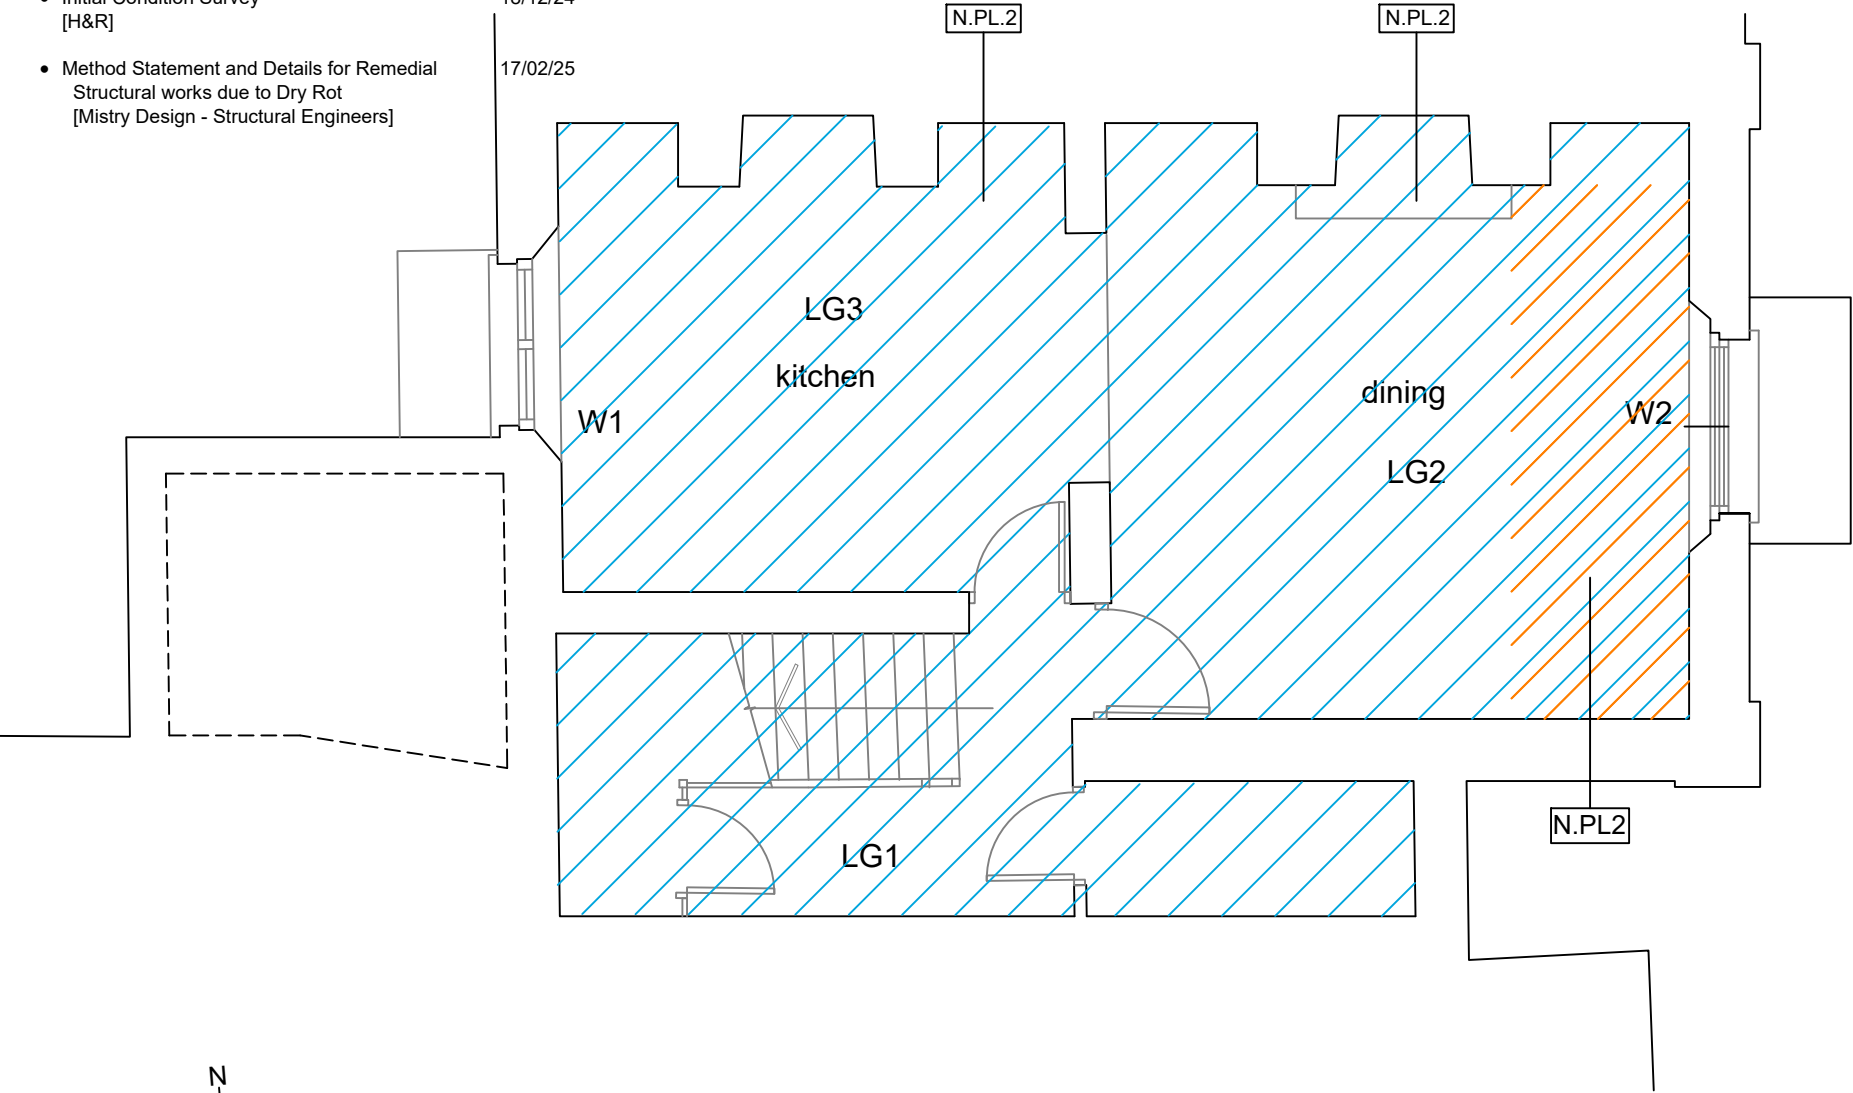
LOWER GROUND FLOOR REFLECTED CEILING F

- N.PL2
- LG1, 2, & 3 existing plasterboard ceiling removed and replaced with plasterboard, skim coat gypsum plaster finish  
See Initial Condition Survey H&R
- N.PL3
- LG2, existing ceiling part plasterboard, part lathe and plaster. Part of ceiling lost due to work to decayed joists on Ground floor

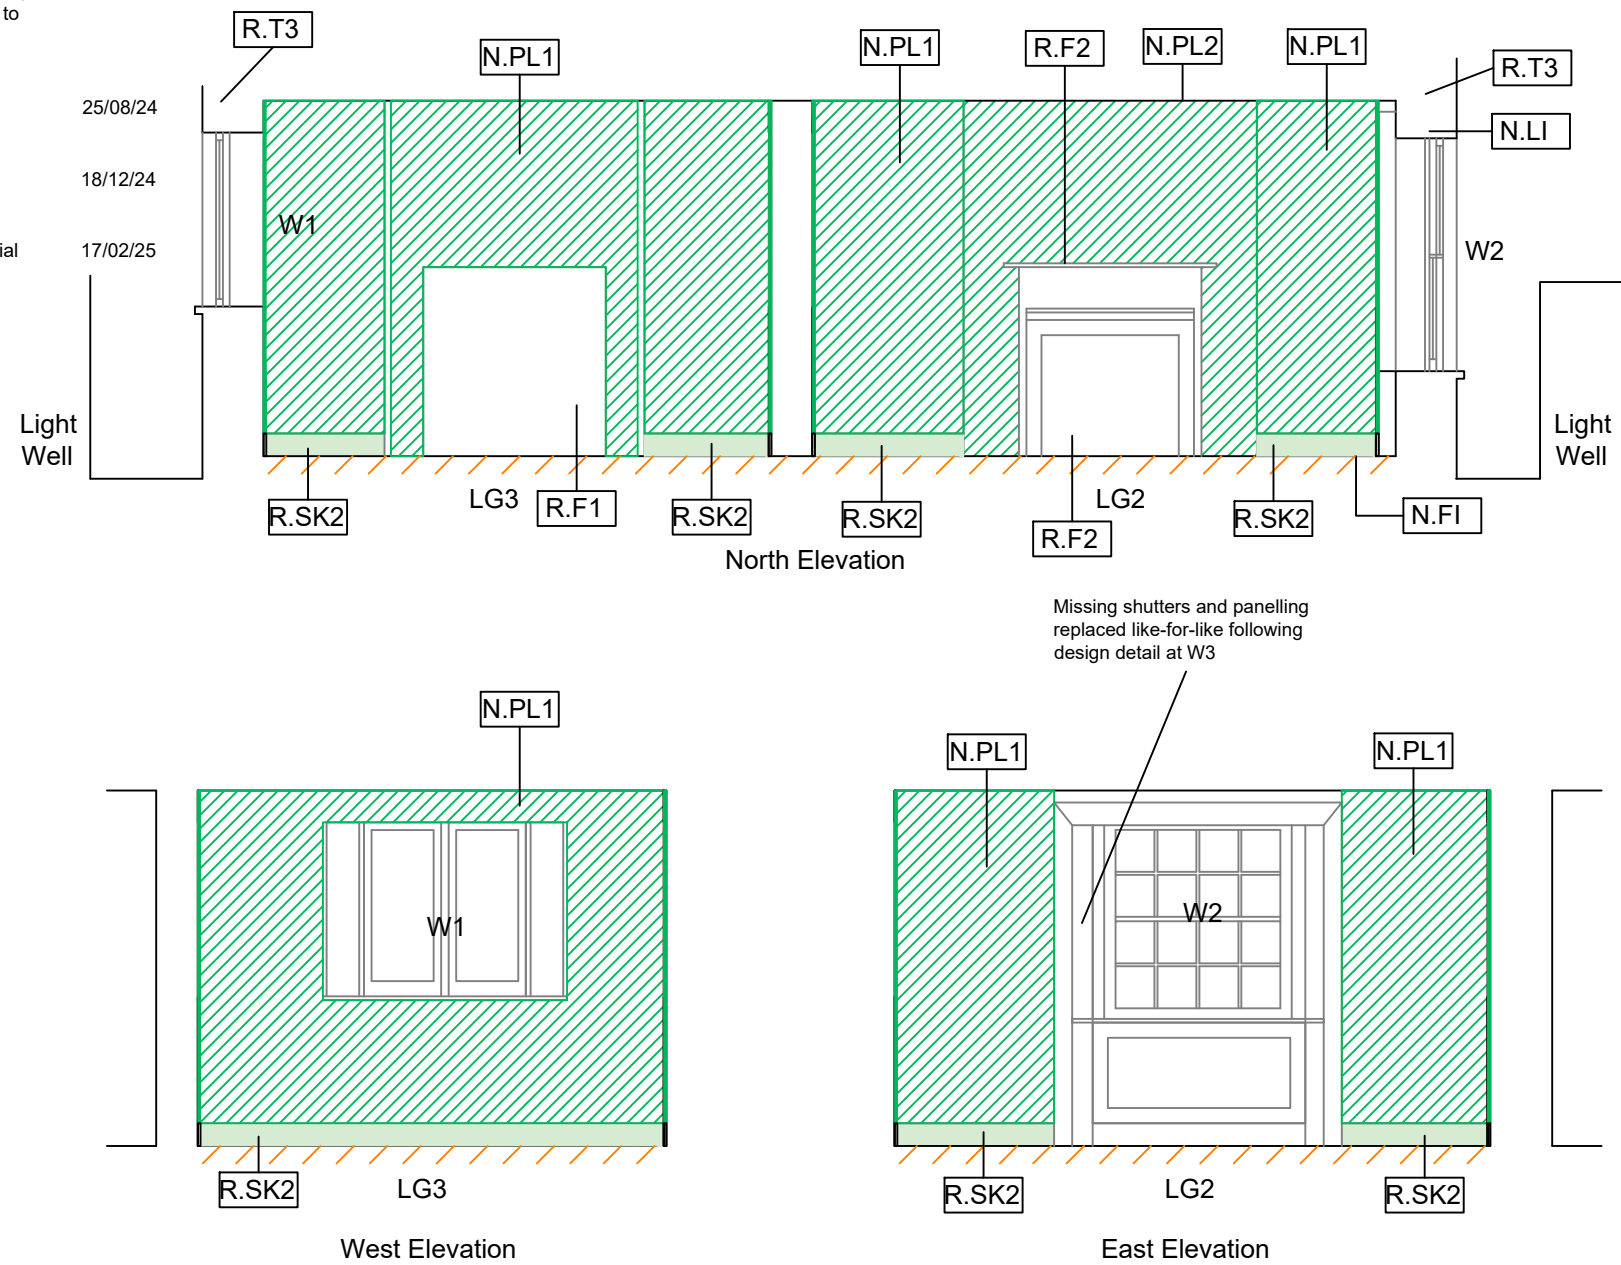
LOWER GROUND FLOOR ROOM ELEVATIONS

- TIMBER**
- Window lintels**
- N.LI** The wall is 325 thick, there is a brick arch on the external face and two timber lintels supporting the wall above.  
Carefully remove decayed timber lintel[s] and any loose brickwork. Prepare brickwork either side of window to receive new pre-cast rc lintel 100x140 mm. Dry pack or re-build brickwork as appropriate  
See structural engineer's [Mistry Design] drawings 2505/01-07

- R.T3** Most of the wall plates are decayed by dry rot.  
Provide temporary support of the joists where the wall plate is to be removed.  
Brick-up in matching bricks in lime mortar

- W1** A 20<sup>th</sup> C casement window
- W2** See Window schedule
- Chimneypiece**
- R.F1** Fireplace brick lining repaired and lined with brick slips to match existing brickwork

- R.F2** Timber mantelpiece cleaned and prepared for decoration. Slate hearth cleaned and re-set in floor.
- R.SK2** Timber skirtings - box profile 125mmx18mm

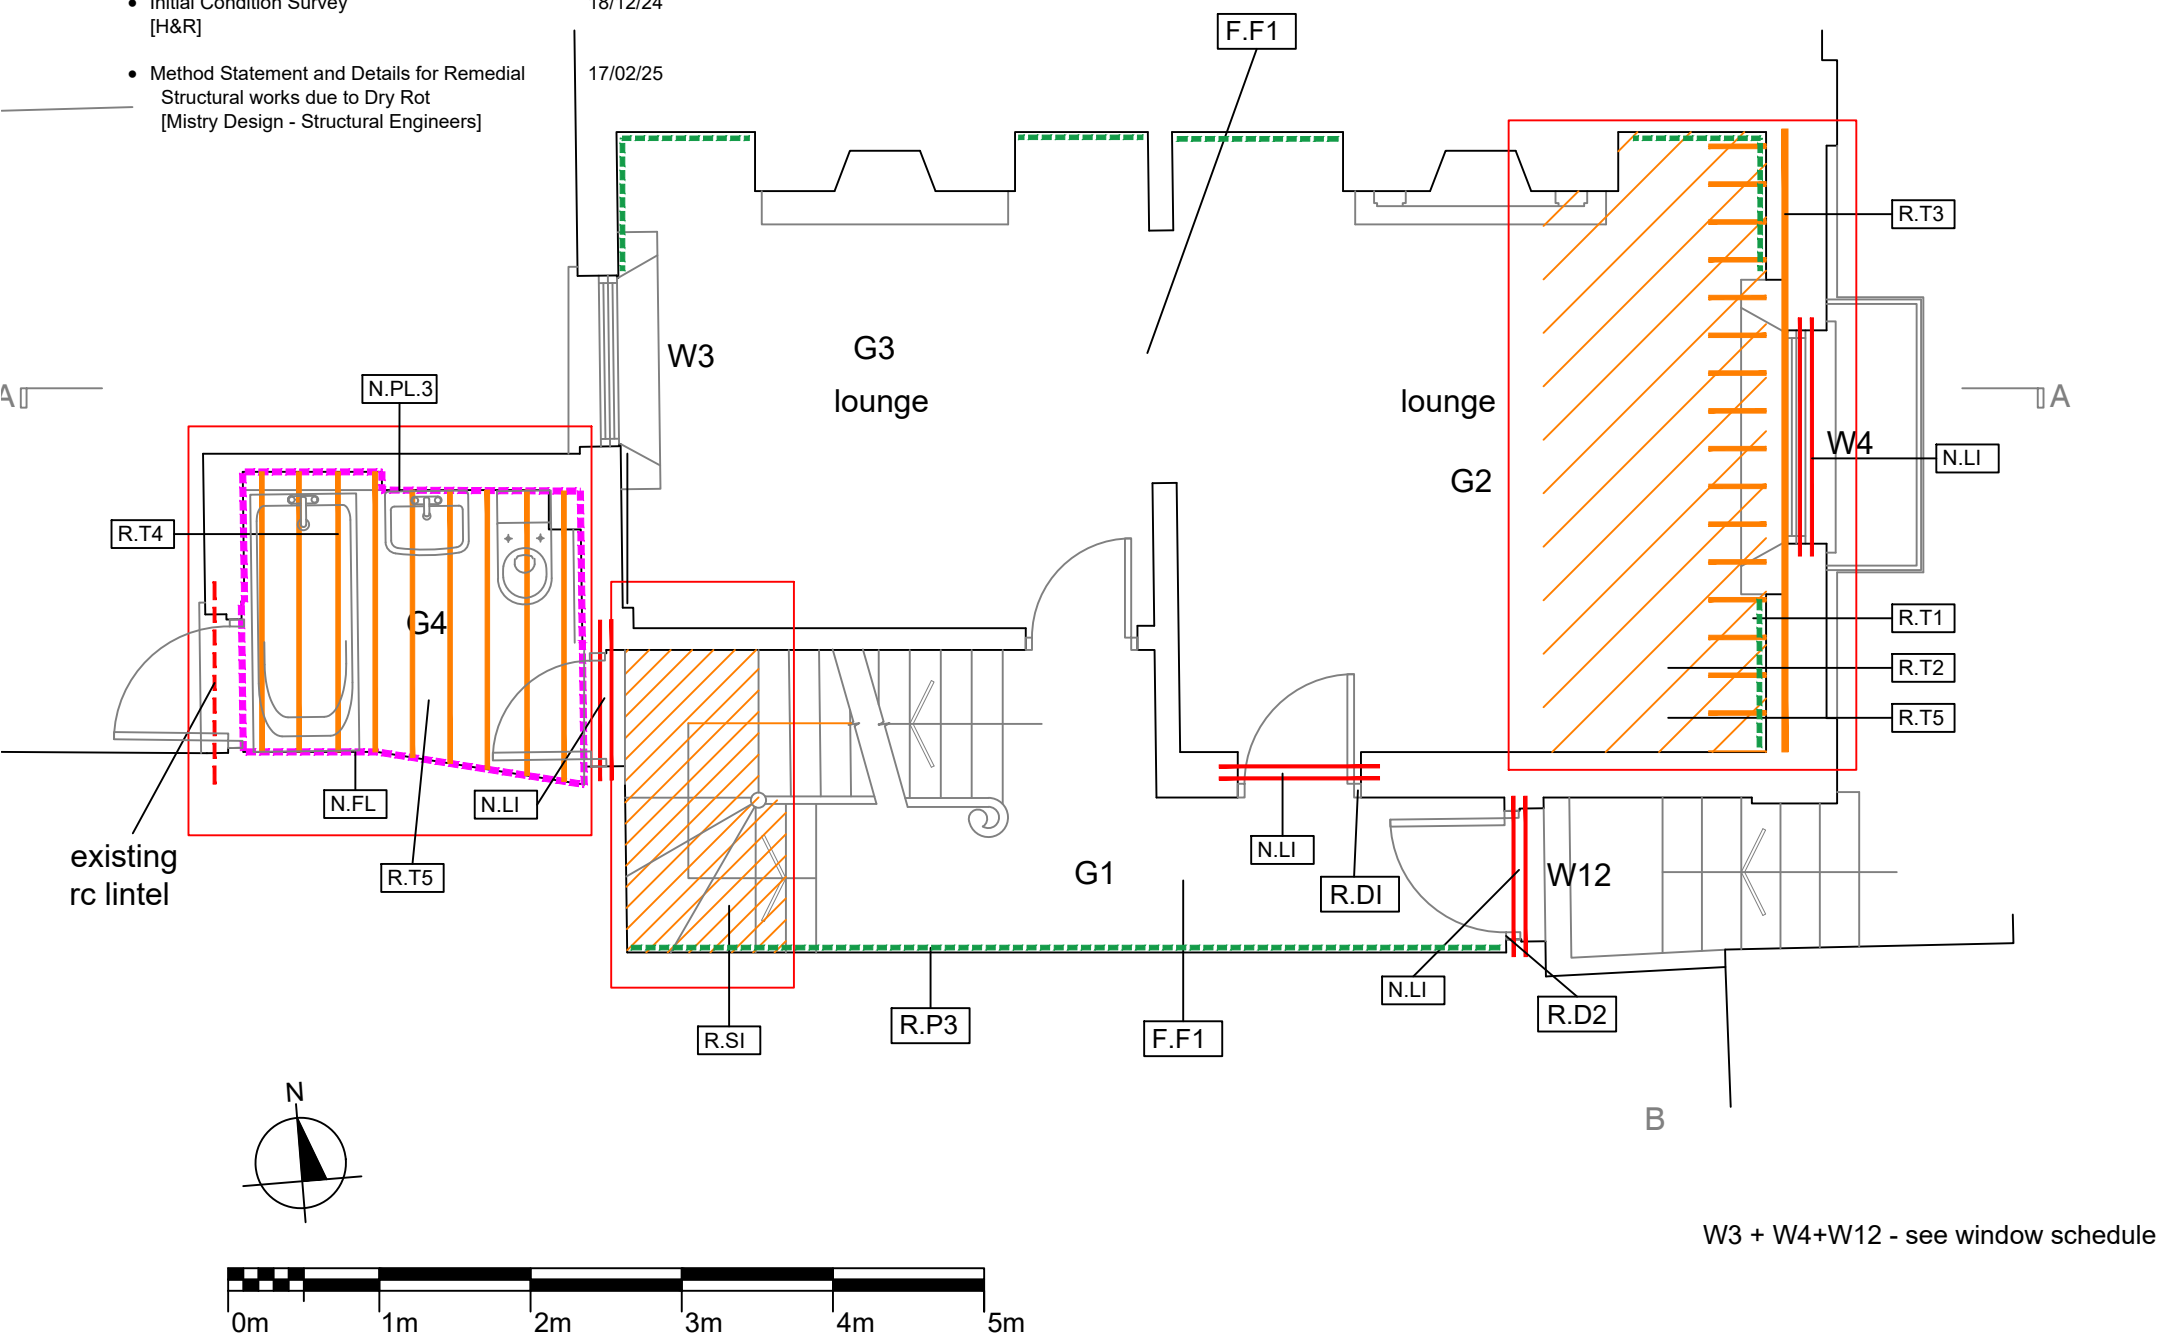
Many of the window lintels have been affected by dry rot and require replacing. Carefully remove the decayed timber lintel[s] and any loose brickwork. Prepare the brickwork either side of the window to receive new pre-cast rc lintel [s]. Dry pack or re-build brickwork as appropriate.

Wall is 325mm thick - there is a brick arch on the external face and two timber lintels supporting the wall above. Replace timber lintels with two rc lintels 100 x 140 mm.

Provide temporary support for the joists affected by dry rot, cut back 200-300 mm to bearing ends, install ss joist hangers to receive 'partnered joists' [R.T2] 12no joists

Most of the existing wall plates as are decayed by dry rot. Provide temporary support of the joists where the wall plate is to be removed. Brick-up in matching bricks in lime mortar See materials specification precommencement Condition 3 D

Carefully remove all decayed [total] timber joists and floor boards. Brick-up joist locations in matching brickwork, using prompt mortar, install new joists in matching species and section @ 400mm crs ends wrapped in dpm and supported on ss joist hangers. Boarding replaced with marine ply [bathrooms] See structural engineer's details 2505/01-03 [Mistry]

Stairs LGF to GF, replace temporary support, remove landing and 4 steps, separate stringer from wall and protect with dpm. Replace 3 no carriage beams in matching species and dimensions. Selecting re-claimed timber boards replace decayed steps, risers and stringer [where decayed] See drg ref: Greenhatch survey dwg

Locate and carefully remove timber bonds from different wall locations, remove loose brickwork and re-build in matching brickwork using special Prompt mortar See materials specification precommencement Condition 3 D

Remove existing door frame, lining and architrave decayed. Install new to match existing. See door frame/lining/moulding detail 14

Scrape off all loose and infected plaster. Masonry and structure to be checked for stability, cleaned and dried. Reinstate plaster using traditional method. Apply 3 coats of lime plaster to match existing mix.

Entire area total dry rot decay [see drawings as existing]

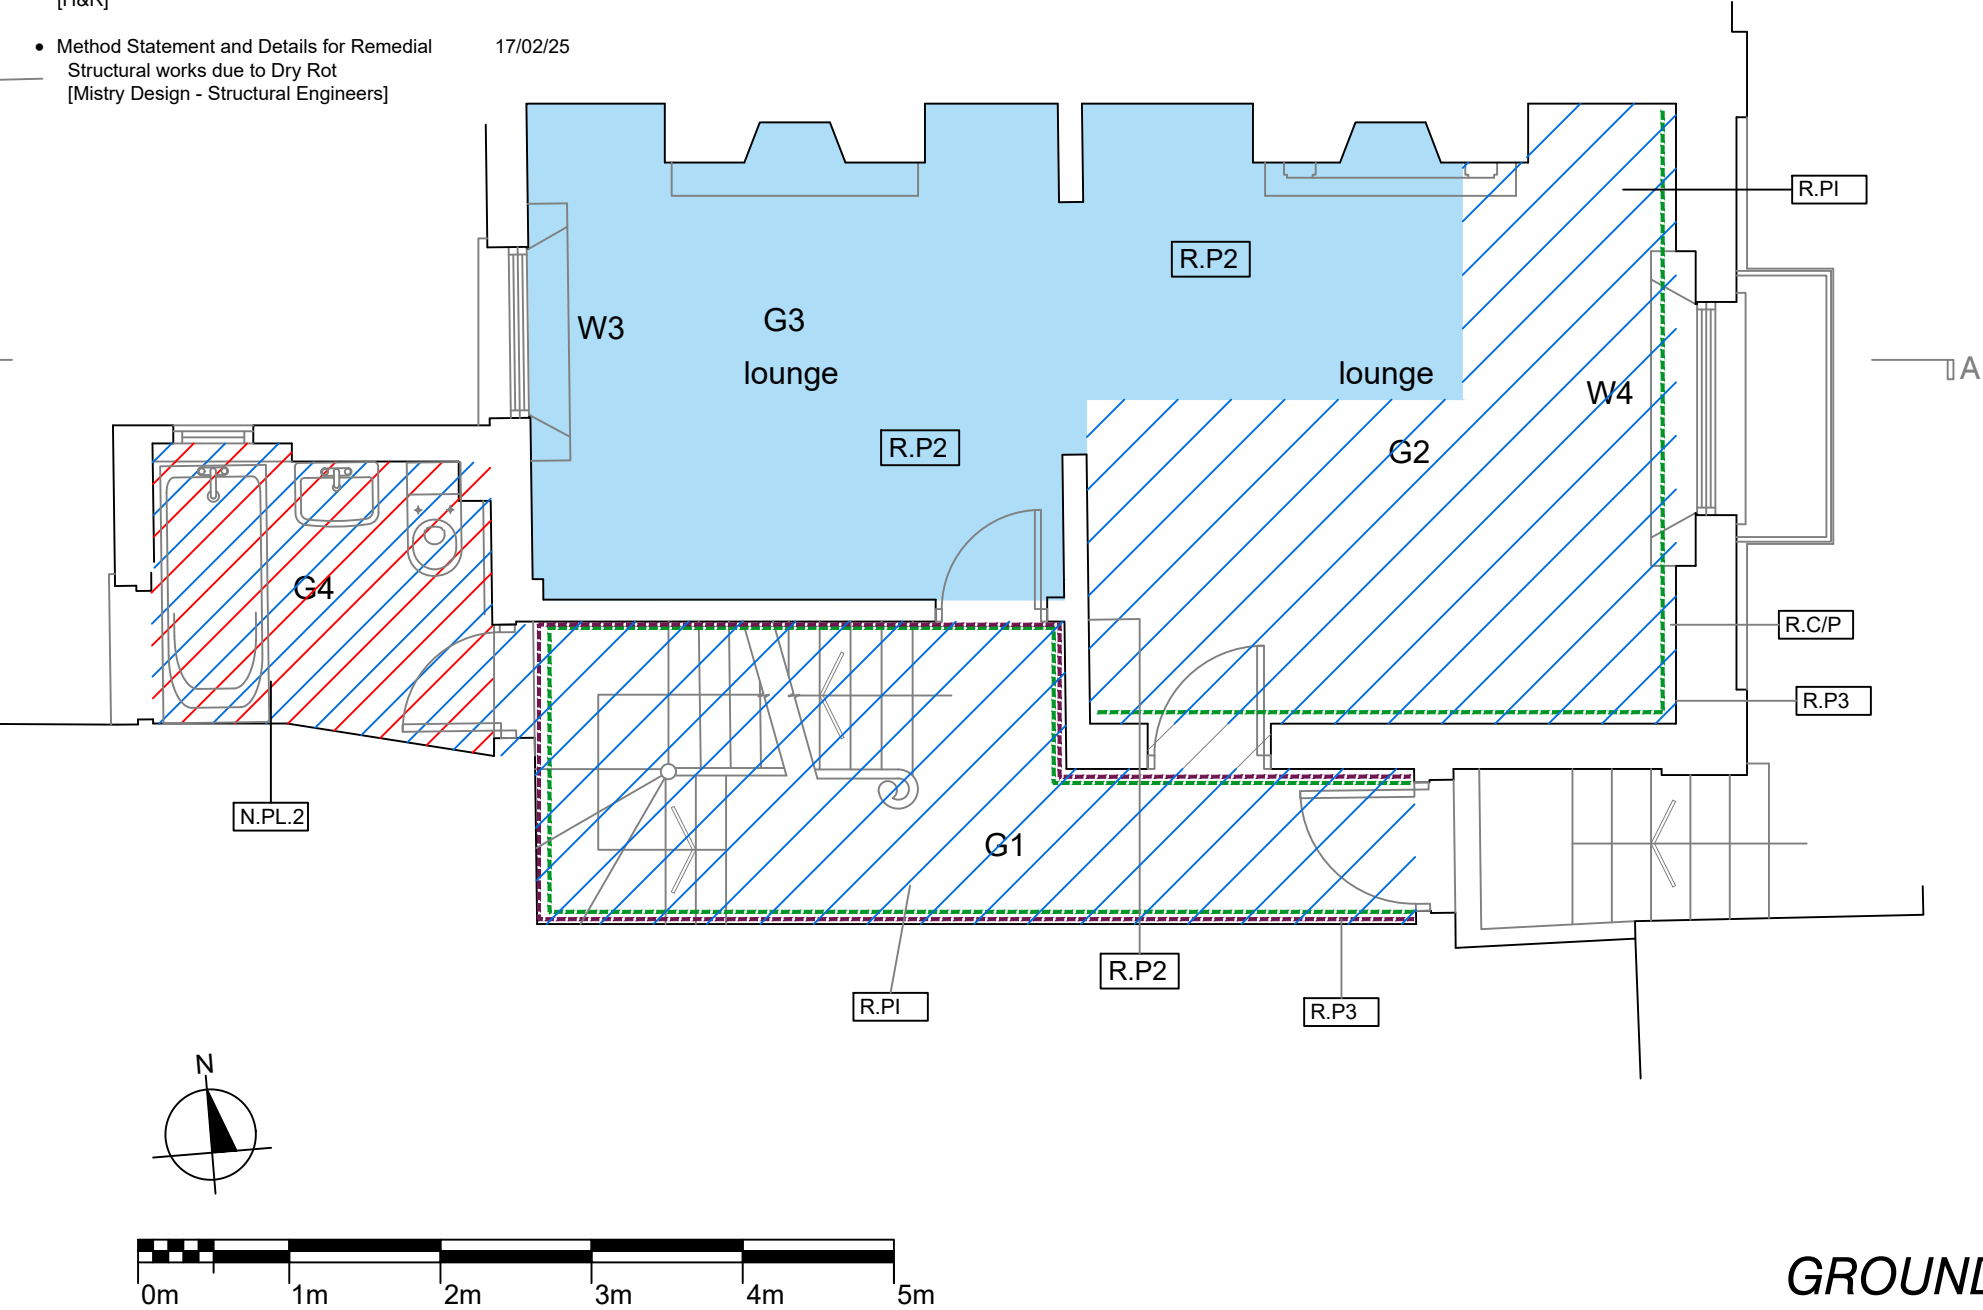
**R.PI** Lost areas of ceiling plaster due to 1st floor joist repairs to be replaced to match existing using like lathes of similar dimensions, nails/pins matching existing. Surfaces to be 3-coat lime plastered to match existing and levelled with adjacent areas of existing plasterwork - see plan dwg no 7

**R.P2** Remove lining paper from all surfaces walls and ceilings, scrape off loose, friable plaster, carrying minor patchwork repairs to existing damaged or defective surfaces. Replaster using established mix, thickness to be levelled with retained plasterwork - see plan dwg no 3

**R.P3** Scrape off all loose and infected plaster. Masonry and structure to be checked for stability, cleaned and dried. Where unstable repoint or replace brickwork. Reinststate plaster using traditional method. Apply 3 coats of lime plaster to match existing mix.

**R.C/P** Replace removed cornice in pre-made matching fibrous plaster. See moulding section detail drawing 14

**N.PL2** Existing decayed ceiling removed (plasterboard) and replaced with British Gypsum water resistant plasterboard, skim 2-coat plaster finish.

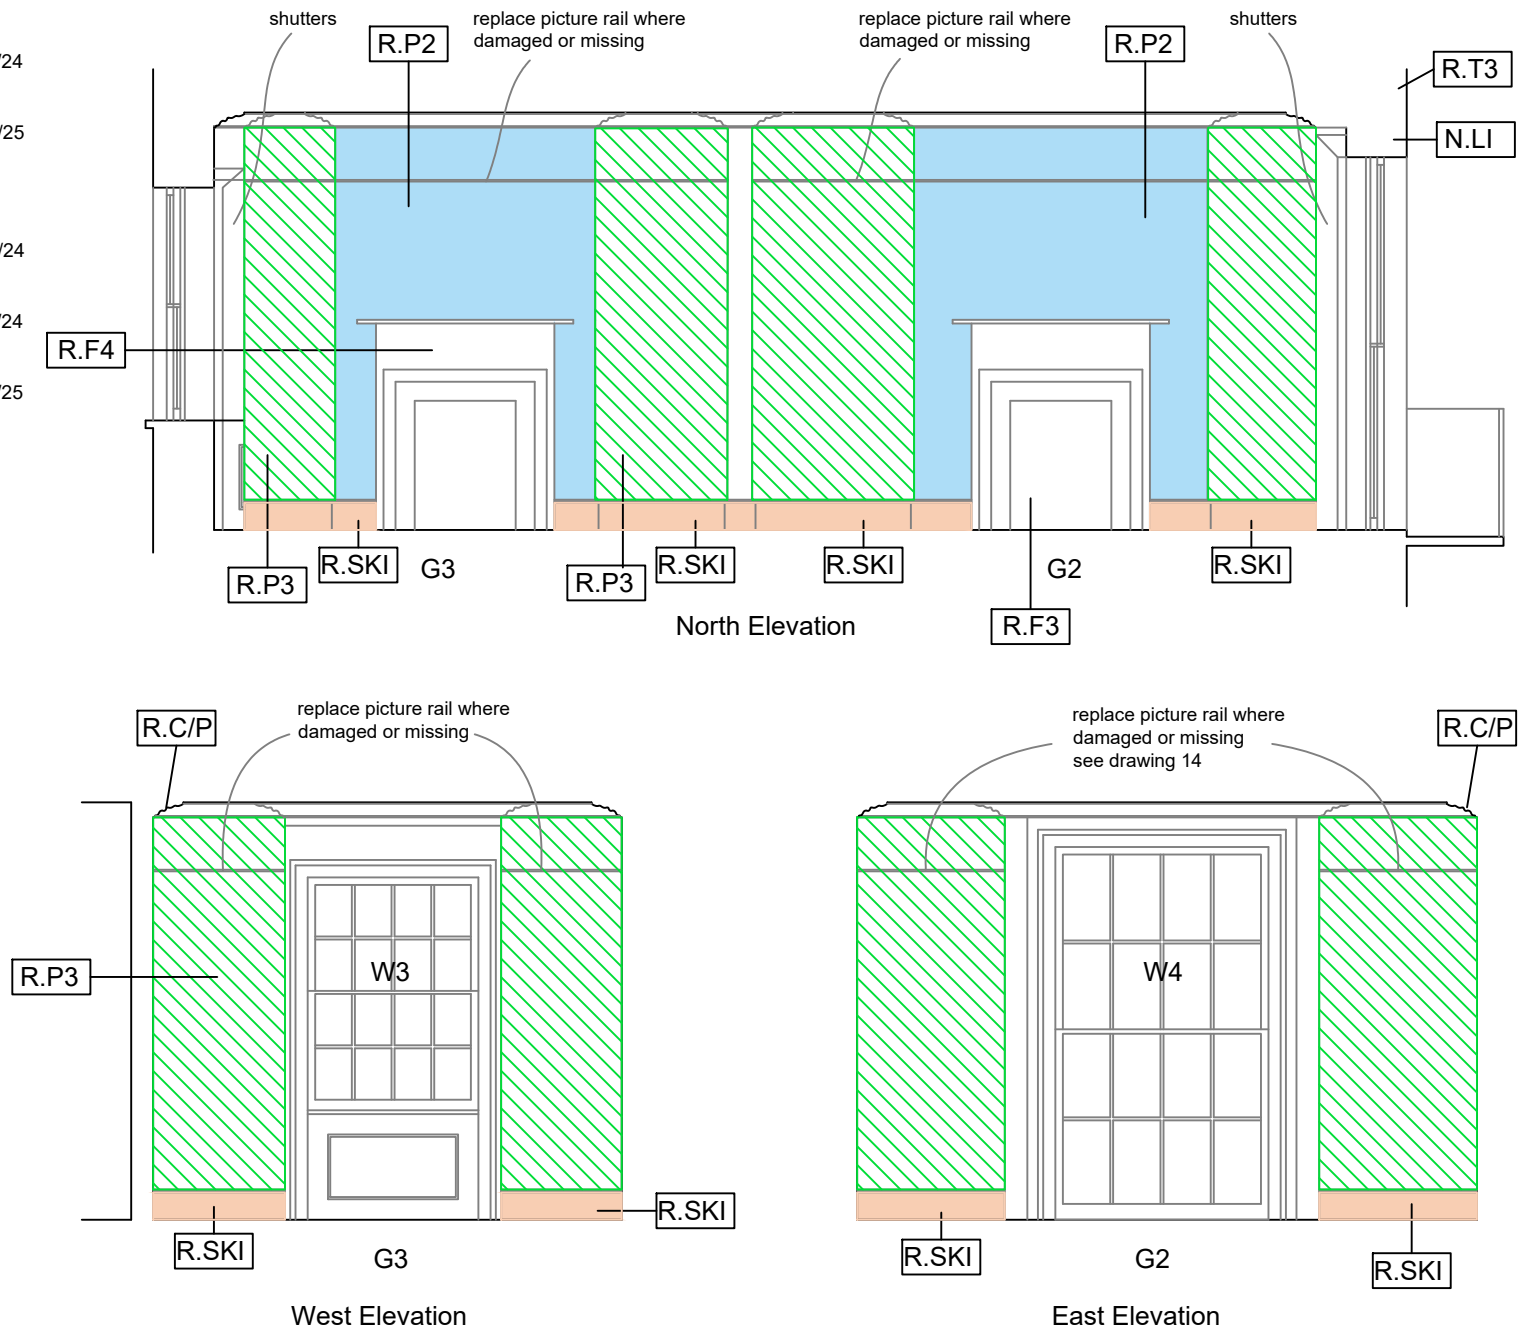
**R.T3** Most of the wall plates are decayed by dry rot. Provide temporary support of the joists where the wall plate is to be removed. Brick-up in matching bricks in lime mortar

**N.LI** The wall is 325 thick, there is a brick arch on the external face and two timber lintels supporting the wall above. Carefully remove decayed timber lintel[s] and any loose brickwork. Prepare brickwork either side of window to receive new pre-cast rc lintel 100x140 mm. Dry pack or re-build brickwork as appropriate  
*See structural engineer's details 2505/01-03 [Mistry Design]*

**R.P3** Scrape off all loose and infected plaster. Masonry and structure to be checked for stability, cleaned and dried. Reinstall plaster using traditional method. Apply 3 coats of lime plaster to match existing mix.

**R.P2** Remove lining paper from all surfaces, scrape off loose, friable plaster, carrying minor patchwork repairs to existing damaged or defective surfaces. Replaster using established mix, thickness to be levelled with retained plasterwork - see plan dwg no 4

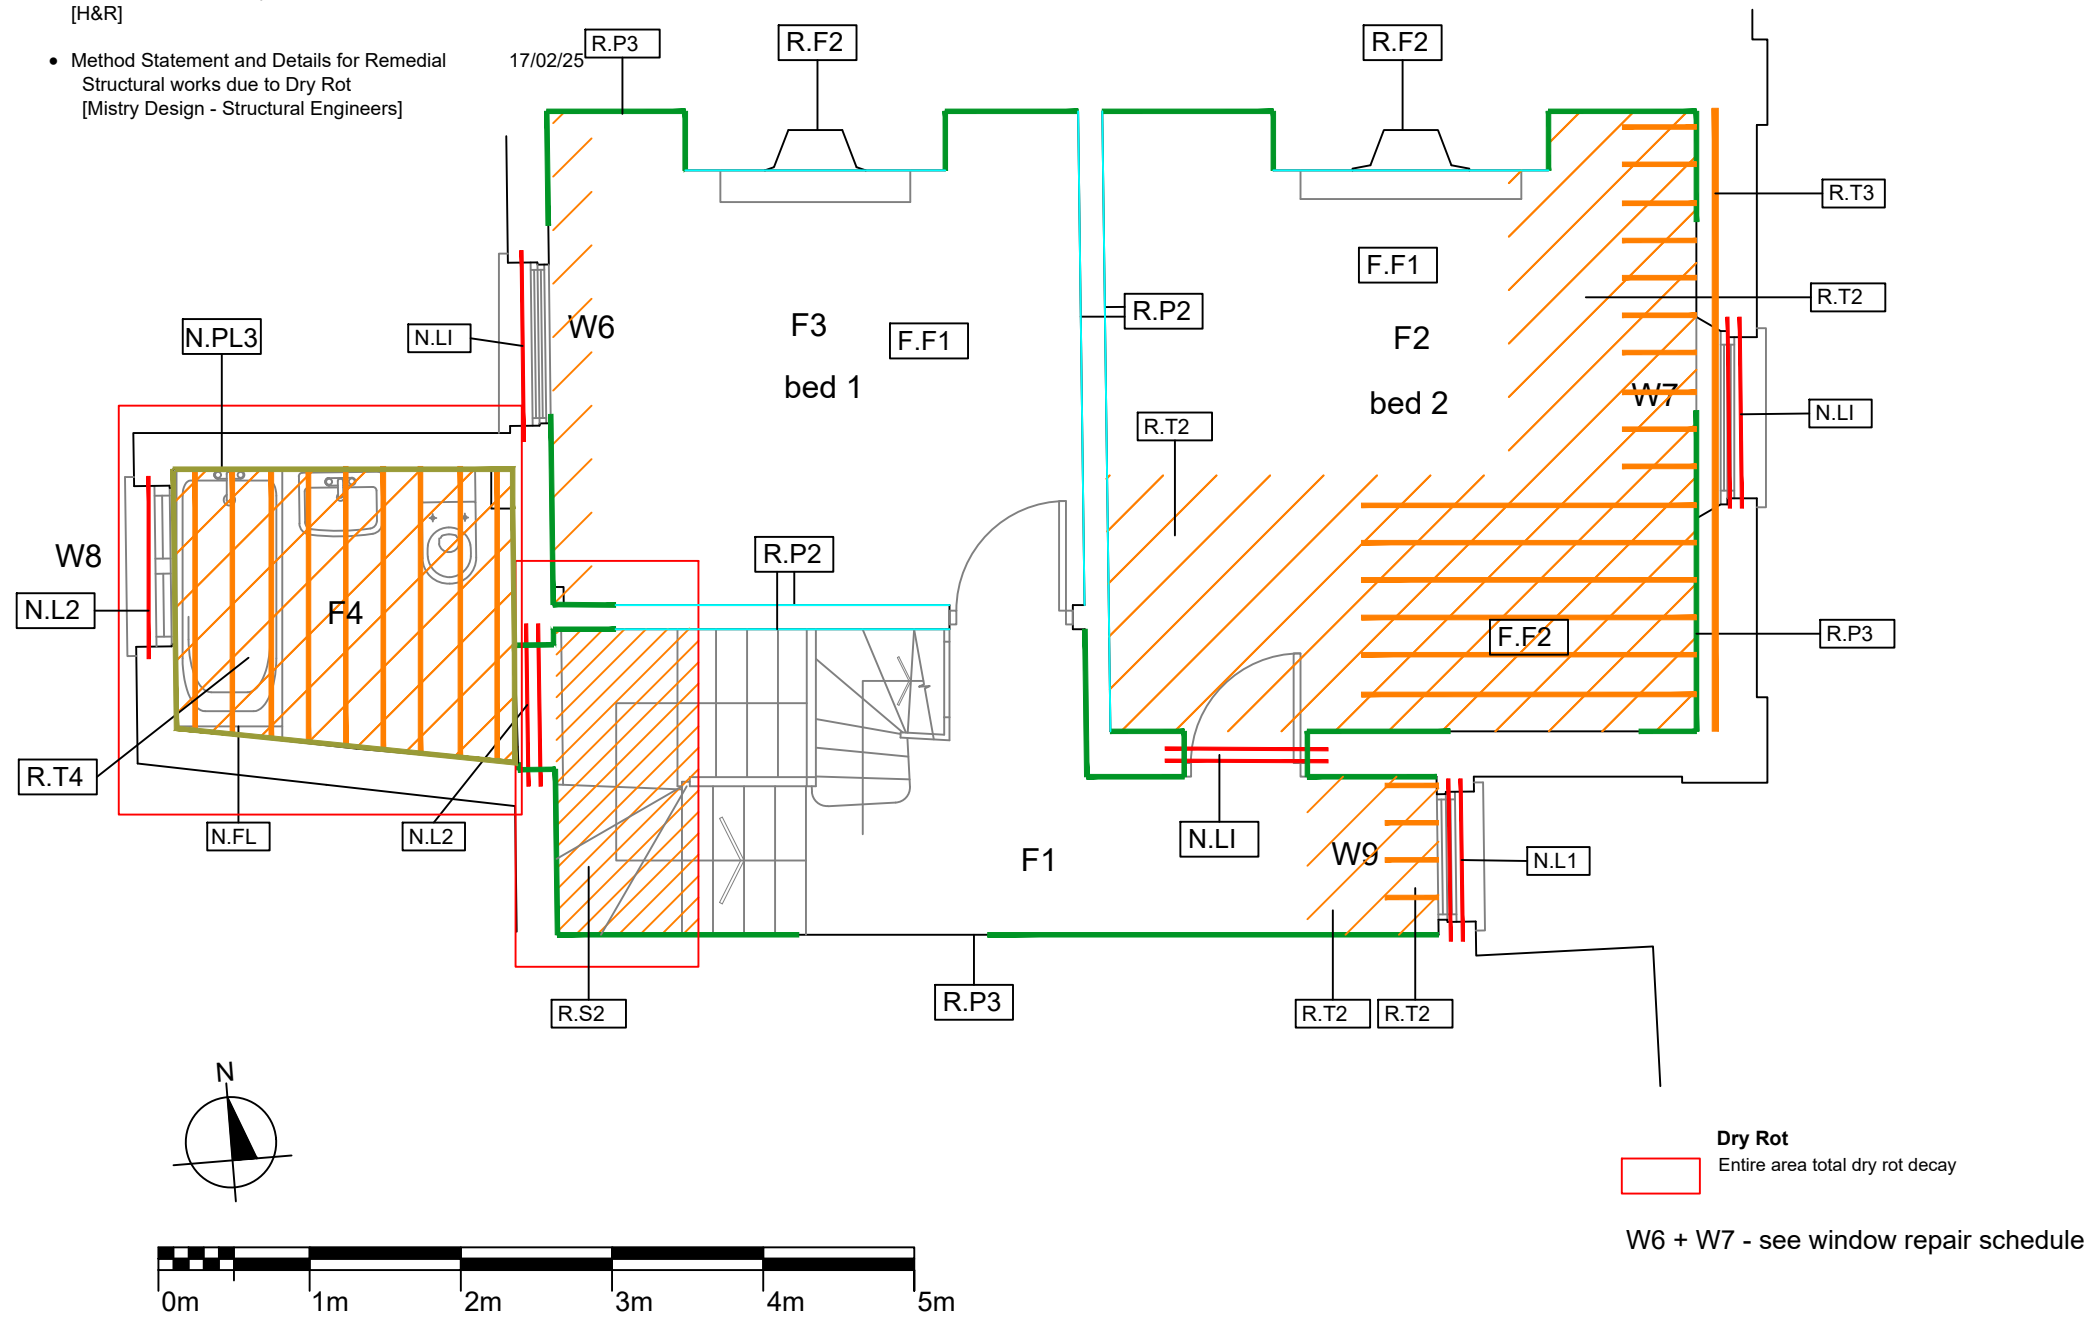
Many of the window lintels have been affected by dry rot and require replacing. Carefully remove the decayed timber lintel[s] and any loose brickwork. Prepare the brickwork either side of the window to receive new pre-cast rc lintel [s]. Dry pack or re-build brickwork as appropriate.

**See St Engineer's dwg 2505/01-03**
- R.T3** Most of the wall plates are decayed by dry rot. Provide temporary support of the joists where the wall plate is to be removed. Brick-up in matching bricks in lime mortar

- R.T4** Carefully remove all decayed [total] timber joists and floor boards. Brick-up joist locations in matching brickwork, using prompt mortar, install new joists in matching species and section @ 400mm crs ends wrapped in dpm and supported on ss joist hangers. Boarding replaced with marine ply [bathrooms].

- R.S2** Stairs GF to 1st F, replace temporary support, remove landing and 3 steps, separate stringer from wall and protect with dpm. Replace 3 no carriage beams in matching species and dimensions. Selecting re-claimed timber boarding replace decayed steps and risers

- N.FL** Locate and carefully remove timber bonds from different wall locations, remove loose brickwork and re-build in matching brickwork using special Prompt mortar

- N.L1** Wall is 325mm thick - there is a brick arch on the external face and two timber lintels supporting the wall above. Replace timber lintels with two rc lintels 100 x 140 mm  
**See structural engineer's drawings 2505/01-03**
- N.L2** Wall is 225mm thick, there is a brick arch on the external face and one timber lintel supporting the wall above. Replace the timber lintel with one rc lintels 100 x 140 mm.  
**See structural engineer's drawings 2505/01-03**
- N.L3** 2 no 100x140 rc lintels  
**See structural engineer's drawings 2505/01-03**

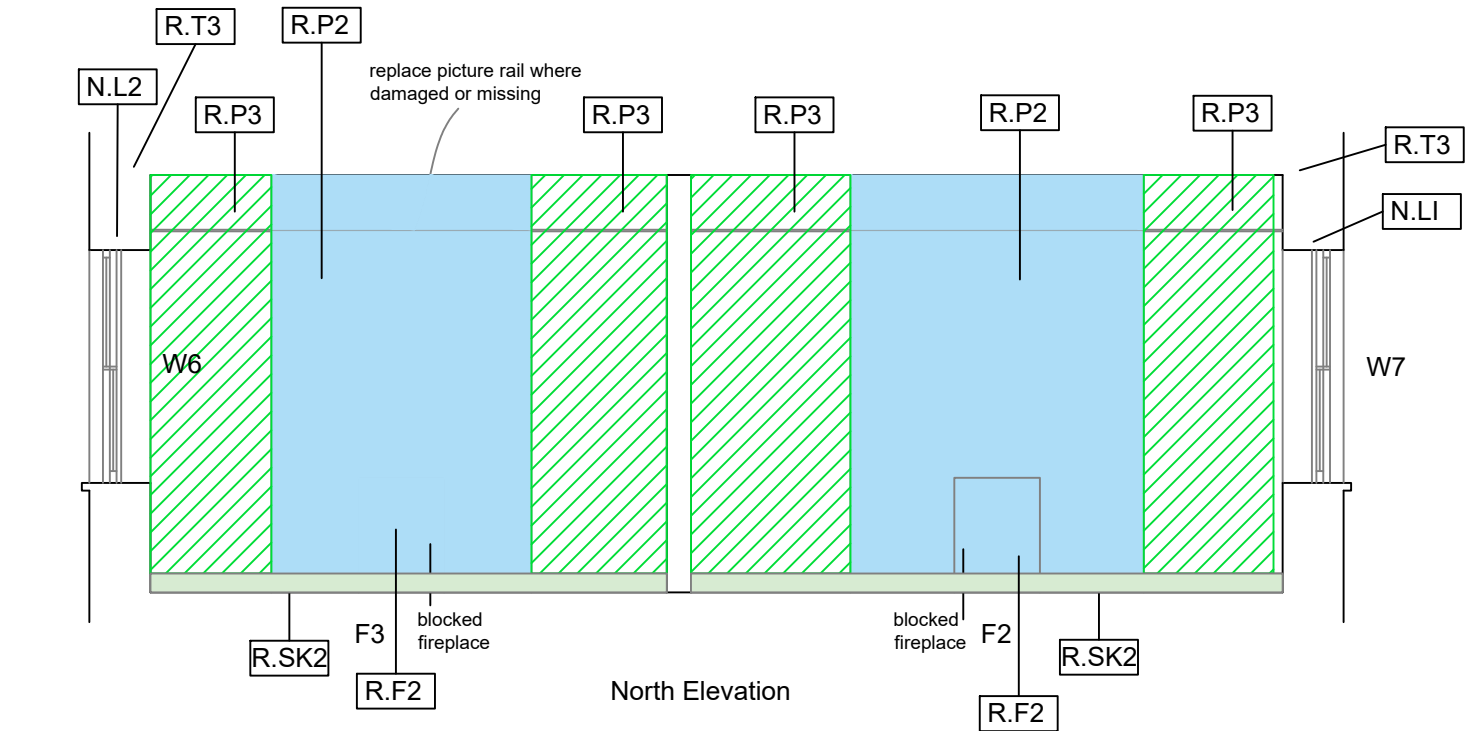
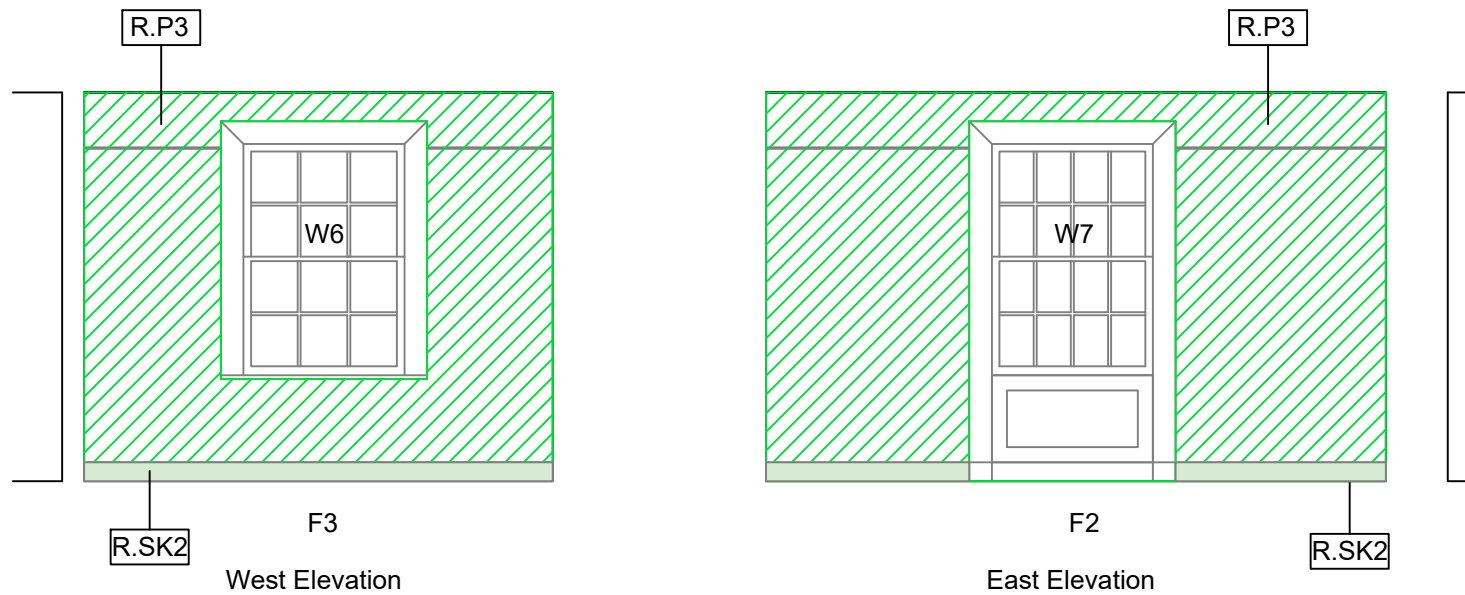
Many of the window lintels have been affected by dry rot and require replacing. Carefully remove the decayed timber lintel[s] and any loose brickwork. Prepare the brickwork either side of the window to receive new pre-cast rc lintel [s]. Dry pack or re-build brickwork as appropriate.

Most of the wall plates are decayed by dry rot. Provide temporary support of the joists where the wall plate is to be removed. Brick-up in matching bricks in lime mortar  
**See structural engineer's [Mistry Design] drawings 2505/01-03**

**N.LI** Wall is 325mm thick - there is a brick arch on the external face and two timber lintels supporting the wall above. Replace timber lintels with two rc lintels 100 x 140 mm  
**See structural engineer's drawings 2505/01-03**

**N.L2** Wall is 225mm thick, there is a brick arch on the external face and one timber lintel supporting the wall above. Replace the timber lintel with one rc lintels 100 x 140 mm.  
**See structural engineer's drawings 2505/01-03**
