LOWER GROUND FLOOR PLAN

GROUND FLOOR PLAN

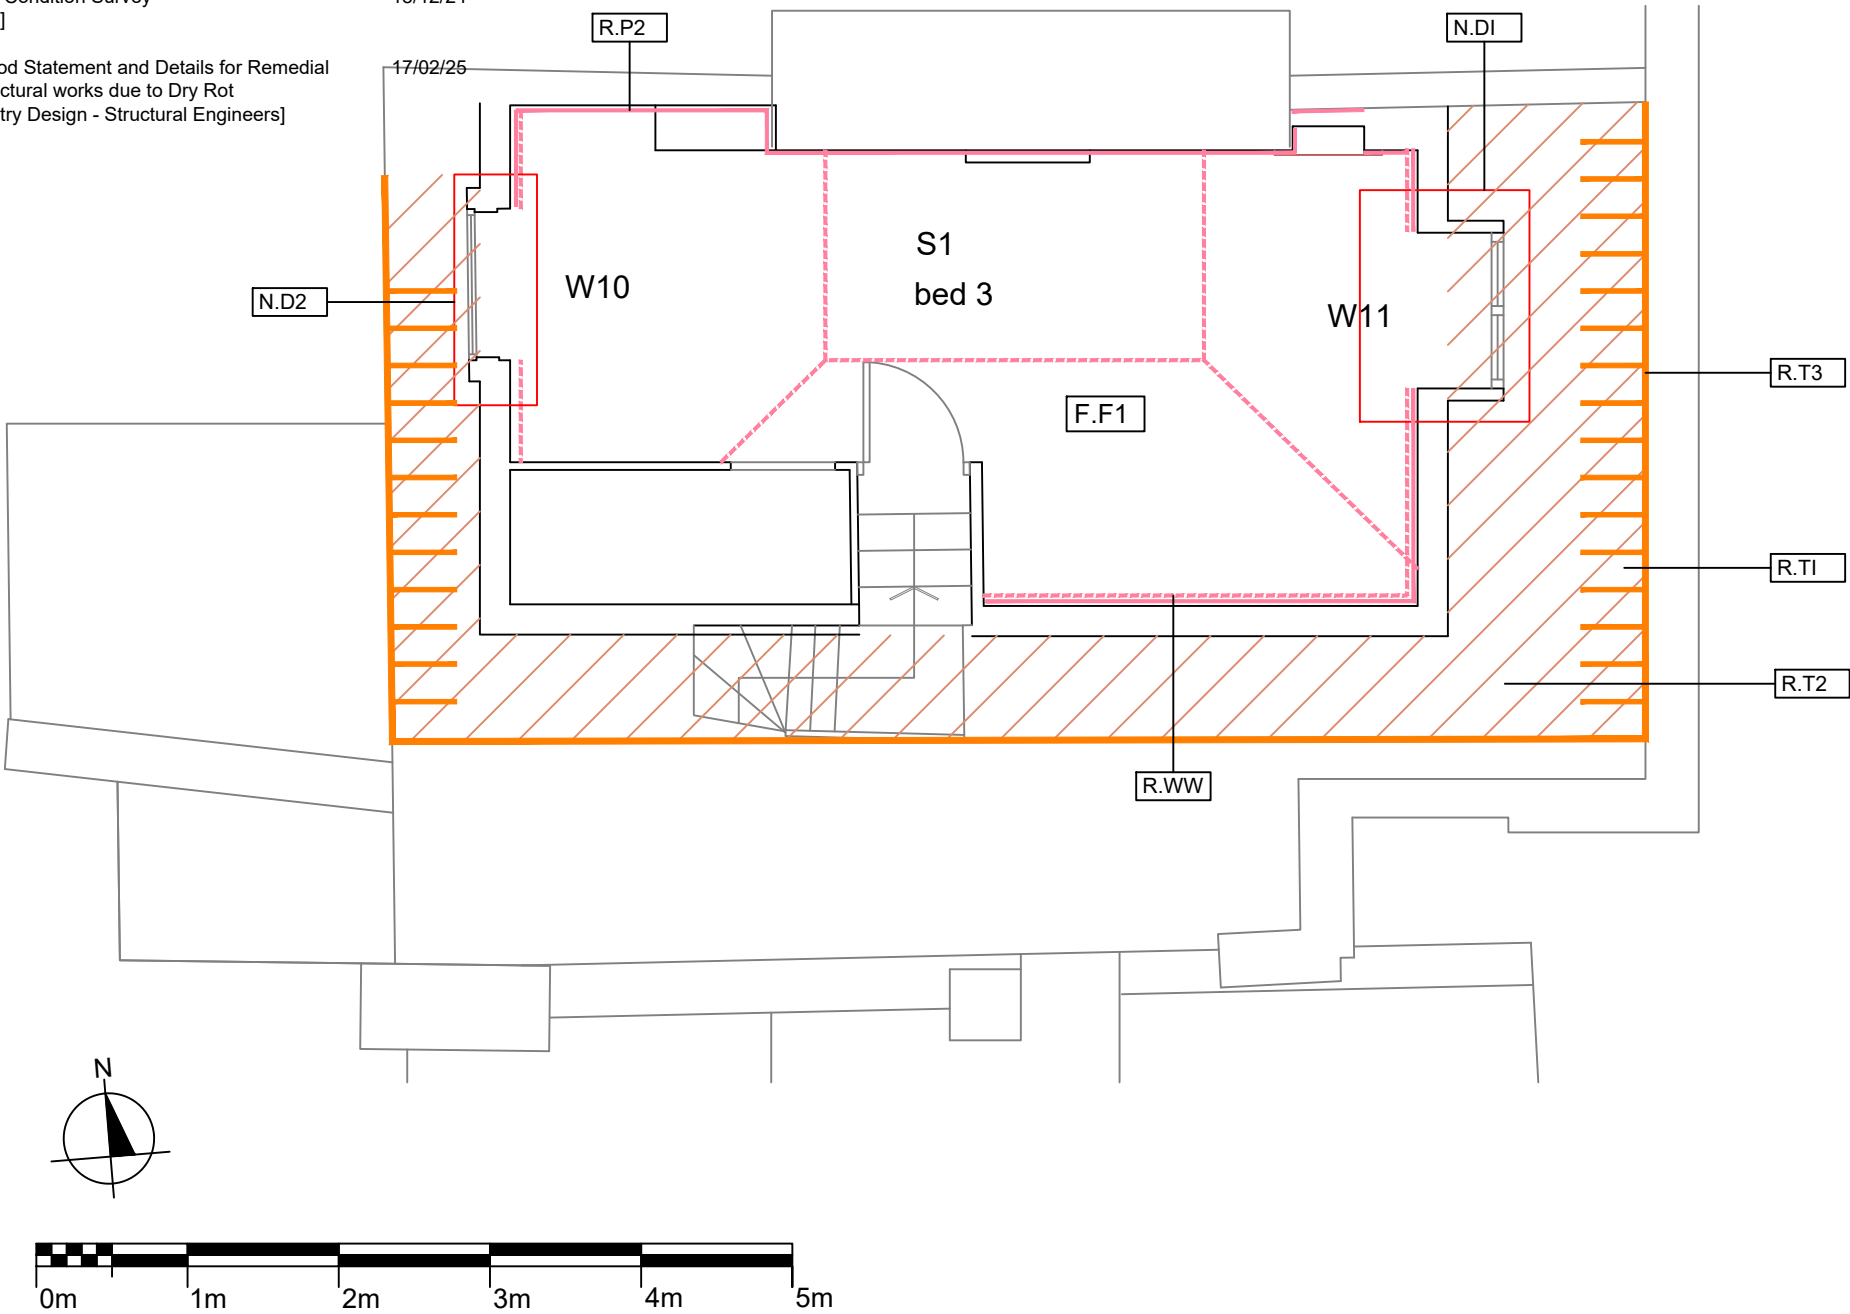
- R.T1** Provide temporary support for the joists as existing affected by dry rot, cut back 200-300 mm to bearing ends, install ss joist hangers to receive 'partnered joists' [R.T2]
- R.T2** Providing temporary support partner cut back joists [R.T1] partner joists in in like species and section size alongside historic member bolted together with M10 bolts at 300mm centres. Partnered joist ends to be supported on ss joist hangers and wrapped in dpm
- R.T3** Most of the wall plates as existing are decayed by dry rot. Provide temporary support of the joists where the wall plate is to be removed. Brick-up in matching bricks in lime mortar

- N.DI/D2** Existing dormers total decay. New construction formed from existing rafters comprising 100x50mm struts and joists marine ply to external face, woodwool board finish, insulation. New windows to replace decayed windows W10 [casement to match no 39 NR] and W11 [casement to match no 43NR] See drawing ref:Window Schedule dwg 17

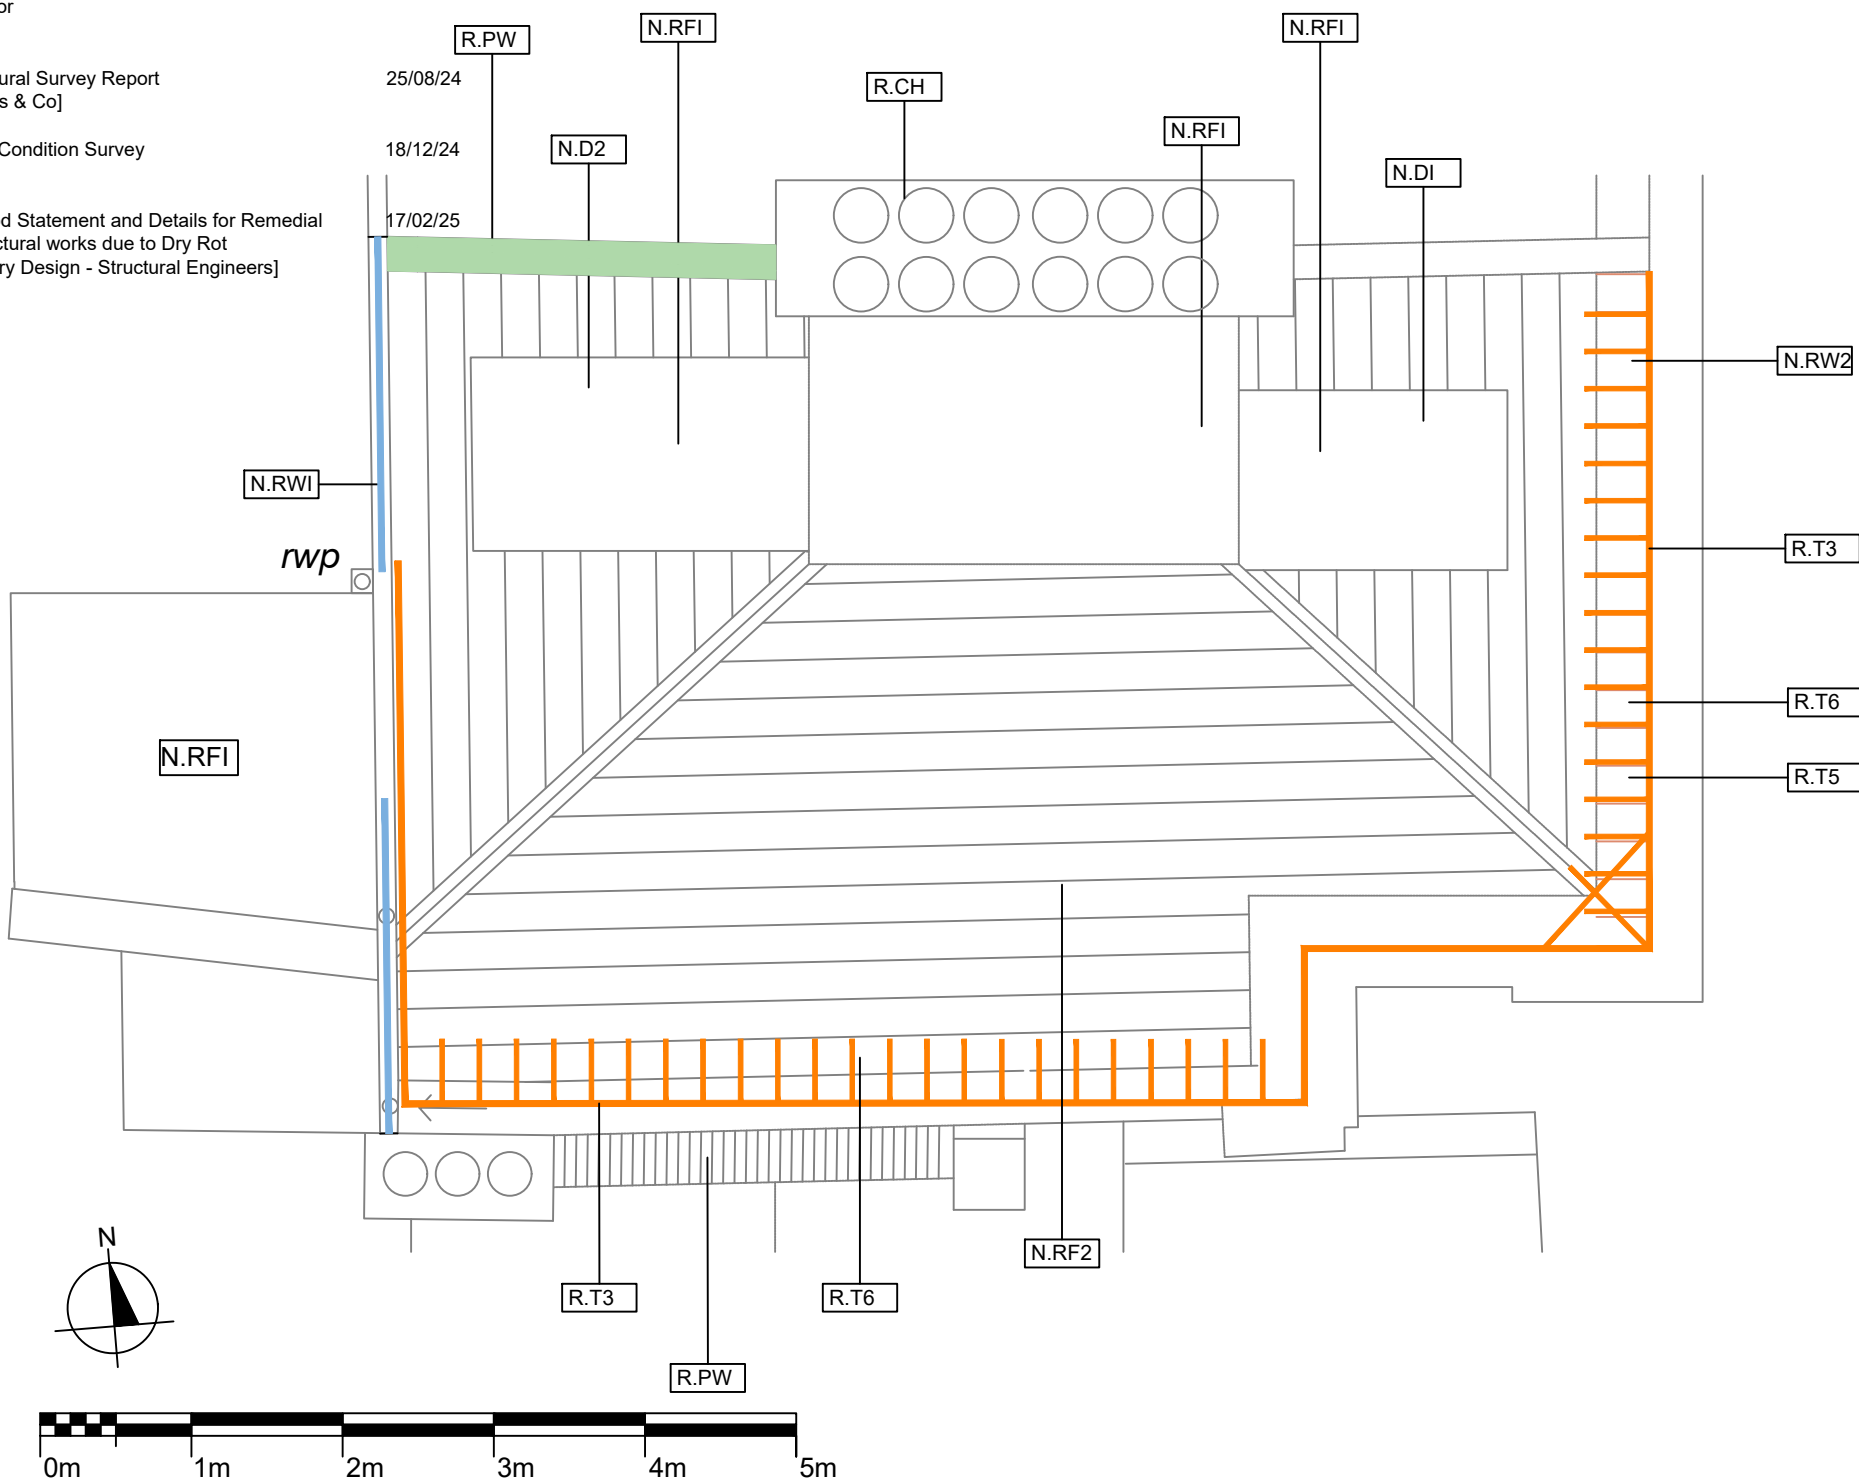
**R.T5** Providing temporary support partner cut back rafters [R.T1] partner joists in in like species and section size alongside historic member bolted together with M10 bolts at 300mm centres.  
Partnered rafters to be supported on wall plate and wrapped in dpm  
**See structural engineer's drawings 2505/01-03**

**R.T3** Most of the wall plates are decayed by dry rot.  
Provide temporary support of the rafters where the wall plate is to be removed.  
Brick-up in matching bricks in lime mortar

**R.T6** Carefully remove all decayed [total] rafter ends. Brick-up in matching brickwork, using prompt mortar, install new partnered rafters in matching species and section @ 400mm crs ends wrapped in dpm and supported on ss joist hangers [13no east, 15no south]  
**See structural engineer's drawings 2505/01-03**

**R.PW** Repair parapet wallhead using existing bricks and new brickwork to match with NHL 5 lime mortar. New lead flashing to gutter. HL5 render

**R.CH** All pots lifted and re-laid into a replacement flaunching of NHL 5 lime mortar. Rake out chimney and re-point all brickwork. Spalled brick cut out and replaced with matching imperial-size bricks. Replace front historic front pot [cracked]

**N.RFI** Remove existing felt roofing and rotted boarding. Replace 18mm with marine ply on existing joists dress in lead code 5

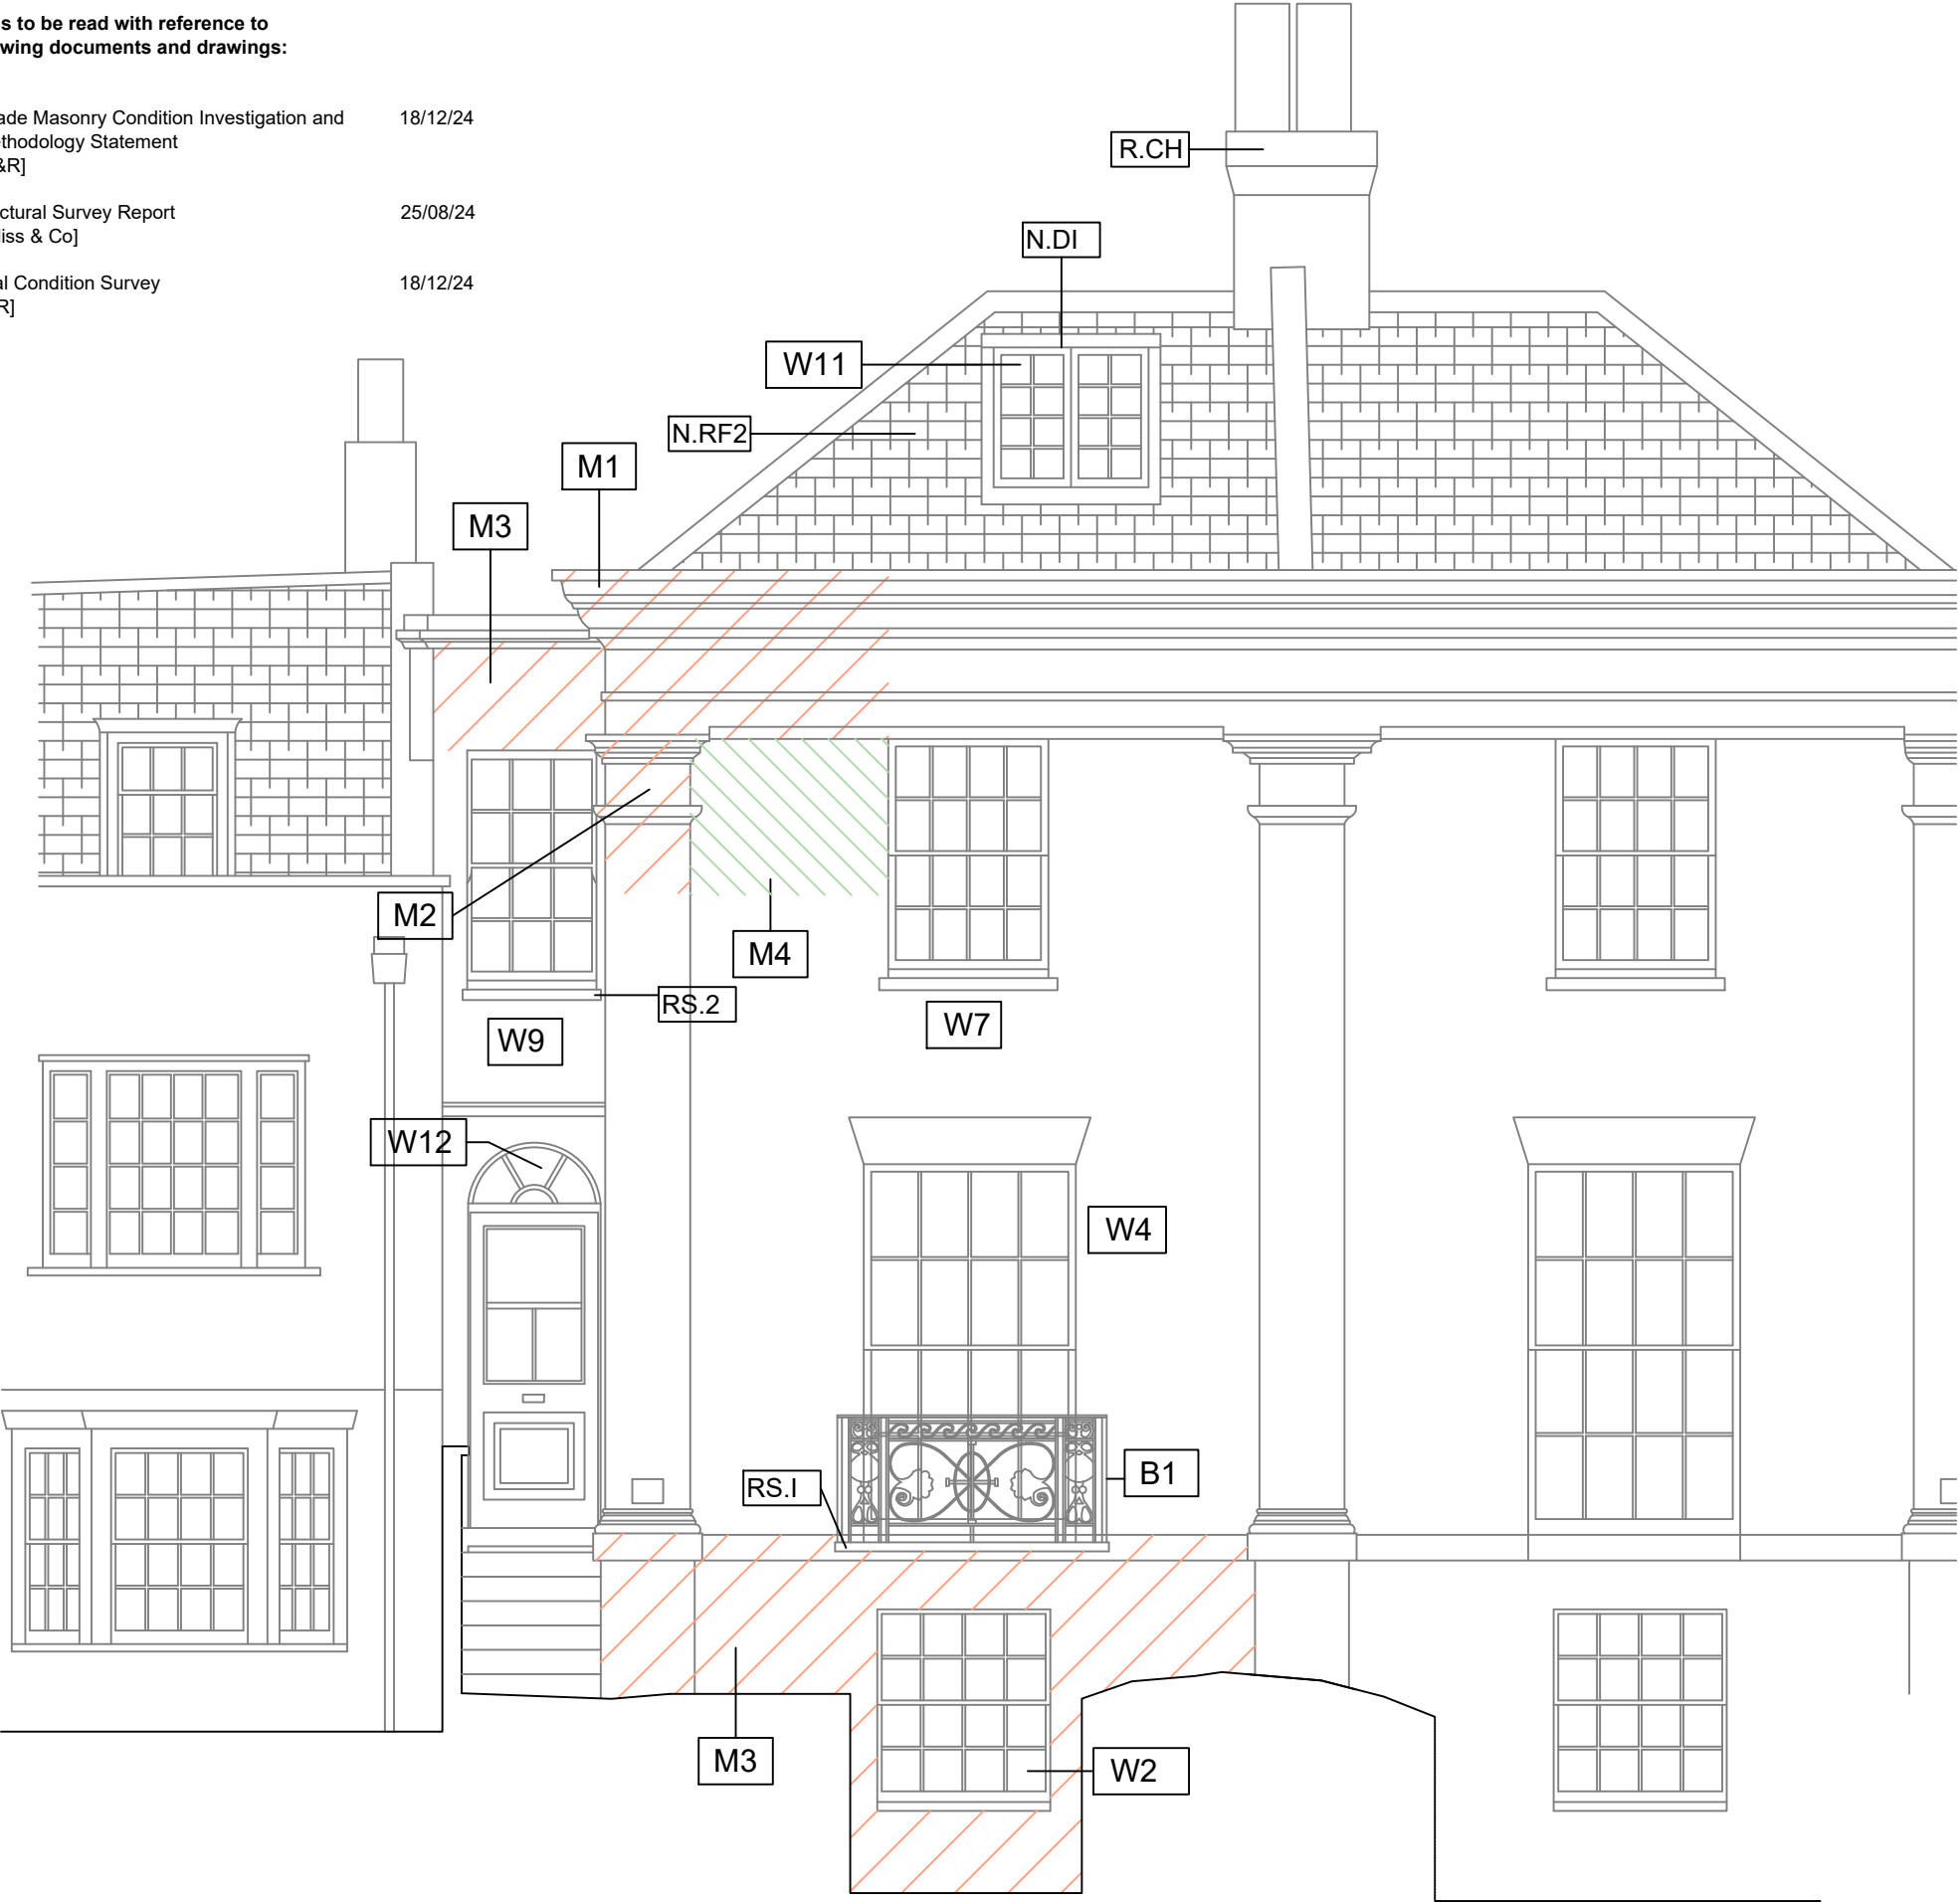
**M2** **Anthemion**  
Completely decayed. Clear loose render to establish secure base. Replace like-for-like in reconstituted stone to match neighbour [no 39NR] see PKS detail 15

**M3** **Render**  
Remove failed render and prepare for 3-coat Prompt Mortar

**M4** **Spalled Brickwork**  
Repair faces in lime render [Specialist Contractor]

**R.CH** All pots lifted and re-laid into a replacement faunching of NHL 5 lime mortar. Rake out chimney and re-point all brickwork. Spalled brick cut out and replaced with matching imperial-size bricks. Replace front historic front pot [cracked]

**N.DI** Existing dormers completely decayed. New construction formed from existing rafters comprising 100x50mm struts and joists marine ply to external face, woodwool board finish, insulation. New windows to replace decayed windows W10 [casement to match no 39 NR] and W11 [casement to match no 43NR] See drawing ref:

**B1** **Balconette**  
Cast Iron balustrade badly corroded & damaged to be restored by specialist company  
Stone cill patch repaired in re-con stone to match existing

**RS.I** Damaged balcony restored using pieced-in re-con stone in co-ordination with restored cast iron balustrade

**RS.2** Failed cill to be replaced in stone like-for-like
