# Arboricultural Consultancy for Aviva

| Insured | Miss Nava Orstein | Address | 112 Mount View Road, London, N4 4JX | | |
| Client | Subsidence Management Services | Contact | Cyril Nazareth | Claim No. | IFS-AVI-SUB-20-0089882 |
| Report Date | 16/06/2021 | | | | |

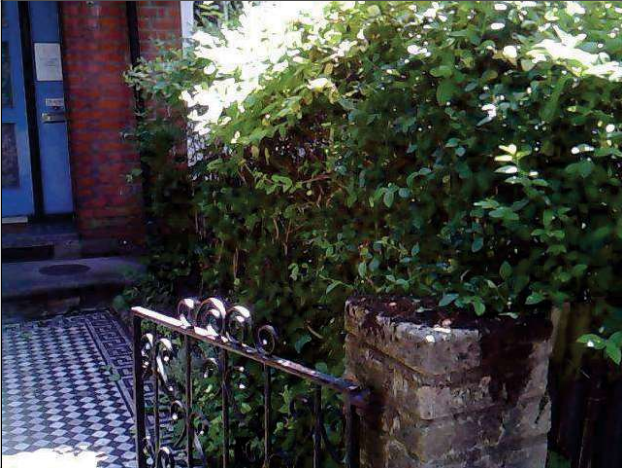
H1 - Mixed species hedge

| Tree No. | Species | Age Cat | Approx. Height (m) | Distance to Building (m) * | Ownership | Action | Requirement |
|---|---|---|---|---|---|---|---|
| H1 | Mixed species hedge | 1 | 2 | 1.3 | C - Insured | Action to avoid future risk | Maintain at broadly current dimensions by way of regular pruning. Hedge comprises Honeysuckle, Ivy and Privet |

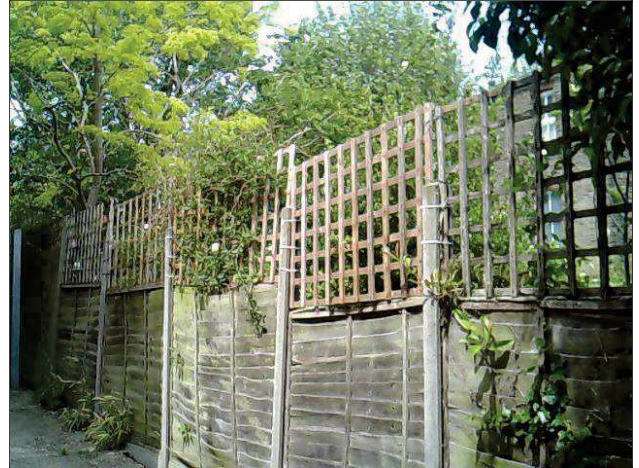
SG2 - Mixed species shrubs

| Tree No. | Species | Age Cat | Approx. Height (m) | Distance to Building (m) * | Ownership | Action | Requirement |
|---|---|---|---|---|---|---|---|
| SG2 | Mixed species shrubs | 1 | 3 | 3.5 | A - Third Party | No action | No works. Including Rose, Pyracantha, Holly and Jasmine |

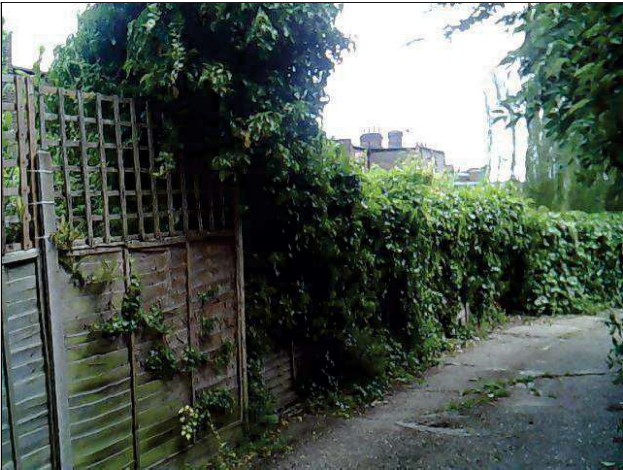
C1 - Ivy

| Tree No. | Species | Age Cat | Approx. Height (m) | Distance to Building (m) * | Ownership | Action | Requirement |
|---|---|---|---|---|---|---|---|
| C1 | Ivy | 1 | 3.5 | 5.3 | E - Boundary Veg (ownership to be confirmed) | No action | No works. |
