# Pre-Works Condition Survey

## NGET Tottenham REM

| <b>Project Reference</b> | R13089 |

Erith have undertaken a *Post-Works Condition Survey* following the completion of the site works. The survey was undertaken to establish the conditions of walls, fences, roads and structures on and surrounding the site to confirm they have not deteriorated because of the works. The survey consists of photographic records.

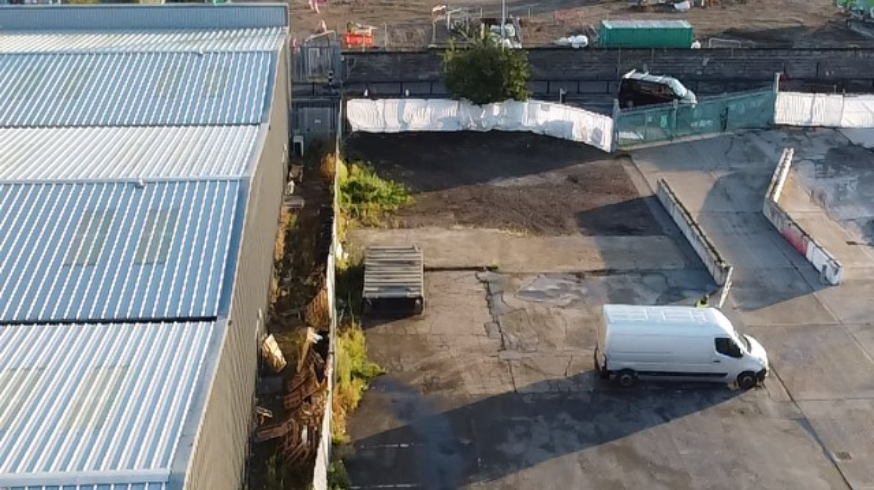
| No. | Photograph | Description |
|---|---|---|
| 1. | | <p>Facing North.<br/>View towards the site entrance gate.</p> <p>Mitie security guards work van.</p> |

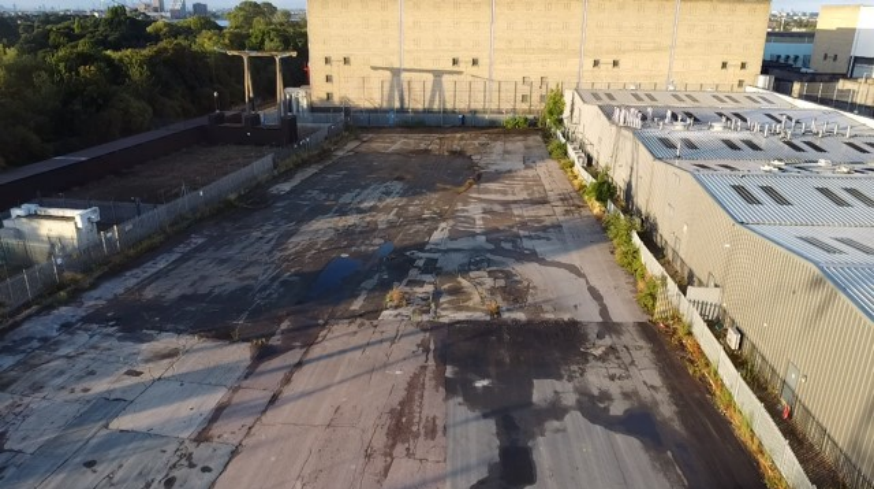
| No. | Photograph | Description |
|---|---|---|
| 2. | | <p>Facing South.<br/>Rear of site, all fly tipped materials cleared.</p> |

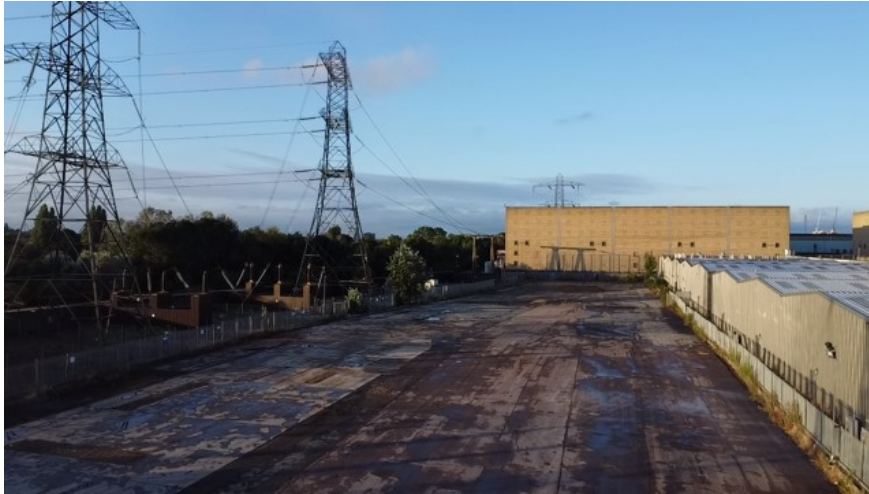
3.

Facing South.  
Wide angle shot of the rear of site.

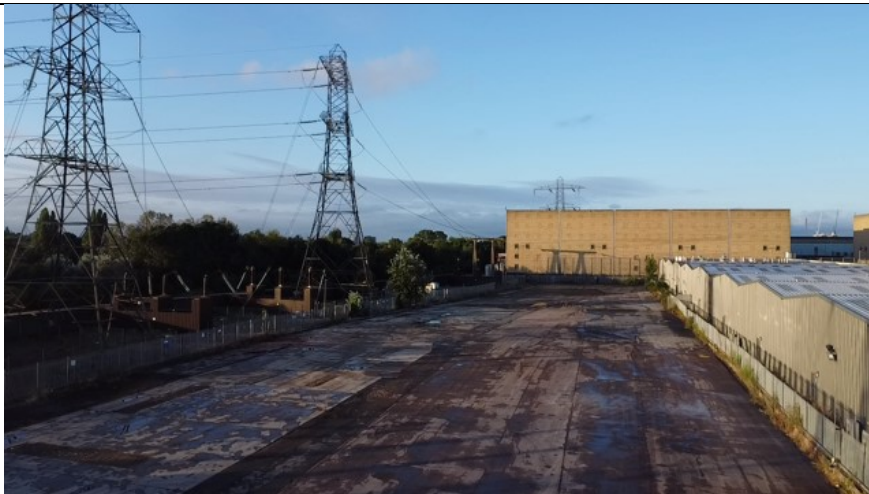
4.

Facing South.  
Wide angle shot of the rear of site.

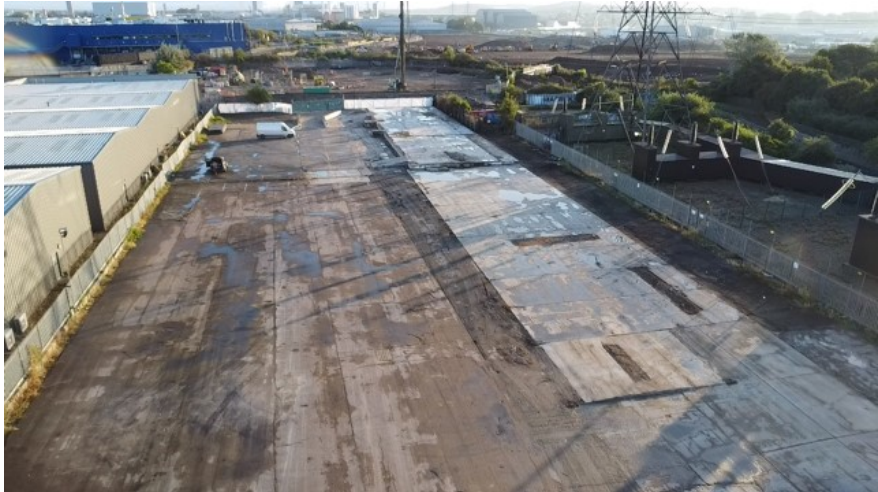
| 5. | | <p>Facing North.<br/>Site Managers and Mitie security guards' vehicles visible in this photograph.</p> <p>Former building slab on the right-hand side of the image with infilled inspection and trial pits visible (dark grey rectangles).</p> |

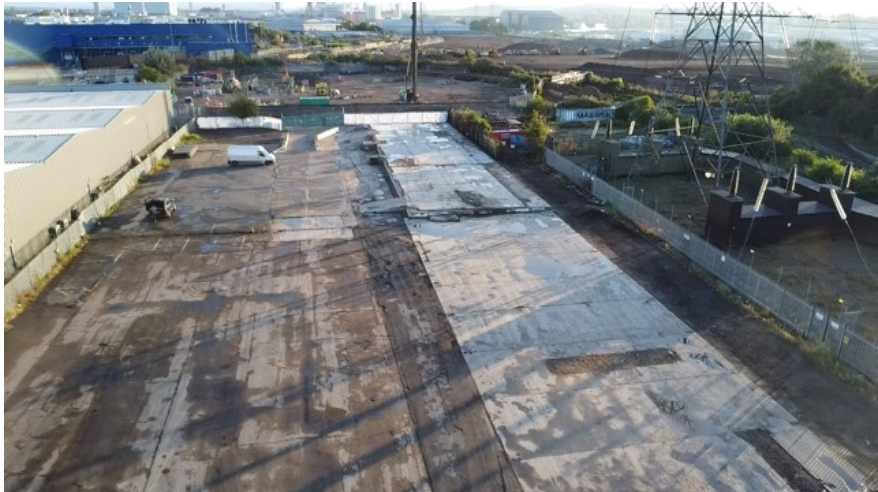
| 6. | | <p>Facing North.<br/>Site Managers and Mitie security guards' vehicles visible in this photograph.</p> <p>Former building slab on the right-hand side of the image with infilled inspection and trial pits visible (dark grey rectangles).</p> |

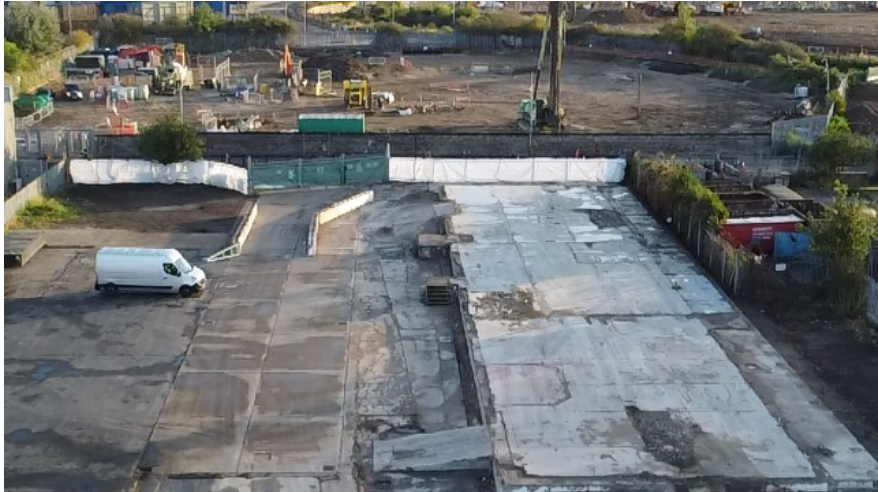
| 7. | | <p>Facing North.<br/>Mitie security guards' vehicles visible in this photograph.</p> <p>Former building slab on the right-hand side of the image with trial pits visible (dark grey rectangles).</p> |

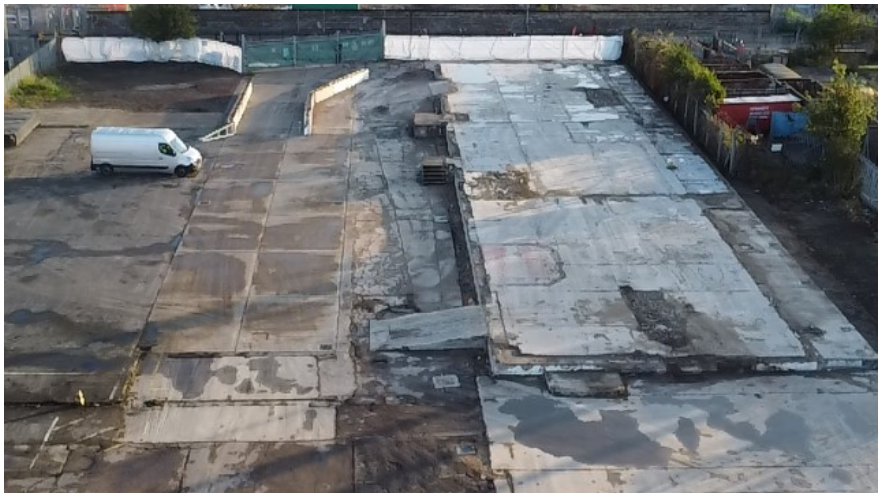
| 8. | | <p>Facing North.<br/>Site Managers and Mitie security guards' vehicles visible in this photograph.</p> <p>Former building slab on the right-hand side of the image with trial pits visible (dark grey rectangles).</p> |

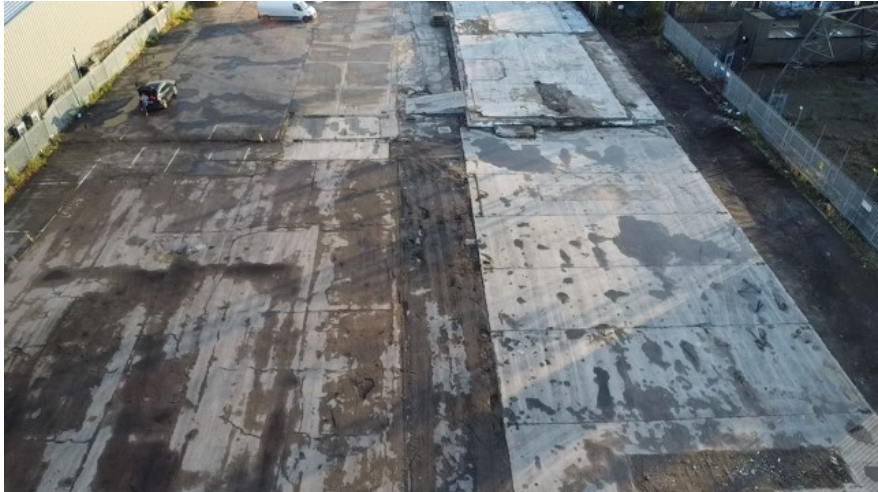
| 9. | | <p>Facing North</p> <p>Area just in front of the black car previously had a fence line on it, from East to West. This has been removed from site.</p> |

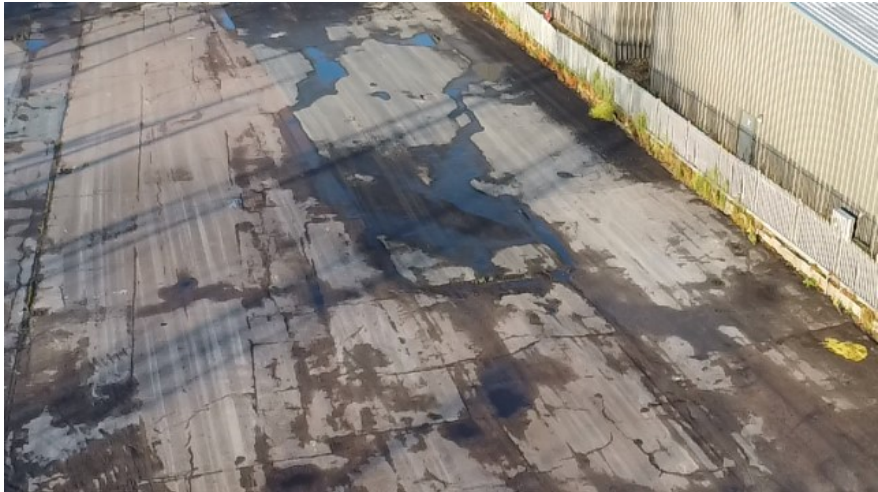
| 10. | | <p>Facing South.</p> <p>Rear of the site, behind the former building.</p> |

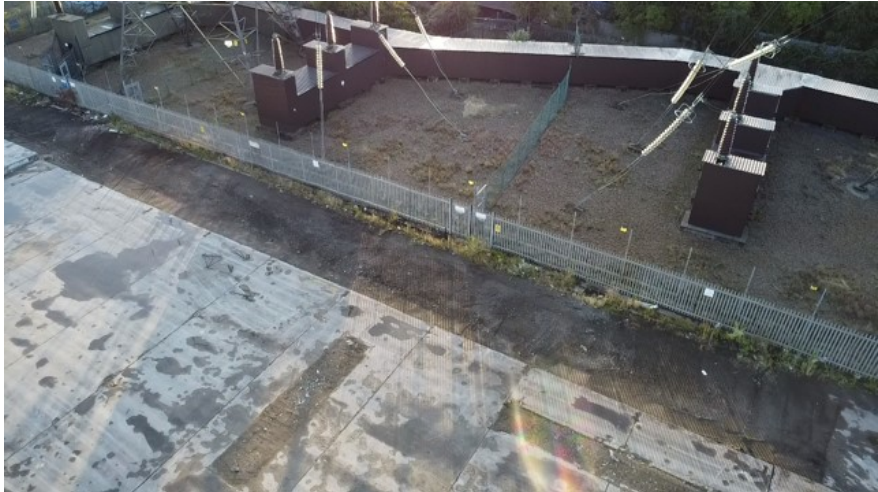
| 11. | | <p>Facing East.</p> <p>Looking into the substation and at the pathway that runs between it and the former building.</p> |

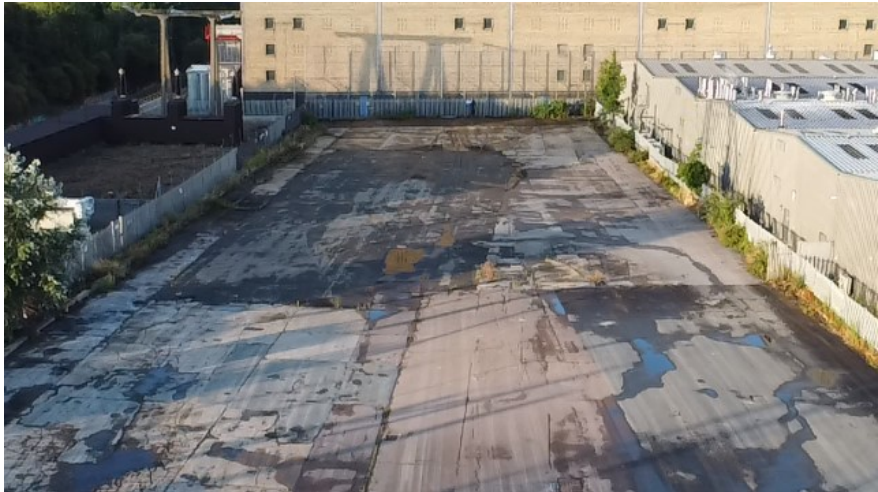
| 12. | | <p>Facing South.</p> <p>View of the rear end of the site.</p> |

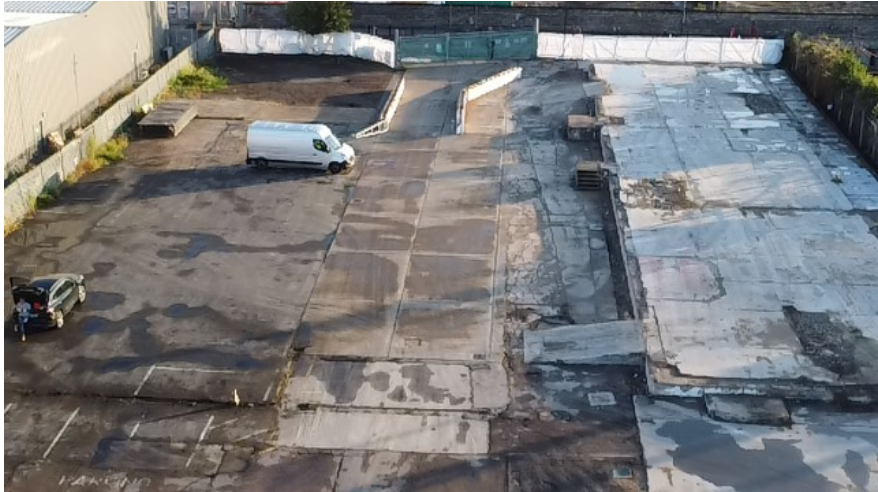
| 13. | | <p>Facing North.<br/>Site Managers and Mitie security guards' vehicles visible in this photograph.</p> <p>Former building slab on the right-hand side of the image with trial pits visible (dark grey rectangles).</p> |

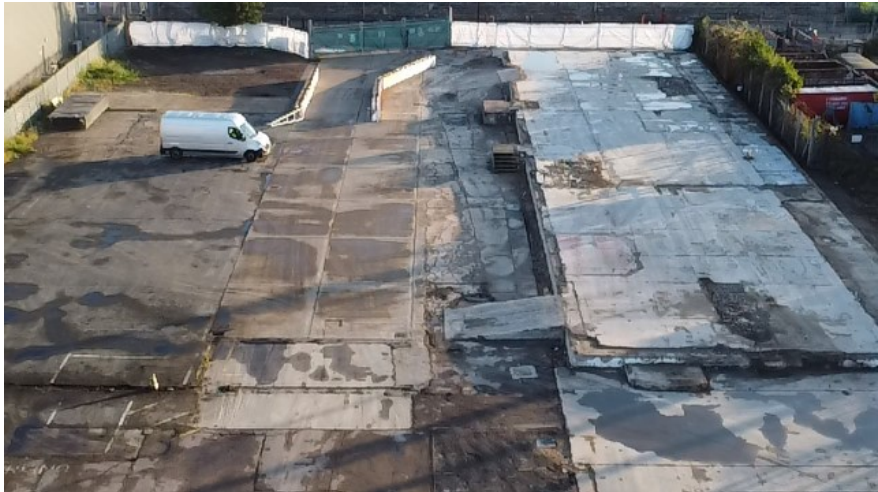
| 14. | | <p>Facing North.<br/>Mitie security guards' vehicles visible in this photograph.</p> <p>Former building slab on the right-hand side of the image with trial pits visible (dark grey rectangles).</p> |

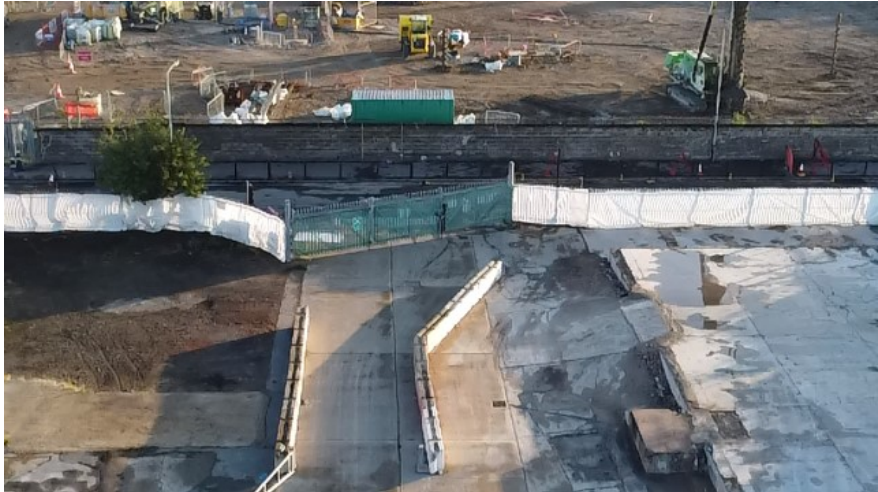
| 15. | | <p>Facing North.</p> <p>View of the entranceway into the site.</p> |

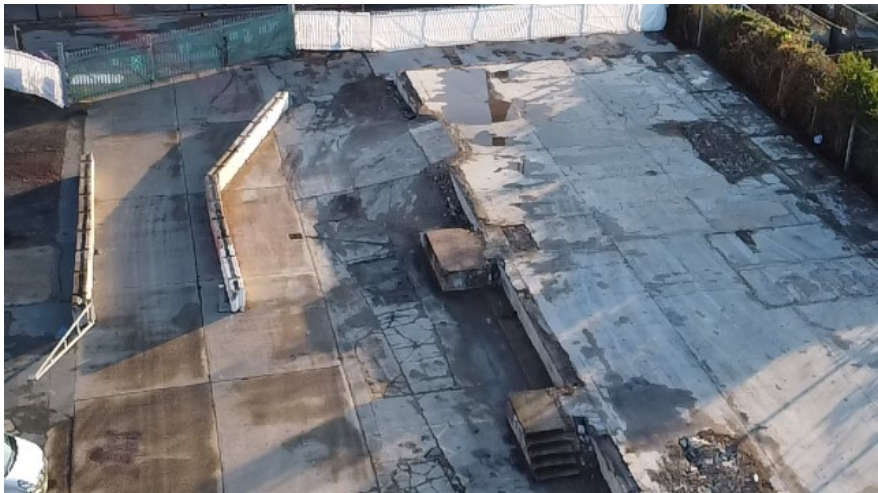
| 16. | | <p>Facing North.</p> <p>View of the northern end of the building slab.</p> |

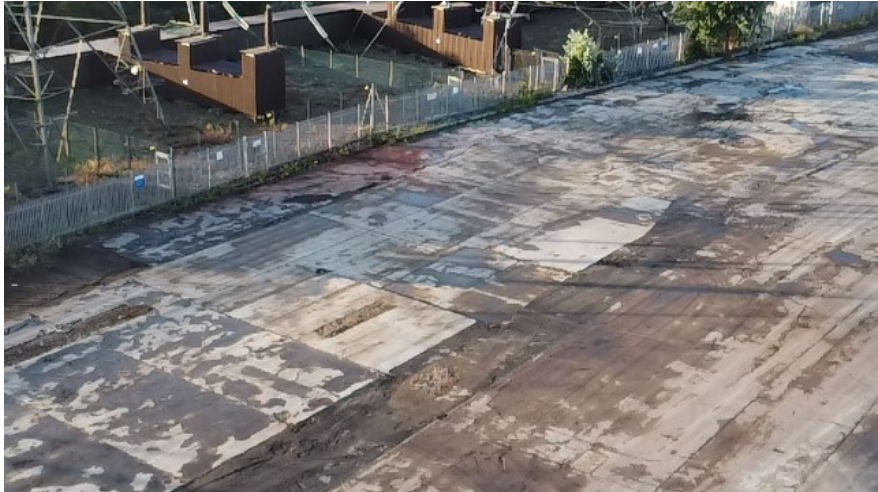
| 17. | | <p>Facing South-East</p> <p>View of the former building slab and substation.</p> |

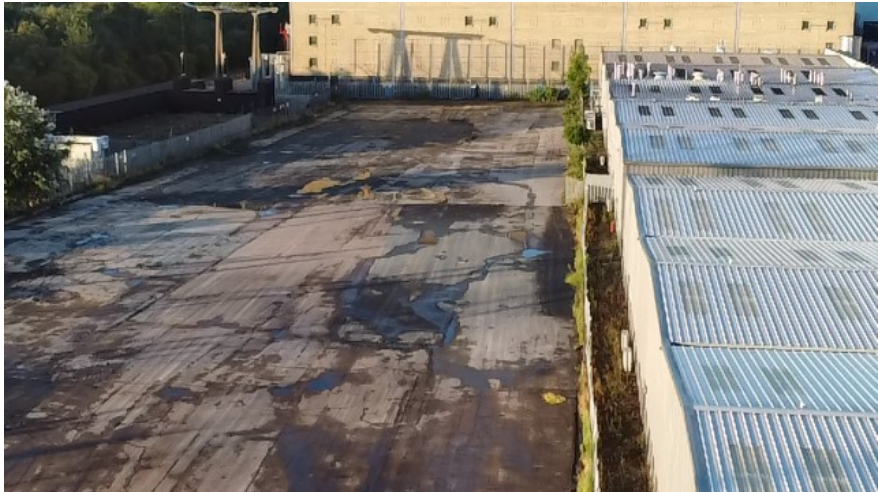
| 18. | | <p>Facing South.</p> <p>View of the rear end of site.</p> |

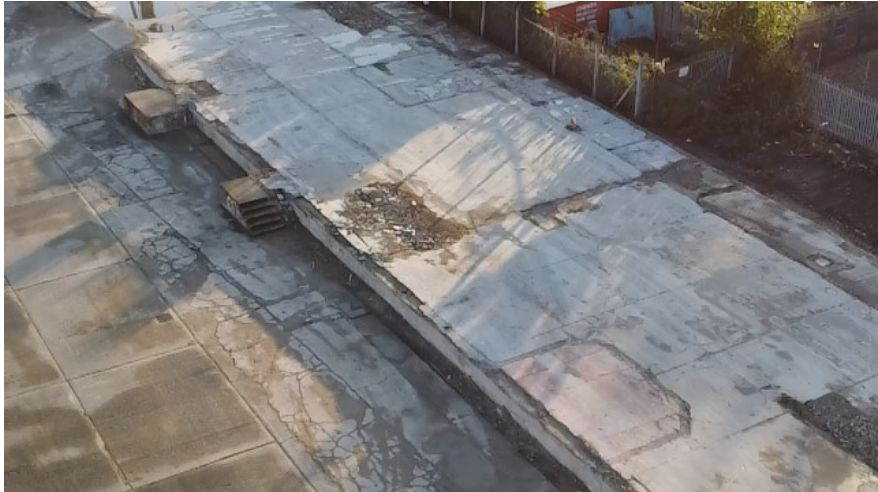
| 19. | | <p>Facing North-East</p> <p>View of the former building slab.</p> |

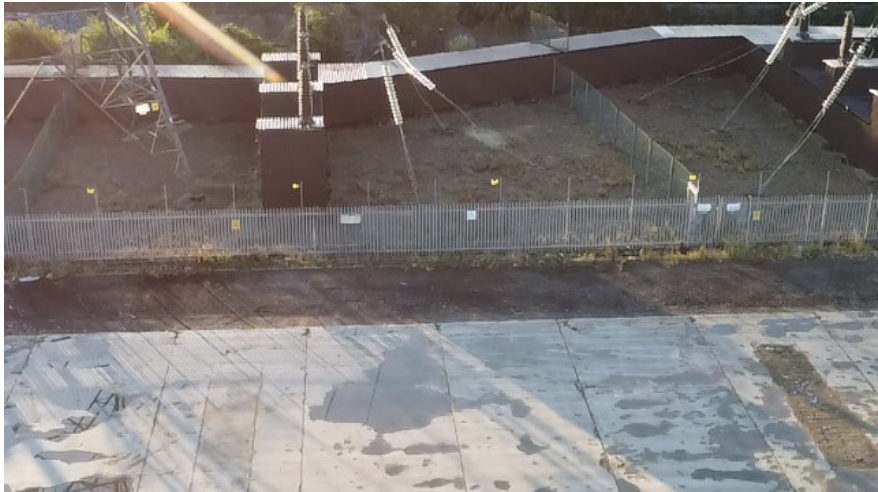
| 20. | | <p>Facing East</p> <p>View of the pathway between the building slab and the substation.</p> |

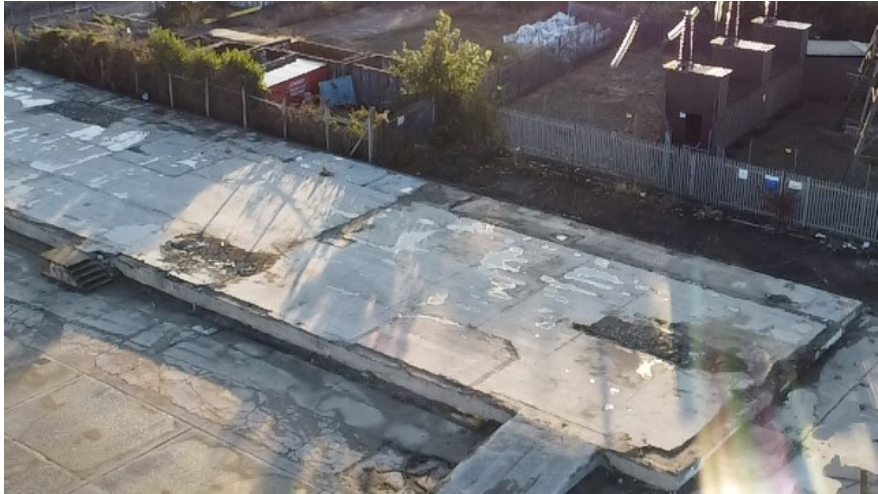
| 21. | | <p>Facing North East</p> <p>View of the edge of the building slab.</p> |

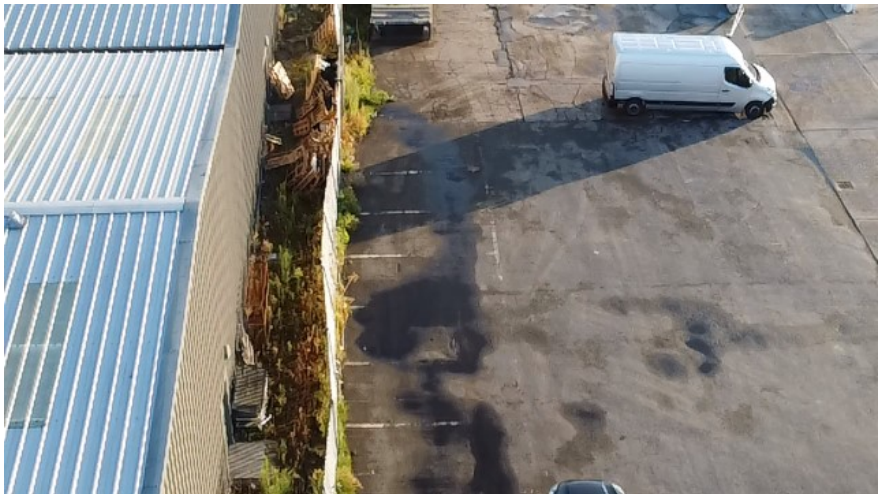
| 22. | | <p>Facing North.</p> <p>View of the West boundary edge where the site cabins previously sat.<br/>Mitie security van and Site Managers car are visible in the image.</p> |
