# Application for Removal or Variation of a Condition following Grant of Planning Permission

### Heritage assessment and supporting information for the locally listed boundary wall between Nos. 84 & 86 and along back of pavement — former boundary wall to Southwood House.

Planning Application Reference: HGY/2025/2929

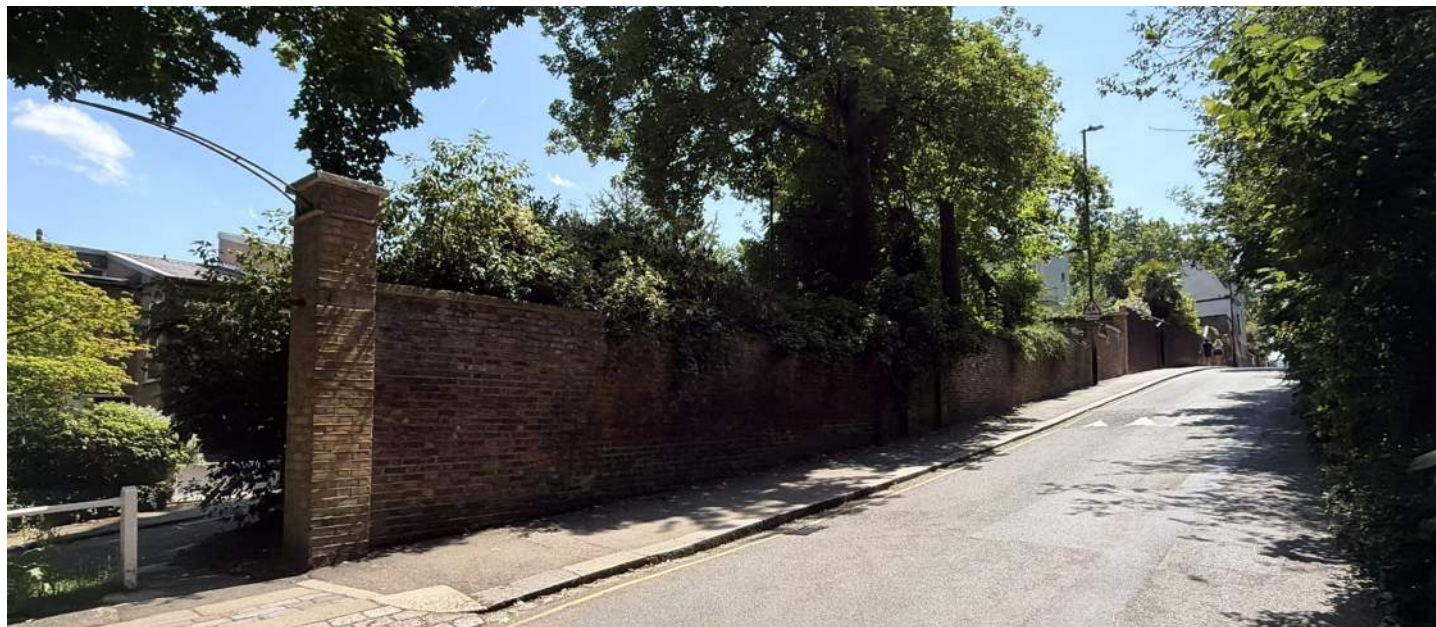
*Photograph A - Showing rebuilt original entrance pillar to Southwood House in a predominantly yellow stock brick which is in contrast to the mixed red stock bricks from the wall adjacent. The entire wall can be seen sloping upwards along Southwood Lane.*

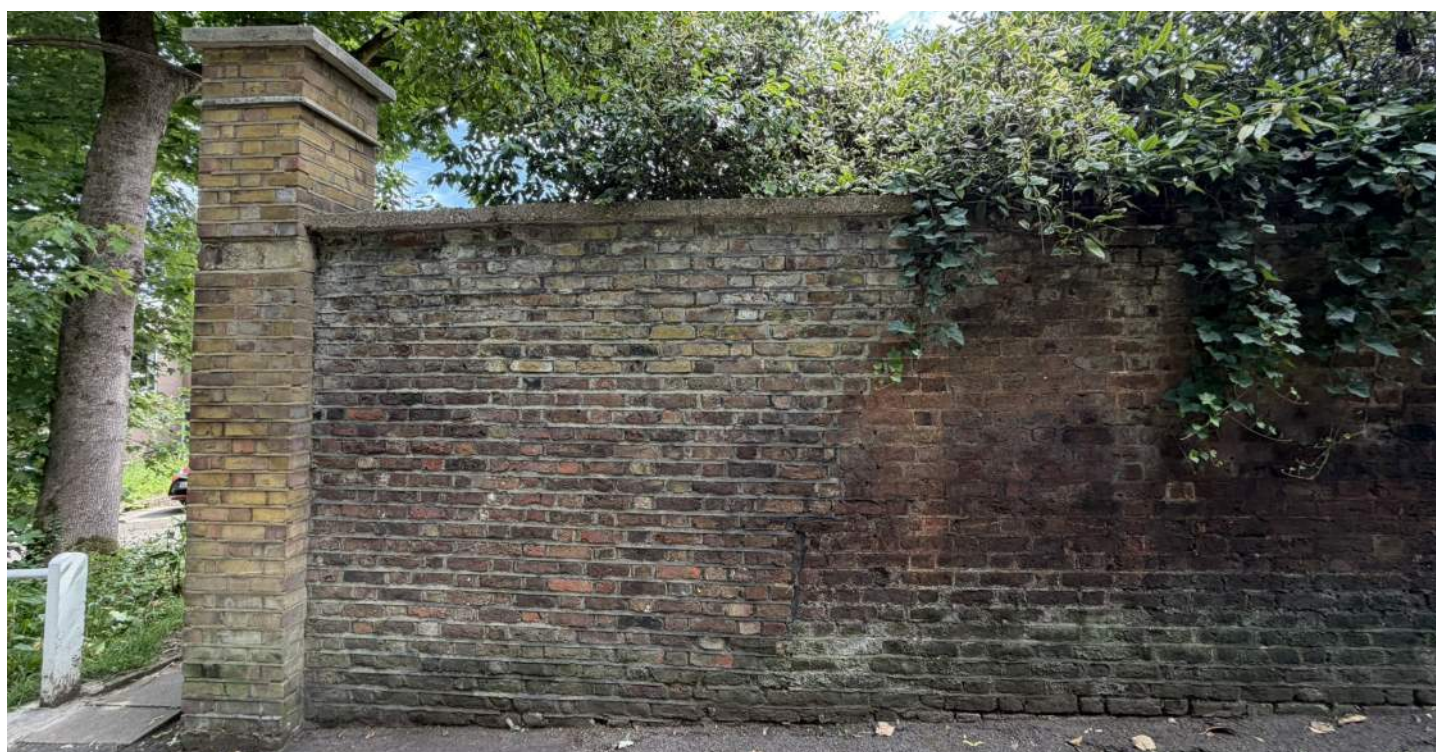
*Photograph B - Showing the Boundary wall next to the pillar having a uniform brick appearance with a solid grey coping stone on the top of the wall. There is no grey/blue plinth stone within the wall or at its base.*

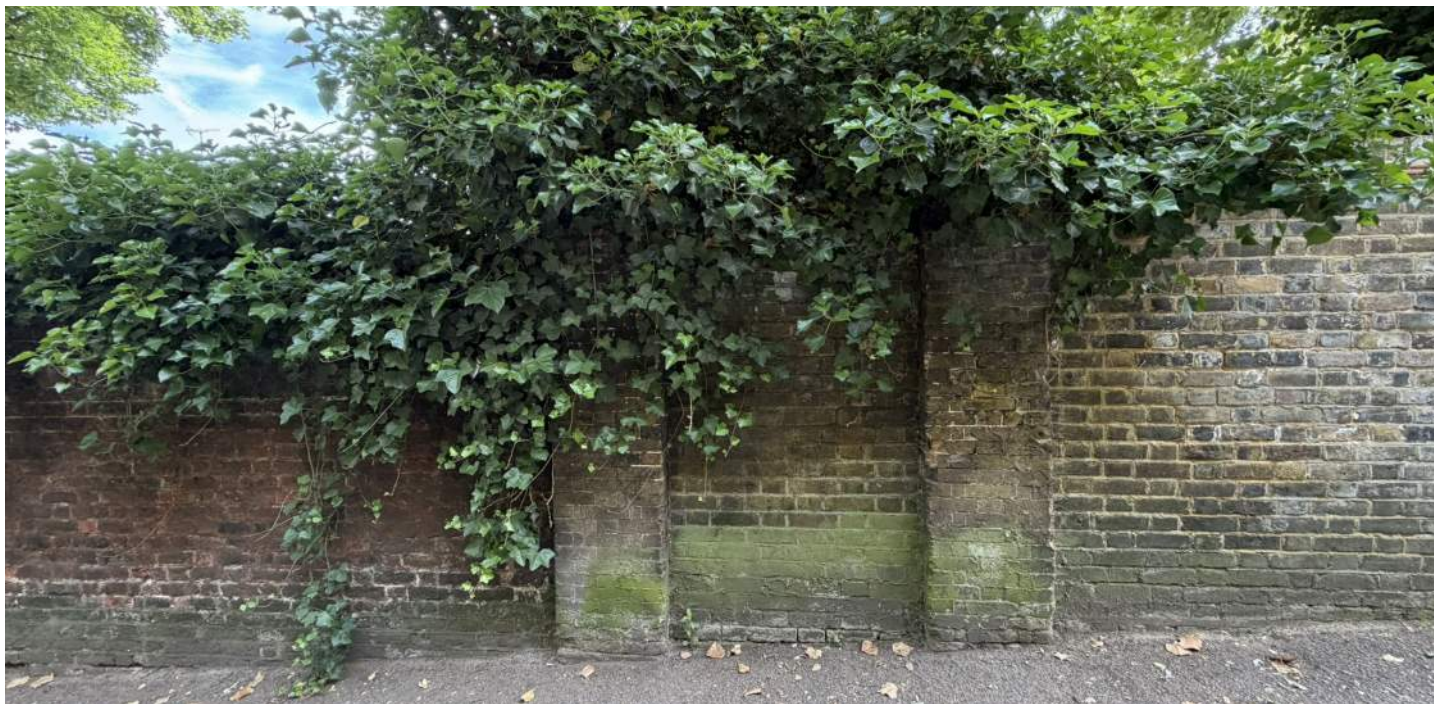
*Photograph C - Showing detailing of two pillars within the wall and extensive planted overgrowth. There is no grey/blue plinth stone within the wall at this location or at its base.*

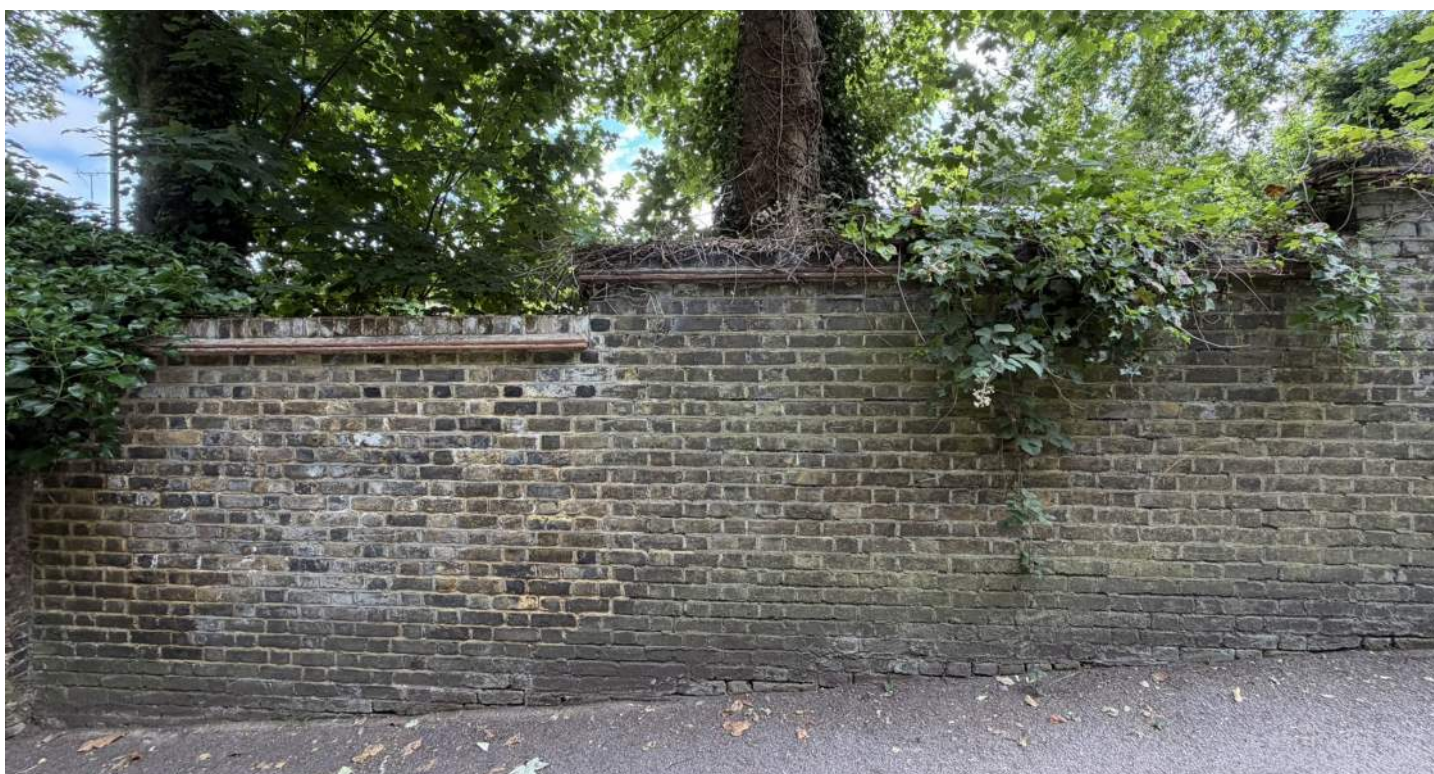
*Photograph D - Showing steps in the boundary wall with a rotated header course at the top and a double tiled detailing and a simple predominantly yellow stock brick formation below. There is no grey/blue plinth stone within the wall at this location.*

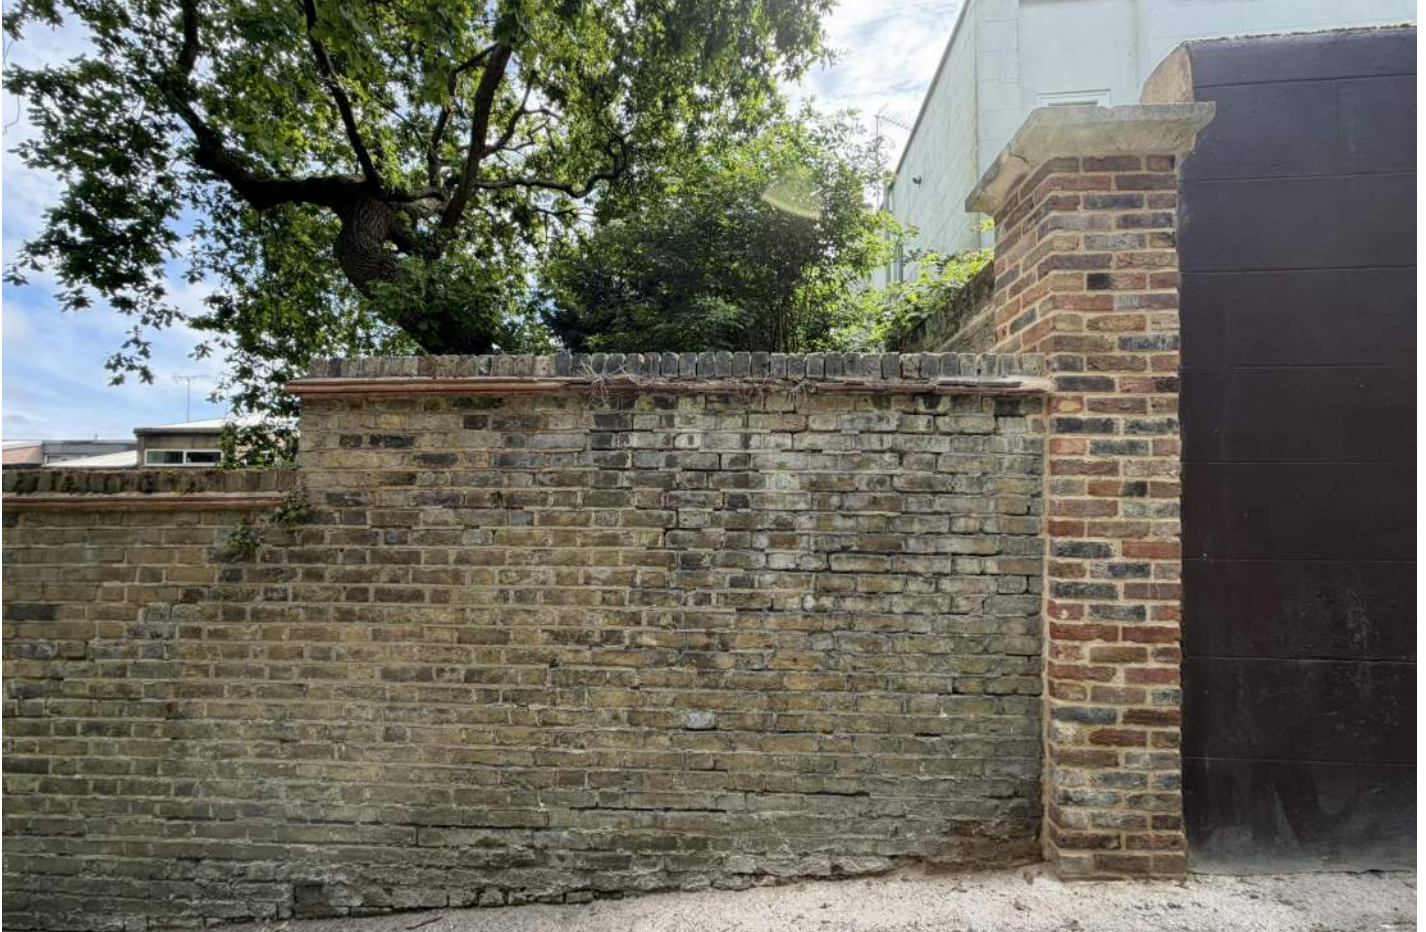
*Photograph E - Showing steps in the boundary wall with a rotated header course at the top and a double tiled detailing and a simple predominantly yellow stock brick formation below. There is no grey/blue plinth stone within the wall at this location from this side of the wall that is visible. Adjacent to the wall is a predominantly mixed red stock pier and the black rendered wall of no 84/Highstone House.*

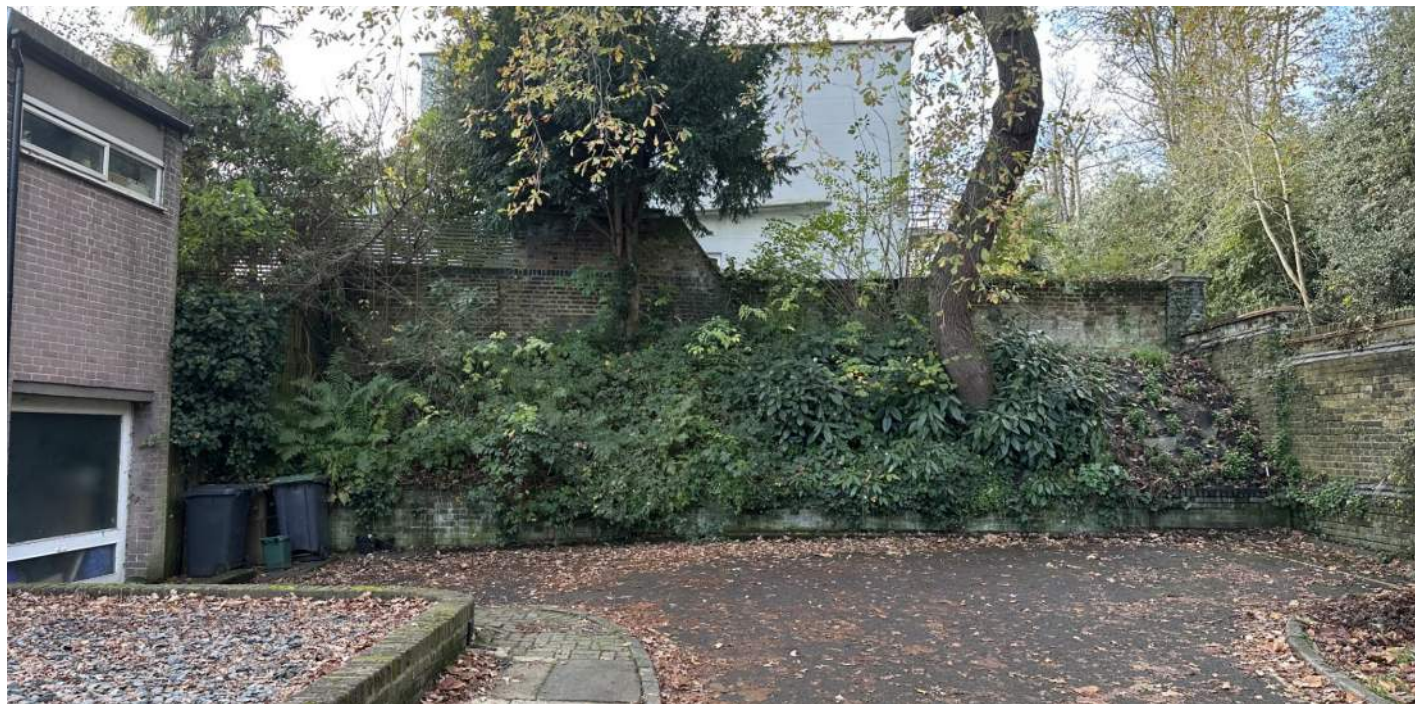
*Photograph F - Showing the boundary wall from the Southwood Estate Cul-de-sac road parallel to Southwood Lane. Further photographs below discuss the condition of this wall in greater detail.*

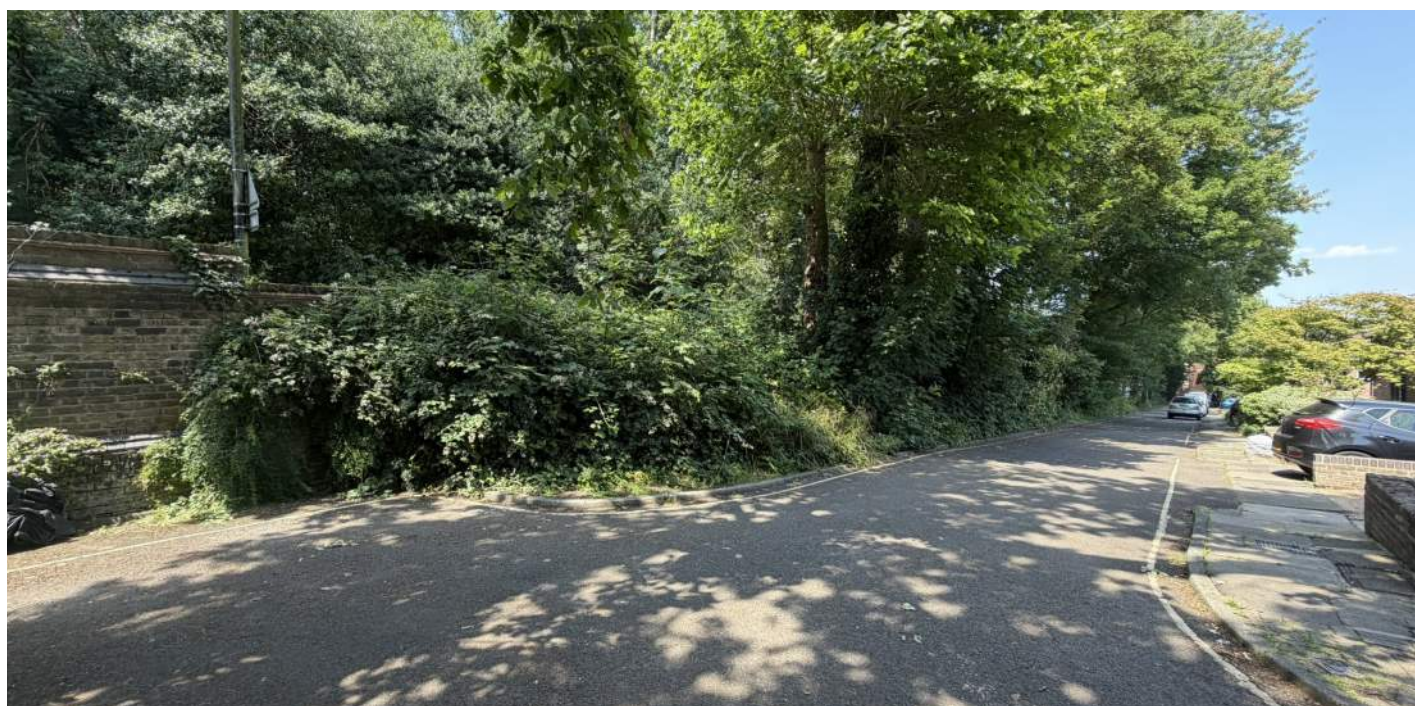
*Photograph G - Looking along the length of the boundary wall towards the North. Dense evergreen planting hides the vast majority of the boundary wall from this side.*

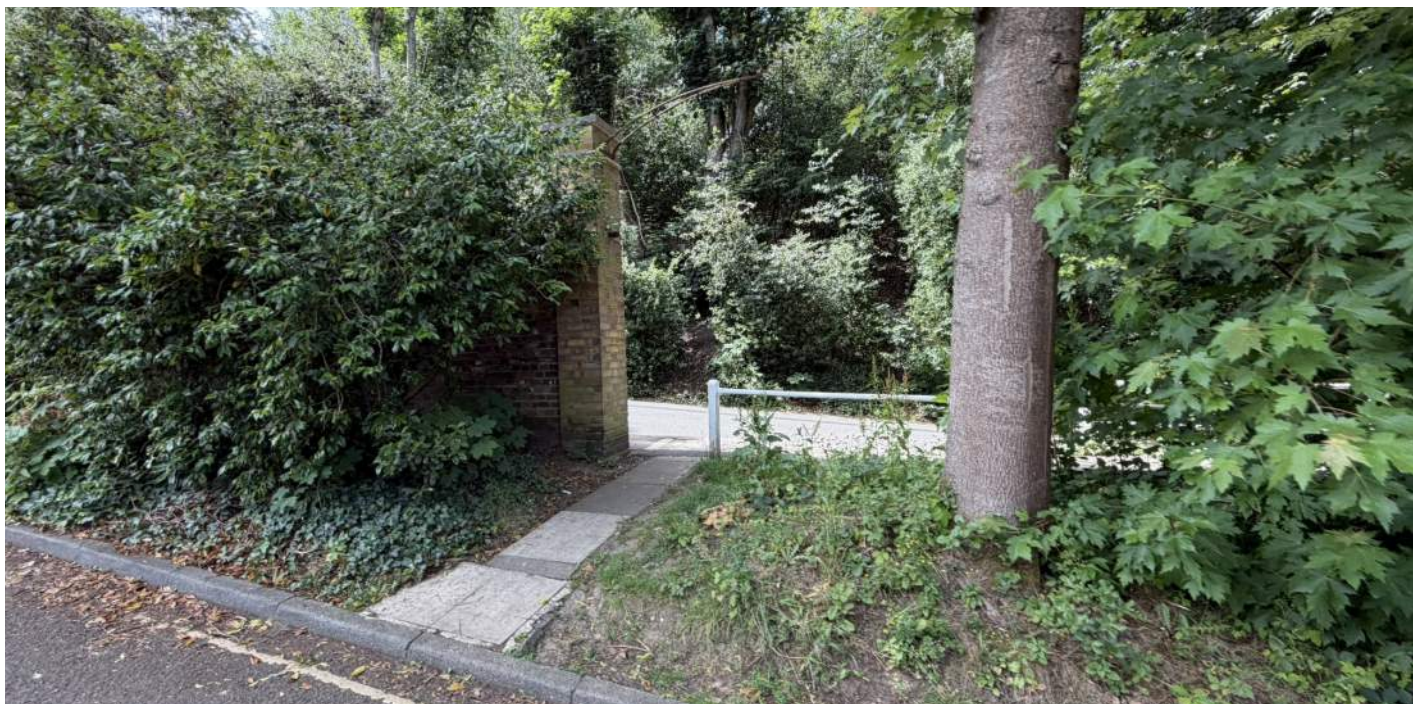
*Photograph H - Showing the end condition of the wall connecting to the public highway (the opposite side of Photograph B). There are no blue/grey plinth stones at this location.*

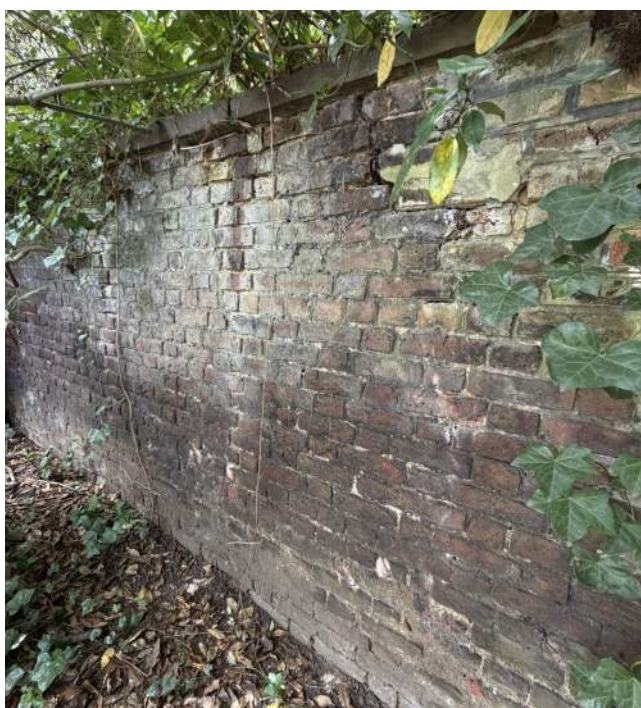
*Photograph J - Looking along the length of the boundary wall as hidden behind the bushes with a solid capping stone at the top and simple wall course below.*

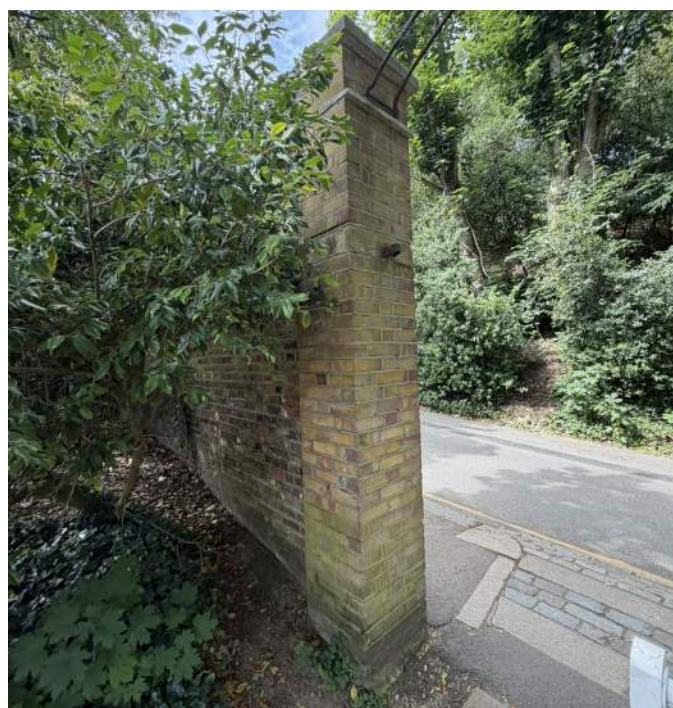
*Photograph K- Detail of rebuilt pillar from the opposite side of photograph B as visible from the public realm. There are no blue/grey plinth stones at this location.*

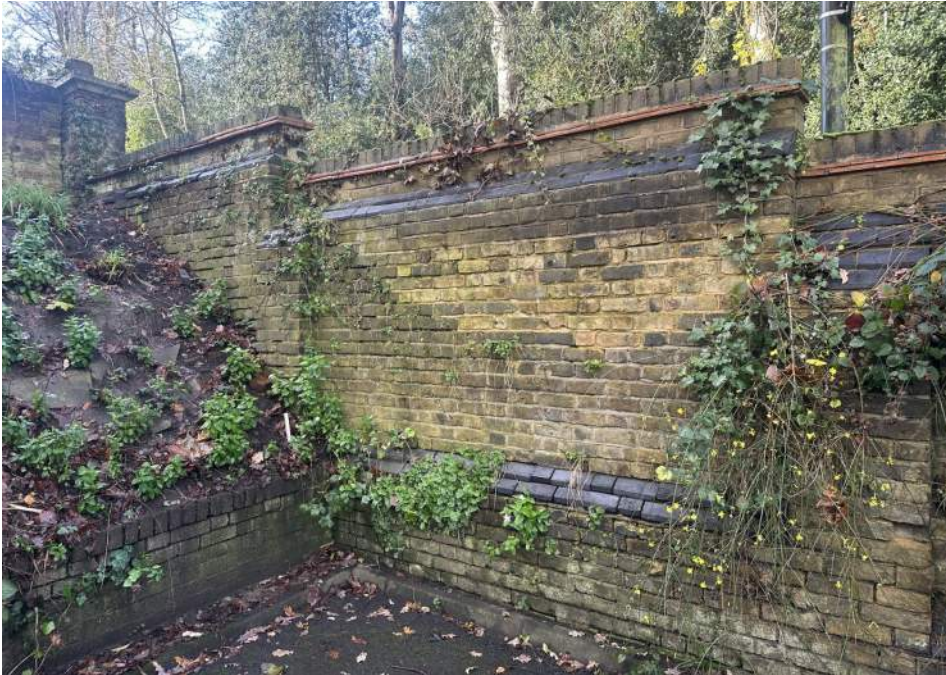
*Photograph L (left) - Detailed photograph of the corner of the wall taken during winter. Grey/Blue double course plinth stones are evident at the top of buttresses and where the brick wall thins from a thicker base to a single brick course at the top. Also evident is a header course and double tile detail. The grey linear element at the base of the wall is the the adjoining cul-de-sac road kerb, set forward of and separate from the wall, which is highway infrastructure and not part of the boundary wall. The base of the wall itself carries no plinth or coping stone.*

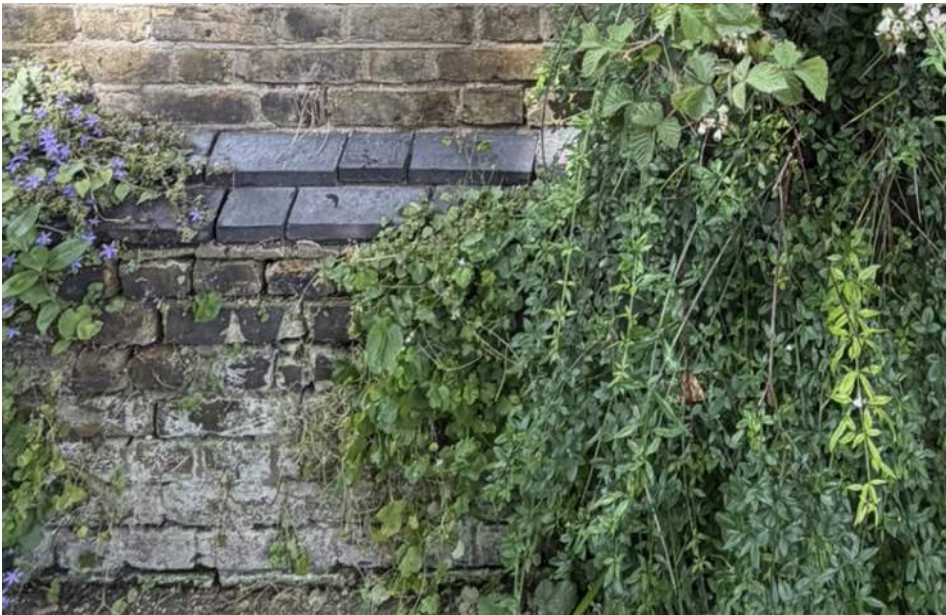
*Photograph M (left) - Closeup of blue/grey plinth stones which appear within the boundary wall only between layers of different thicknesses of brick and not at the base.*

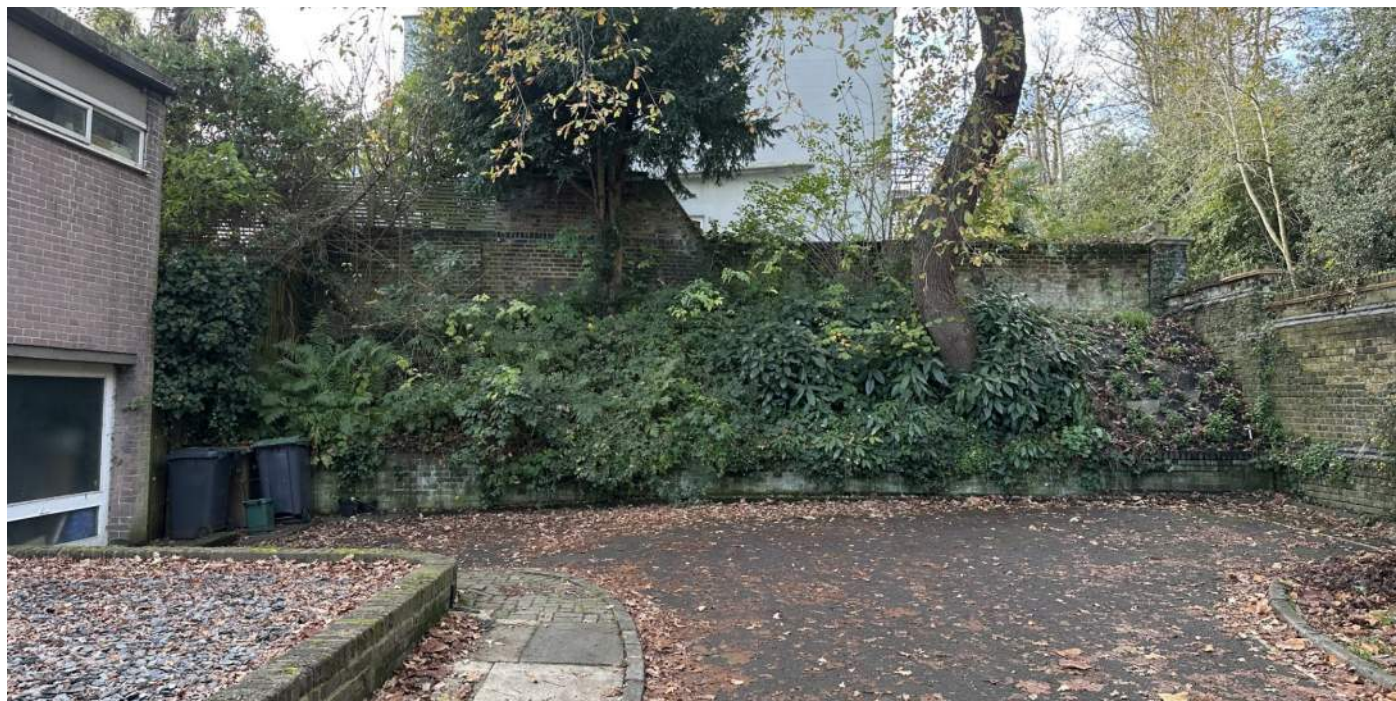
*Photograph N - Photograph taken in Winter/early Jan showing the partially visible portions of the North facing boundary wall. Details of this wall are discussed further in the photographs below.*

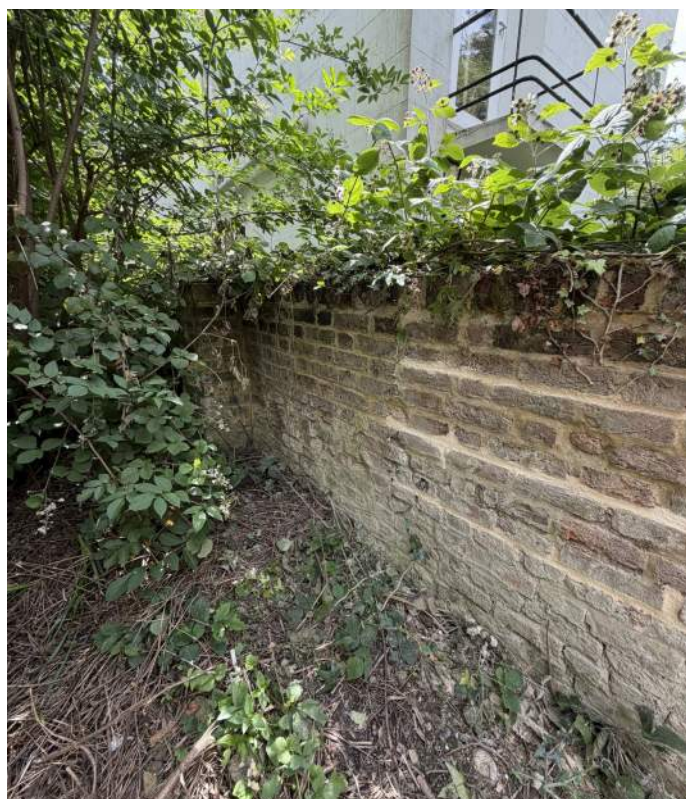
*Photograph O - Shows a small portion of yellow stock bricks with a vertical header course, there are no coping or plinth stones along the length of this wall.*

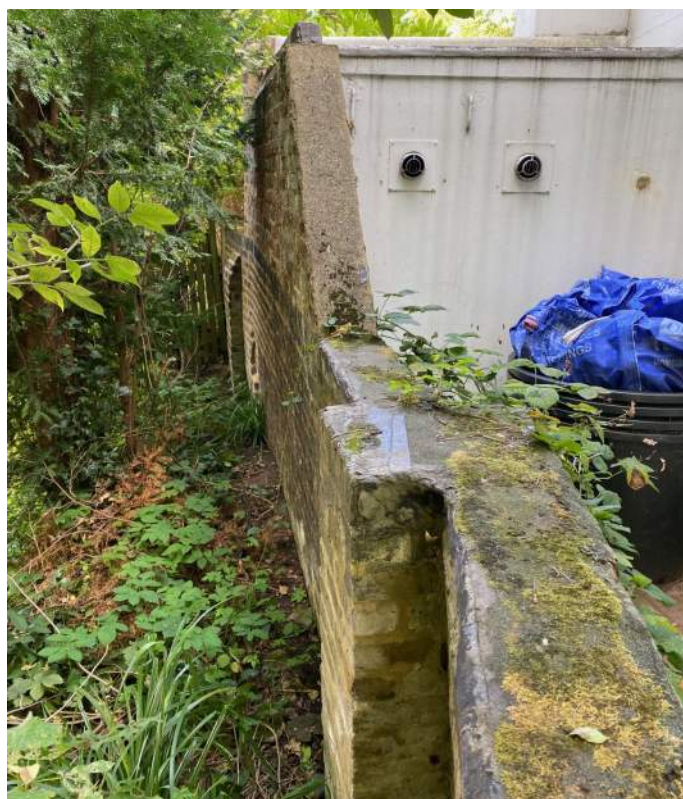
*Photograph P - Showing a square topped buttress and the sloping brickwork behind (presumed a later addition)*

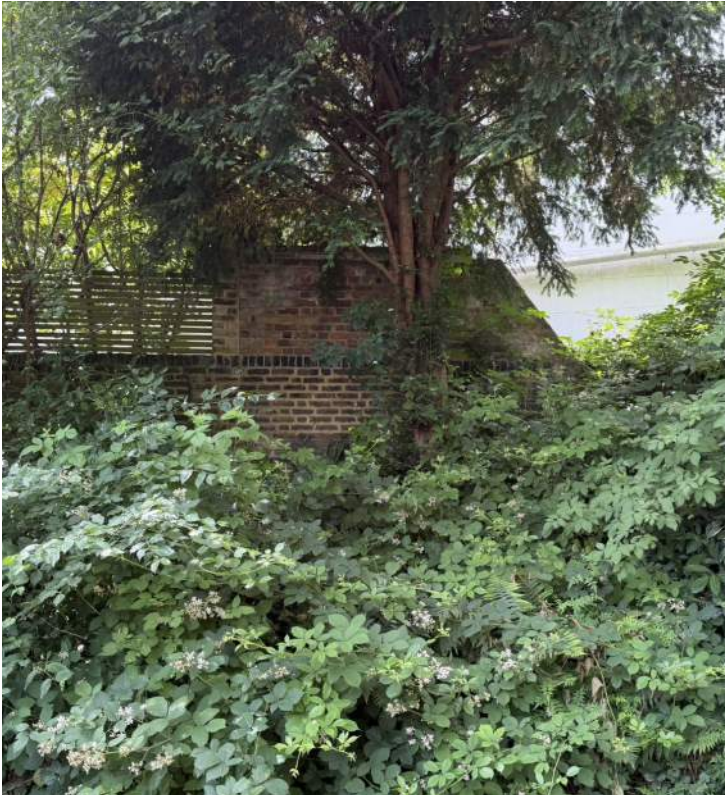
*Photograph Q - Shows the contrasted difference between the lower weathered yellow stock bricks with a vertical header course and an upper diagonally climbing course of primarily red bricks which presumably was a later addition made to the wall which caps off a boiler room to no 84/Highstone House behind it.*

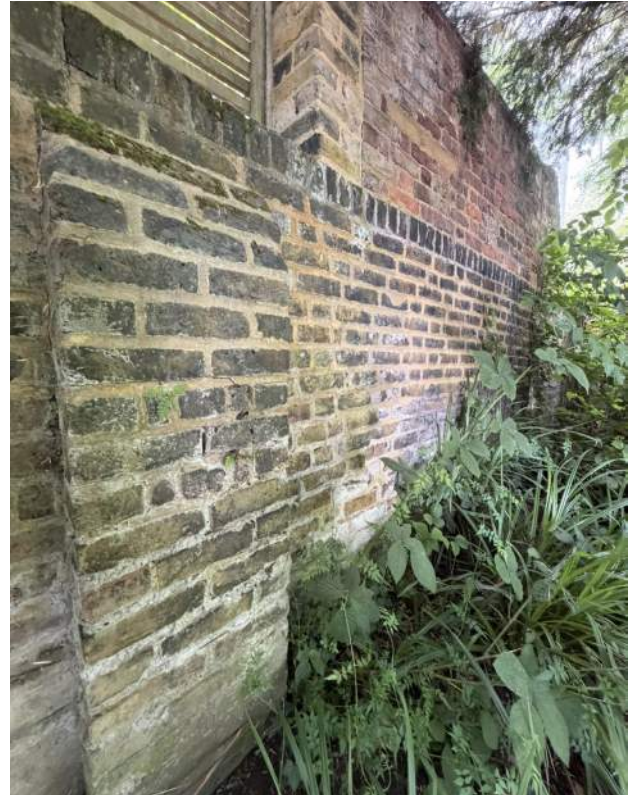
*Photograph R - side view (diagonal wall to the left) showing a different buttress style on the boundary wall where brickwork curves up to the top to meet the wall behind it.*

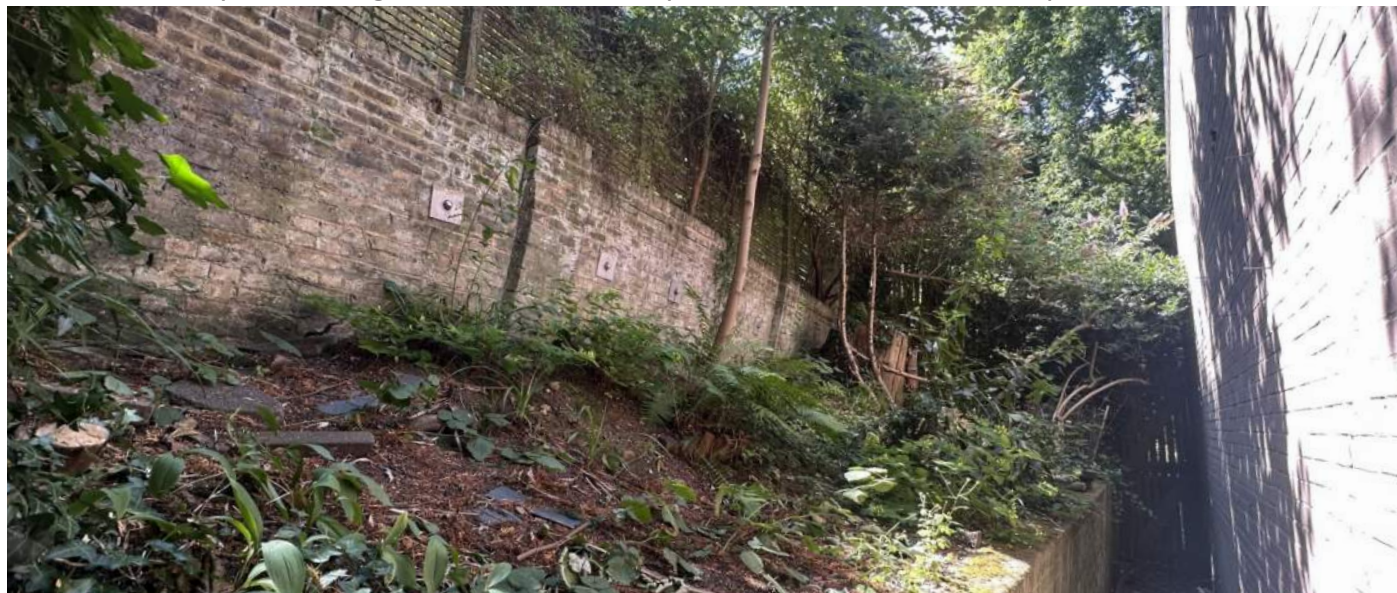
*Photograph S - Photograph showing failing boundary wall between no. 84/Highstone House and no.86, not visible from the public realm.*

The Heritage aspects and condition of this structurally failing wall has been documented in the Heritage, Energy Design and Access Statement (HEDAS/Section 4 of planning permission ref: HGY/2025/2929) but is included here for completeness. There is a significant lean and cracking in the wall. Notably there is no blue/ grey plinth stones or coping stones at any location over the entire length of this wall.

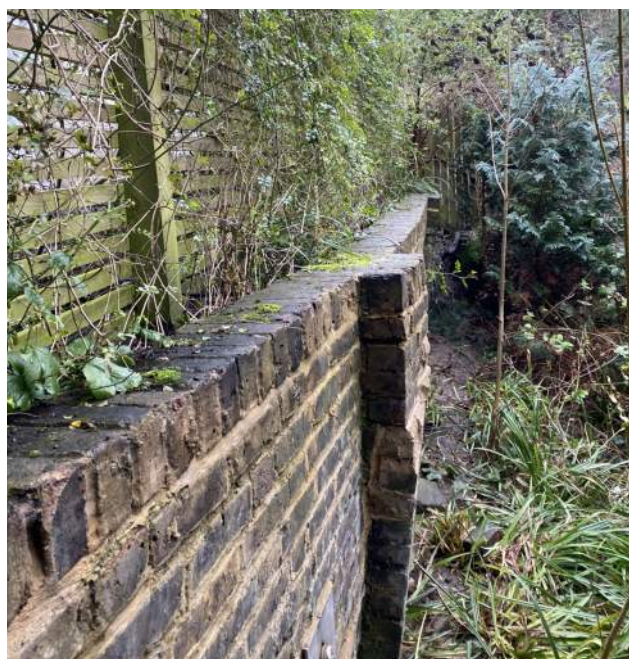
*Photograph T - showing the poor condition of buttressing with a flat top and brick header courses as modified by application HGY/2014/3447*

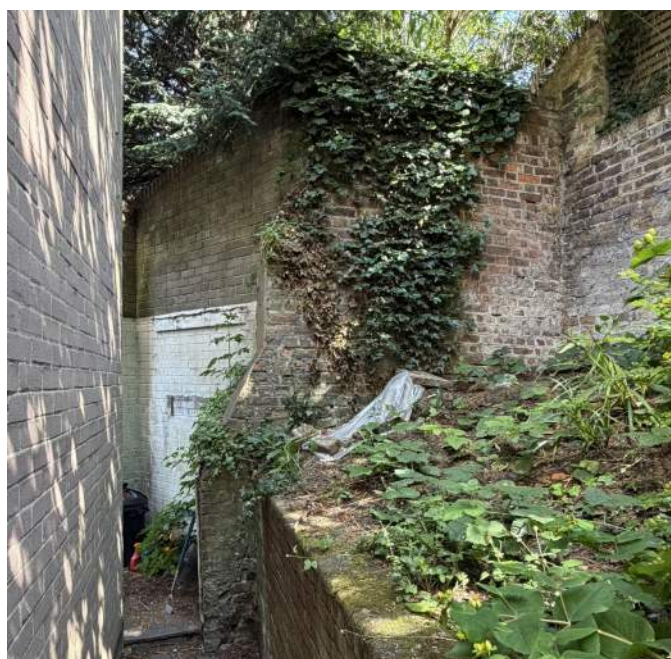
*Photograph U - showing the end masonry wall in a predominantly red brick with a chamfered end suggesting the wall was cut and previously longer (presumably cut in 1958).*
