10 The Gables, Fortis Green NW10 3EA

May 2026

## 1. PHOTOGRAPHIC SCHEDULE

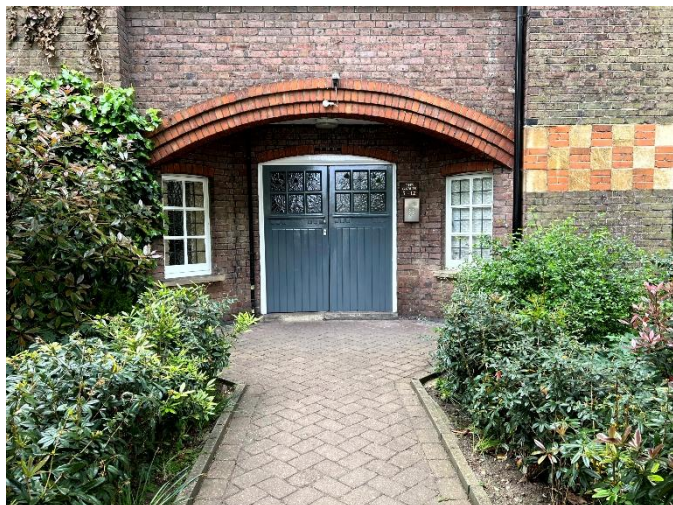
1 Main entrance elevation to The Gables, a Grade II listed Edwardian mansion block exhibiting characteristic Arts and Crafts detailing including decorative brickwork, recessed archway and original fenestration. External appearance contributes significantly to the listed building significance.

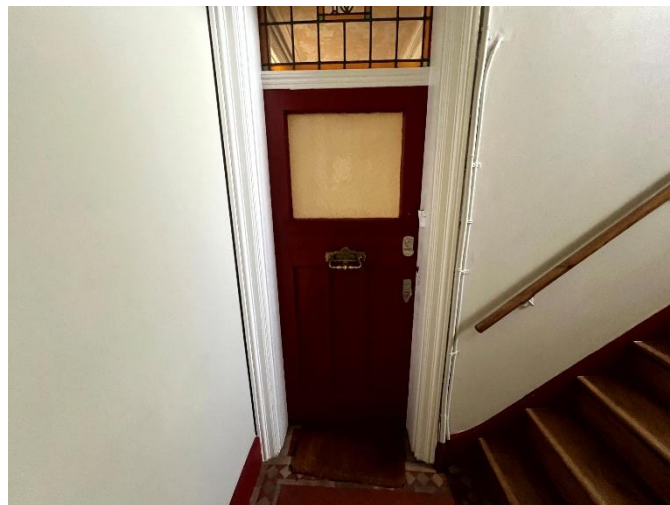
2 Communal entrance approach to Flat 10 showing surviving original entrance door surround, moulded joinery and circulation layout. Original proportions and architectural detailing remain largely intact.

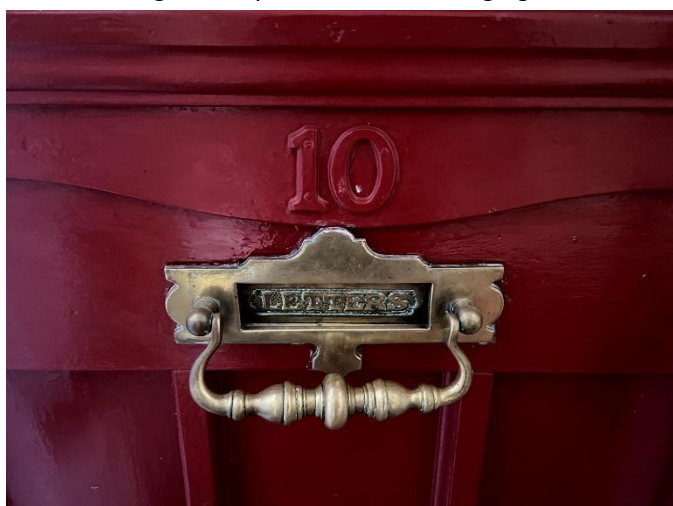
3 Original timber entrance door with surviving period ironmongery and raised moulded panels. Door appears original historic fabric and contributes positively to the significance of the flat.

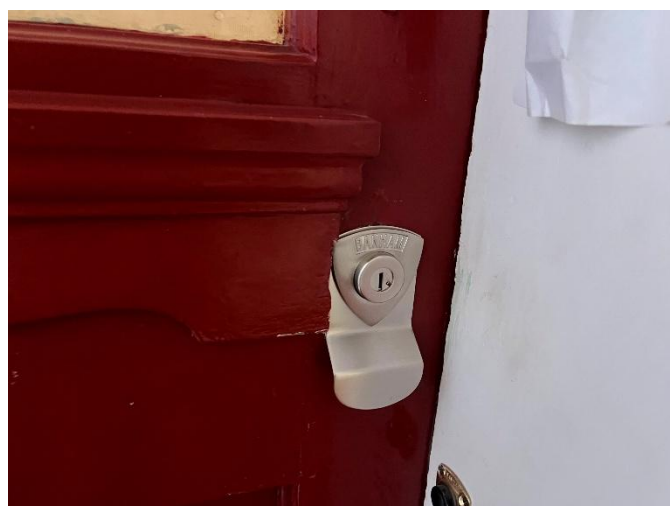
4 Replacement supplementary locking arrangement fitted to original entrance door. Modern security alteration of limited heritage significance, likely installed to satisfy current security requirements.

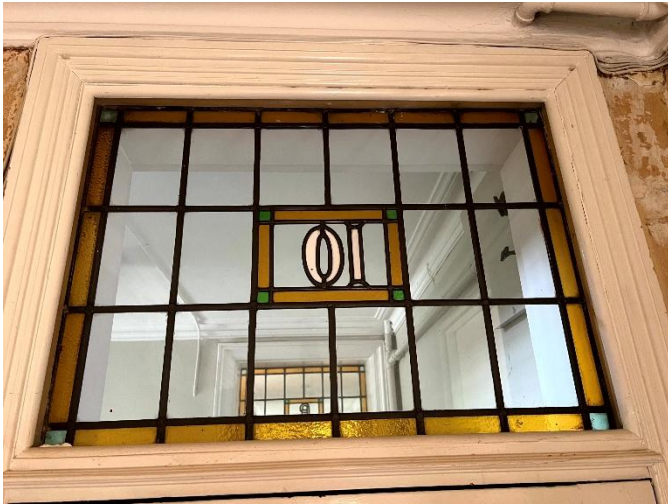
5 Original leaded and stained over-door light incorporating decorative glazing bars and flat number motif. Significant surviving historic feature proposed to be retained and revealed as part of refurbishment works.

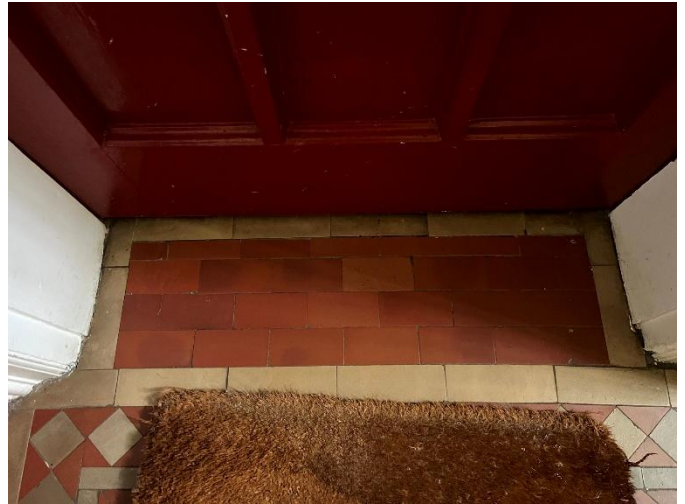
6 Original quarry tiled threshold and entrance flooring detail. Surviving historic floor finish of heritage significance requiring protection and retention during proposed works.

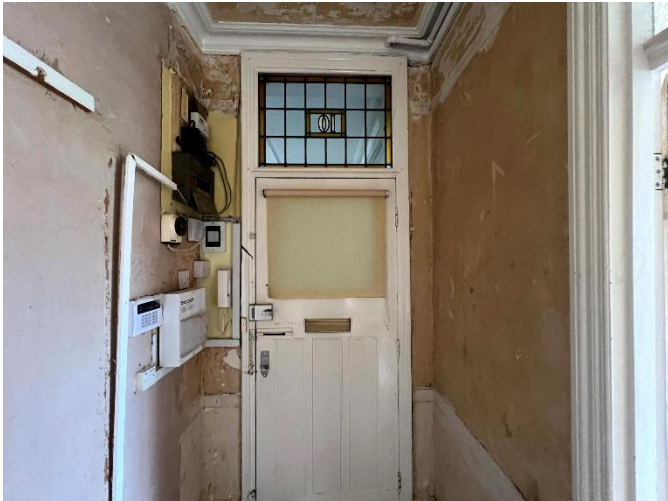
7 Hallway arrangement showing surviving original joinery, over-door glazing panels, cornicing and historic circulation layout. Proposed works comprise non-structural refurbishment and services upgrading only.

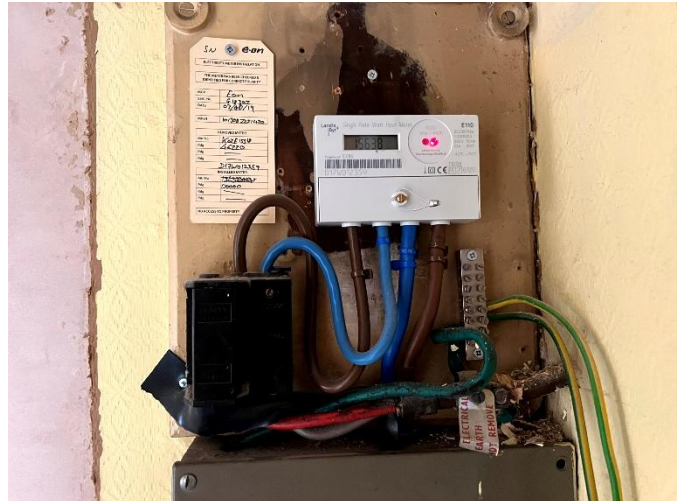
8 Existing consumer unit and electrical installation. Installation appears dated and does not satisfy current electrical safety standards, supporting proposed rewiring and consumer unit replacement.

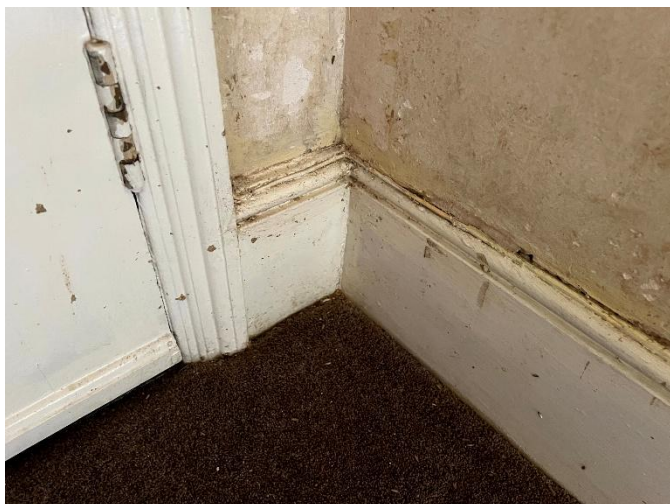
9 Original deep timber skirting and architrave detailing within hallway. Historic joinery largely retained although showing evidence of wear and previous decoration build-up.

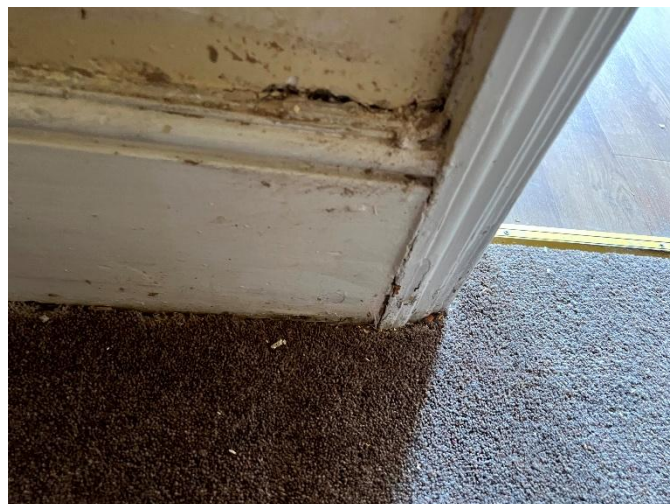
10 Localised deterioration and staining to skirting and lower wall junctions, likely associated with historic moisture retention and age-related deterioration. Repairs considered reasonable and proportionate.

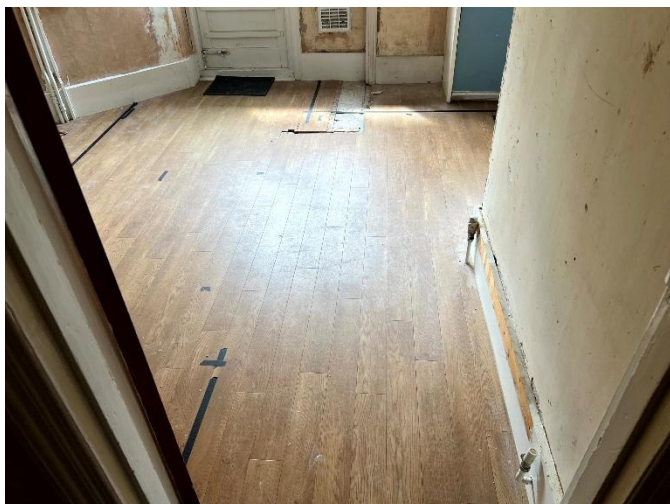
11 Non original laminate flooring with evidence of repeated disturbance associated with previous service installations and alterations throughout.

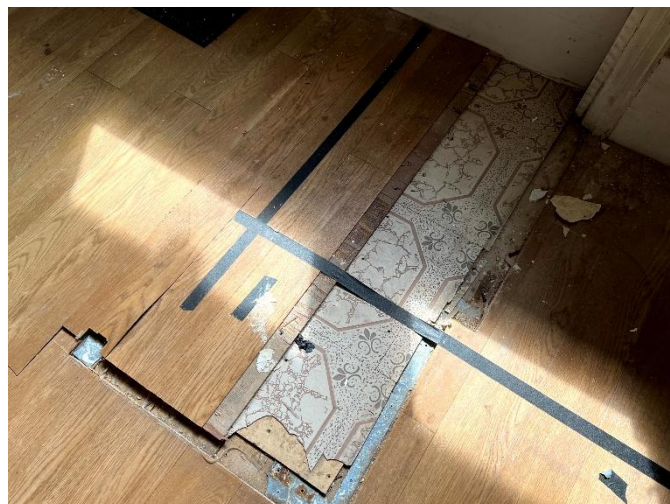
12 Existing floor construction (beneath both laminate and vinyl) showing fragmented finishes and historic service penetrations. Condition supports proposed floor repairs and coordinated services rationalisation.

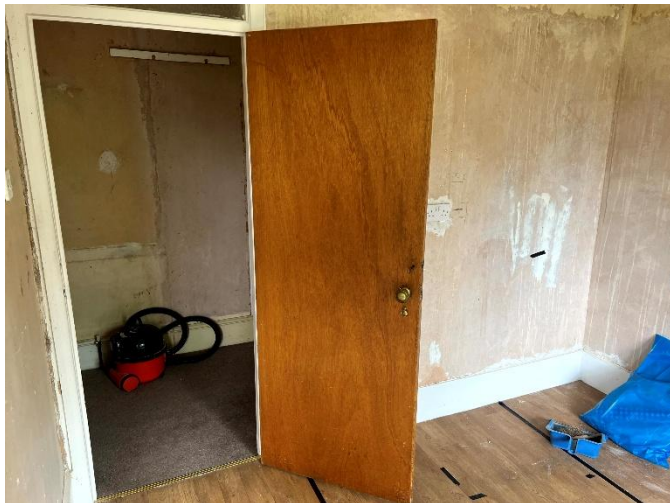
13 Internal doorway and surviving historic room proportions. Existing timber door appears to be a later replacement rather than original Edwardian joinery.

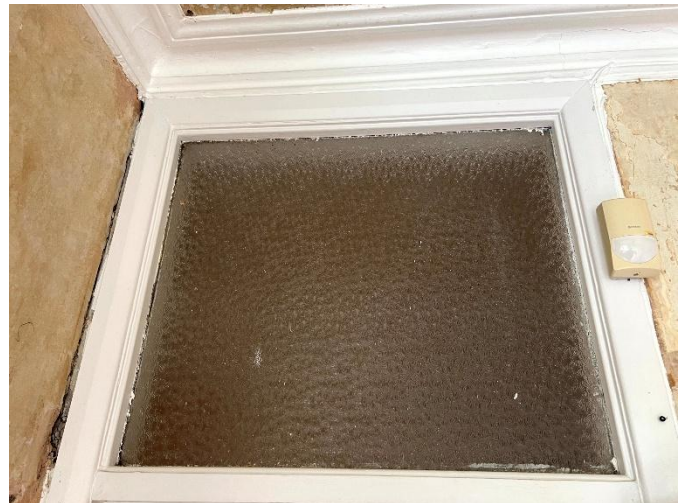
14 Original obscured glazed over-door panel with moulded timber surround. Historic feature contributing positively to internal character and proposed for retention.

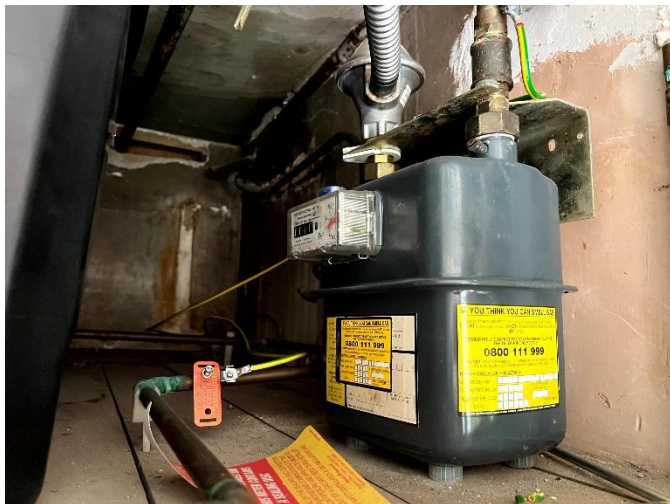
15 Existing gas meter and associated pipework installation. Arrangement appears dated and visually intrusive with limited heritage significance. Proposed rationalisation considered appropriate.

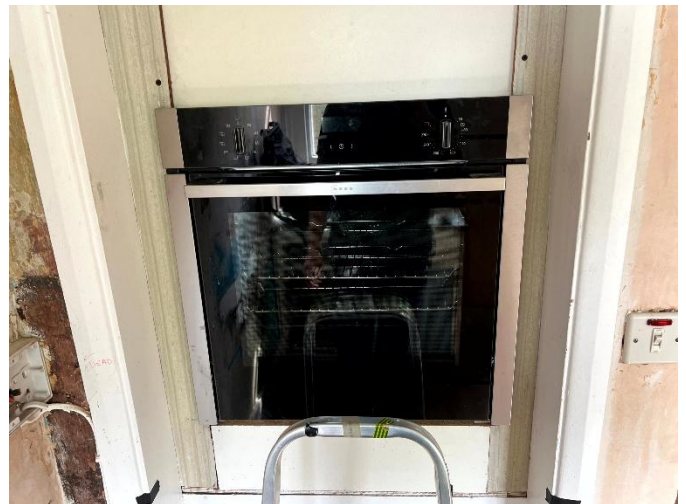
16 Existing integrated oven installation set within later partition arrangement. Modern insertion of limited architectural significance.

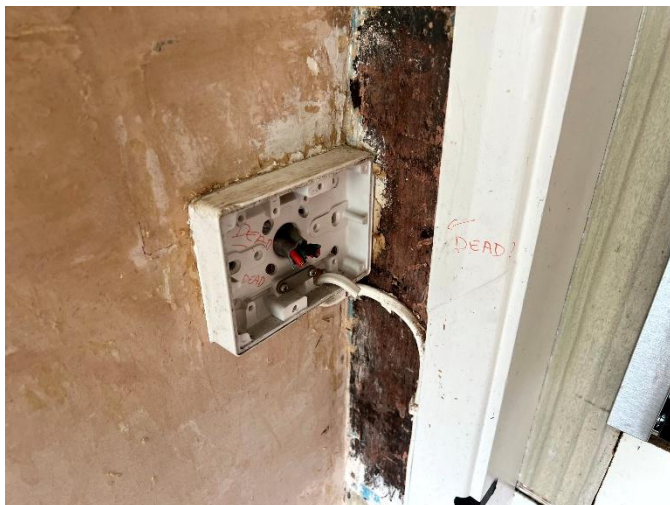
17 Redundant electrical outlet and exposed service chasing to historic wall construction. Illustrates cumulative impact of piecemeal historic alterations to services.

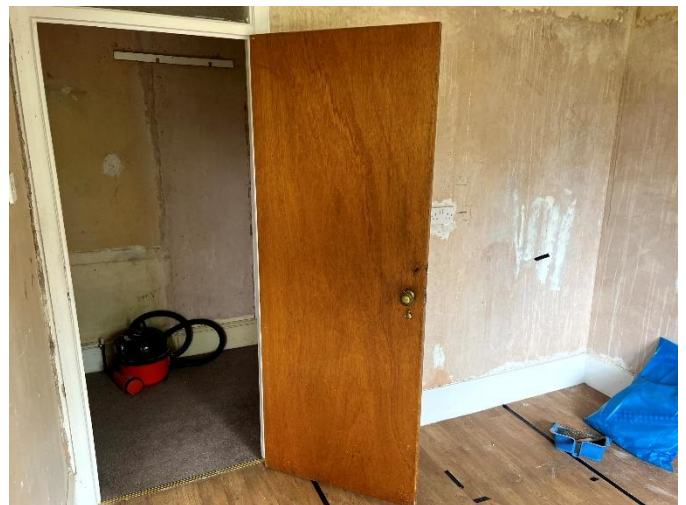
18 Secondary view of later replacement internal door and stripped wall finishes exposing underlying historic plaster construction.

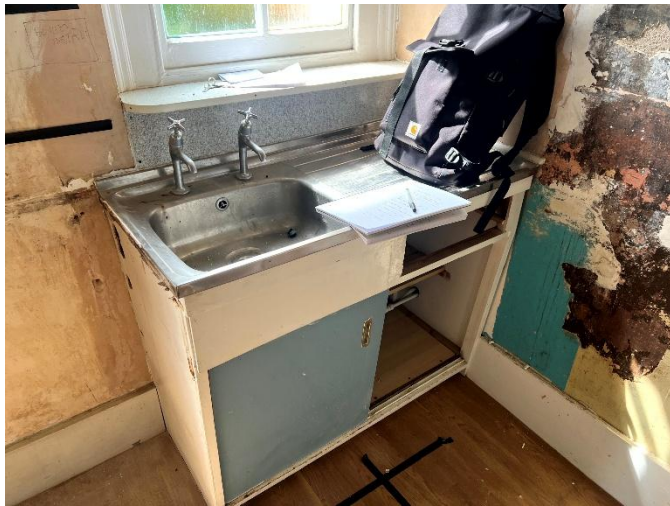
19 Existing kitchen sink arrangement with evidence of localised moisture deterioration and defective finishes to adjacent wall surfaces. Supports proposed kitchen replacement works.

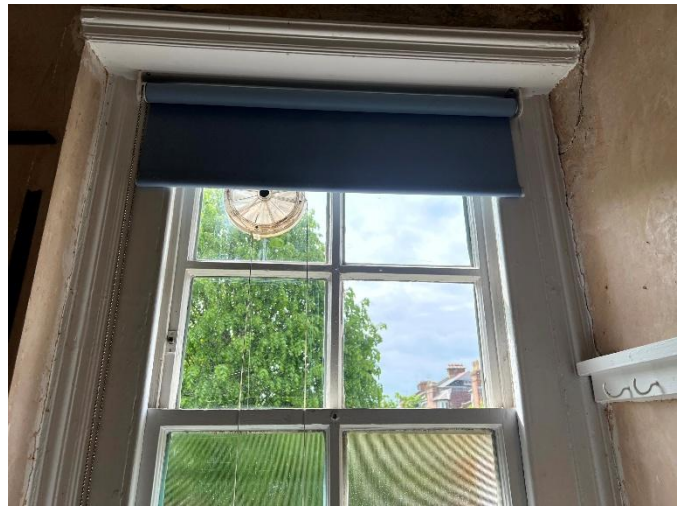
20 Original timber sash window and reveal detail within kitchen. Window contributes significantly to the character of the listed building and should be retained and repaired.

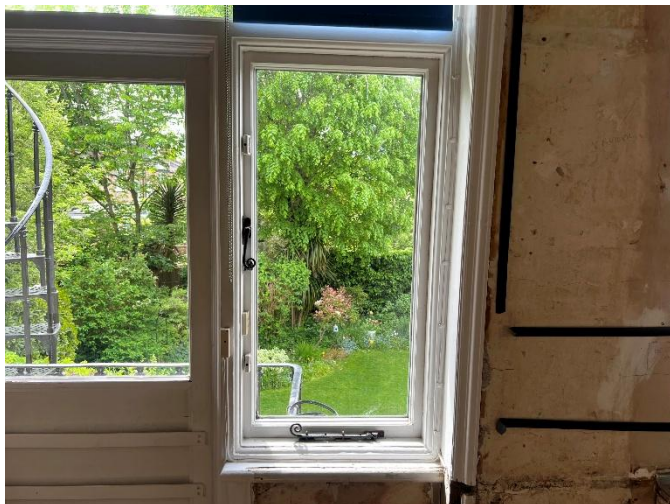
21 Original timber casement window arrangement with surviving historic proportions and glazing pattern. Repair-led approach recommended.

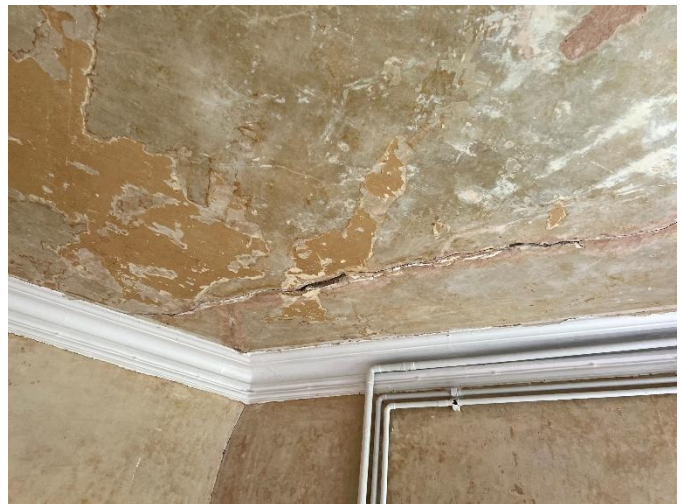
22 Deteriorated lath and plaster ceiling finish with cracking and localised failure. Repairs should retain surviving historic plaster wherever practicable.

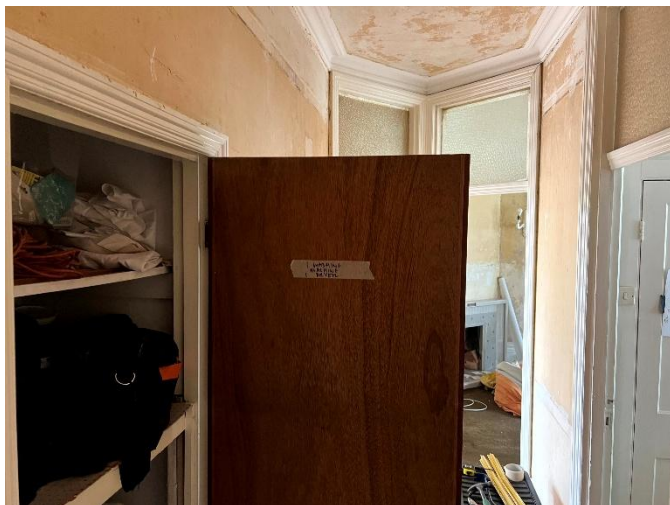
23 Hallway storage arrangement and surviving joinery detailing. Historic spatial arrangement remains legible despite later alterations.

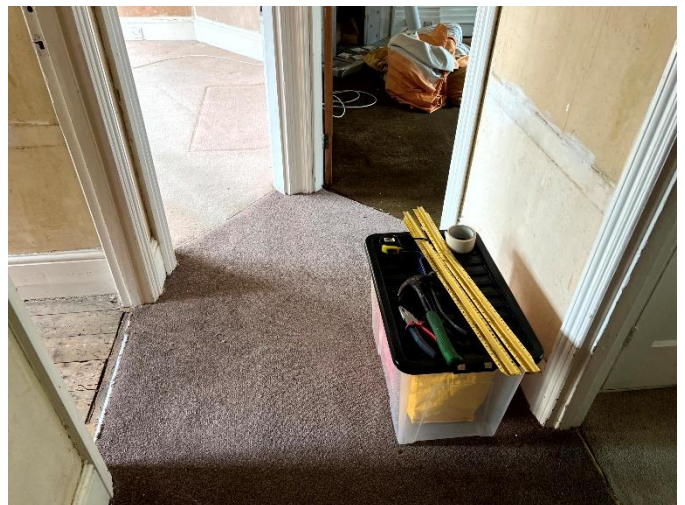
24 General internal circulation areas showing retained skirtings, architraves and original room arrangement.

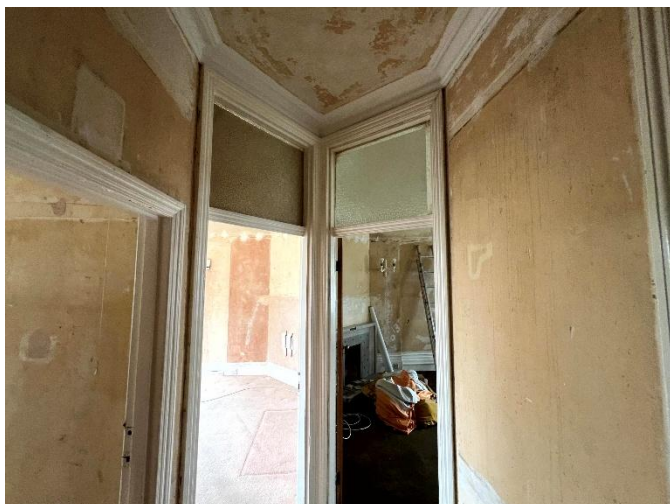
25 View through principal circulation route illustrating retained historic plan form and over-door glazing details characteristic of the Edwardian layout.

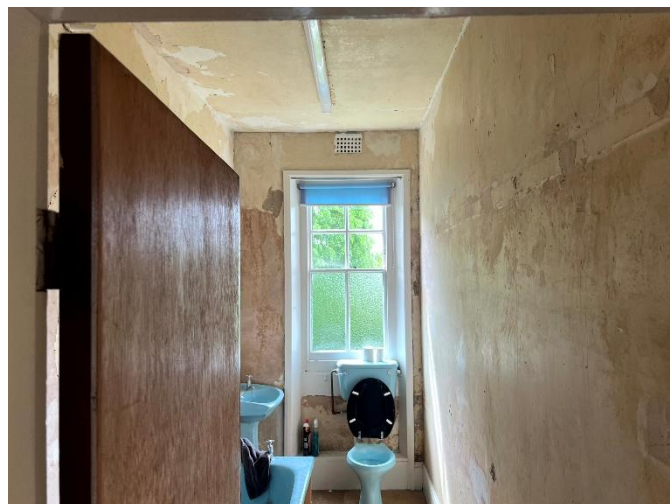
26 Bathroom arrangement showing original room proportions and retained historic window opening. Existing sanitaryware appears later twentieth century insertion.

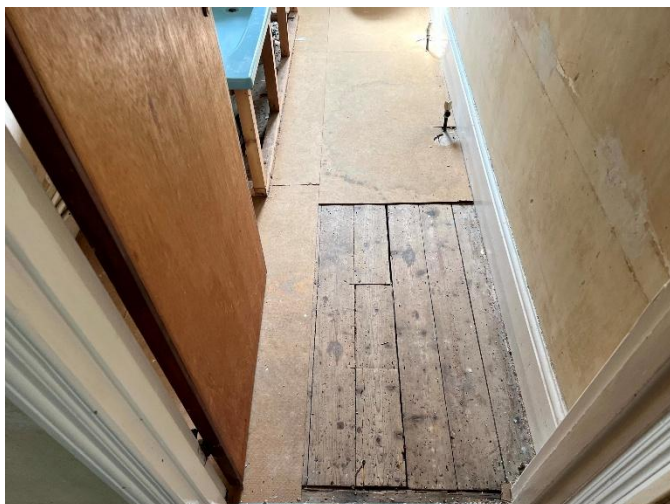
27 Exposed original timber floorboards within bathroom threshold area. Historic floor fabric exhibits wear and previous alteration associated with plumbing works.

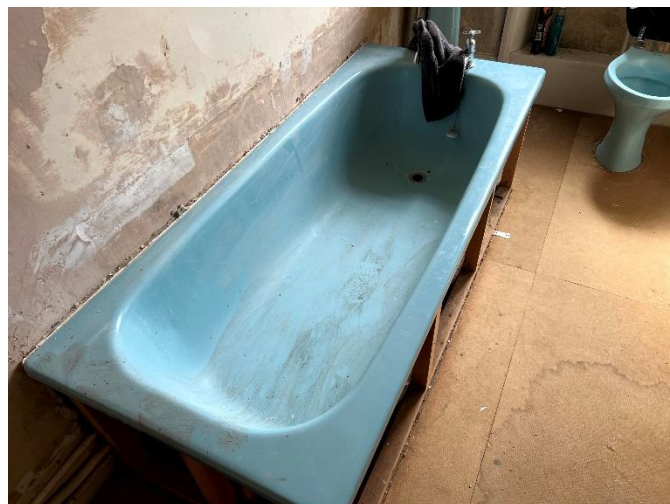
28 Existing bath installation of later date and limited heritage significance. Proposed replacement considered acceptable in principle.

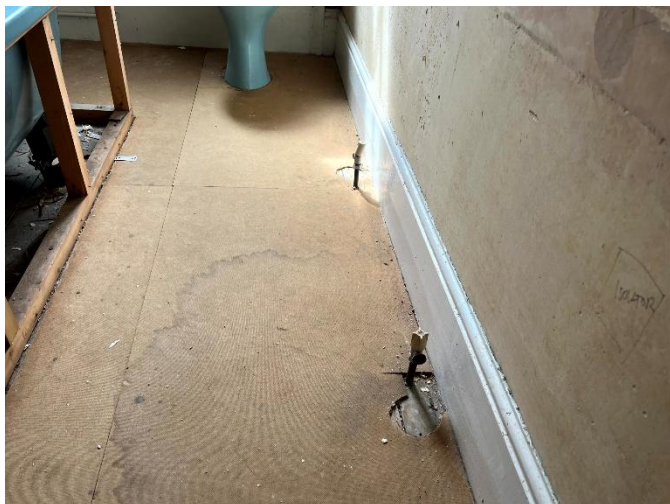
29 Existing floor finish and skirting arrangement within bathroom. Evidence of age-related wear and previous disturbance to floor construction.

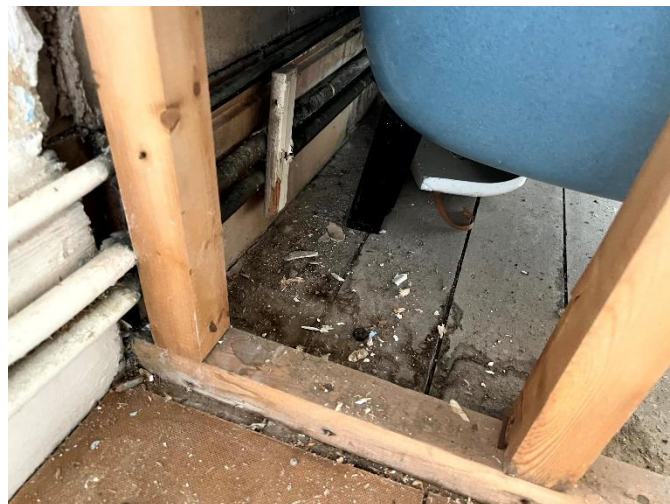
30 Exposed floor void and historic plumbing routes beneath bathroom. Illustrates extent of previous interventions to original floor structure.

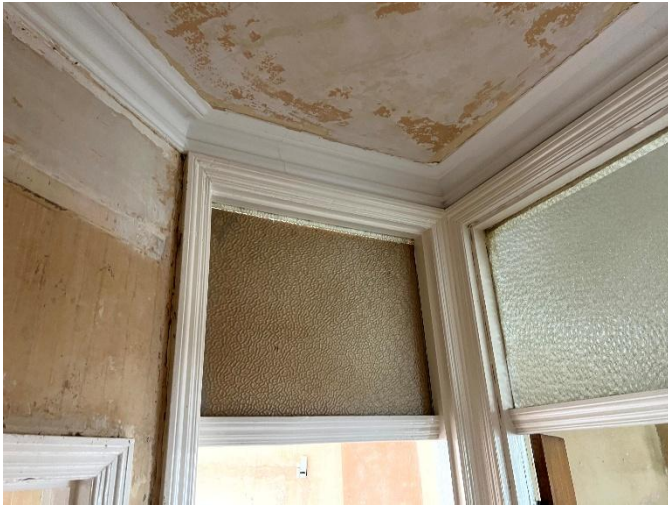
31 Original over-door obscured glazing panel with moulded timber surround. Important surviving historic feature proposed for retention.

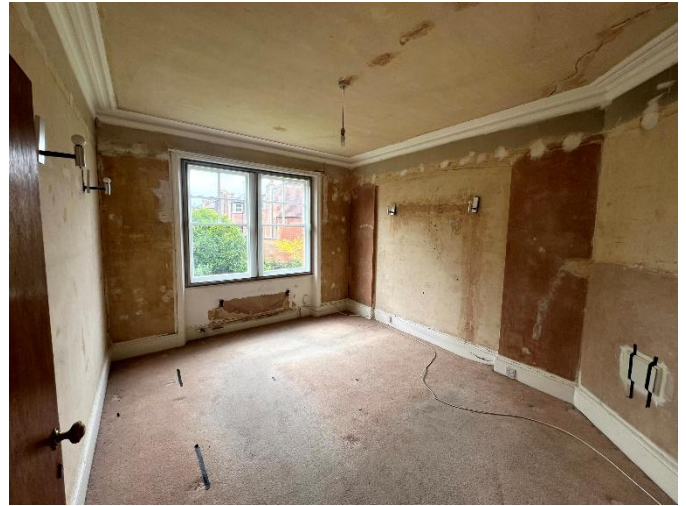
32 General view of bedroom 1 showing retained cornicing, window proportions and original spatial arrangement. Proposed works remain non-structural.

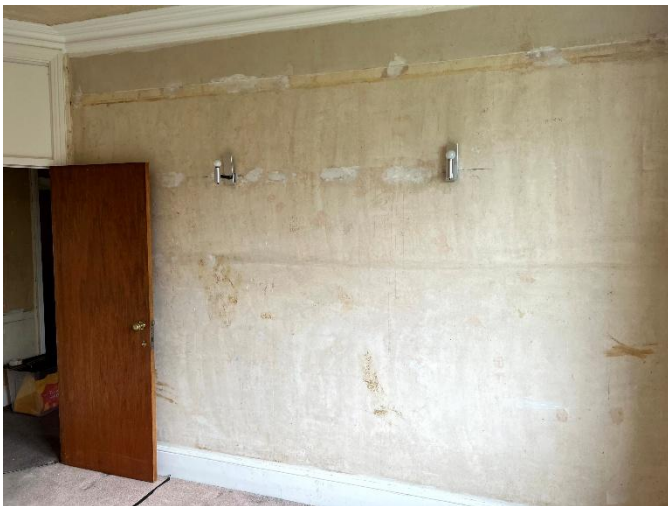
33 Wall elevations showing evidence of historic service routes and previous fittings. Existing plaster finishes appear heavily disturbed by historic interventions.

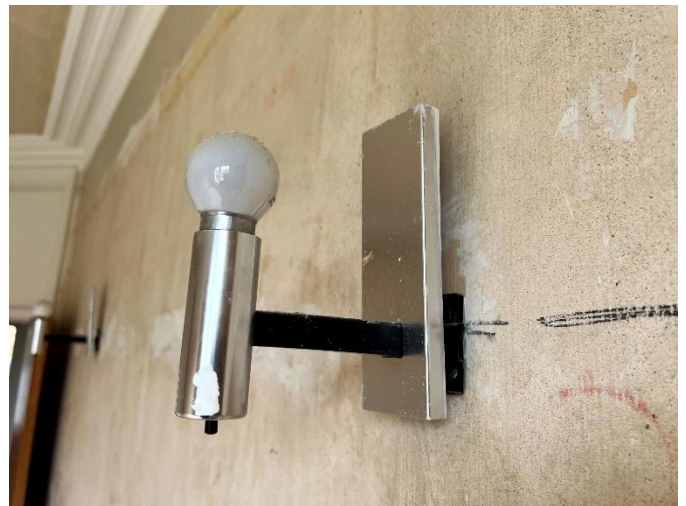
34 Later wall-mounted light fitting fixed to historic plaster wall. Proposed electrical upgrades should minimise further disturbance to original fabric.

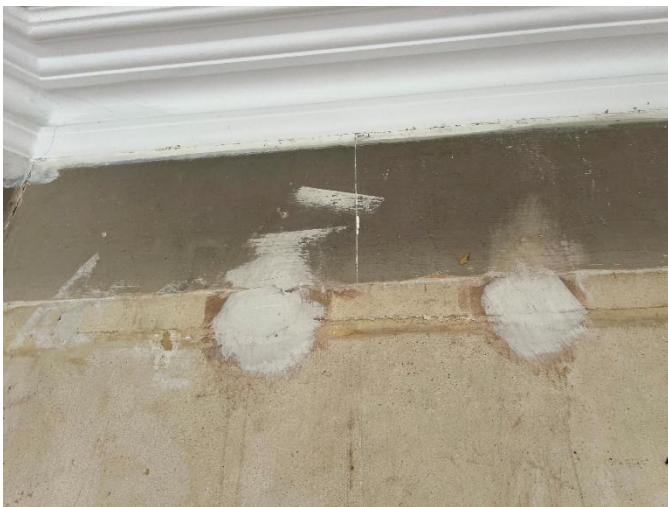
35 Localised plaster repairs and historic fixings beneath cornice line. Evidence of previous alterations and removal of earlier features.

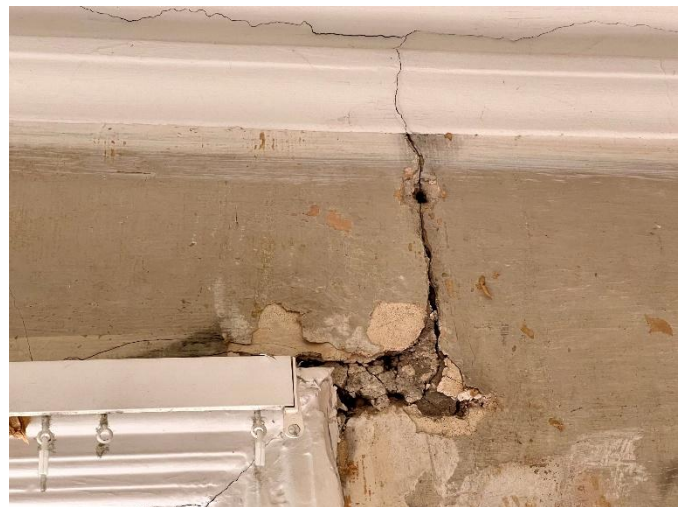
36 Localised cracking and failure to plaster adjacent to cornice junction. Condition consistent with age-related movement and historic disturbance rather than significant structural failure.

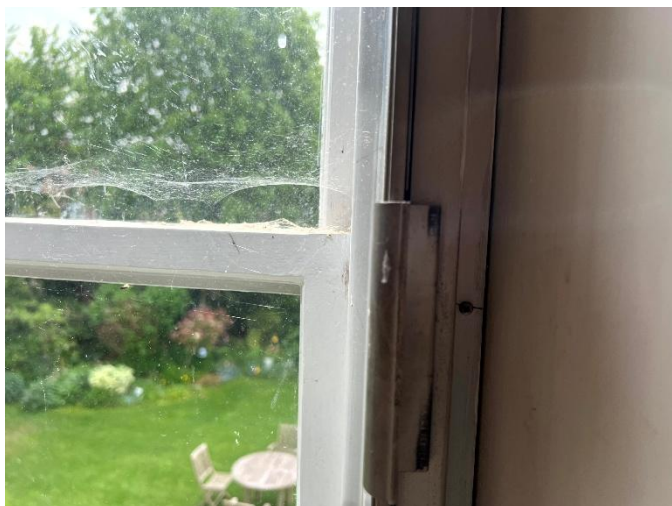
37 Original timber window frame and secondary glazing detail. Window exhibits age-related deterioration but remains important historic fabric. Secondary glazing should be removed with a more modern sympathetic approach taken.

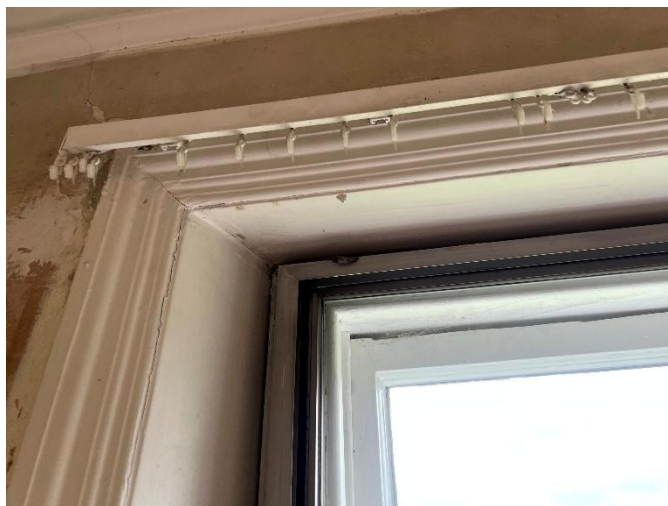
38 Original window reveal and moulded architrave detailing. Surviving historic joinery contributes positively to significance of the flat.

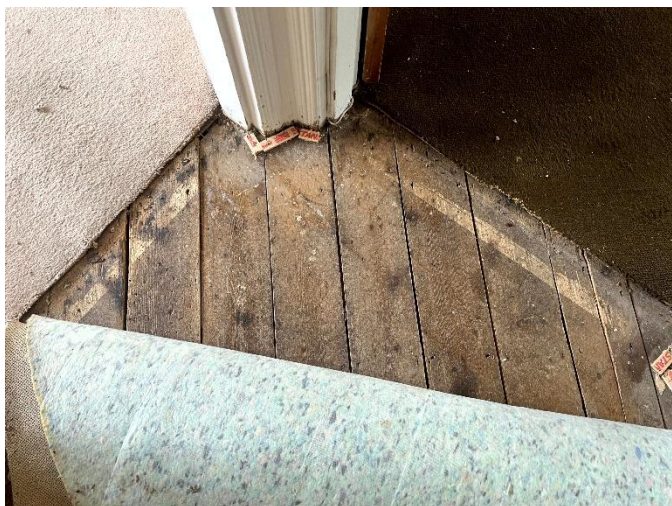
39 Exposed original timber floorboards adjacent to doorway threshold. Boards exhibit wear, splitting and previous disturbance associated with historic services.

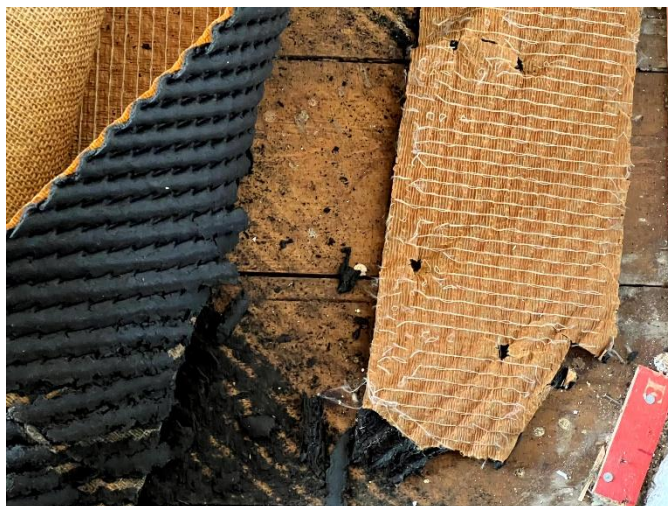
40 Close-up of historic floor finishes and adhesive residues associated with earlier coverings.

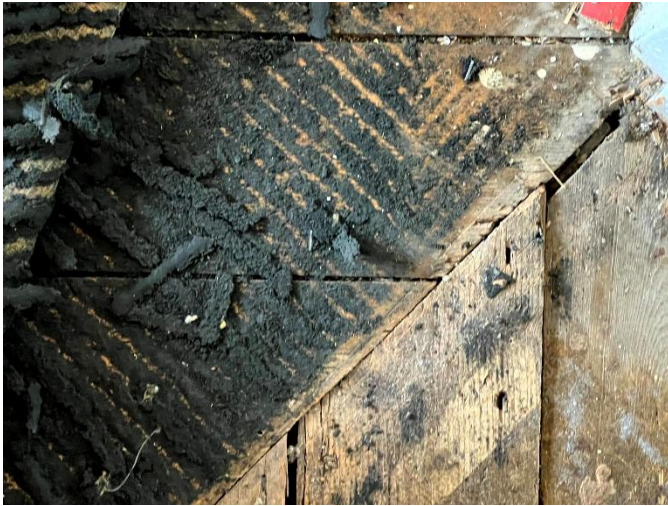
41 Fragmented floorboard junctions and historic service penetrations within original timber floor structure. Comparable to defects identified within approved Flat 18 refurbishment works.

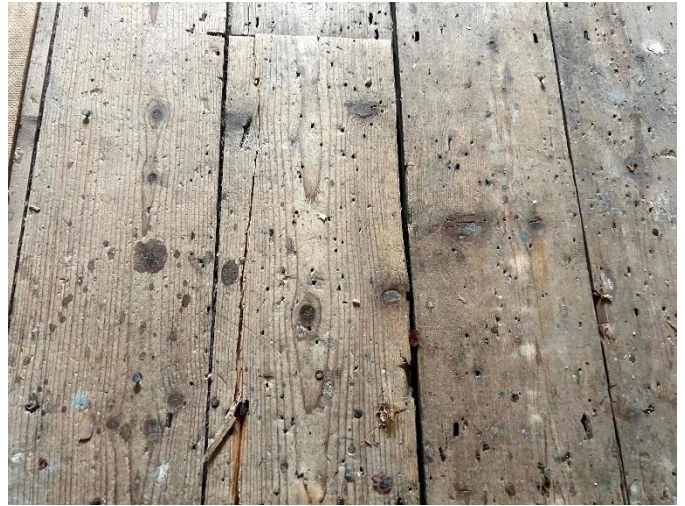
42 General condition of original timber floorboards to bathroom showing age-related abrasion, historic repairs and localised deterioration. Possible woodboring beetle issues previously.

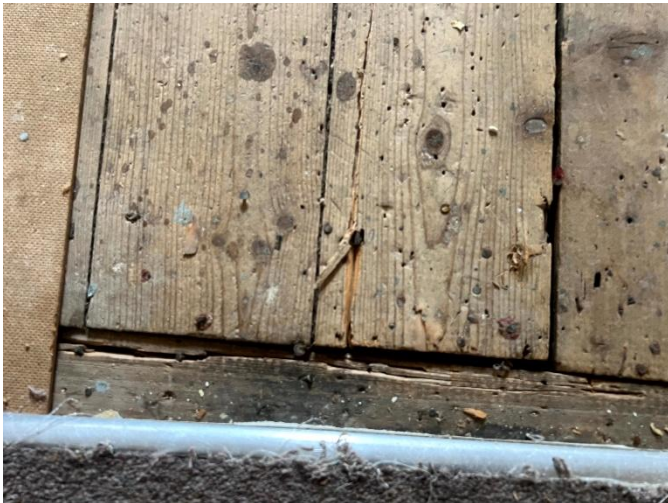
43 Additional view of deteriorated original floorboards with evidence of repeated lifting and disturbance from previous alterations.

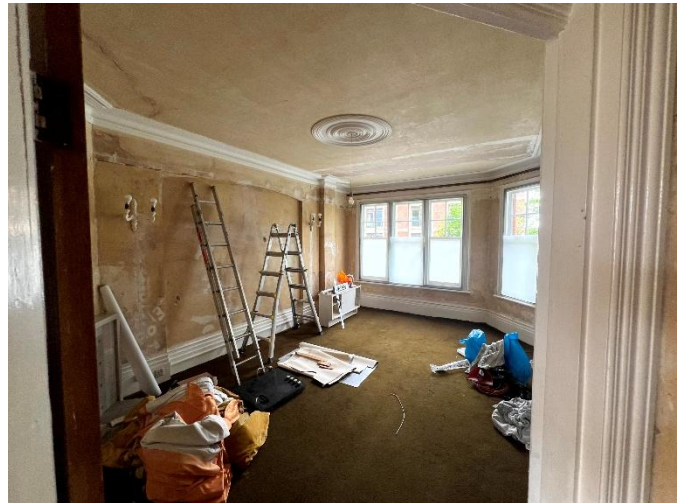
44 General view of principal reception room retaining original proportions, cornicing and window arrangement characteristic of the building's Edwardian design.

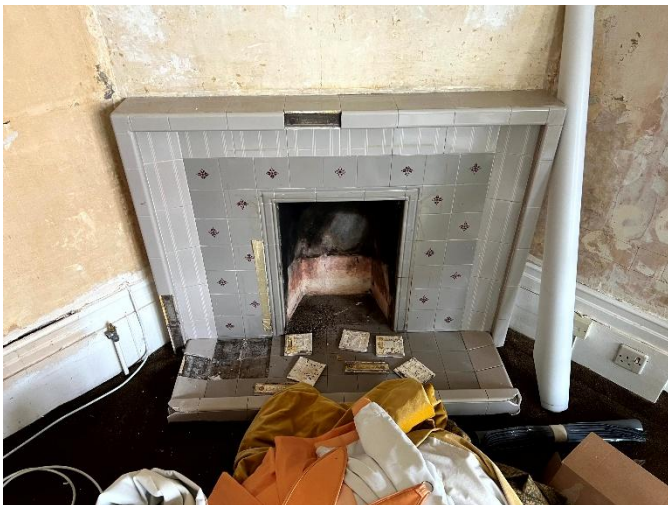
45 Later fireplace surround and associated finishes. Existing installation appears altered historically and is of limited heritage significance relative to retained architectural fabric.

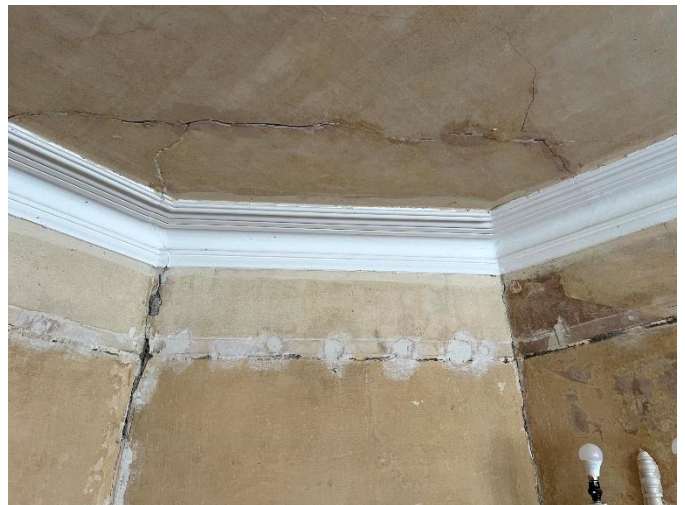
46 Cracking and localised deterioration to lath and plaster ceiling adjacent to cornice line. Repairs should adopt a conservation-led approach retaining sound historic plaster.

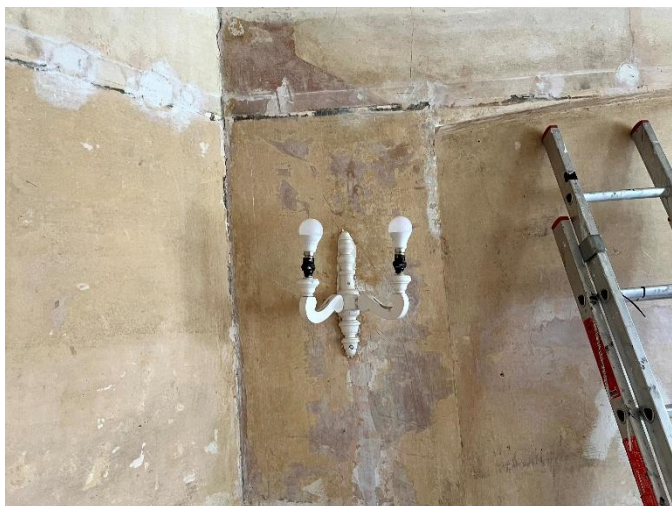
47 Areas of historic wall disturbance and previous electrical installations. Existing service routes should be reused where practicable during refurbishment works.

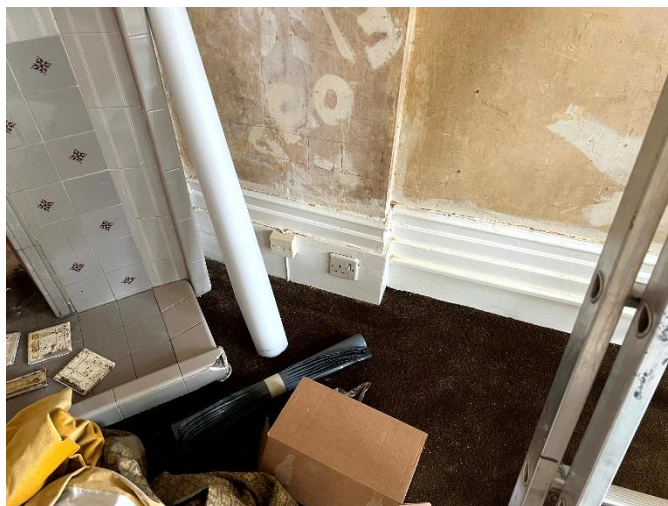
48 Secondary view of fireplace and wall finishes illustrating extent of previous alteration and redecoration works.

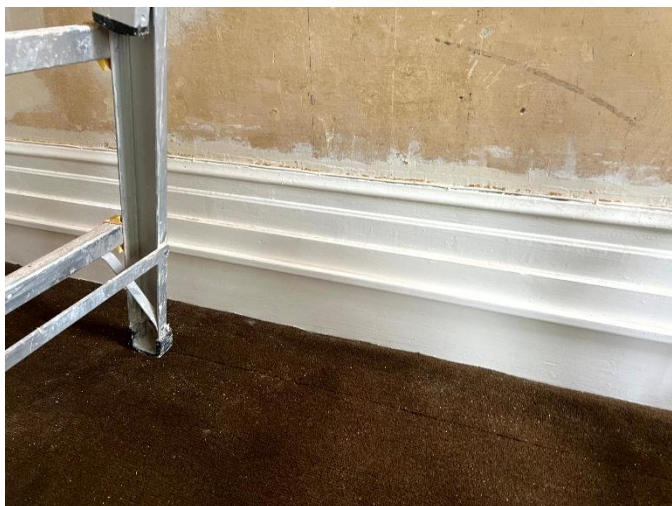
49 Original deep moulded skirting detail within principal room. Significant surviving historic joinery requiring protection during proposed works.

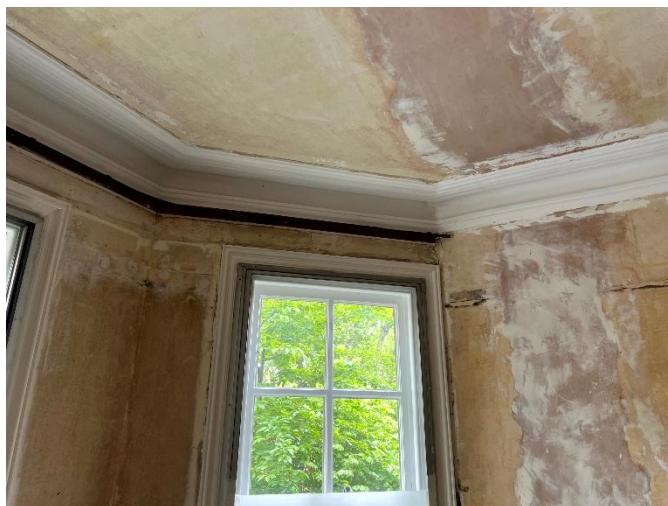
50 Original Bay window arrangement with moulded cornicing and retained Edwardian proportions. Important architectural feature of heritage significance.

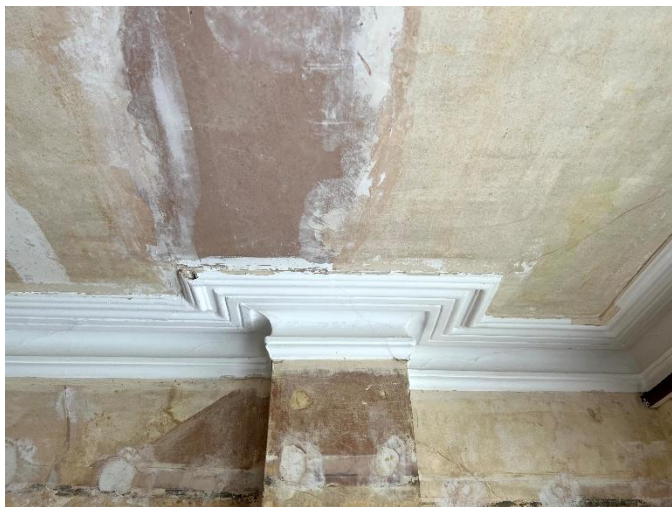
51 Decorative plaster cornice and ceiling junction detail. Original feature contributing positively to the architectural character of the flat.

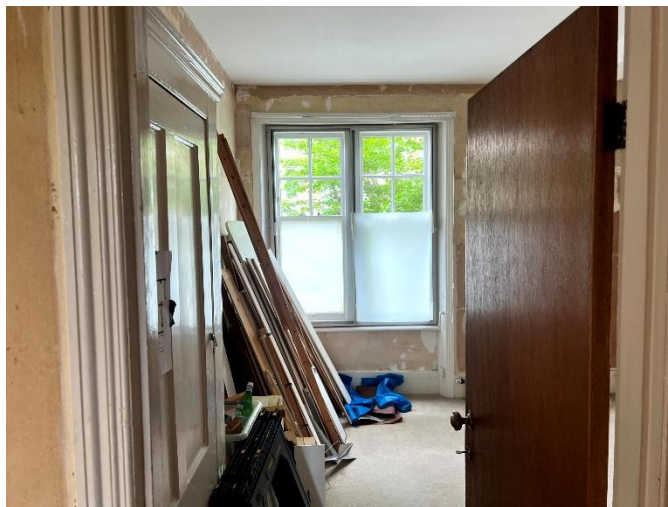
52 View along internal corridor into bedroom 2 demonstrating survival of original layout and over-door glazing arrangements.

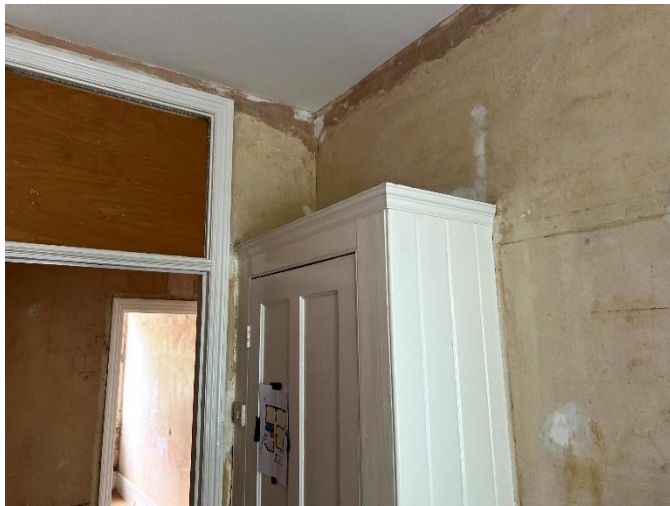
53 Surviving built-in storage joinery and upper over-panel detail. Cupboard arrangement likely historic and contributes positively to significance of interior.

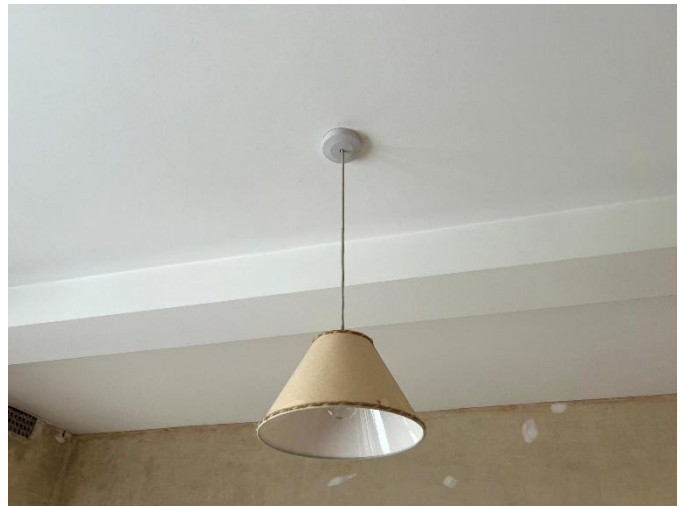
54 Replacement ceiling light fitting suspended from original ceiling position, which is not original. Proposed rewiring intends to retain existing lighting locations.

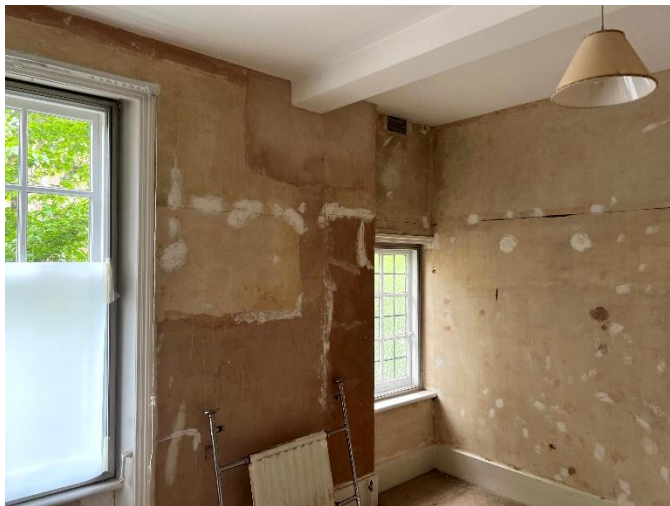
55 View of boxed bulkhead/downstand structure spanning across the room at high level. The formation is likely associated with a historic alteration involving either removal of an earlier partition wall and/or concealment of structural strengthening and service installations undertaken during a previous refurbishment phase. The bulkhead does not appear consistent with the original Edwardian ceiling arrangement and is considered a later intervention of limited heritage significance.

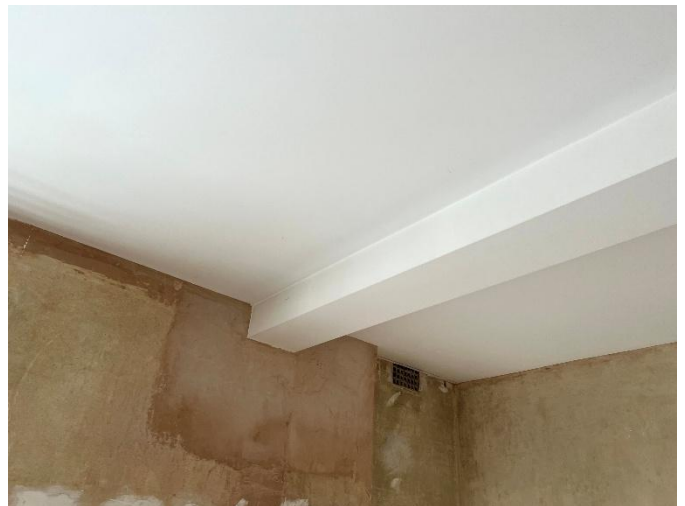
56 Secondary view of altered ceiling and wall arrangement showing boxed beam structure aligned with evidence of former wall junctions and historic alterations to the room layout. The lowered ceiling section and boxed enclosure are likely associated with historic remodelling works predating the current ownership and appear comparable to interventions approved within previous Listed Building Consent applications at The Gables, particularly where later twentieth century alterations and structural rationalisation had already materially affected the original fabric. Given the apparent age and established existence of the alteration, reinstatement of the original ceiling and partition arrangement would not typically be considered necessary as part of the current proposals, provided no further material alteration to the structure is proposed. The existing intervention is therefore considered part of the evolved historic fabric of the flat rather than a new unauthorised alteration arising from the current refurbishment works.

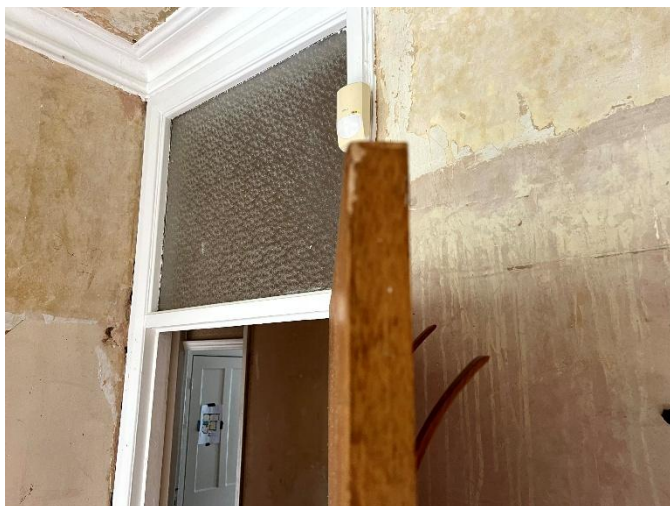
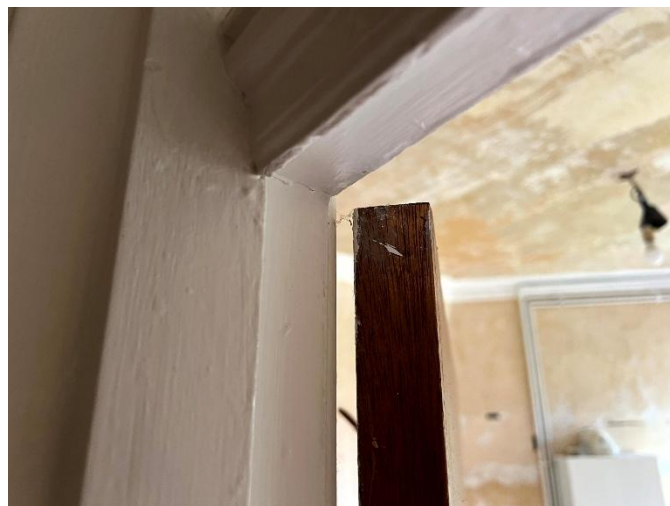
57 Note. Kitchen doors are not fire compliant and likely require upgrading to comply with current regs.

58 As above.

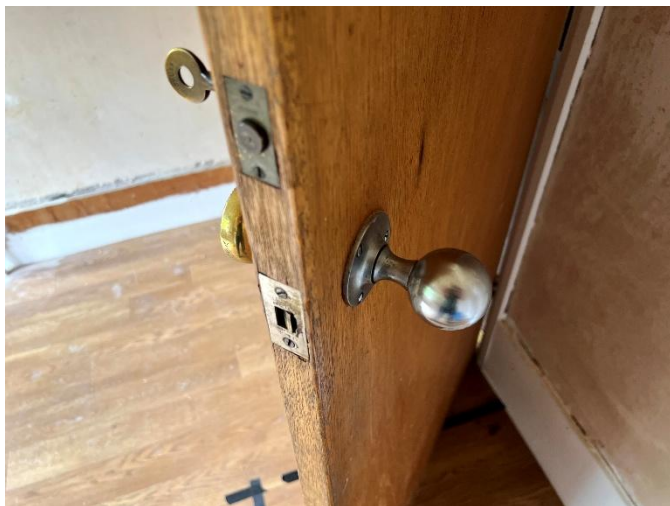
59 Existing internal door and ironmongery. Door appears later replacement rather than original Edwardian joinery, although retained within current refurbishment proposals.
