10 The Gables, Fortis Green NW10 3EA

May 2026

## 1. PHOTOGRAPHIC SCHEDULE

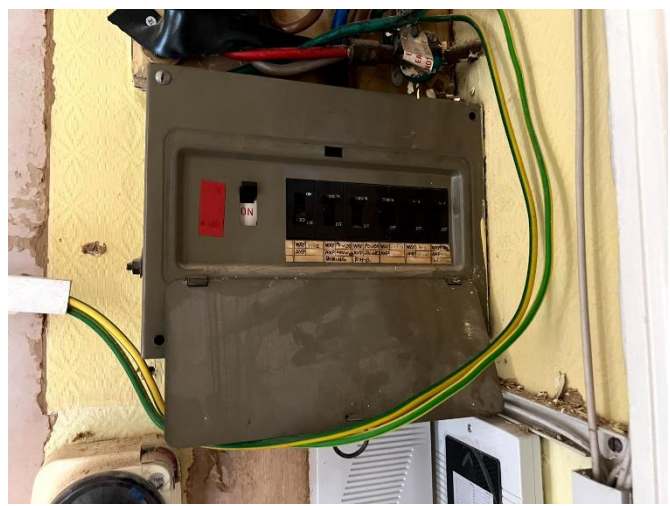
60 Existing older-style consumer unit and associated electrical installation located adjacent to the flat entrance. The installation appears dated in character and likely predates current wiring regulations. Replacement of the consumer unit, associated protective devices and incoming electrical tails is considered reasonable as part of the proposed refurbishment works, subject to confirmation of supply capacity and compliance by a qualified electrical contractor.

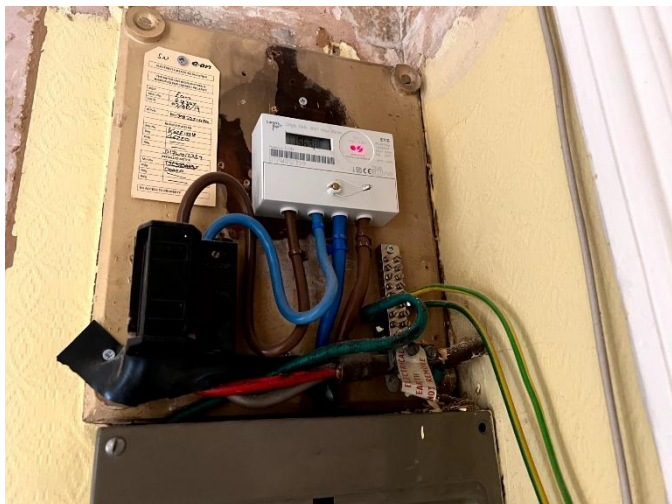
61 Existing electrical meter arrangement and incoming supply cabling serving the flat. The installation comprises a mixture of older infrastructure together with more recent meter replacement works, indicating incremental upgrades over time rather than a full coordinated renewal of the electrical installation. The condition and configuration support the recommendation for a comprehensive electrical inspection and assessment of earthing, bonding and incoming supply adequacy prior to refurbishment works proceeding.

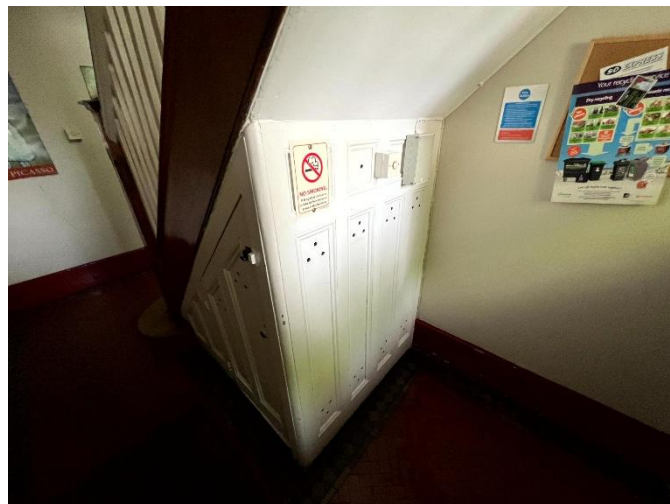
62 Communal electrical service riser/meter cupboard located beneath the principal staircase serving multiple flats within the building. The enclosure appears to contain individual intake equipment, meters and distribution equipment associated with separate residential units. Given the Grade II listed status of the building, any alterations affecting communal electrical infrastructure or containment routes should be carefully coordinated to minimise disturbance to historic communal fabric and joinery.

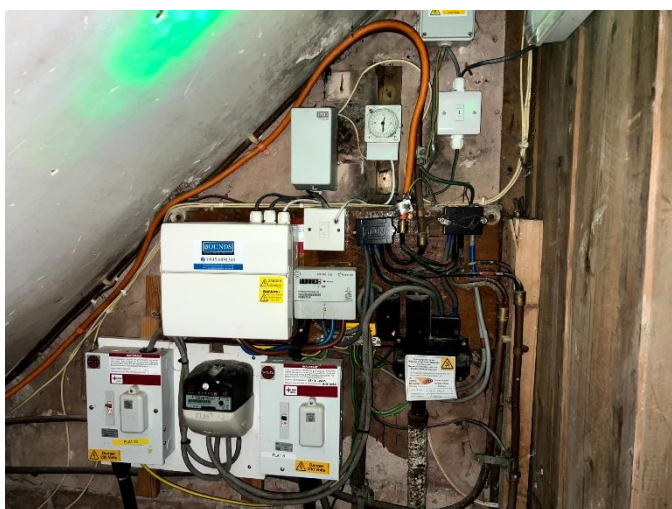
63 Communal electrical intake and sub-main distribution arrangement serving multiple flats within the building. The installation comprises equipment of varying ages and specifications, indicating phased historic upgrades to individual flats rather than wholesale renewal of the wider building infrastructure. Whilst no intrusive investigations were undertaken, the mixed-age nature of the installation may necessitate further assessment of available load capacity and compatibility should substantial electrical upgrades be proposed within the subject flat.
