# 37 North Road, N6: Interim visit to review initial stabilisation repairs

**Site note 2 for 26 February 2026, job no. 162-58**

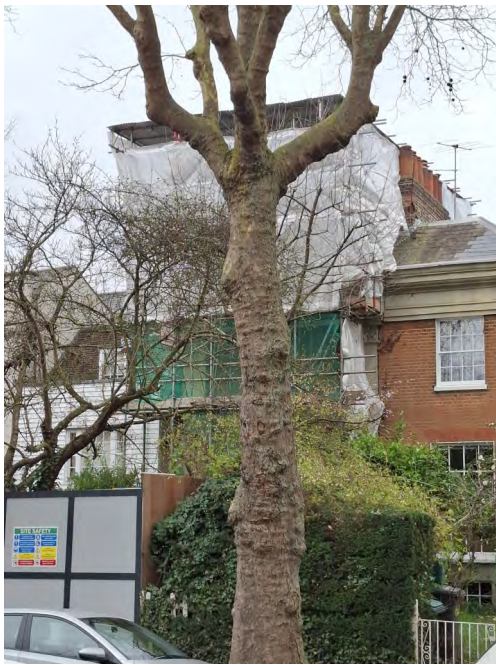
**Fig 1:**

East frontage; temporary scaffold roof and enclosure in place to protect structure and allow drying during refurbishment works (there had previously been severe roof leaks)

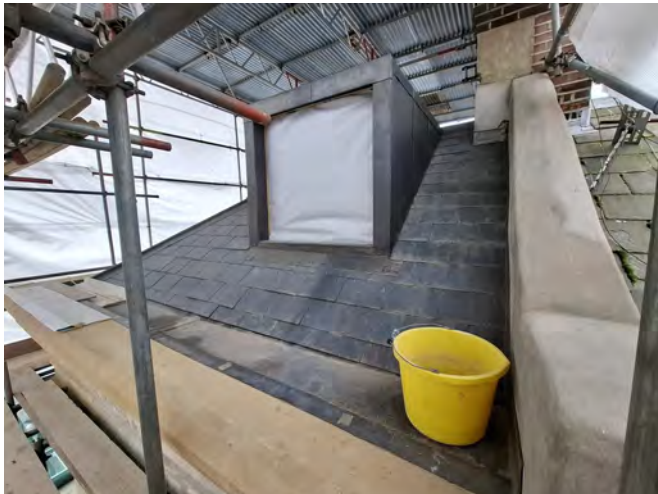
**Fig 3:**

Roof, east pitch; traditional repair materials (Welsh slate, lead sheet, lime render) nearing completion. Final upstand detail and flashing pending upon cornice

- 3     *Lead flashing chases need to be sealed around the roof perimeter*
- 4     *Front gutter ledge pending upstand and cornice flashing in lead*
- 5     *110mm dia. roof drainage pipework recommended in cast iron*

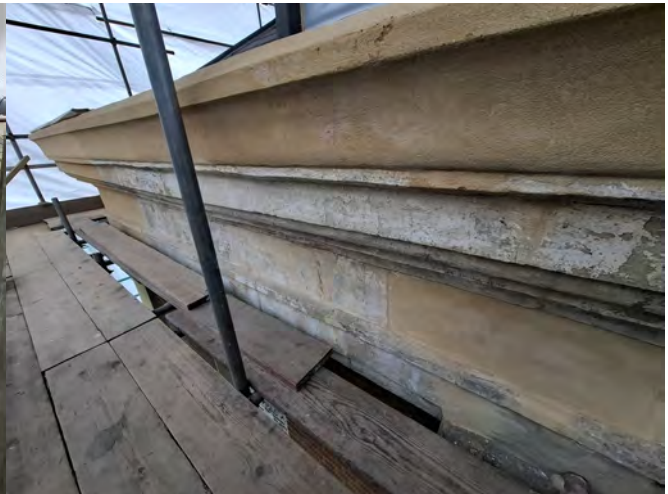
**Fig 4:**

East frontage, cornice; lime render repairs complete. Final cosmetic render touch-ups and paintwork (breathable mineral silicate system) pending

- 10    *Ivy roots to be burnt off and bricks cleaned at frontage (suggest Rockman provide a trial panel first)*
- 11    *Minor render repairs prior to painting at high level frontage*

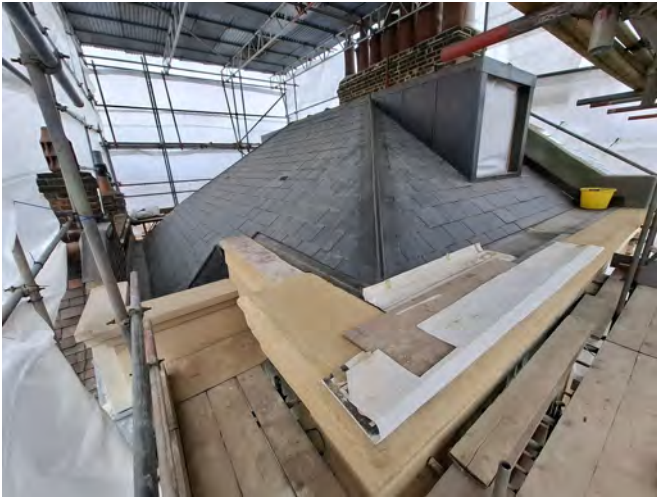
**Fig 5:**

Roof, south pitch; repairs nearing completion. Lead flashing and paintwork pending for wallheads

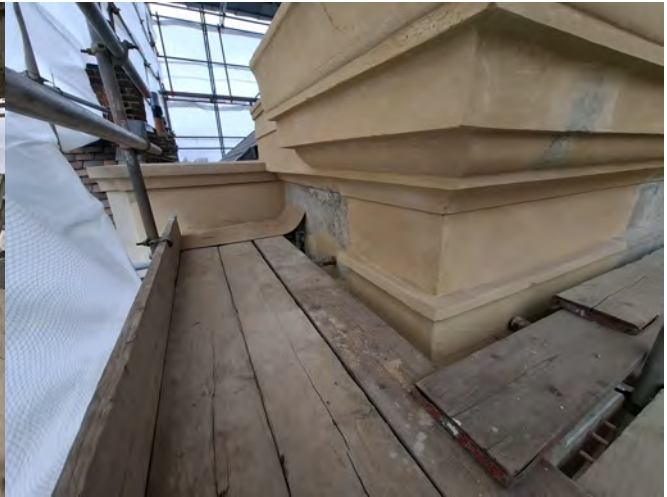
**Fig 6:**

South flank; refurbished render pending touch-ups and paintwork

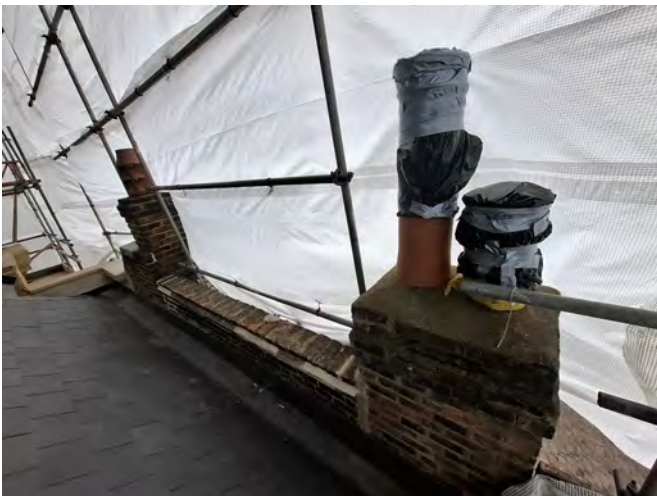
**Fig 7:**

Roof, south pitch; chimneys on party wall line temporarily closed. Mortar repairs completed to wall head

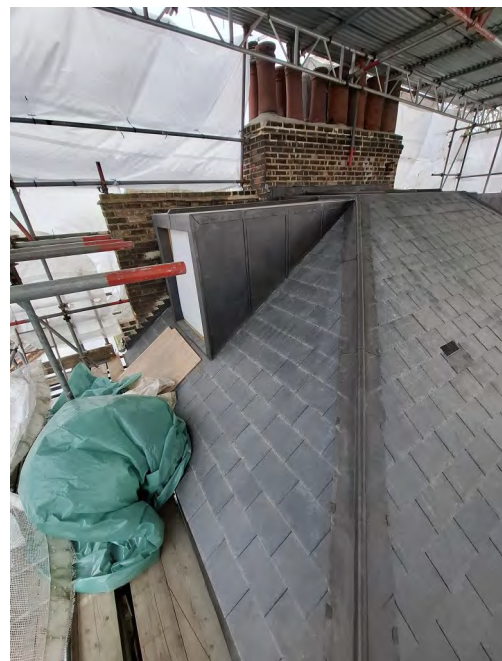
**Fig 8:**

Roof, south and west pitches; slate, lead and brickwork repairs nearing completion. Remedial works to chimneypots pending. Slate vents in south pitch recommended for removal

- 1     *Asbestos chimney pot cowl to be removed under controlled conditions*
- 2     *Damaged historic chimney pot to be replaced (I will track down a company I have come across before)*

- 6     *Pitch vents (2no) recommend to be removed and slated whilst installing roof maintenance access window*
- 7     *Recommended roof build-up will be insulation between and under rafters, leaving 50mm gap below slate membrane, and providing VCL below insulation before plastering. The roof shape is complex so the VCL needs to be very carefully installed and verified before plastering starts*

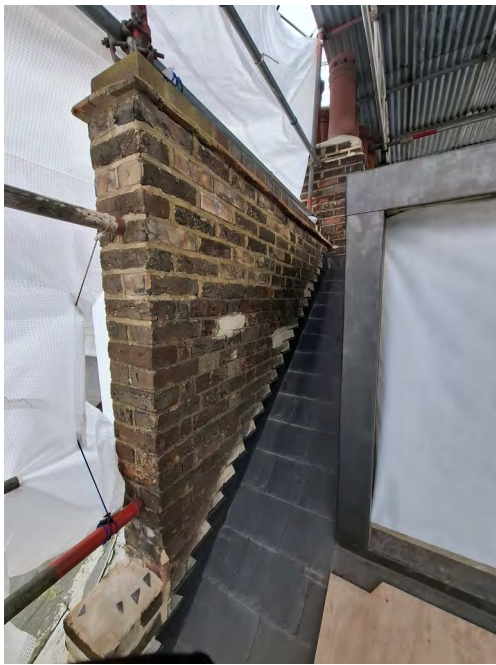
**Fig 9:**

Roof, west pitch; repairs nearing completion. Seal for mortar chases at lead flashing was pending

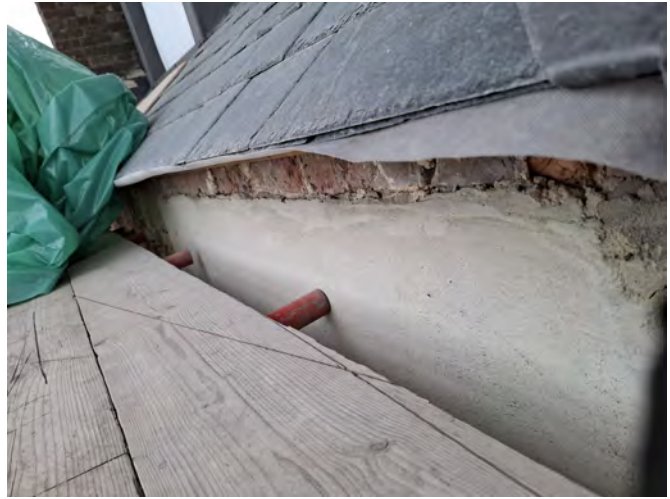
**Fig 10:**

Roof, west pitch; repairs nearing completion. Traditional welsh slate with modern breather membrane as a fail-safe underlay. Cast iron eaves gutter was pending

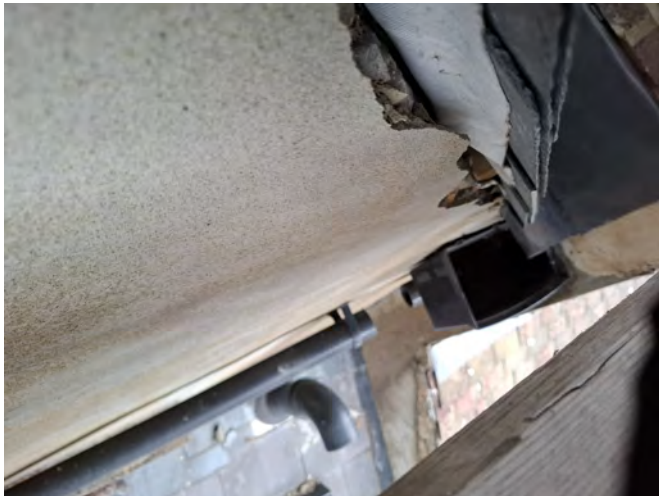
**Fig 11:**

Roof, west pitch; render to be patched upto underside of slate verge. Cast iron rainwater goods pending

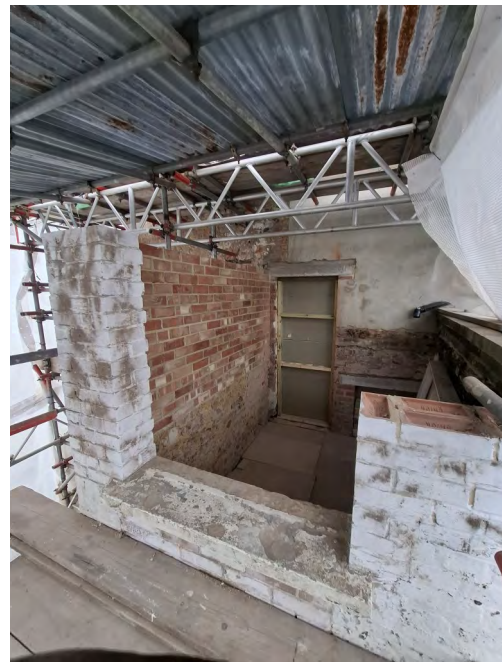
**Fig 12:**

Rear (west) elevation; replacement of decayed outshot roof pending. Consolidation of brickwork pending along with render and/or breathable paint finish

- 8     *Render and paint pending at rear elevation, cracked sill to be repaired*
- 9     *Lead flashing suggested for first floor window sill (south-east) or use of a stone element*

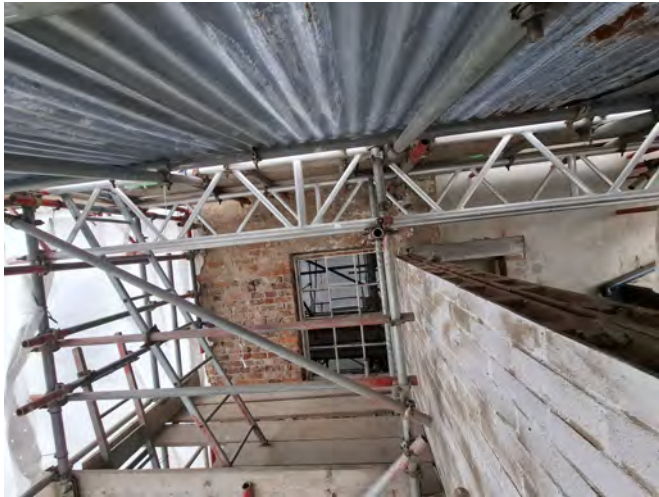
**Fig 13:**

Rear (west) elevation; render and breathable paint finish pending (previous poor quality render coating had comprehensively failed by debonding)

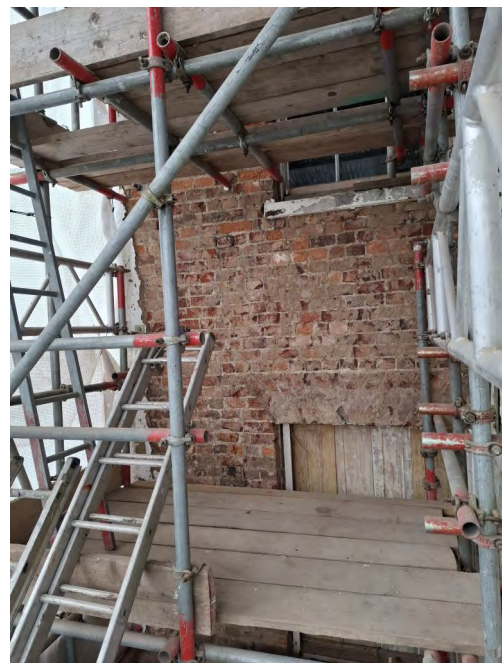
**Fig 14:**

Rear (west) elevation; render and breathable paint finish pending

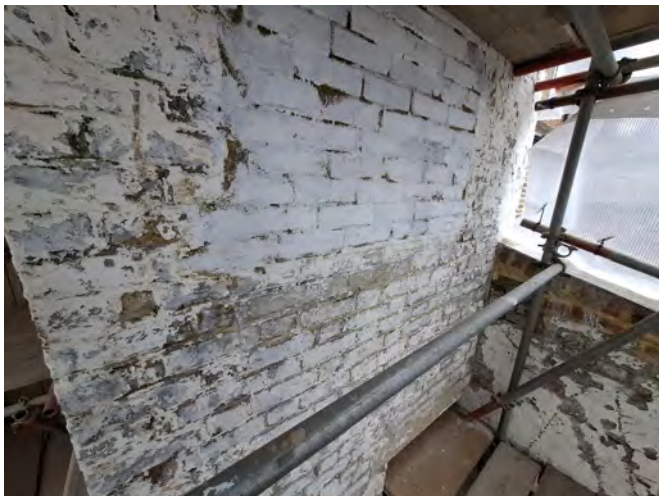
**Fig 15:**

Rear (west) elevation; render and/or breathable paint finish on outshot remained pending

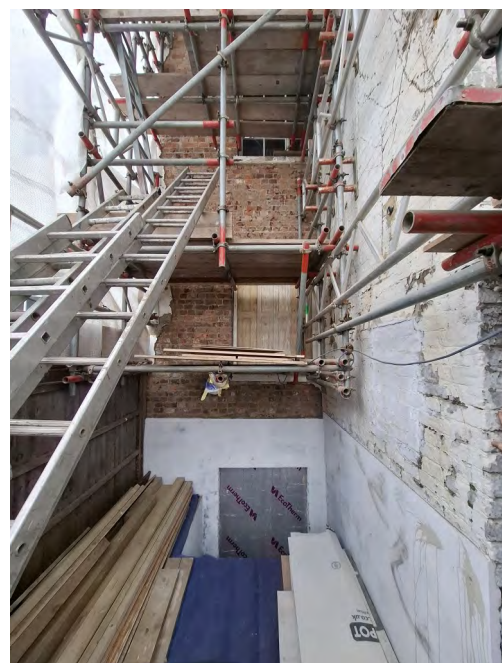
**Fig 16:**

Rear (west) elevation; render and breathable paint finish pending. Window joinery refurbishment pending

- 16    *Ensure all window and door frames are repaired and isolated from brick reveals using strips of DPM. External mortar weatherseals can be completed once frames are back in-situ*

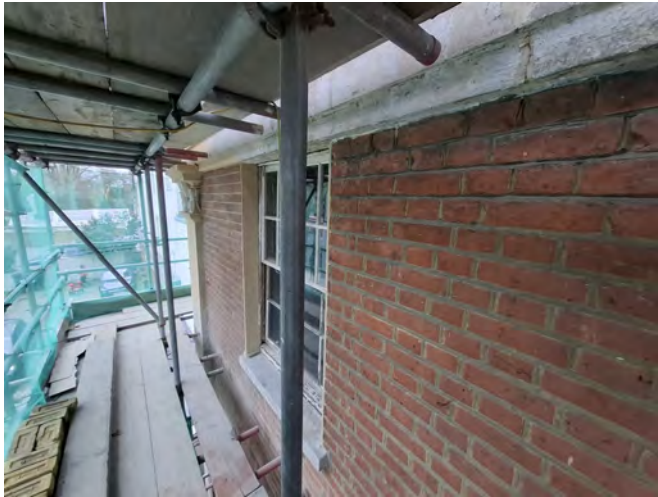
**Fig 17:**

East frontage, first floor; masonry repairs nearing completion

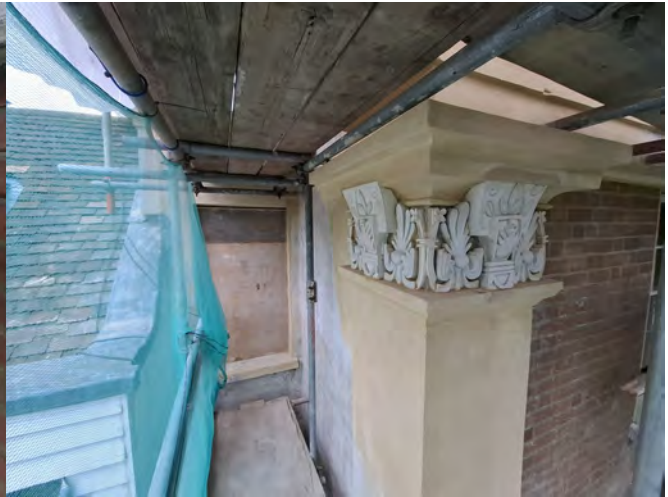
**Fig 18:**

East frontage, first floor; render capital repair nearing completion (pending breathable paint finish). Render sill on inset window suggested to be flashed in lead or replaced in stone for durability/resilience)

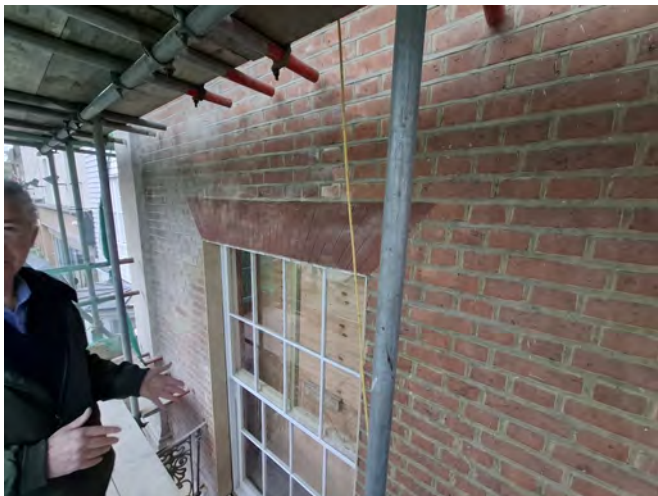
**Fig 19:**

East frontage, ground floor; render weatherseal at window reveal to be re-done once joinery refurbishment has been completed. Specialist cleaning of salt/damp staining and ivy roots pending

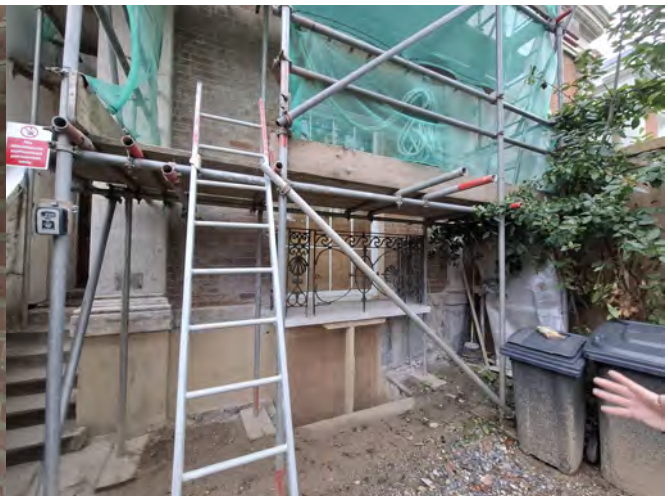
**Fig 20:**

East frontage, ground floor; refurbishment of stone balcony nearing completion (pending iron balustrade repairs and re-attachment to stone slab and brick elevation)

- 12    *Areas of render replacement needed for frontage low level (flank wall beside entrance and following proposed lightwell alterations)*
- 13    *Balcony balustrade to be restored, metal feet to be set into wall and stone ledge using lead caulking within dovetailed masonry pockets*

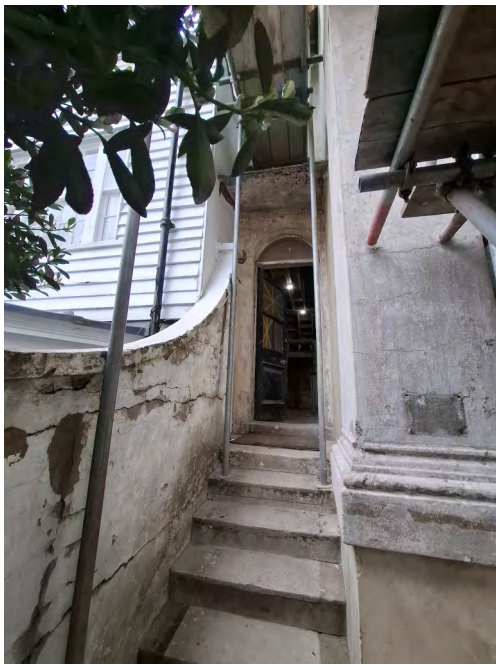
**Fig 21:**

East frontage, ground floor; render repairs to be re-done at flank wall. South boundary wall to be refurbished

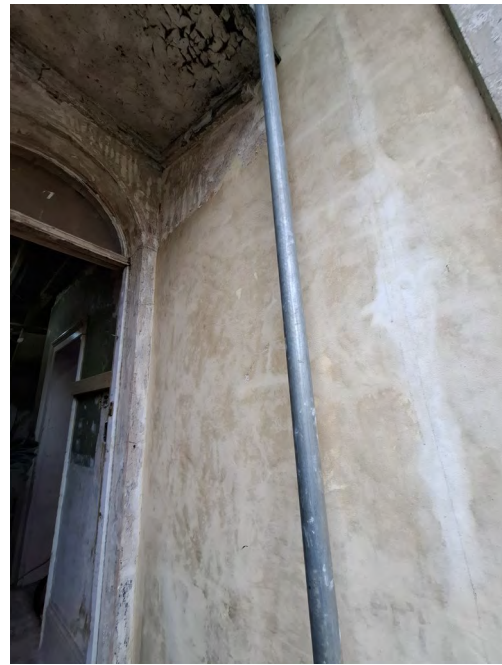
**Fig 22:**

East frontage, ground floor; render repairs to be re-done at flank wall (recent skim applied has not bonded)

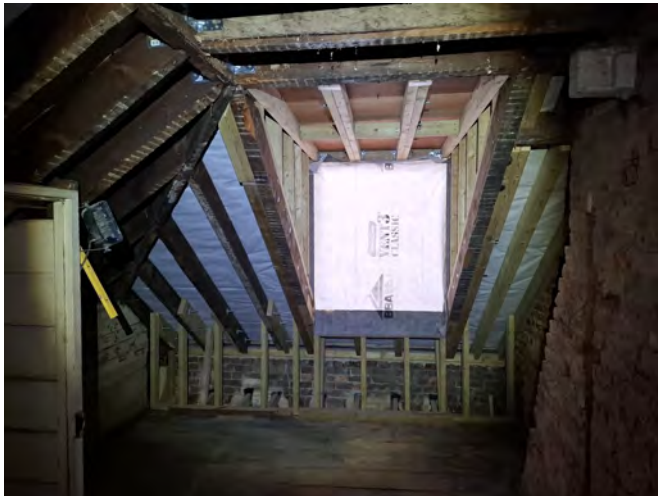
**Fig 23:**

Second floor (attic), east side; piece-in timber repairs complete at interface with dry rot infected wallhead

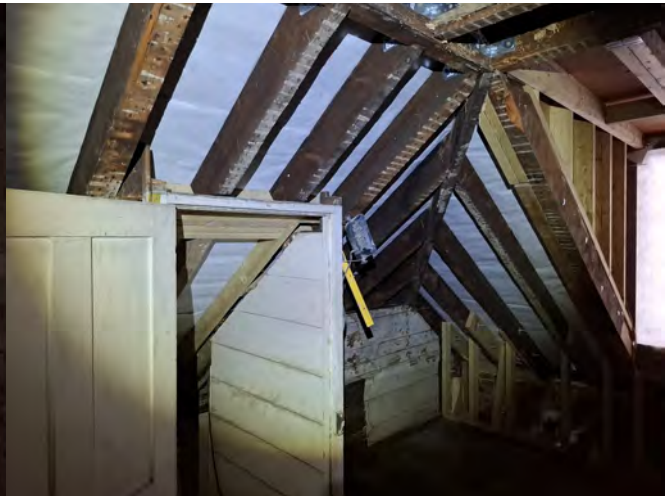
**Fig 24:**

Second floor (attic), west side; piece-in timber repairs complete at interface with dry rot infected wallhead

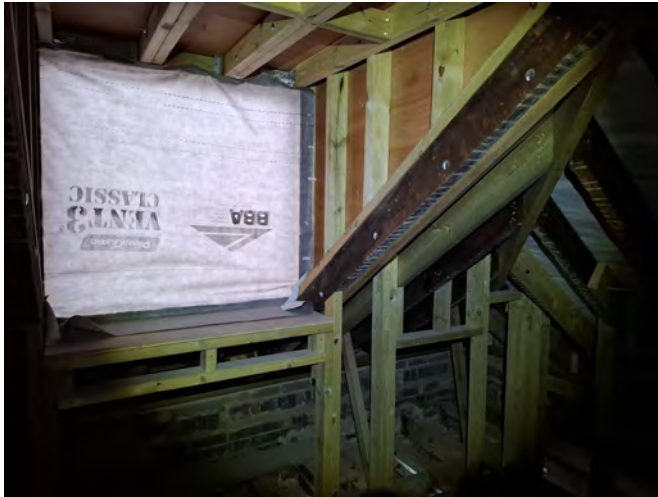
**Fig 25:**

Second floor (attic), west side; piece-in timber repairs complete at interface with dry rot infected wallhead

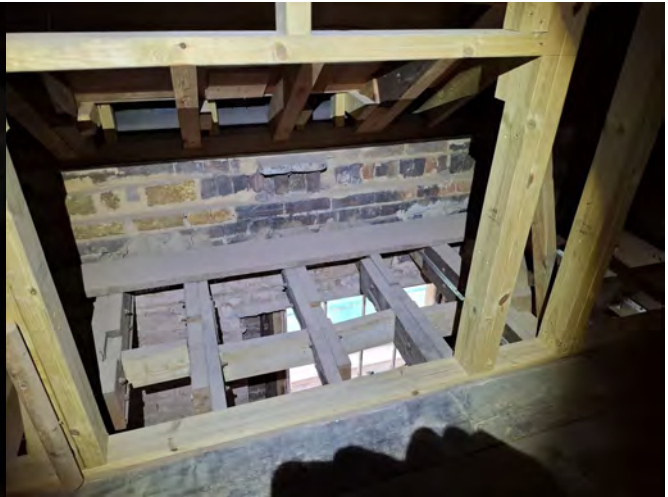
**Fig 26:**

Second floor (attic), west side; piece-in timber repairs complete at interface with dry rot infected wallhead. Rafter feet and floor joists isolated from the brickwork using DPM

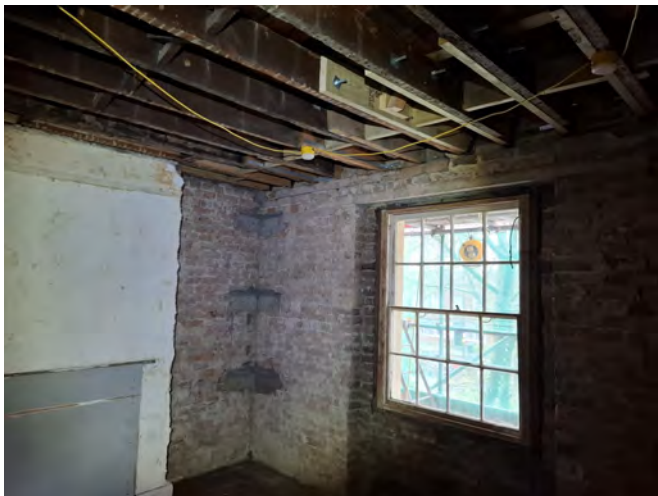
**Fig 27:**

First floor, east side; piece-in timber repairs complete at interface with dry rot infected wallhead (underside of second floor). Corner ties installed to connect frontage to party wall

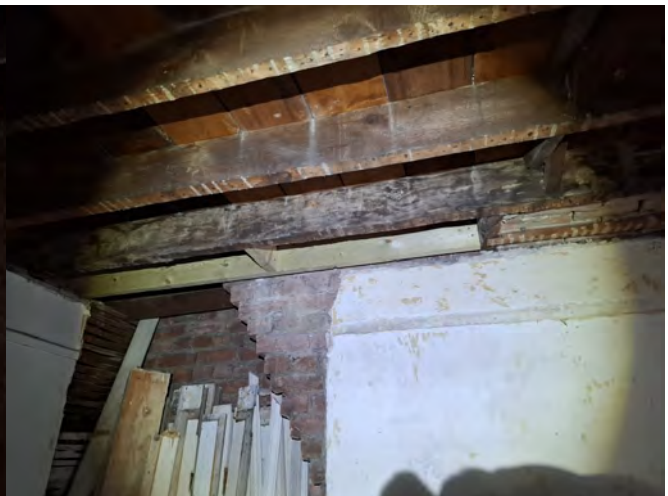
**Fig 28:**

First floor, north side; piece-in timber repairs complete (underside of second floor)

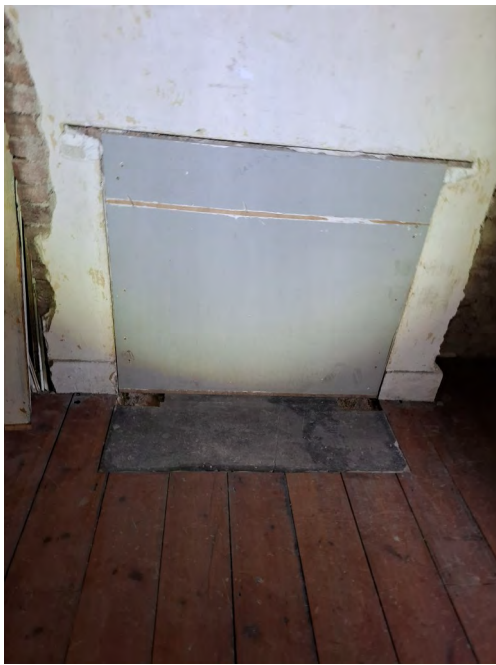
**Fig 29:**

First floor, east side; temporary boarding on fireplace pending removal for reinstatement of a chimneypiece and trickle ventilation up the flue

- 15    *Fireplaces at all (4no) floor levels are recommended to remain open to provide trickle ventilation of interiors. Intumescent baffle grilles can be fitted into the base of flues to moderate airflow volume*

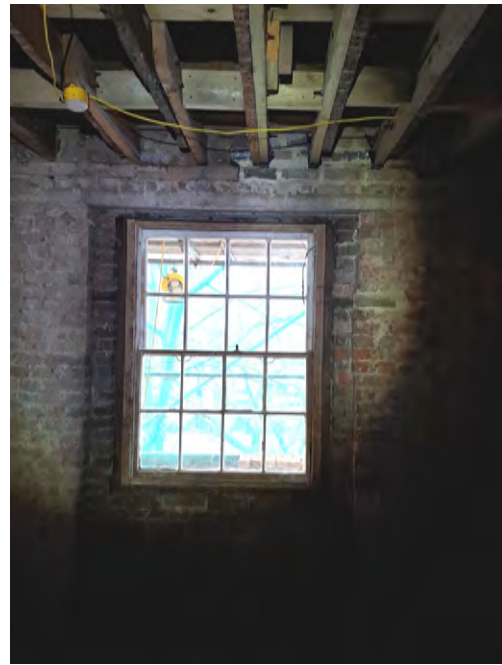
**Fig 30:**

First floor, east side; decayed timber lintel replaced in concrete due to latent decay risk

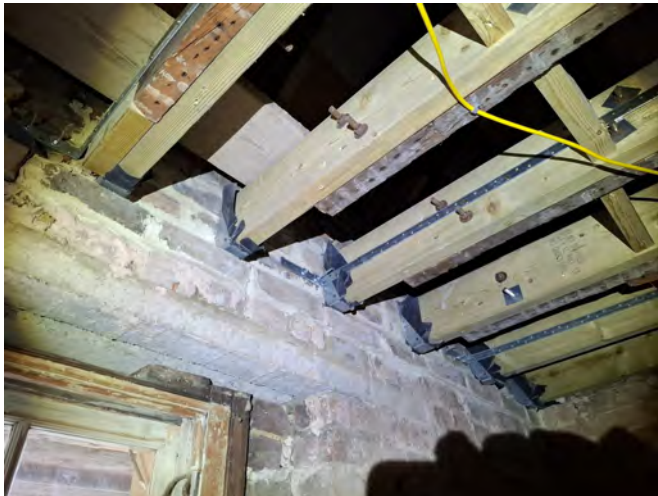
**Fig 31:**

First floor, east side; piece-in timber repairs complete at interface with dry rot infected wallhead (note protective isolation detailing underside of second floor)

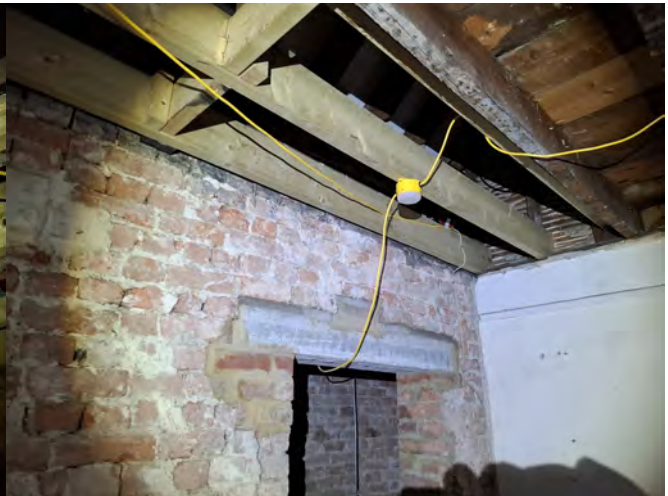
**Fig 32:**

First floor, south side; piece-in timber repairs complete at interface (underside of second floor). Decayed timber lintel replaced in concrete due to latent decay risk

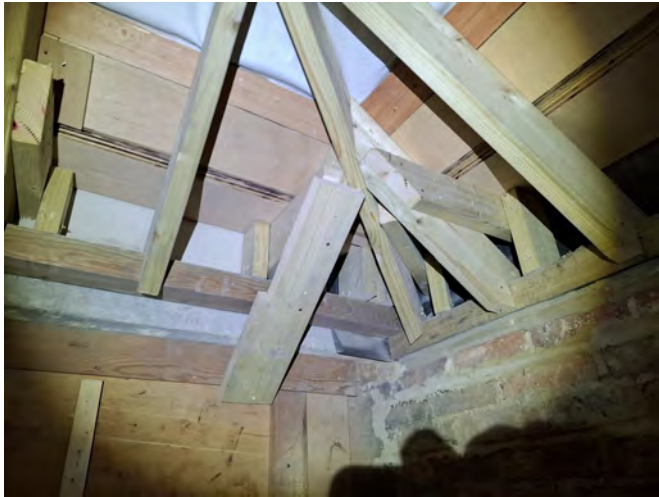
**Fig 33:**

First floor, south side; piece-in timber repairs complete at interface with dry rot infected wallhead (underside of roof). Decayed timber lintel replaced in concrete due to latent decay risk

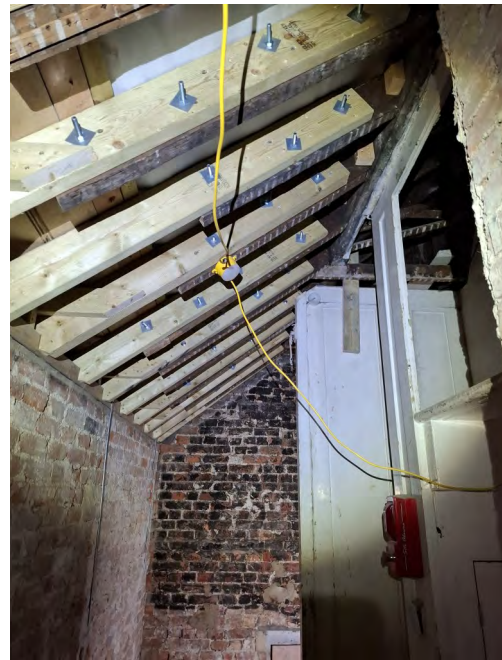
**Fig 34:**

First floor, south side; piece-in timber repairs complete at interface with dry rot infected wallhead (underside of roof)

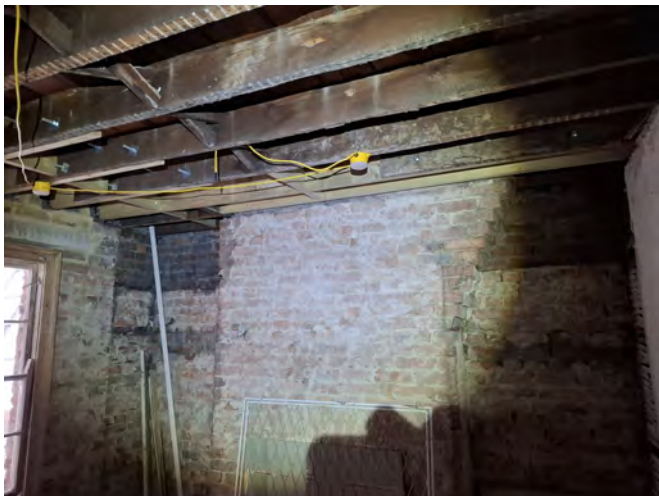
**Fig 35:**

First floor, west side; temporary boarding on fireplace pending removal for reinstatement of a chimneypiece and trickle ventilation up the flue

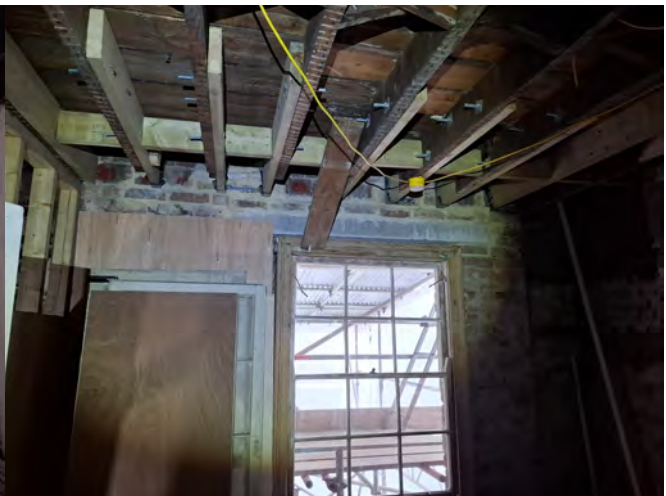
**Fig 36:**

First floor, west side; piece-in timber repairs complete at interface with dry rot infected wallhead (underside of second floor). Decayed timber lintel replaced in concrete due to latent decay risk

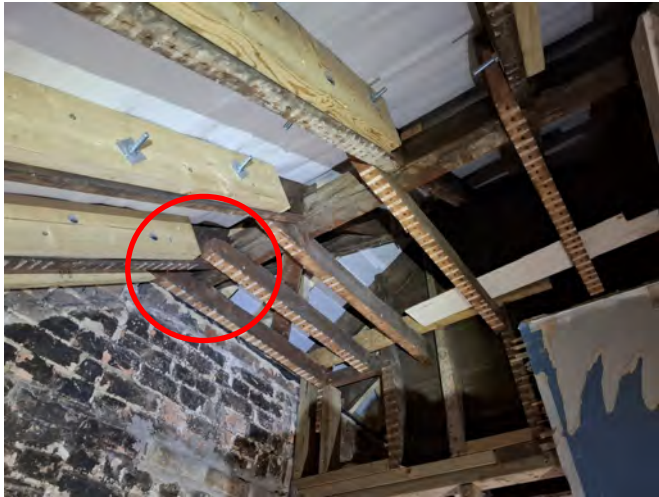
**Fig 37:**

First floor, west side; underside of roof structure

Tie beam into rear elevation does not appear sufficiently attached—reinforcement suggested

- 14    *There is a tie beam in the roof structure over the stairwell which H+R suggest is provided with a restraint connection to the brickwork of the rear wall*

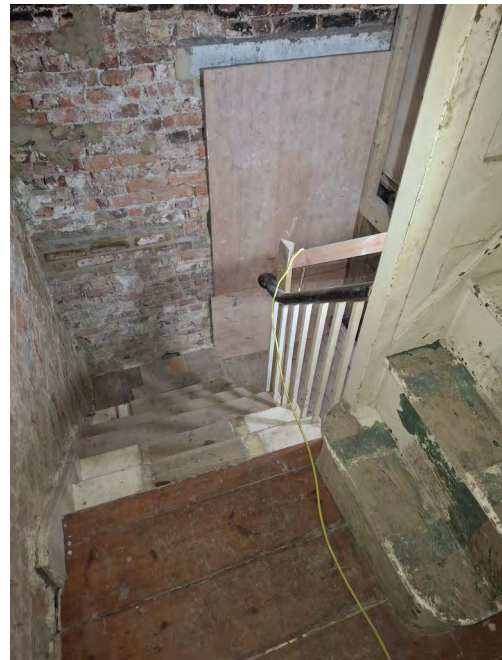
**Fig 38:**

First floor, west side; stairwell

Repair and isolation of stair landing was pending. Decayed timber lintel replaced in concrete due to latent decay risk

- 17    *All staircase landings to be reinstated with DPM isolation from brickwork*

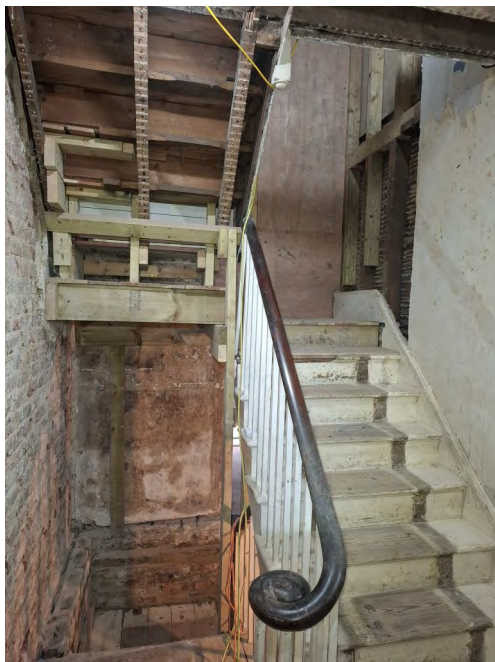
**Fig 39:**

Ground floor, west side; stairwell

Repair and isolation of stair landing was pending

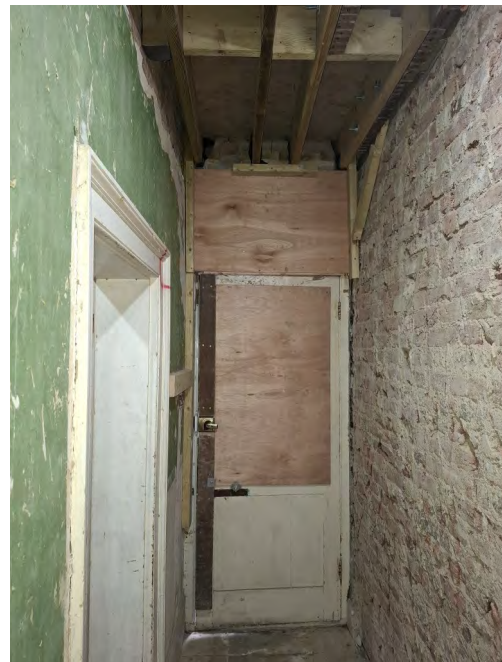
**Fig 40:**

Ground floor, east side; front door frame replacement and isolation pending. Overhaul of door leaf pending

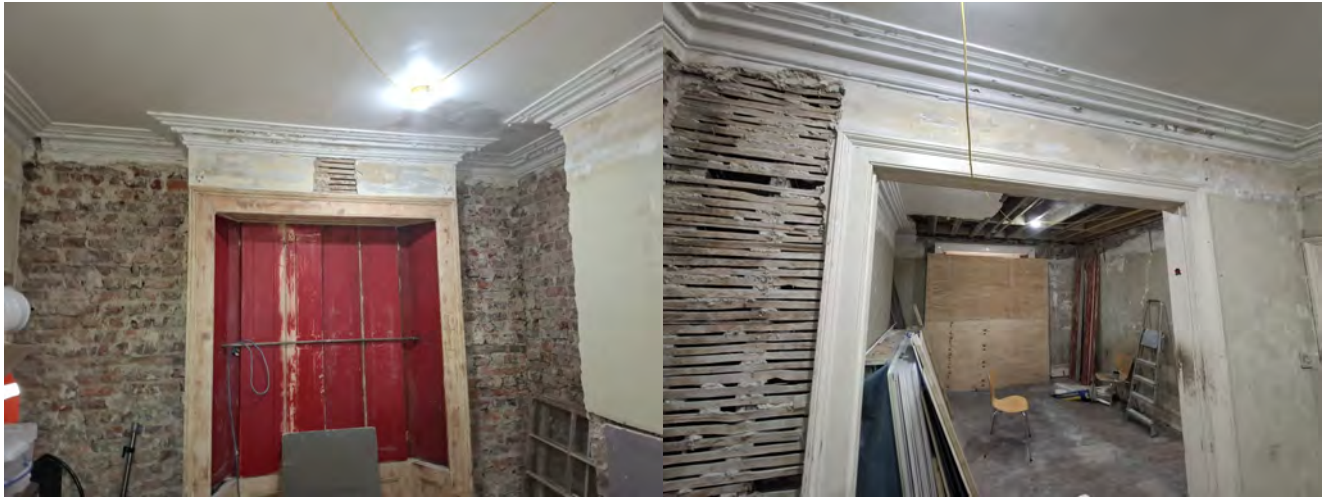
**Fig 41:**

Ground floor, west side; damaged plaster removed to encourage drying (reinstatement pending)

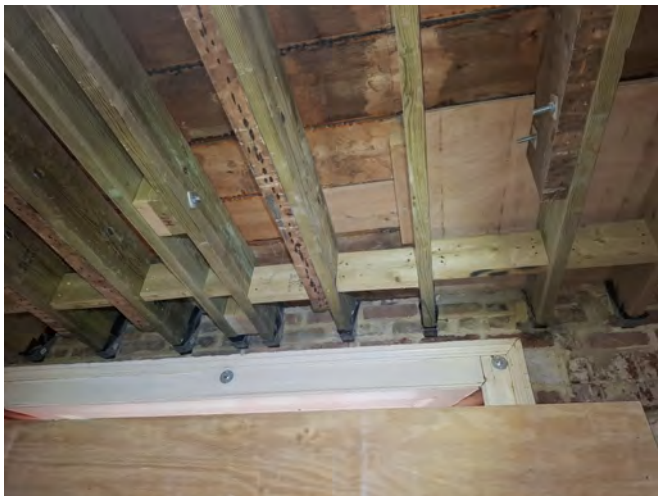
**Fig 43:**

Ground floor, east side; piece-in timber repairs complete at interface with dry rot infected wall (underside of first floor). Decayed timber lintel replaced in concrete due to latent decay risk

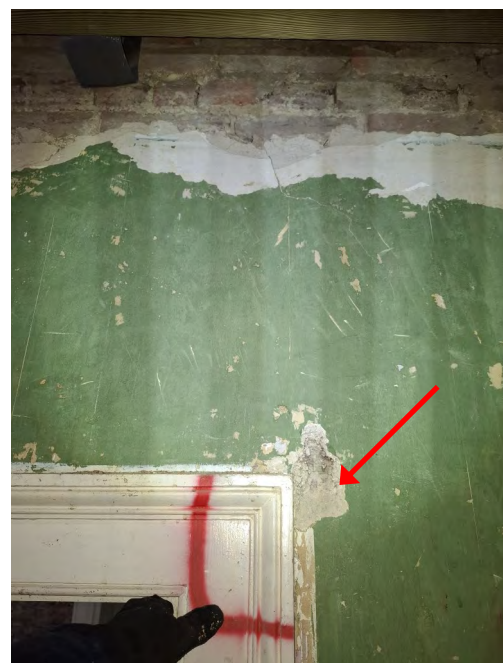
**Fig 44:**

Ground floor, south side; internal door lintel previously suspected to be vulnerable to decay was exposed and confirmed to be dry and free of decay (suitable for retention in-situ)

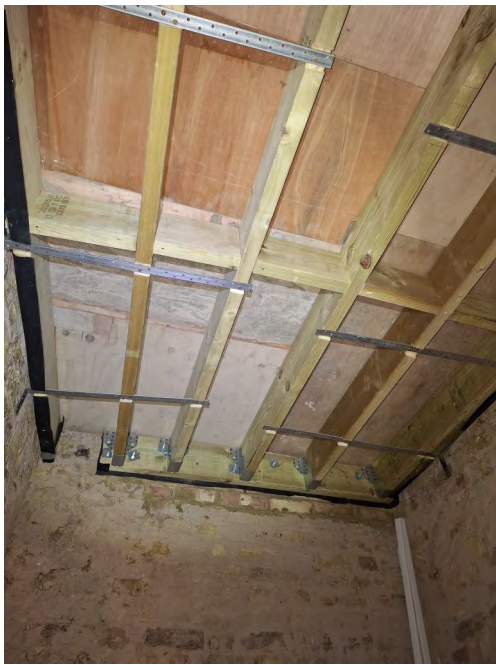
**Fig 45:**

Ground floor, west side; underside of first floor in outshot wing. New timbers isolated from the dry rot infected brickwork to mitigate against recurrence of decay

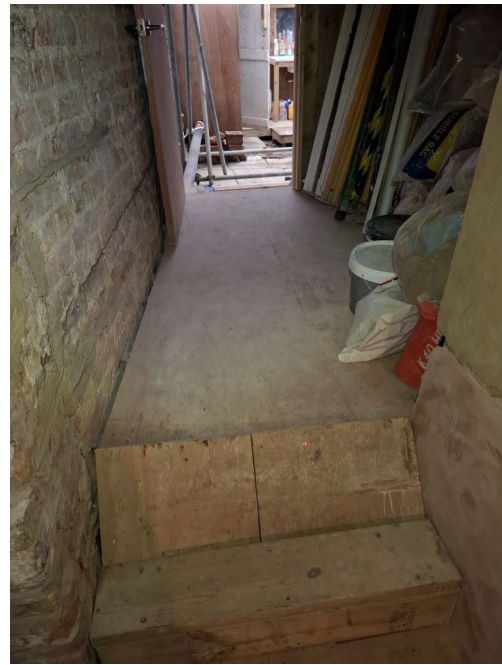
**Fig 46:**

Ground floor, west side; floor in outshot wing. New timbers isolated from the dry rot infected brickwork to mitigate against recurrence of decay

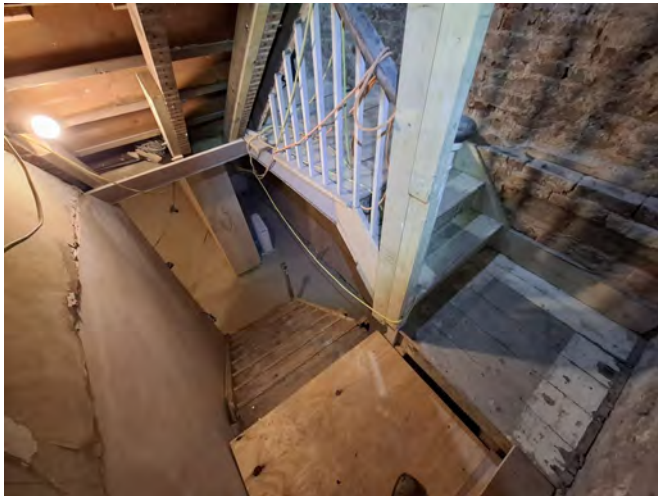
**Fig 47:**

Ground floor, west side; stairwell

Repair and isolation of stair landing was pending

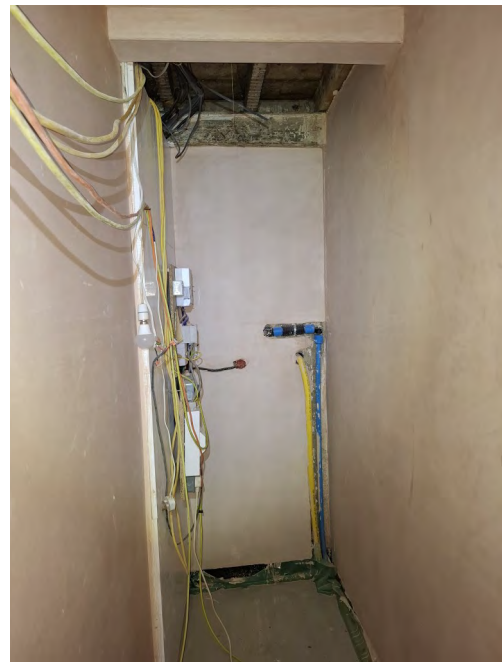
**Fig 48:**

Basement, south side; completion of remedial wall and floor linings to isolate interiors from damp affected and dry rot infected brickwork structure behind

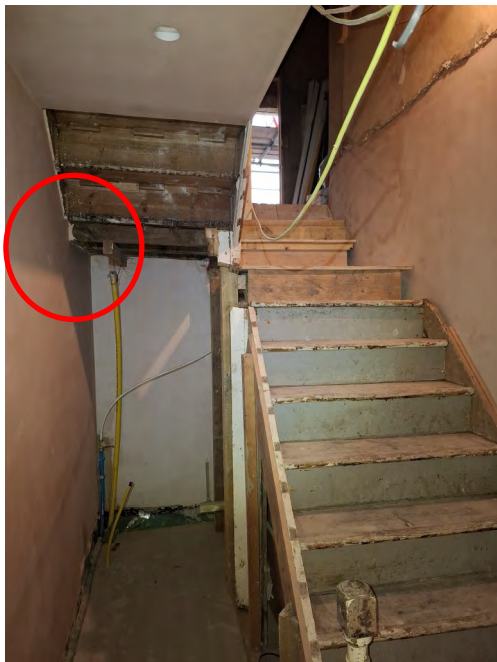
**Fig 49:**

Ground floor, west side; stairwell  
Repair and isolation of stair landing was pending.  
All new and existing joists bearing into brickwork recommended for isolation

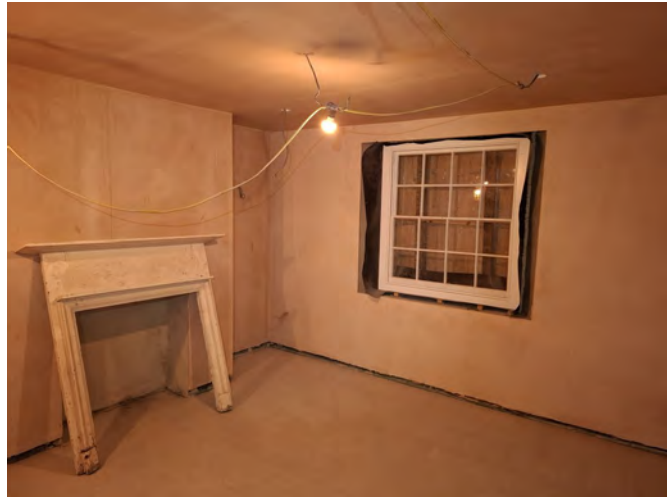
**Fig 50:**

Basement, east side; completion of remedial wall, window and floor linings to isolate interiors from damp affected and dry rot infected brickwork structure behind. Fireplace and ventilation detail pending

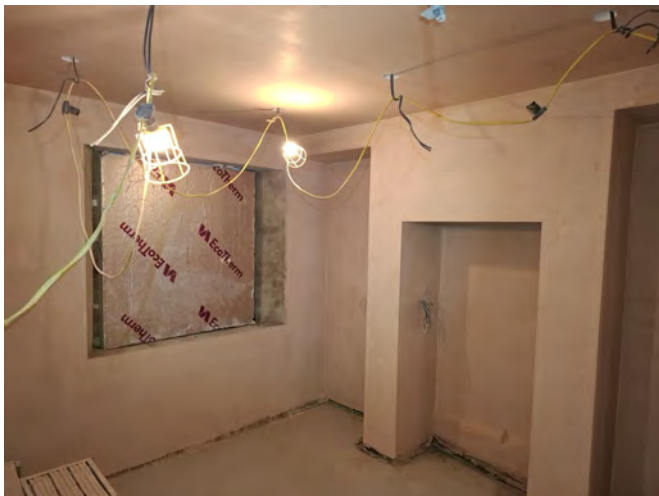
**Fig 51:**

Basement, west side; completion of remedial wall, window and floor linings to isolate interiors from damp affected and dry rot infected brickwork structure behind. Fireplace and ventilation detail pending

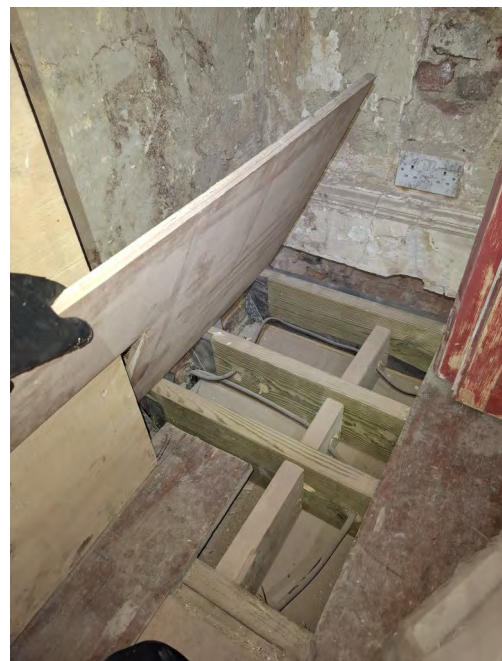
**Fig 52:**

Ground floor, east side; confirmation of completed timber repair and isolation detail for floor joists to mitigate against decay recurrence in dry rot infected brickwork
