# **PROTECTED TREE REPORT (TREE WORKS)**

| <b>Application number</b> | HGY/2026/1717 |
| <b>Site Address:</b> | 1A Dukes Avenue Hornsey London N10 2PS |

| <b>Tree Inspector</b> | DM | <b>Date:</b> 22 <sup>nd</sup> July 2026 |

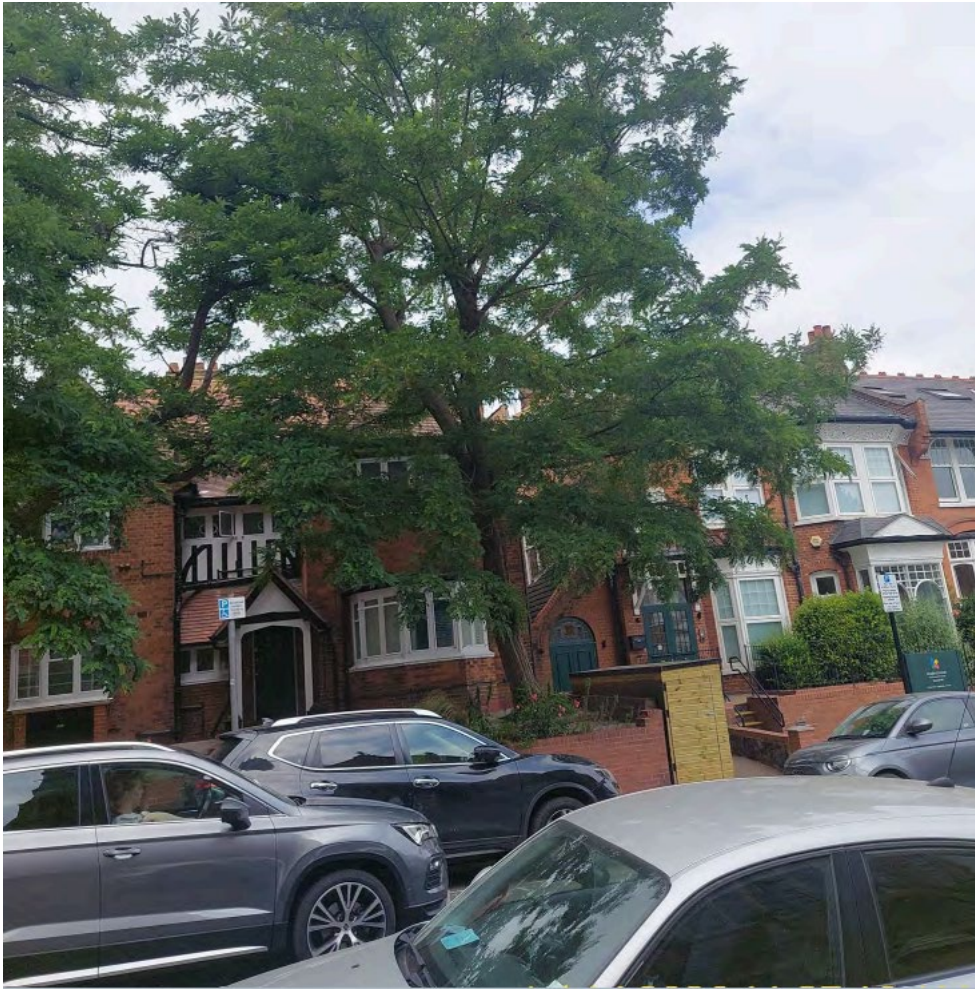
T1

The acute lean is at a 45° angle with perpendicular corrective growth within the crown. There is no recent lifting of the root bole, but direct damage has been caused over time to the surrounding area on the tension north side of the trunk.

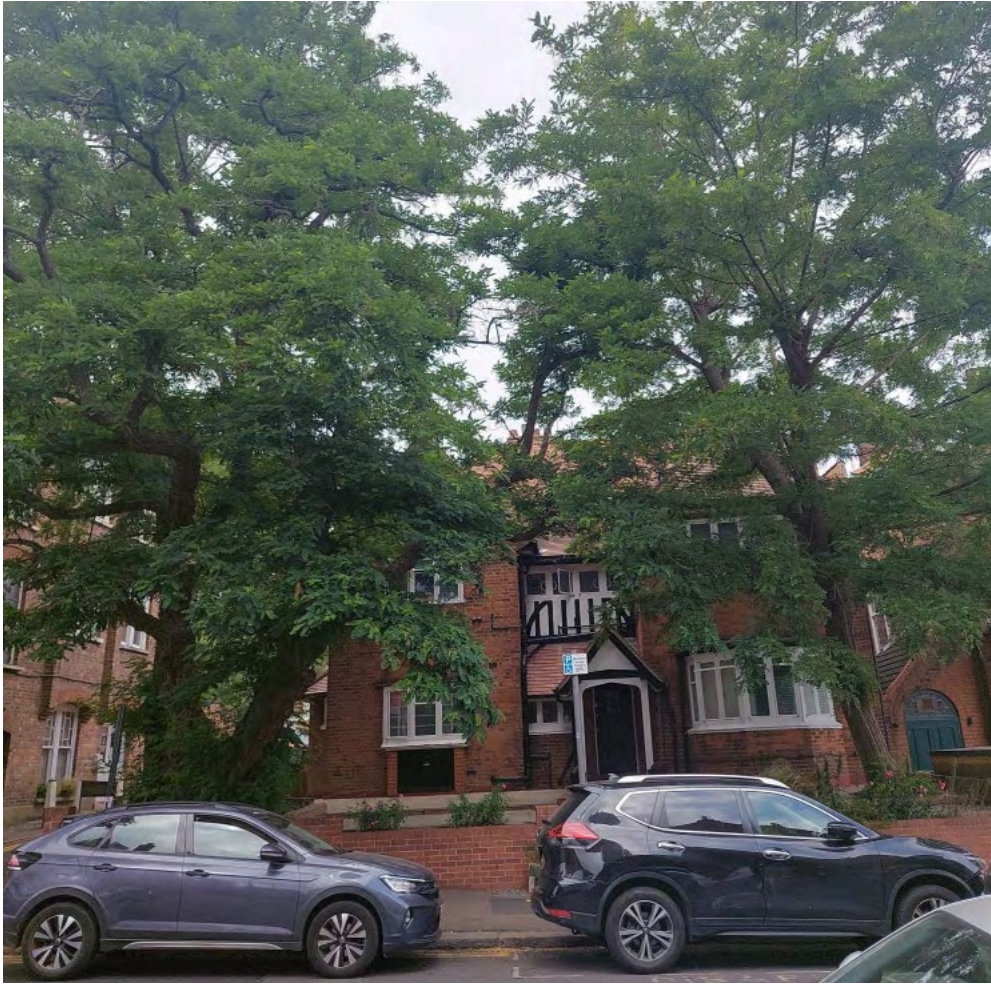
**T1 (right) & T2 (left)**

Both trees are adjacent and leaning out towards the footway, highway, and an adjacent children's nursery.

I hold no objections to the proposed crown reduction works to the larger Robina tree T2.

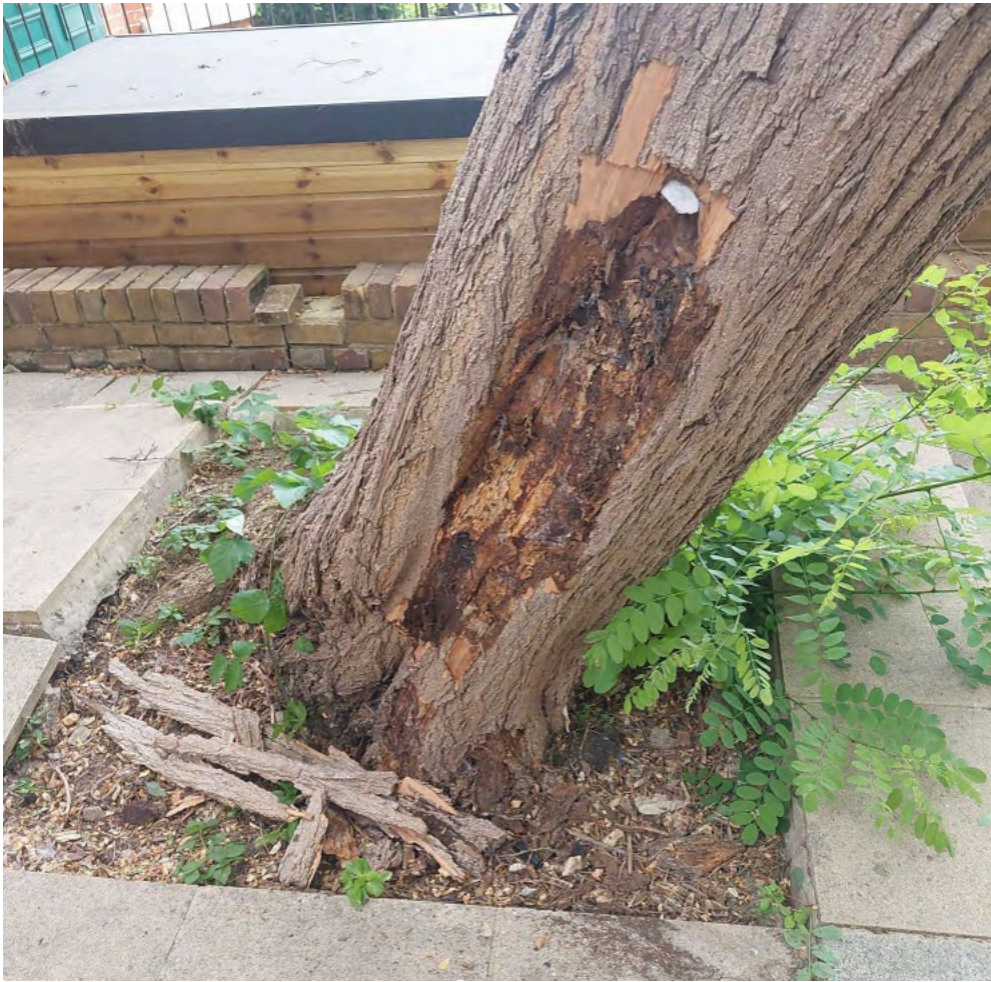
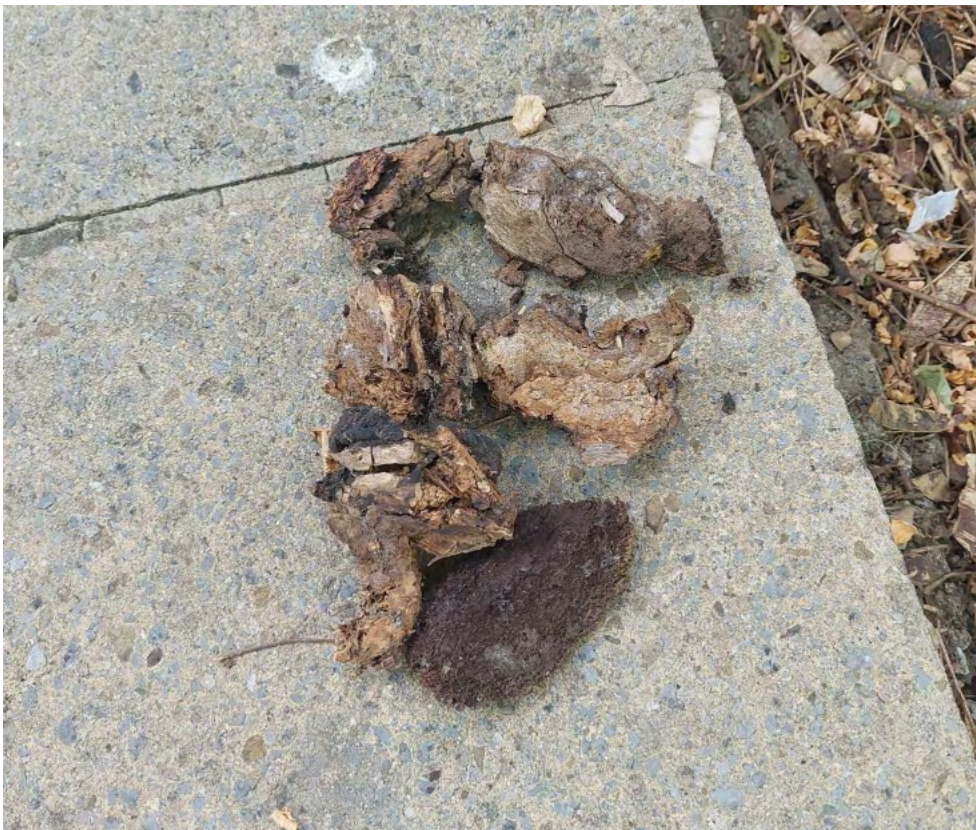
There is longitude cracking across the wood fibres low down on the west side of the stem and significant dead peeling bark plates.

Old fungus fruiting bodies were found at the base of the tree which were hard to identify. However, I am certain the fungus was the *Inonotus hispidus* (white/ soft rot mode of decay). There is mycelium activity under the bark and dead cambium.

**Dead peeling bark and old fungal fruiting bodies**

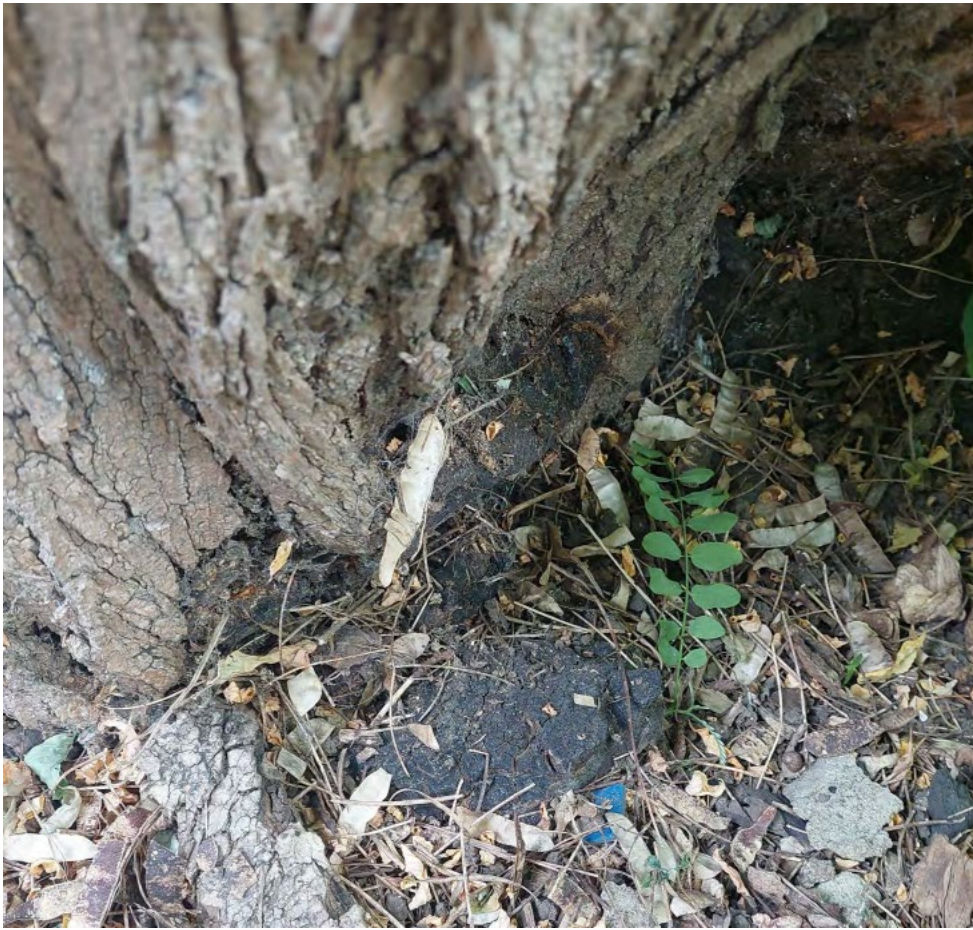
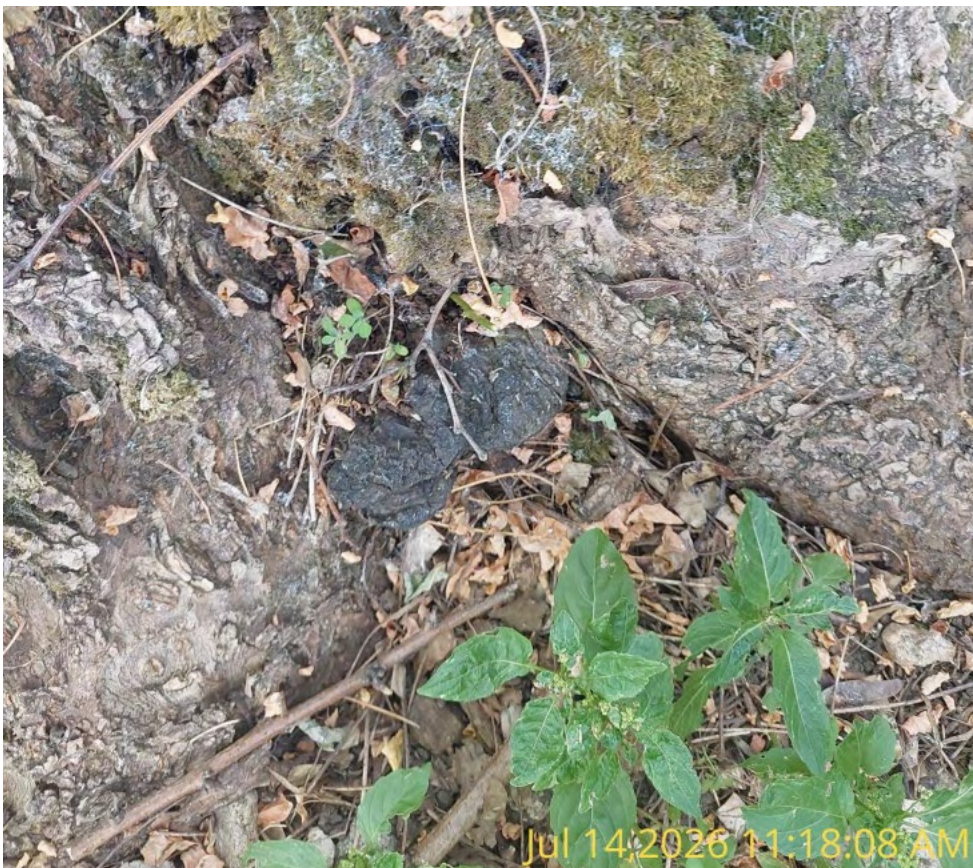
**Fungal fruiting bodies est side of the trunk**

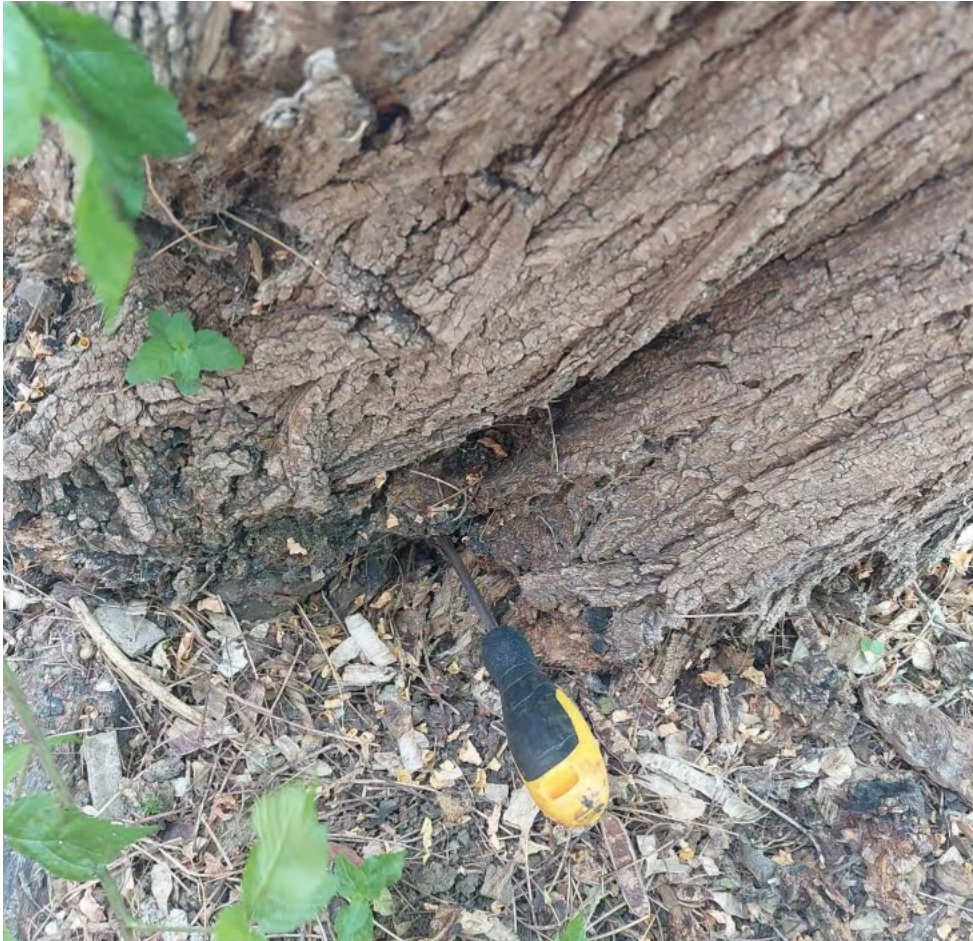
When probed with a 450mm probe, the decay was found to be extensive, with the probe lost within the trunk in all directions including down into the buttresses of the roots.

**450mm Probe west side of the trunk's base**

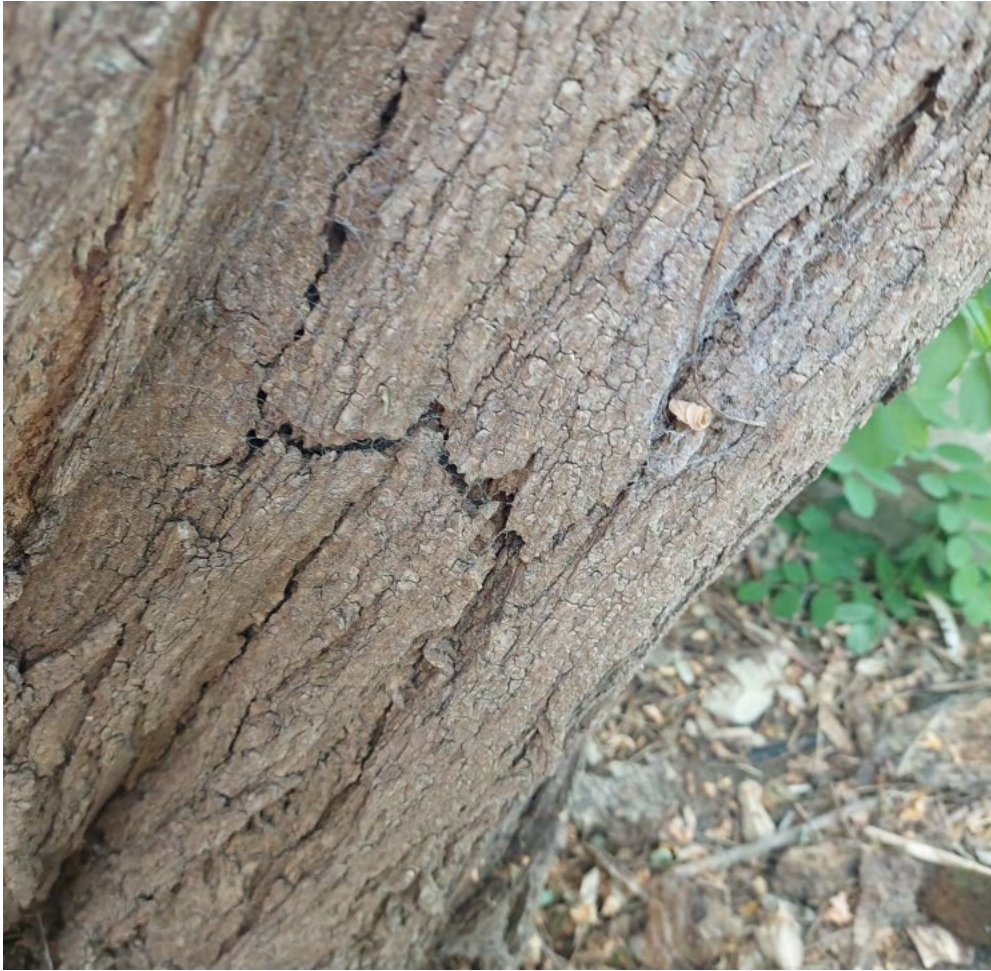
**Longitude cracking west side of the trunk**

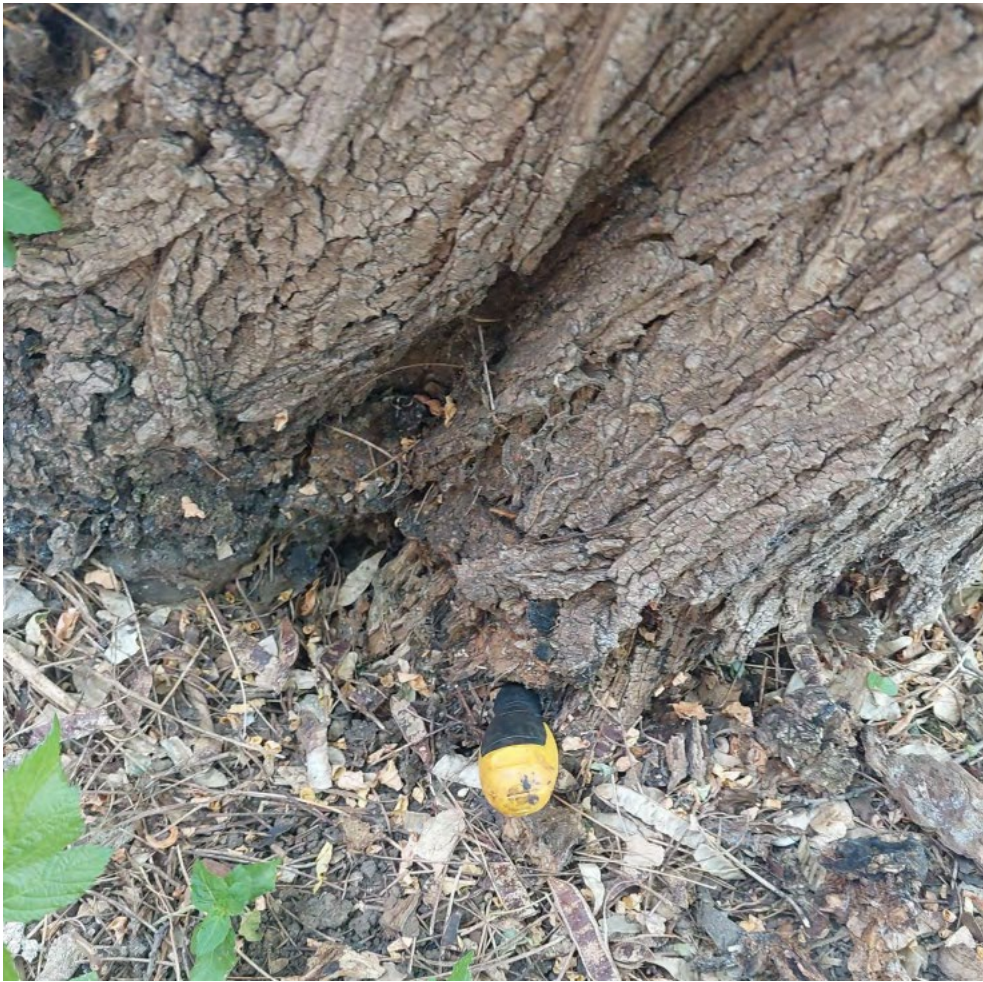
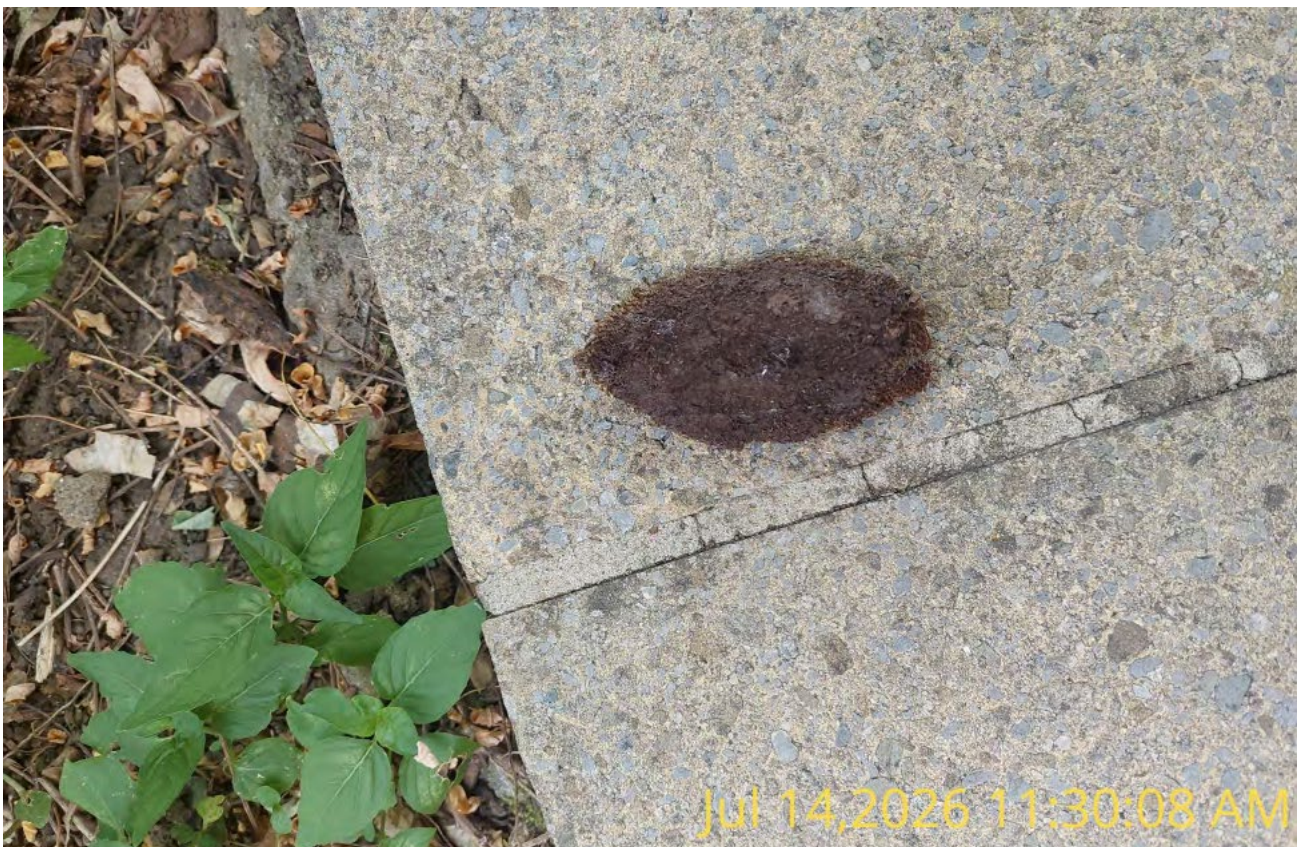
450mm Probe on south side of trunk and possible *Inonotus hispidus* fungus fruit

It is for the above observations, and reasons that I hold no objections to the removal of the Robinia tree T1.
