**Initial Assessment Report**

**Aviva Insurance**

Mrs June Barr  
55 Rosebery Road  
London

**Our Reference:** IFS-AVI-SUB-25-0123998

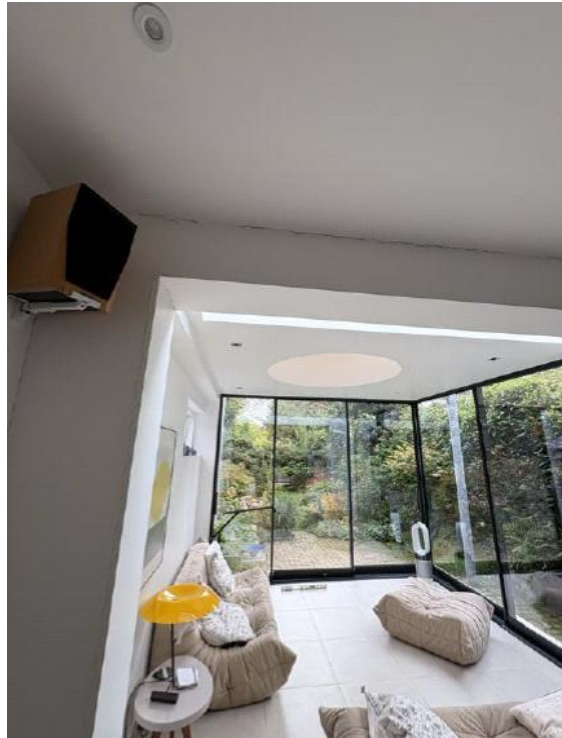
1

Cracking about support beam.

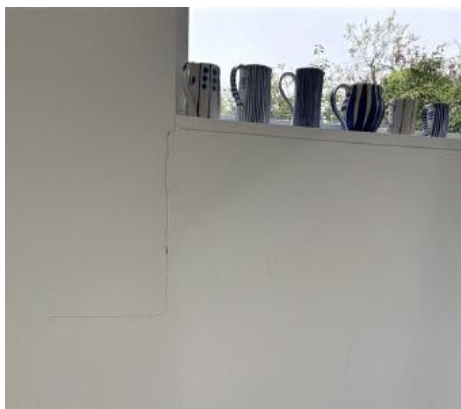
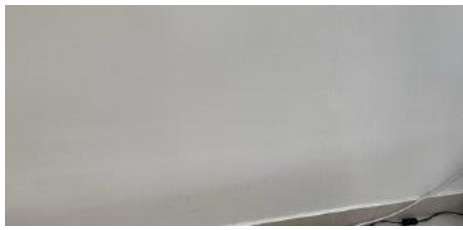
2

Cracking to extension wall

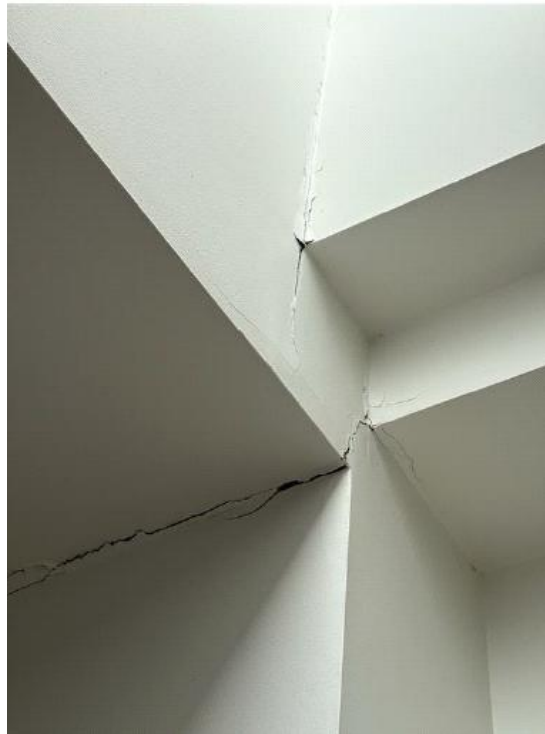
3

Close up of support beam seating
