# North London Reinforcement Project

Visual Condition Surveys  
Highway Access Points

| Location: | Watermead Way |
| DCO Ref: | AC71/AC72 |

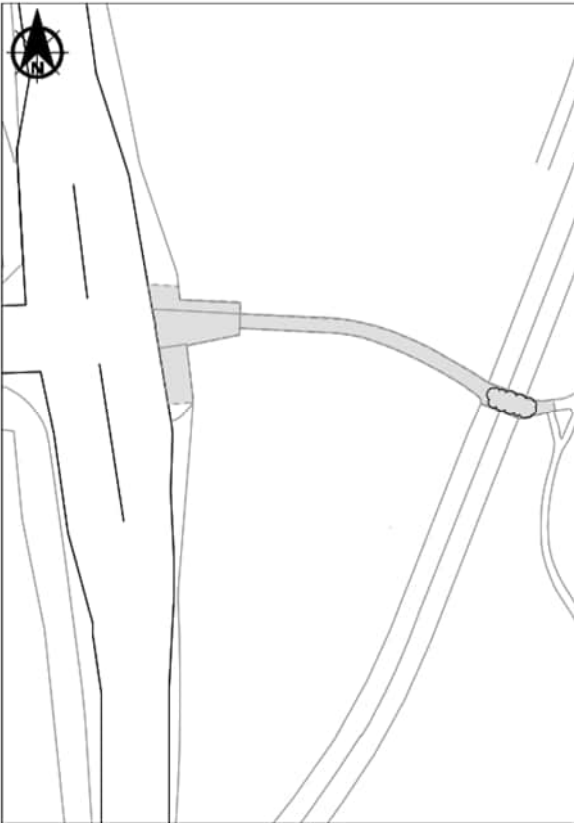
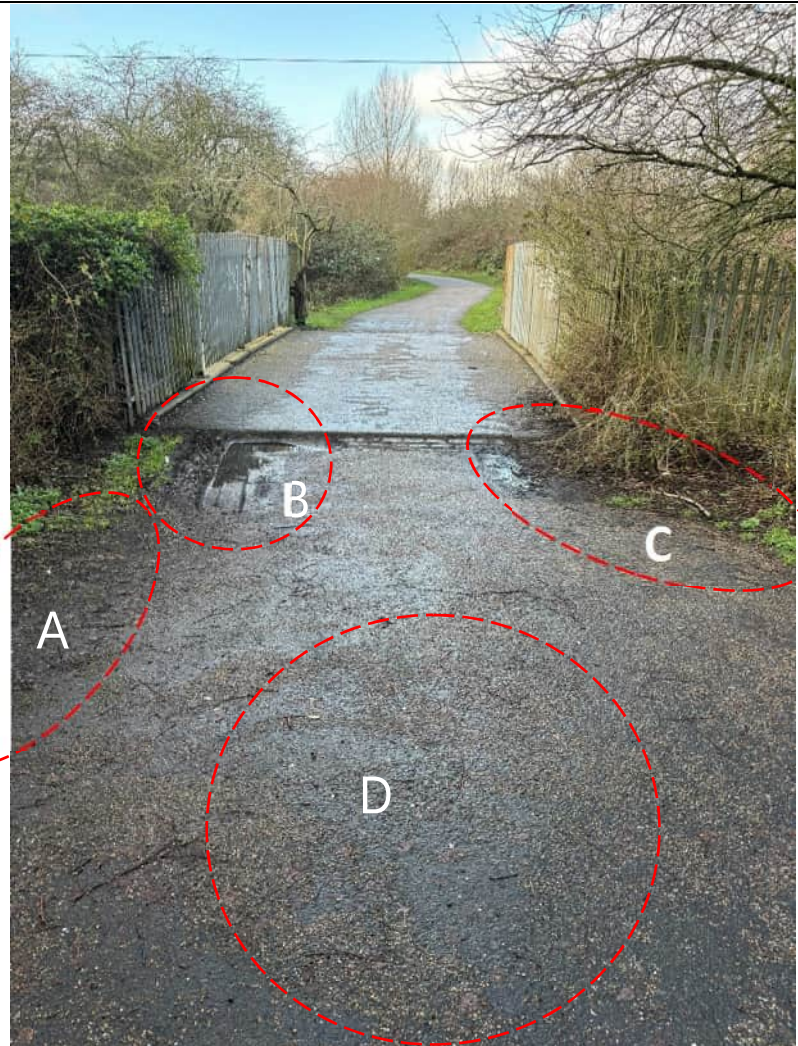
**Location 1**

- A. Evidence of surface dressing wear at edge of pathway.
- B. Evidence of water pooling on pathway surface.
- C. Evidence of surface dressing wear and vegetation encroachment onto pathway.
- D. Evidence of general surface wear on pathway surface.

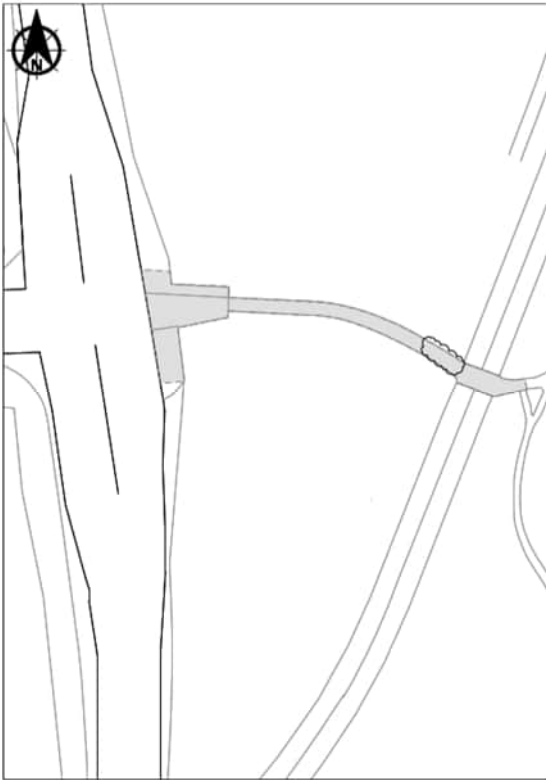
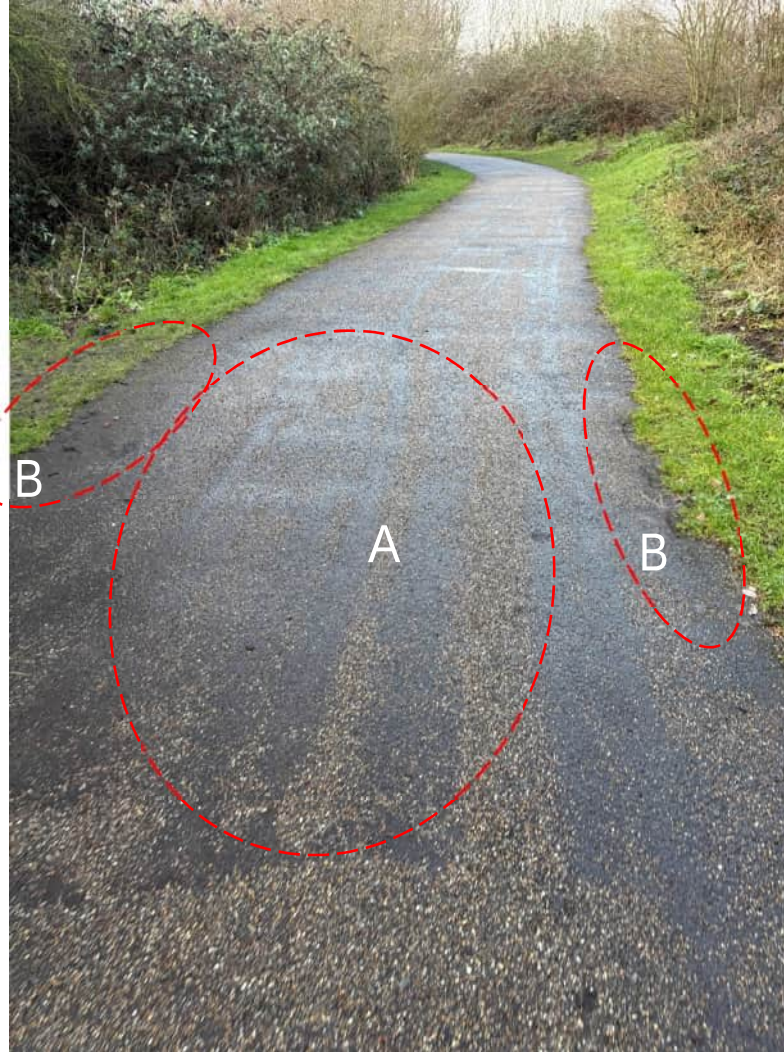
**Location 2**

- A. Evidence of general surface wear on pathway surface.
- B. Evidence of surface dressing wear at edge of pathway.

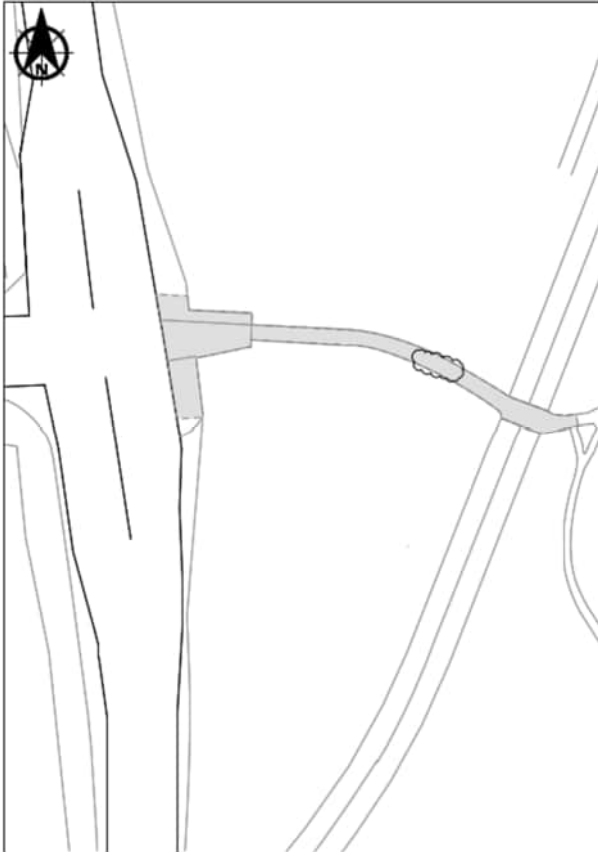
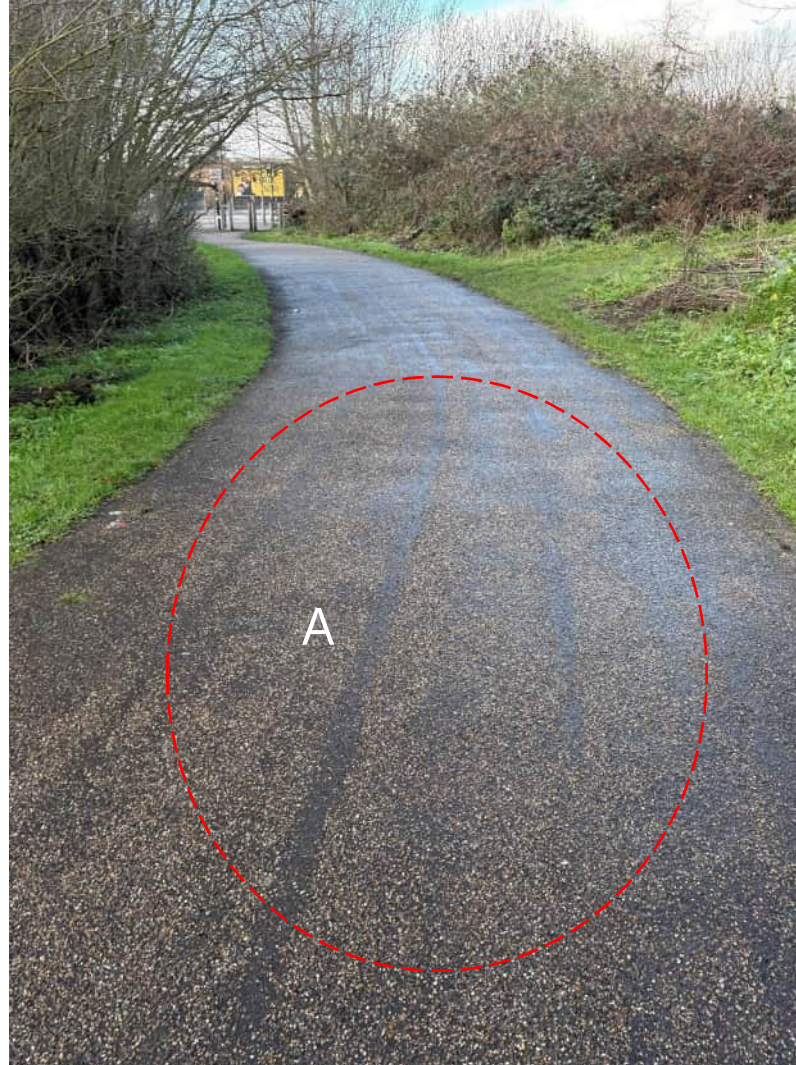
**Location 3**

- A. Evidence of general surface wear on pathway surface.

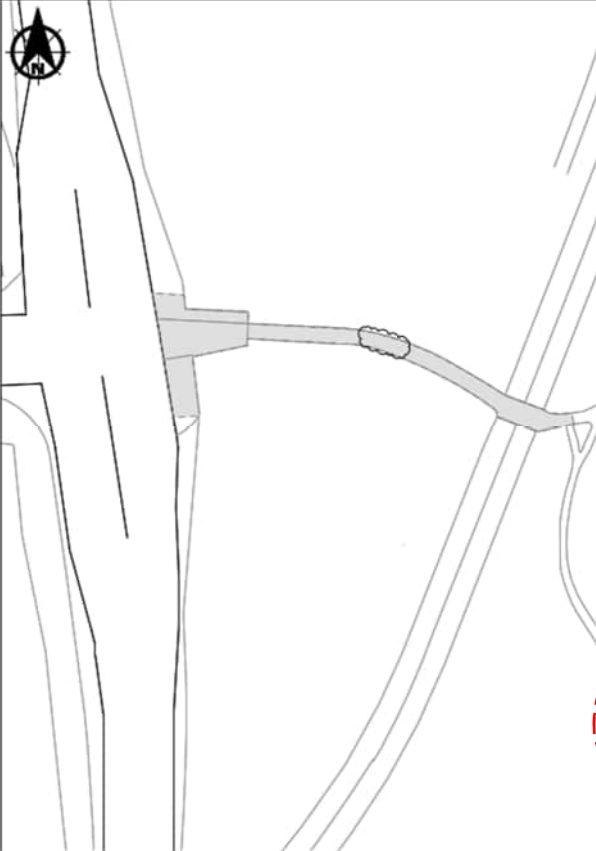
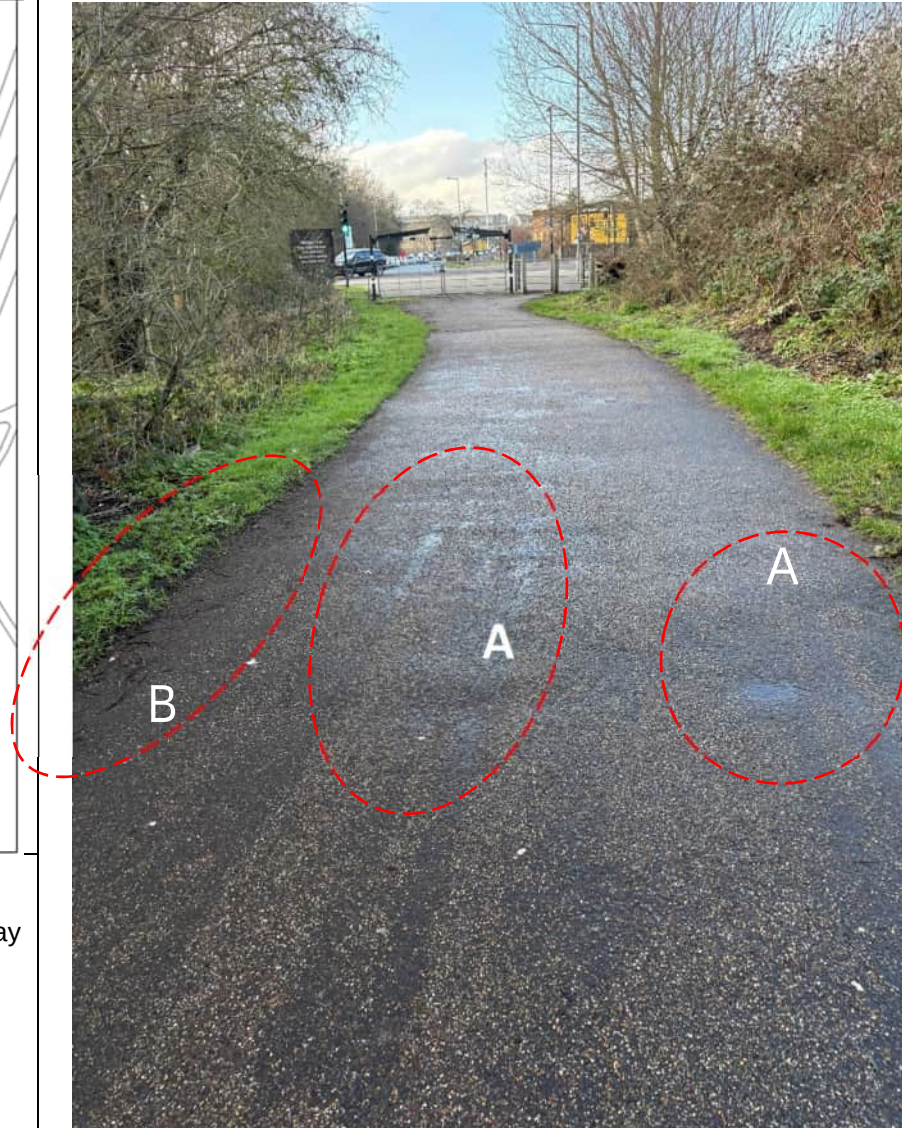
**Location 4**

- A. Evidence of general surface wear on pathway surface.
- B. Evidence of surface dressing wear along pathway edge.

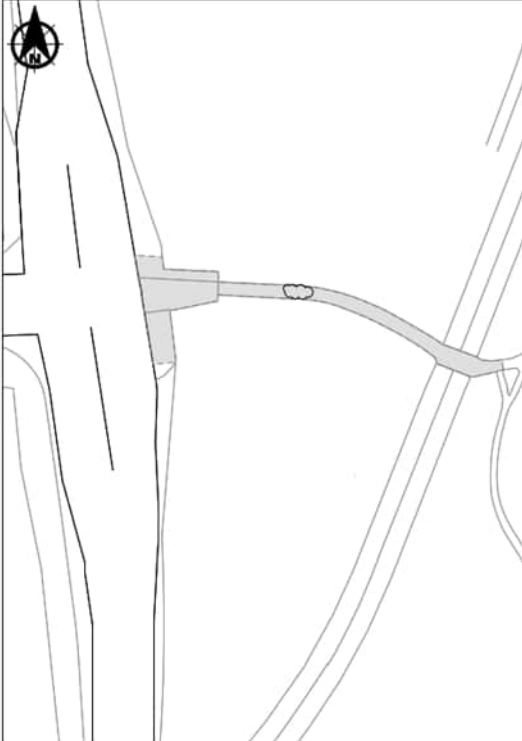
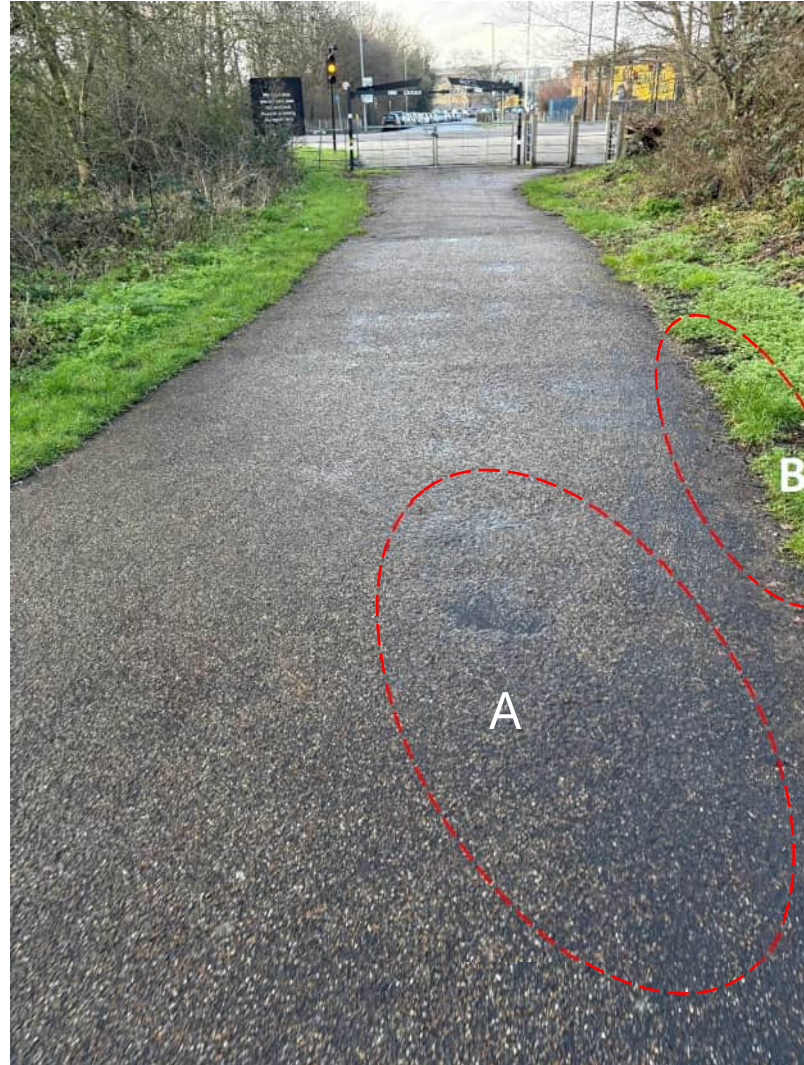
**Location 5**

- A. Evidence of general surface wear on pathway surface.
- B. Evidence of surface dressing wear along pathway edge.

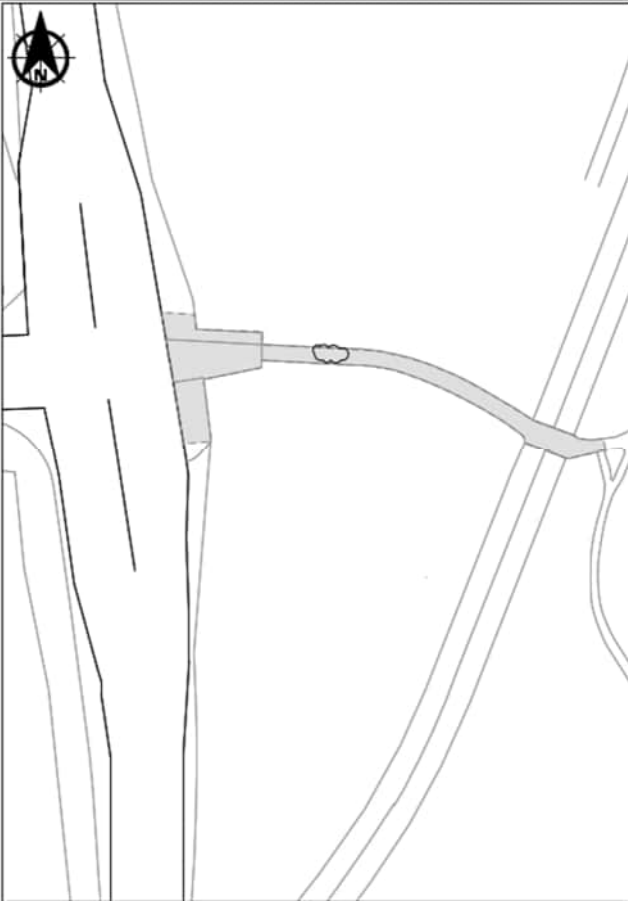
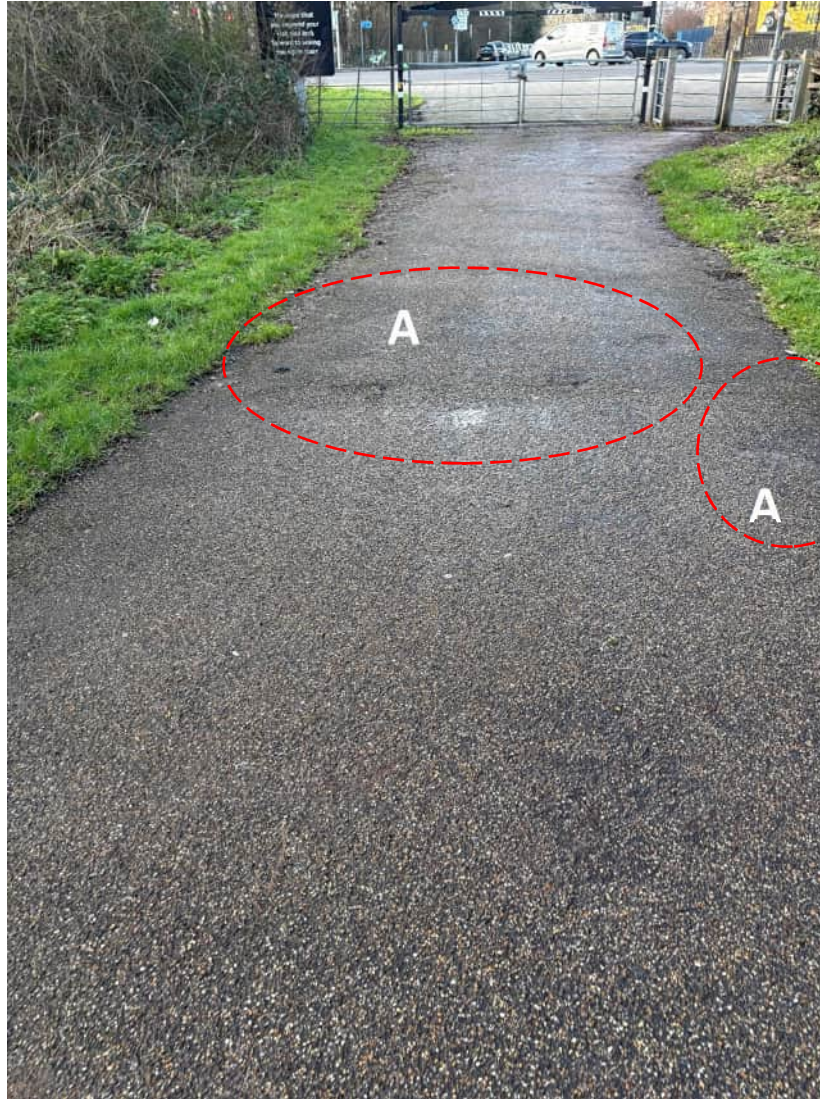
**Location 6**

- A. Evidence of general surface wear on pathway surface.

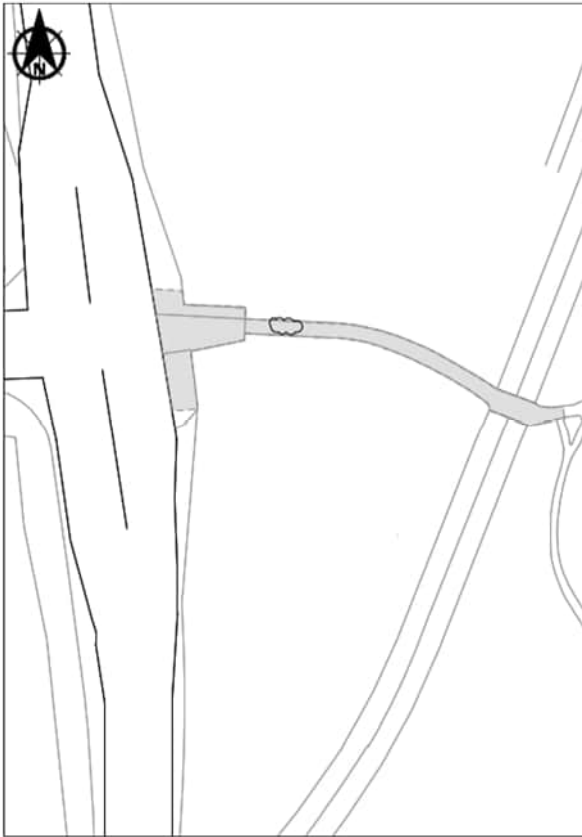
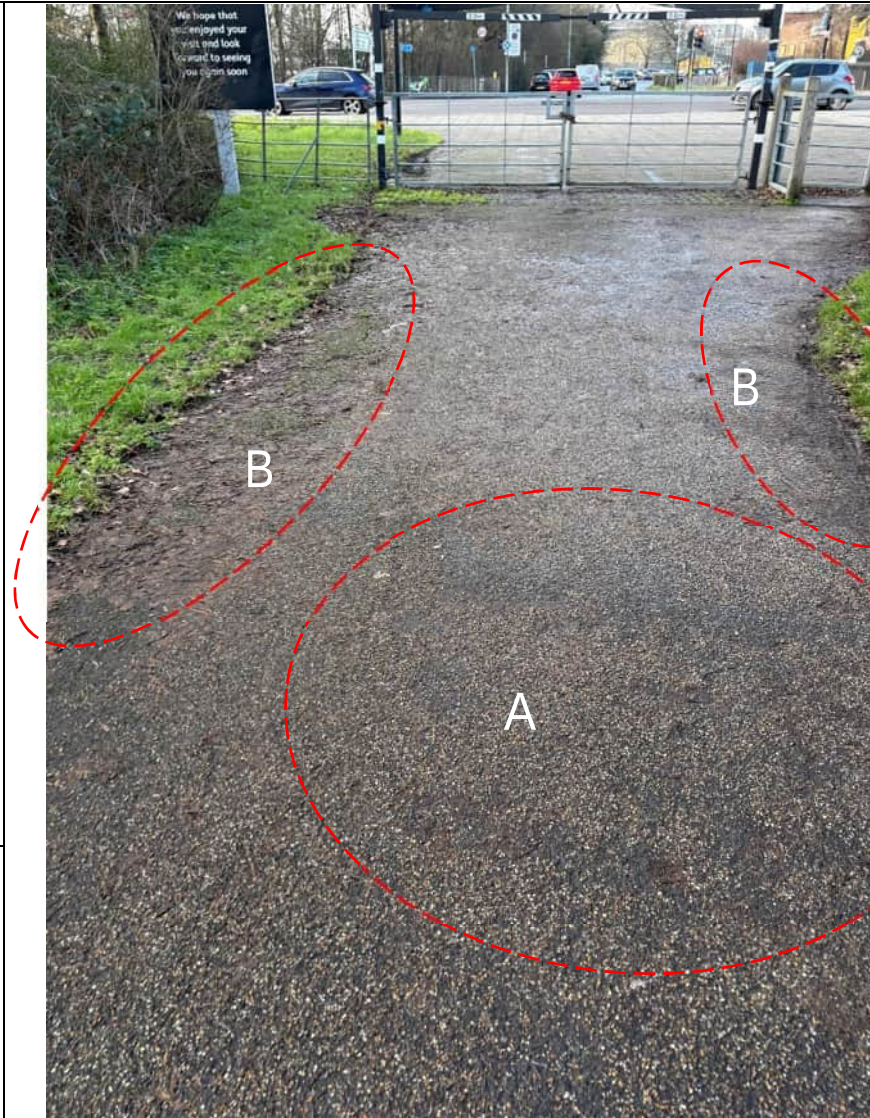
**Location 7**

- A. Evidence of general surface wear on pathway surface.
- B. Evidence of surface dressing wear and vehicle overrun at pathway edge.

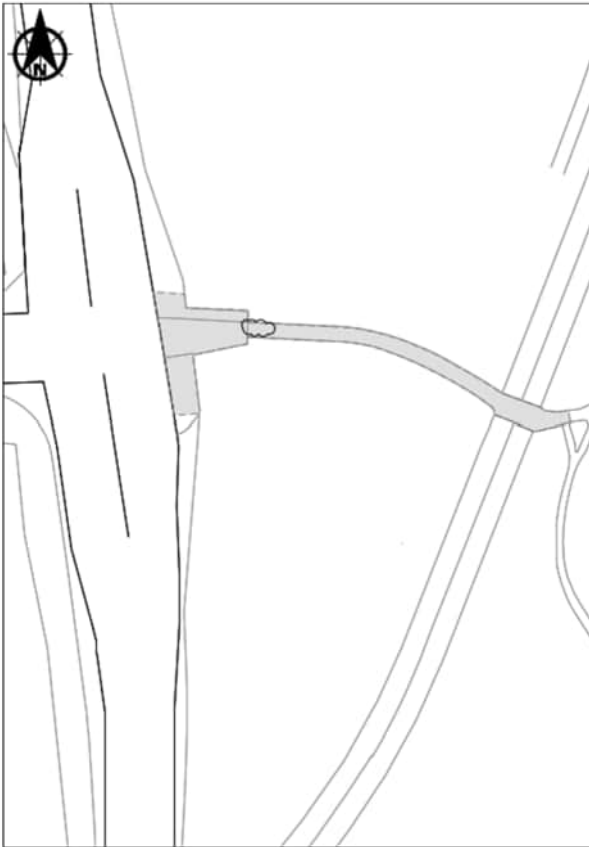
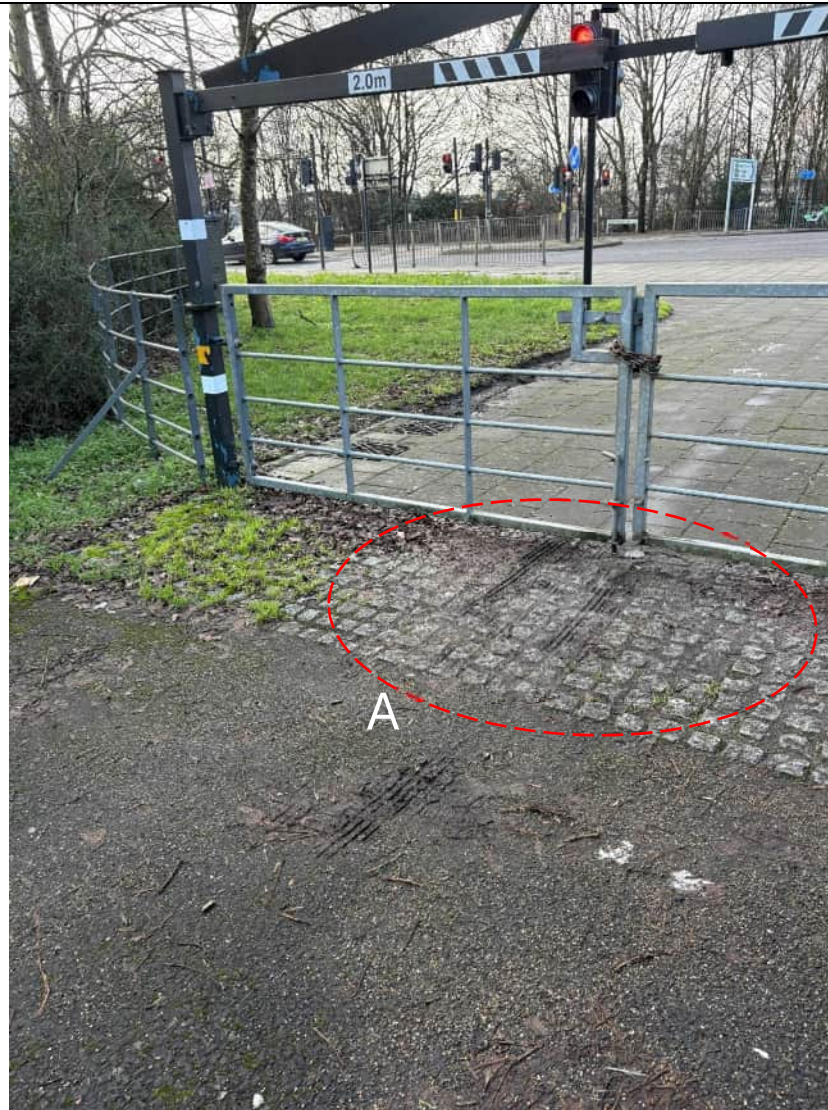
**Location 8**

- A. Evidence of general surface wear on pathway surface.

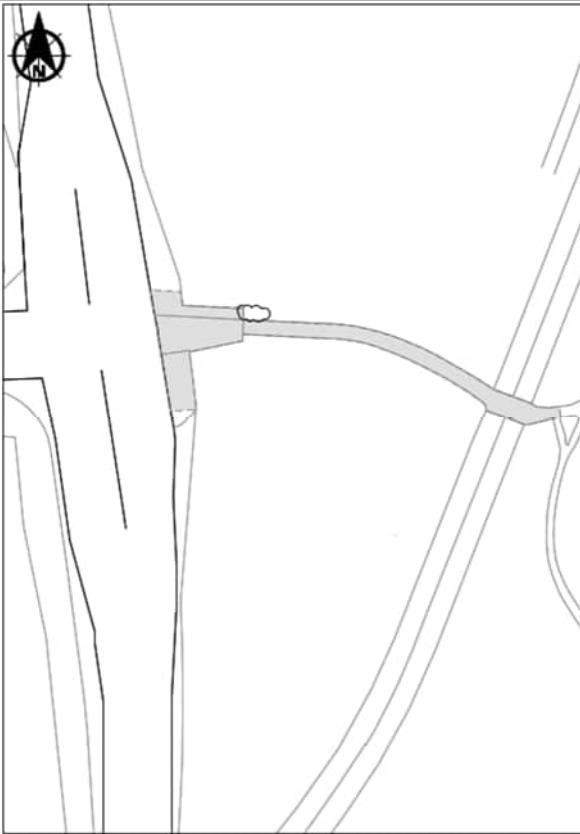
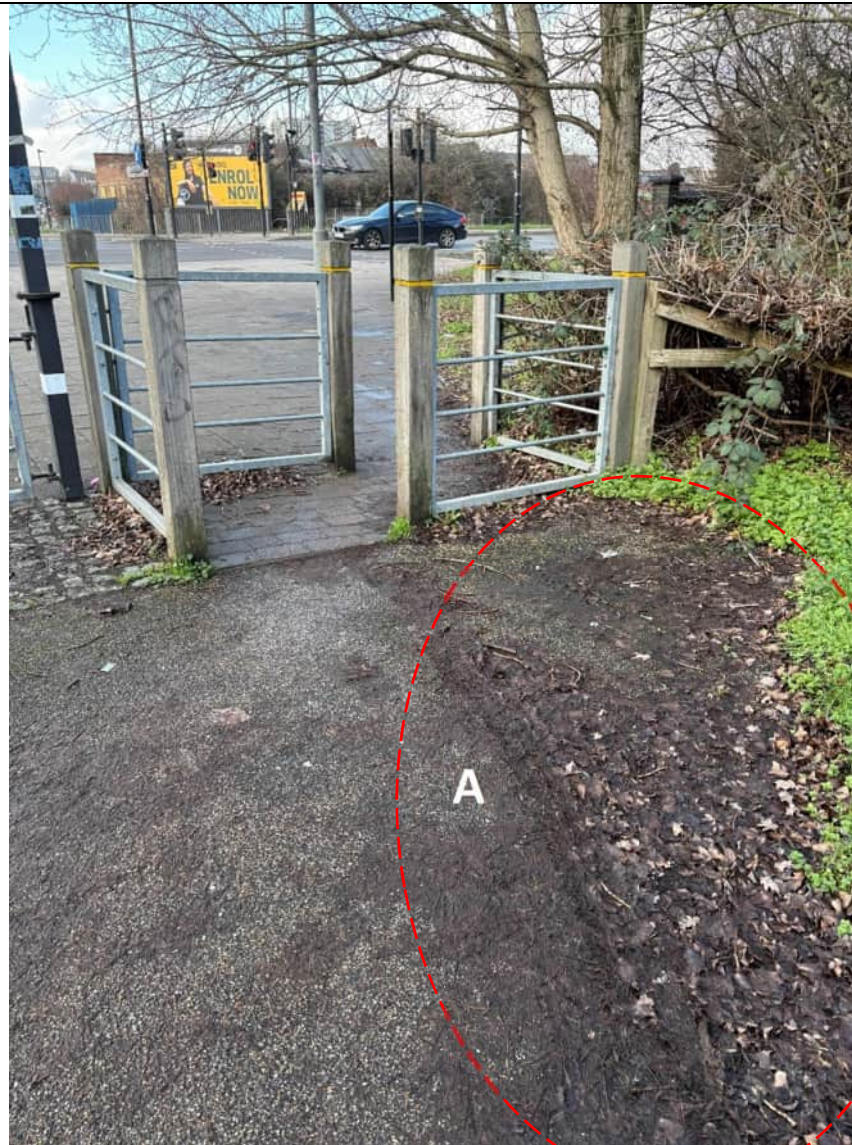
**Location 9**

- A. Evidence of surface dressing wear at pathway edge and vehicle tracks within vegetation.

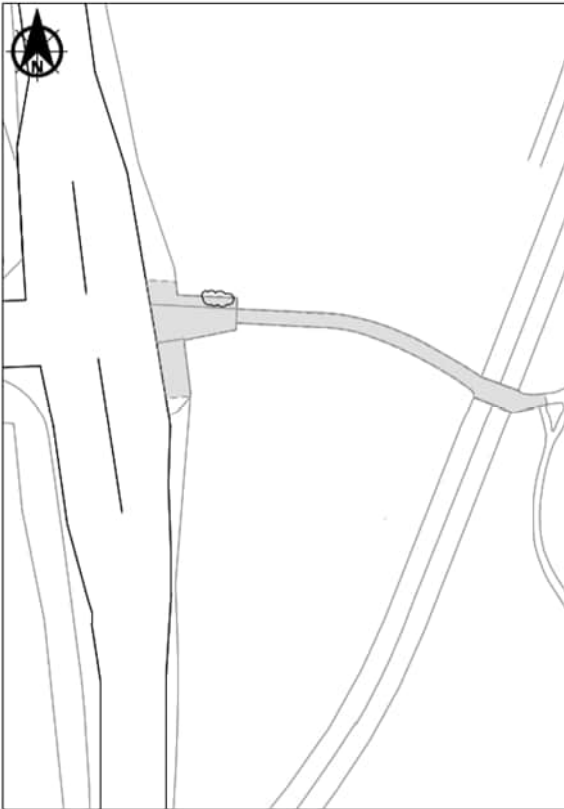
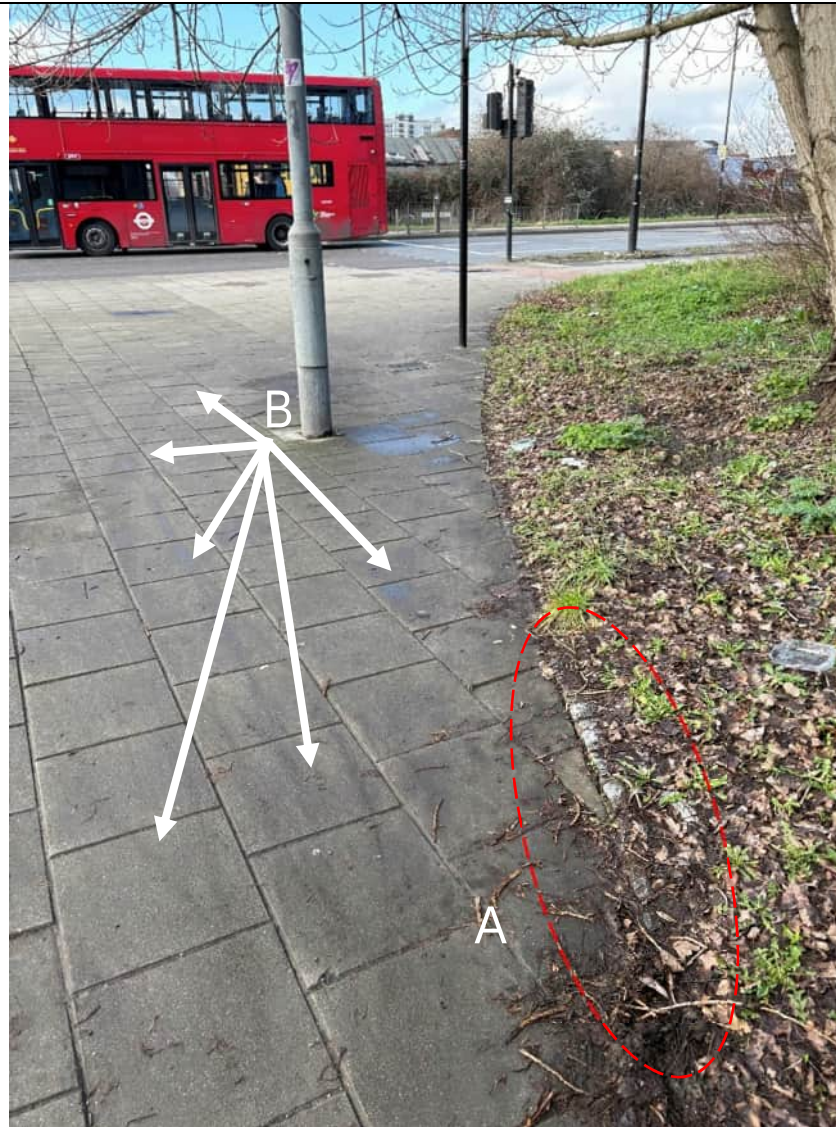
**Location 10**

- A. Evidence of surface dressing wear at pathway edge.
- B. Evidence of marks on pavement surface.

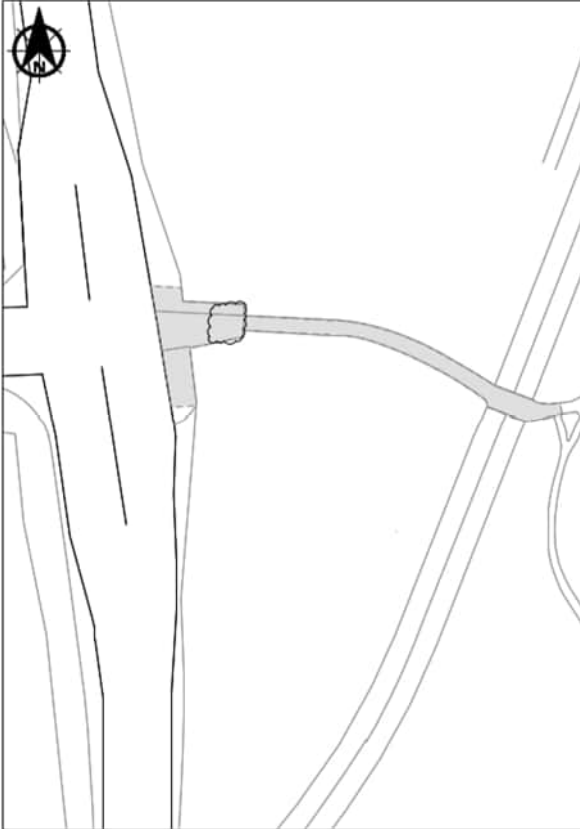
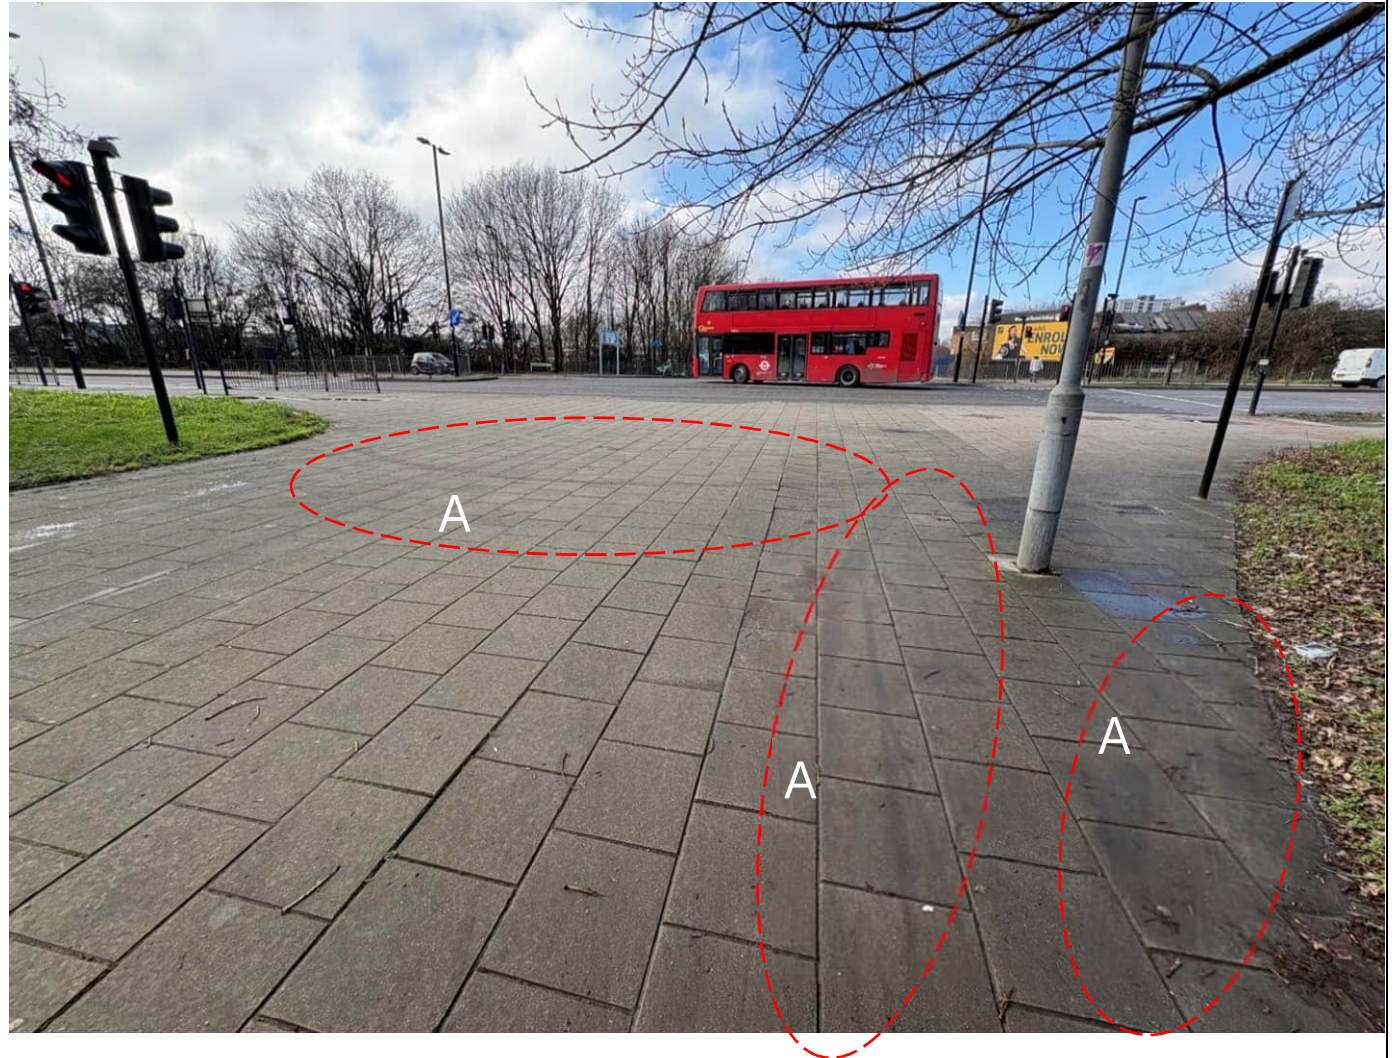
**Location 11**

- A. Evidence of marks on pavement surface.

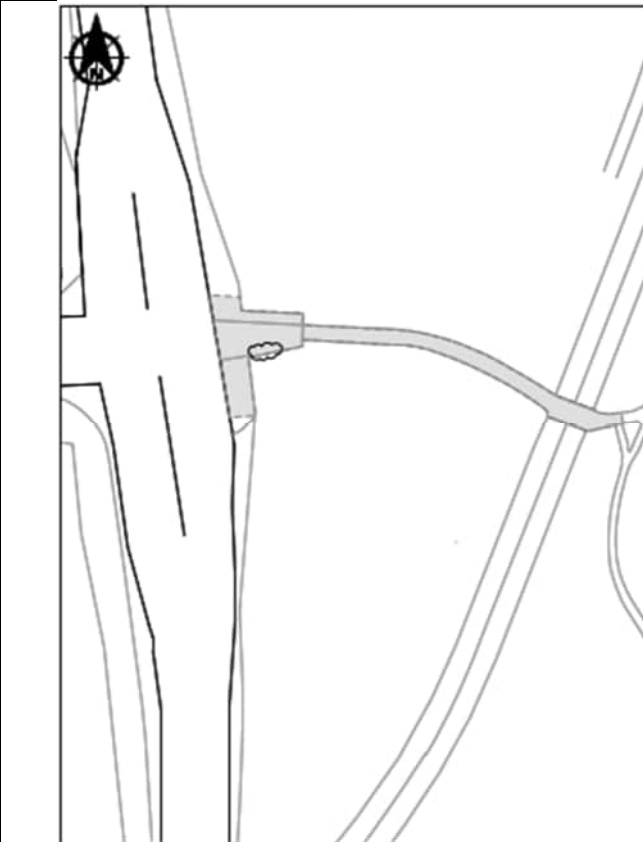
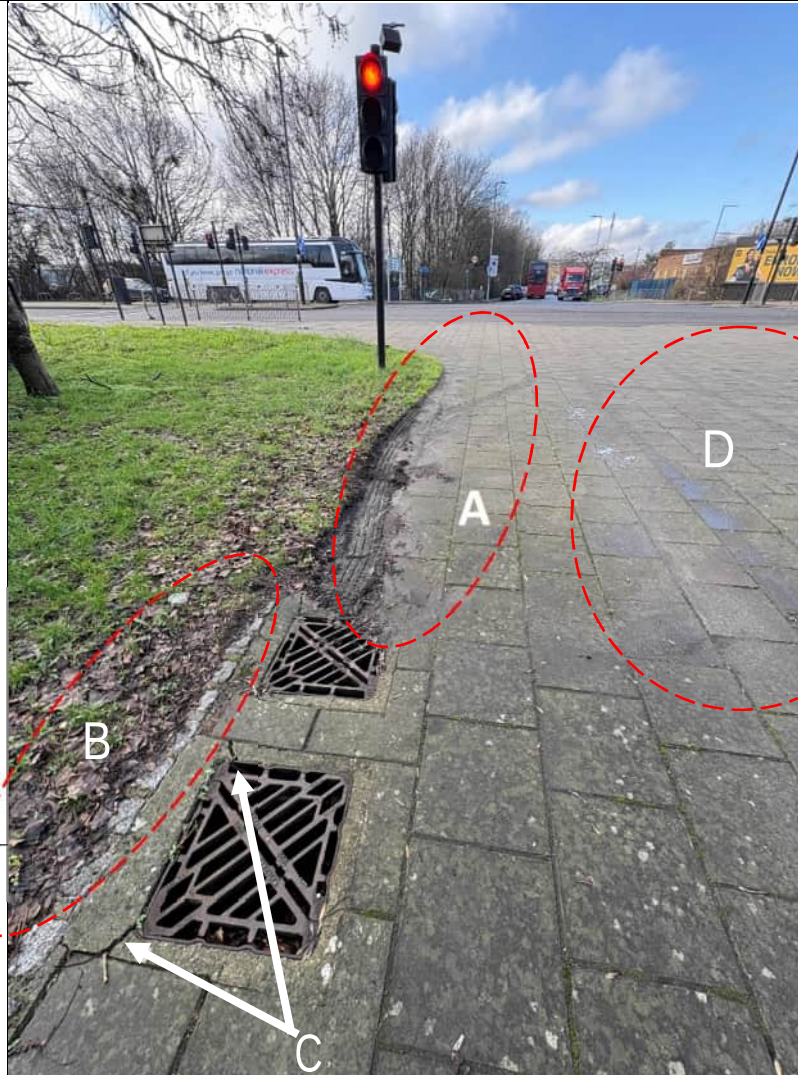
**Location 12**

- A. Presence of vehicle tracks on pavement surface.
- B. Evidence of surface dressing wear at edge of pavement.
- C. Evidence of cracks on pavement surface around drain cover.
- D. Evidence of marks on pavement surface.

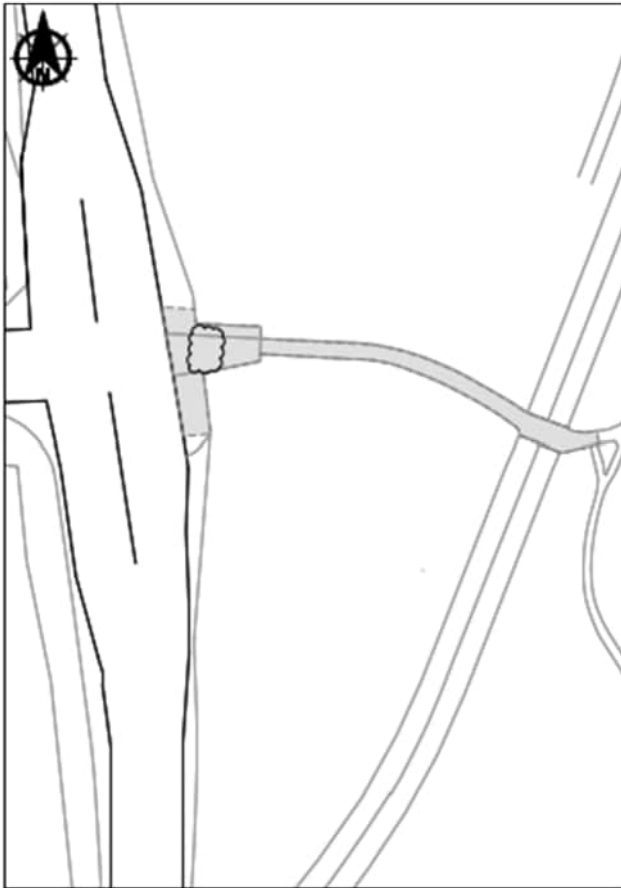
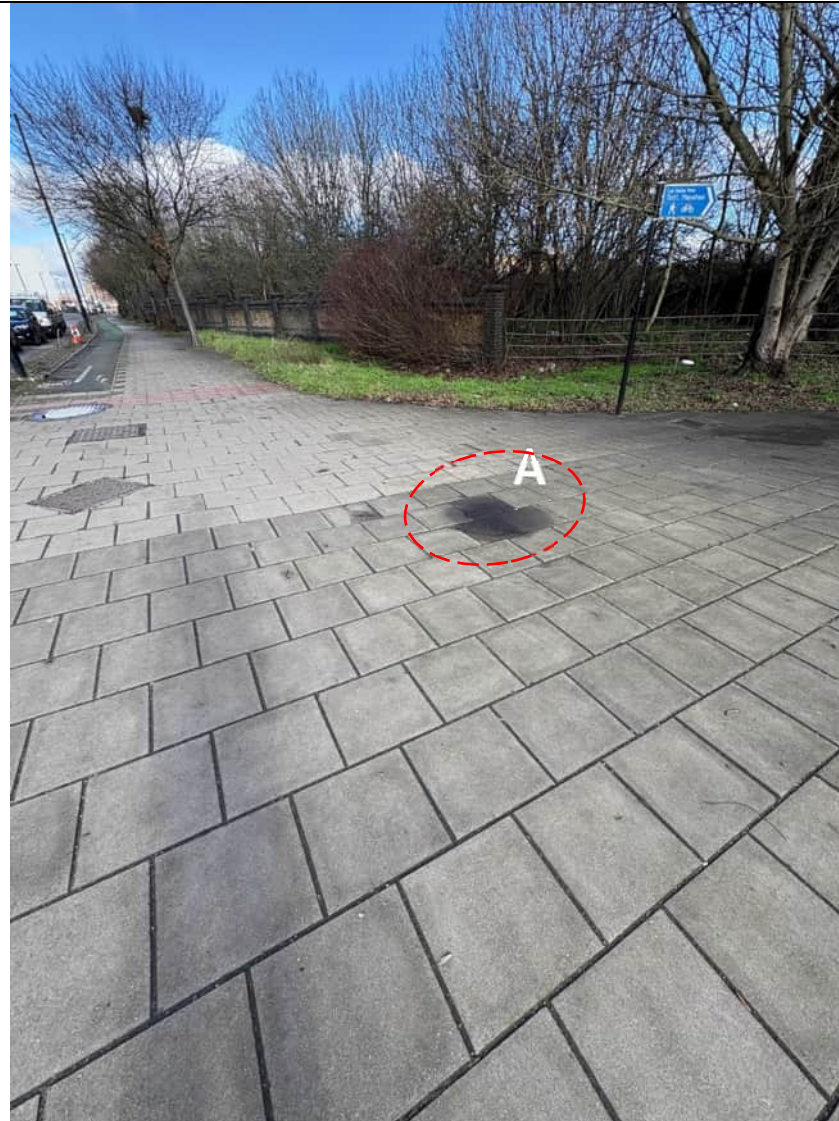
**Location 13**

- A. Evidence of water pooling on pavement surface.

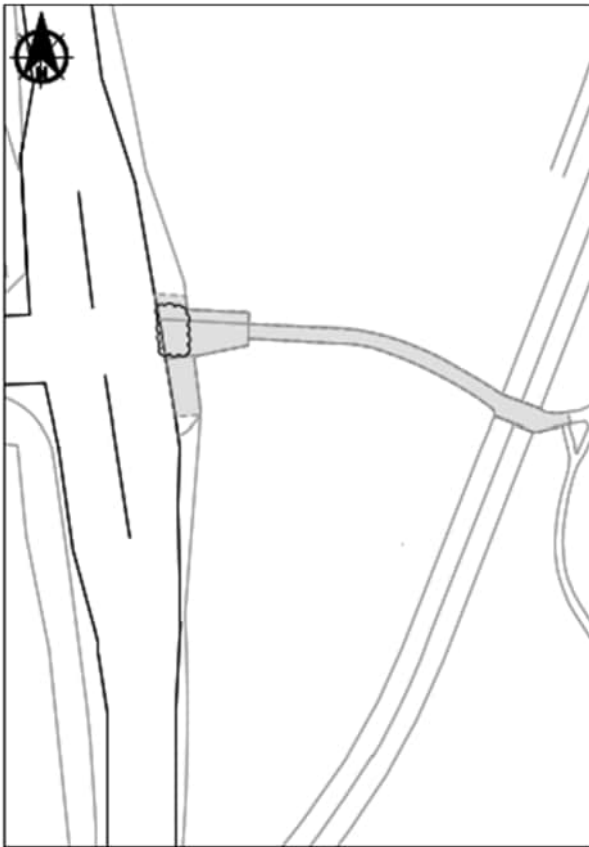
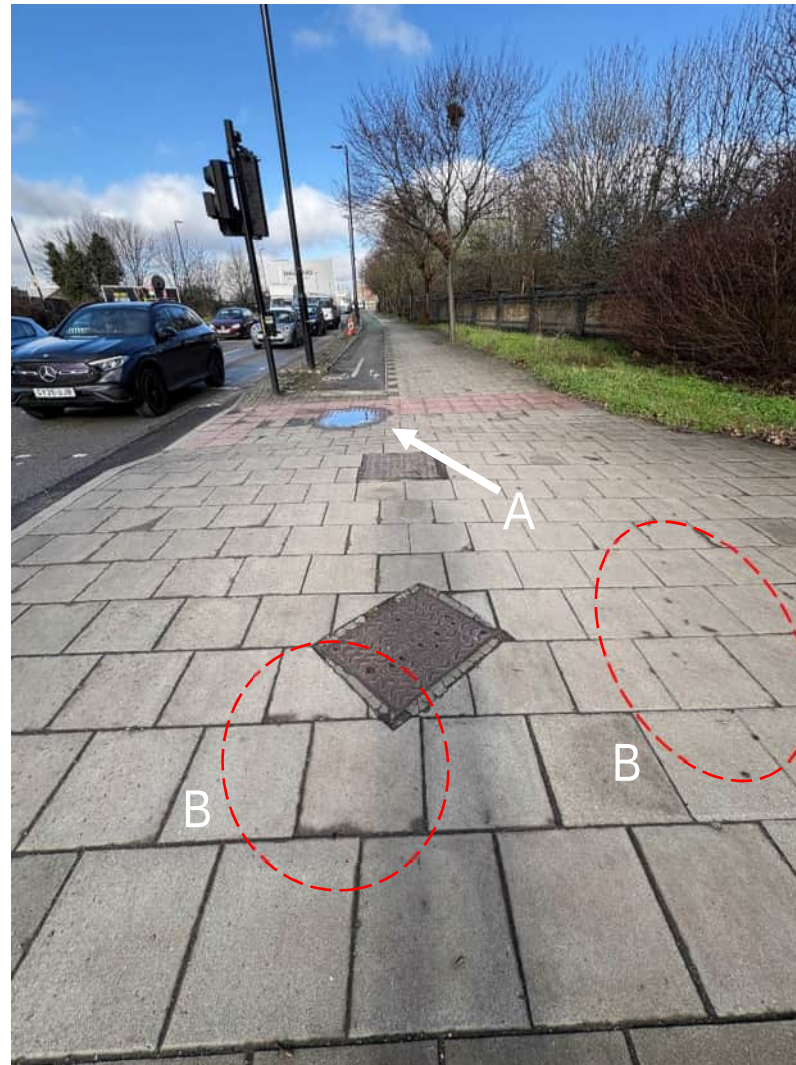
**Location 14**

- A. Evidence of pooling of water across pavement surface.
- B. Evidence of general surface wear across pavement surface.

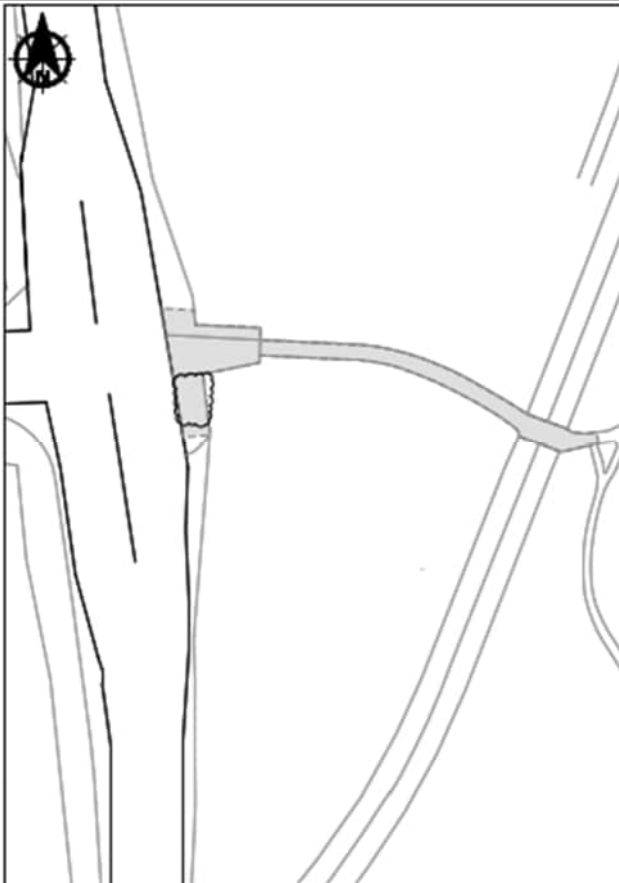
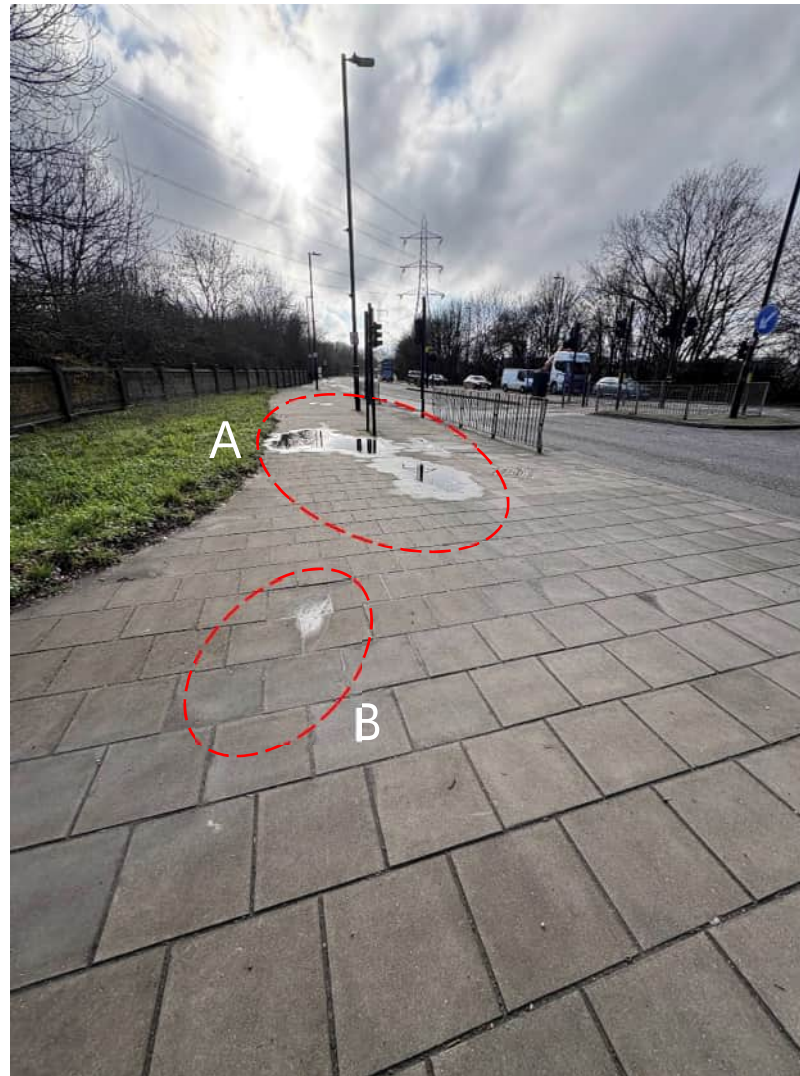
**Location 15**

- A. Evidence of pooling of water across pavement surface.
- B. Evidence of general surface wear across pavement surface.
