# North London Reinforcement Project

Visual Condition Surveys  
Highway Access Points

| Location: | Watermead Way |
| DCO Ref: | AC71/AC72 |

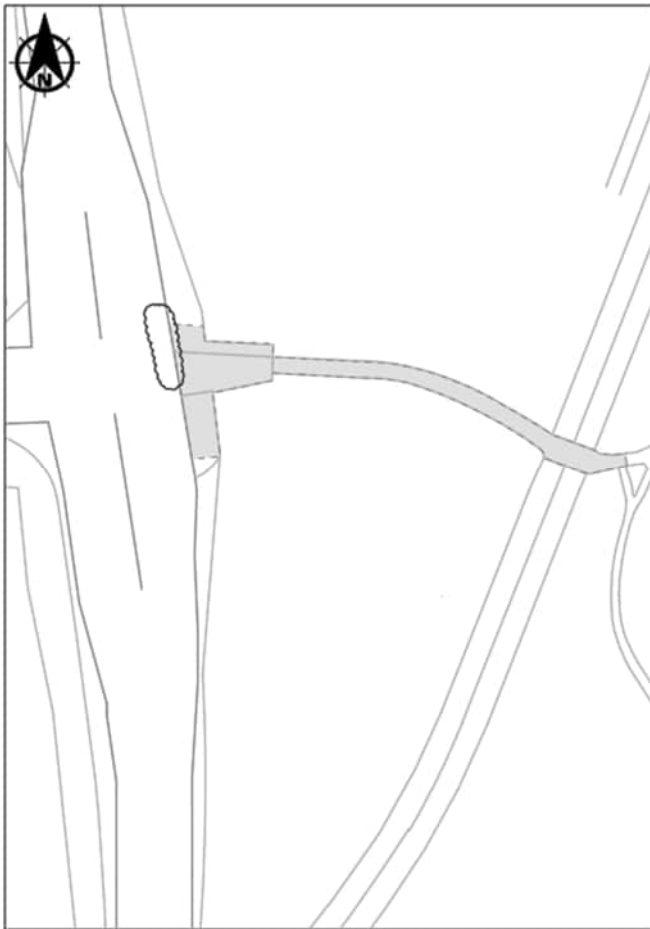
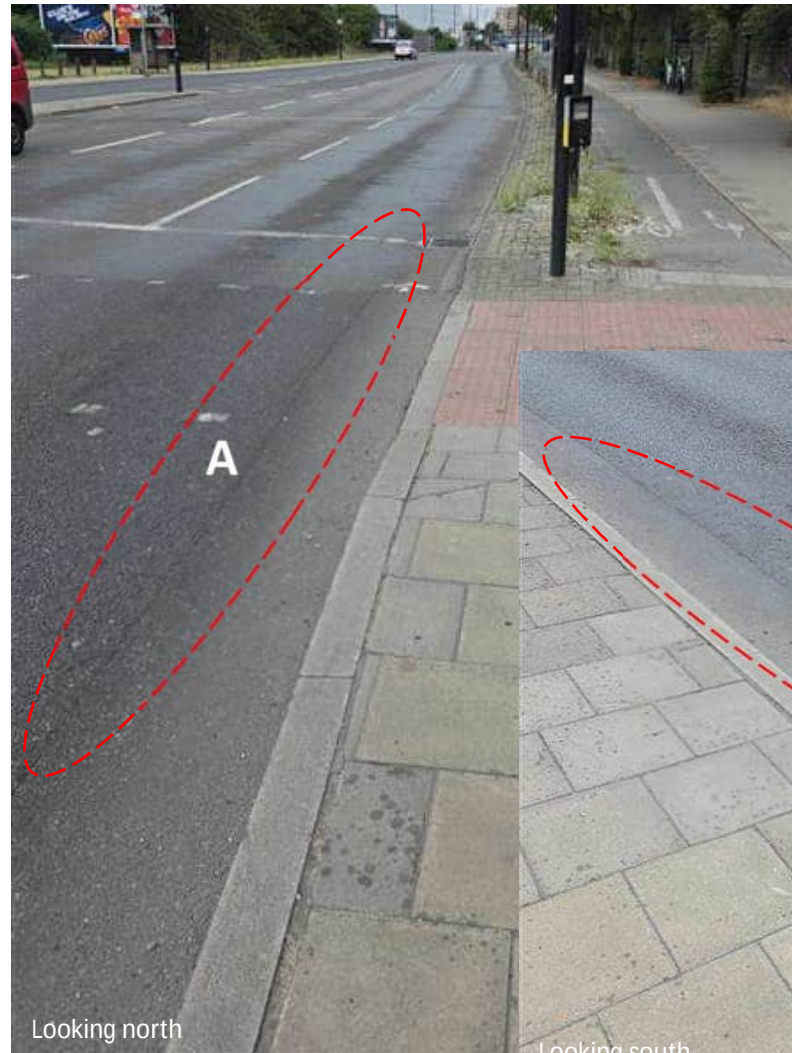
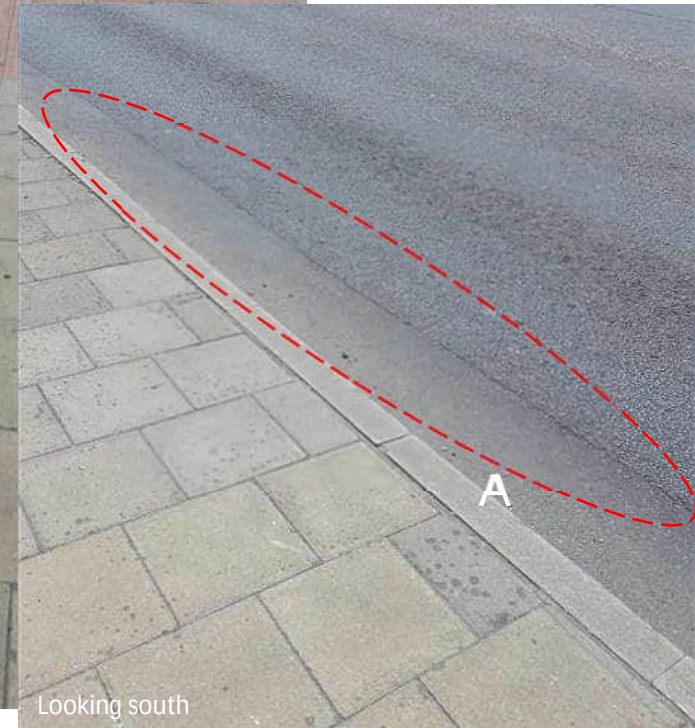
**Location 16**

- A. Evidence of surface change and linear crack starting at pedestrian crossing and continuing southward in front of existing dropped kerbs.

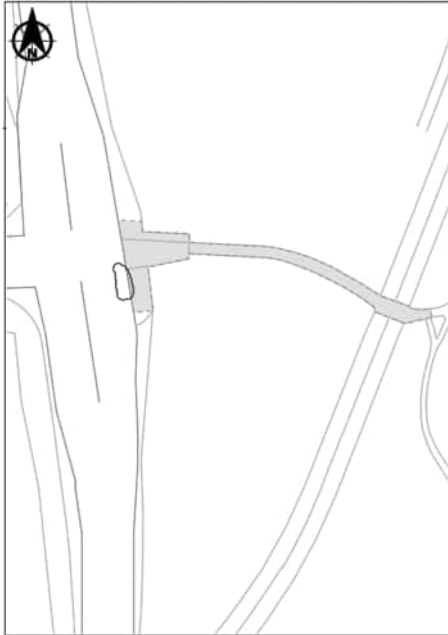
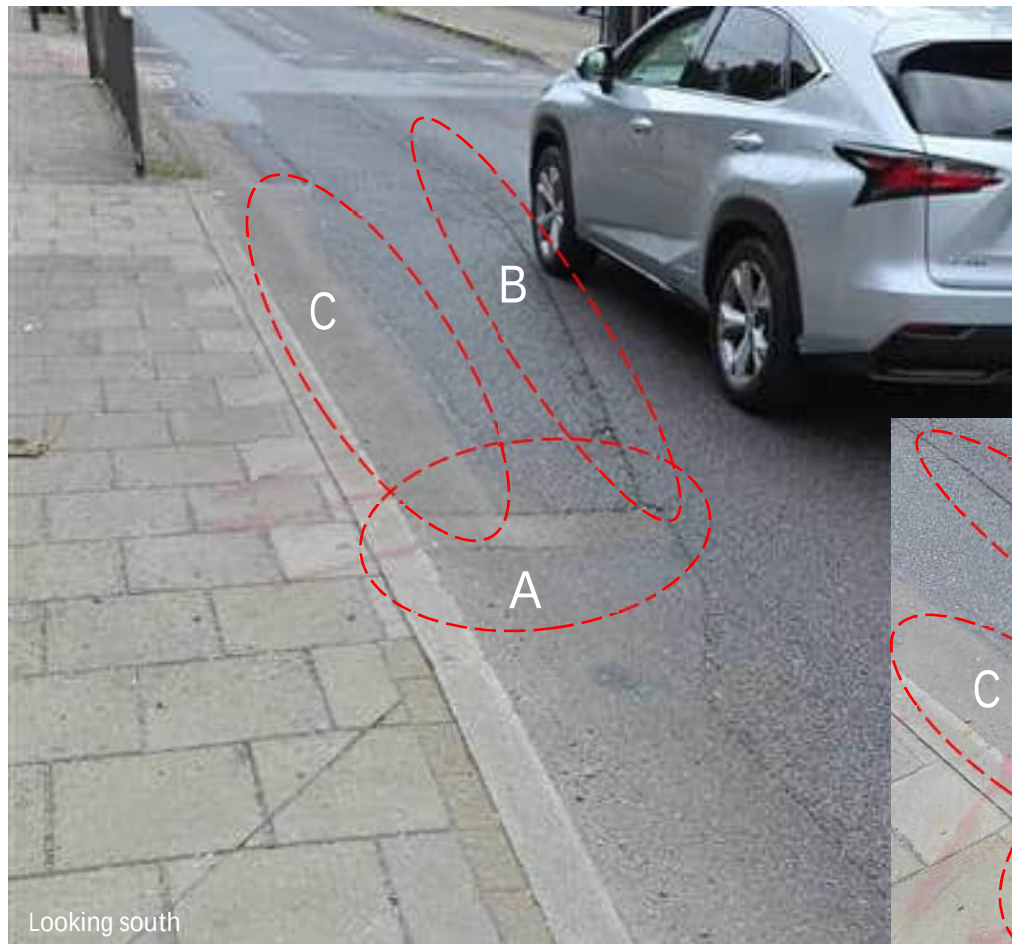
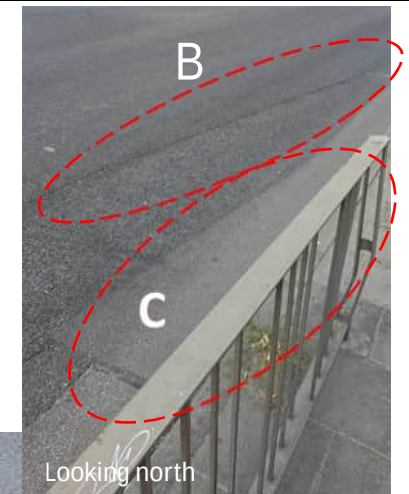
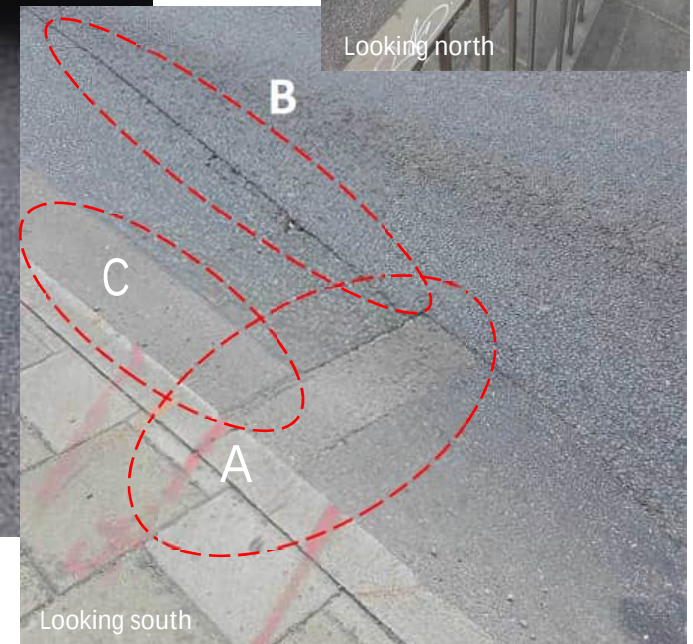
**Location 17**

- A. Evidence of patch repair.
- B. Evidence of a linear crack with a small amount of failure along its length.
- C. Surface change with bituminous seal between surfaces.

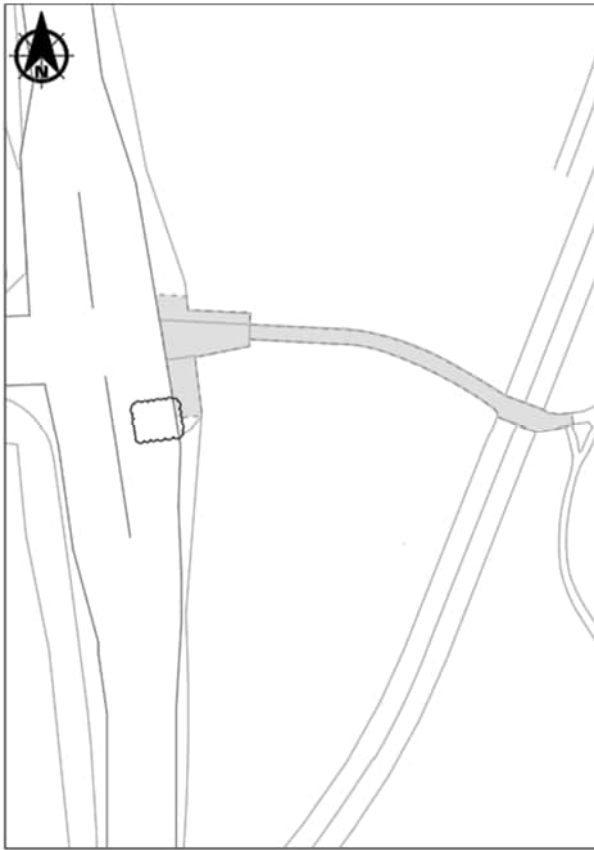
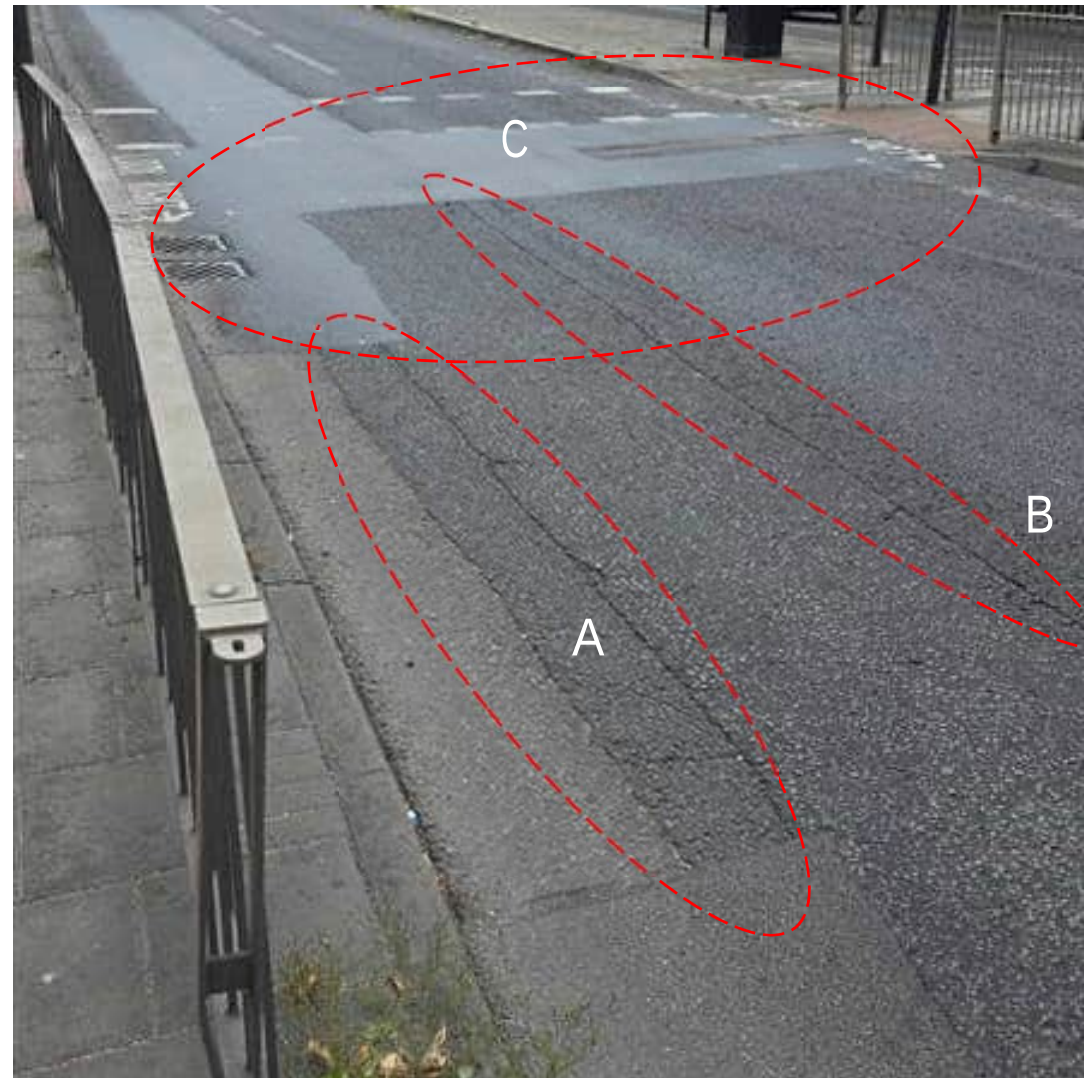
**Location 18**

- A. Evidence of patch repair with minor failures at change of surfacing.
- B. Evidence of a linear crack with a small amount of failure along its length (continuation from Locations 16 and 17).
- C. Large patch repair at crossing and heading south on Watermead Way.
