# Assunnah Islamic Centre, Bruce Grove

## Structural Engineering Condition Report

19th Century Barn

April 2026

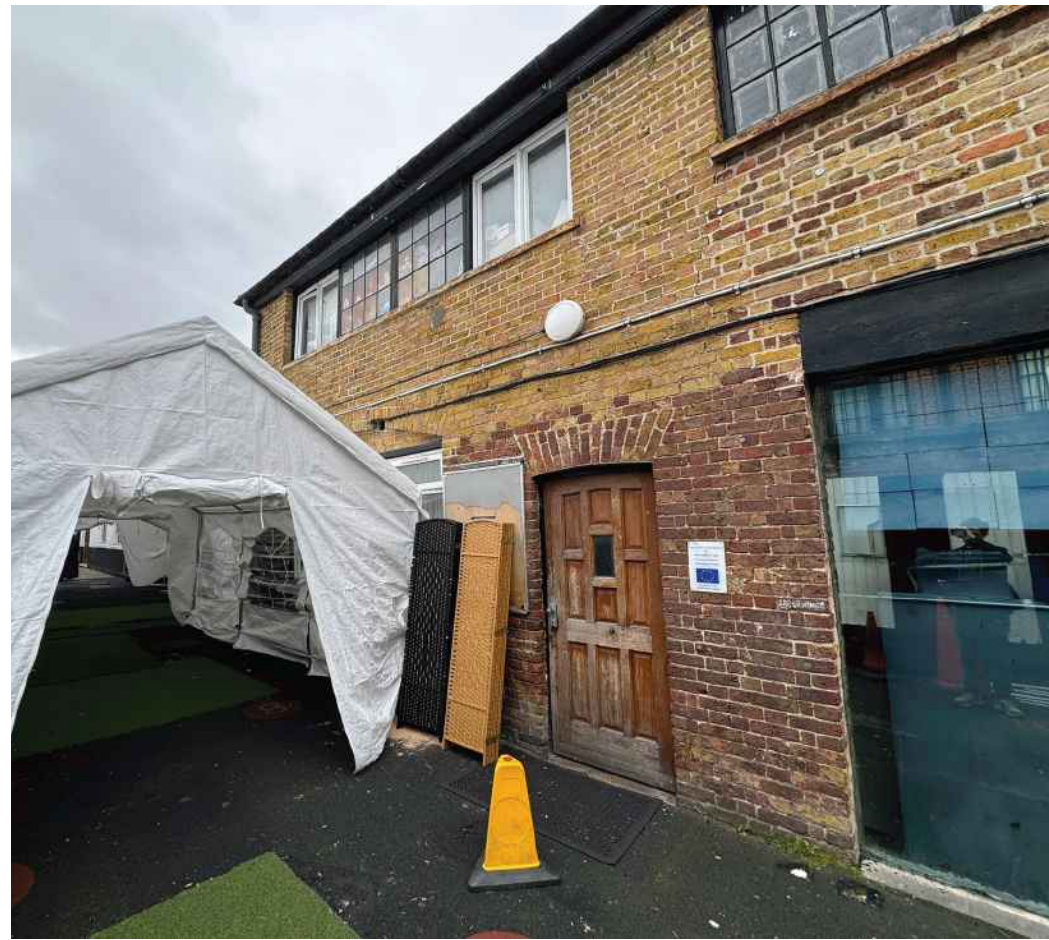
**Photo 01 - East Elevation**

The primary structure consists of external loadbearing brick masonry walls to the east, south and west elevations - Photo 01. At the northern end, the wall separating the 19th and 18th century portions of the building comprises the original 18th century timber gable wall - Photo 02.

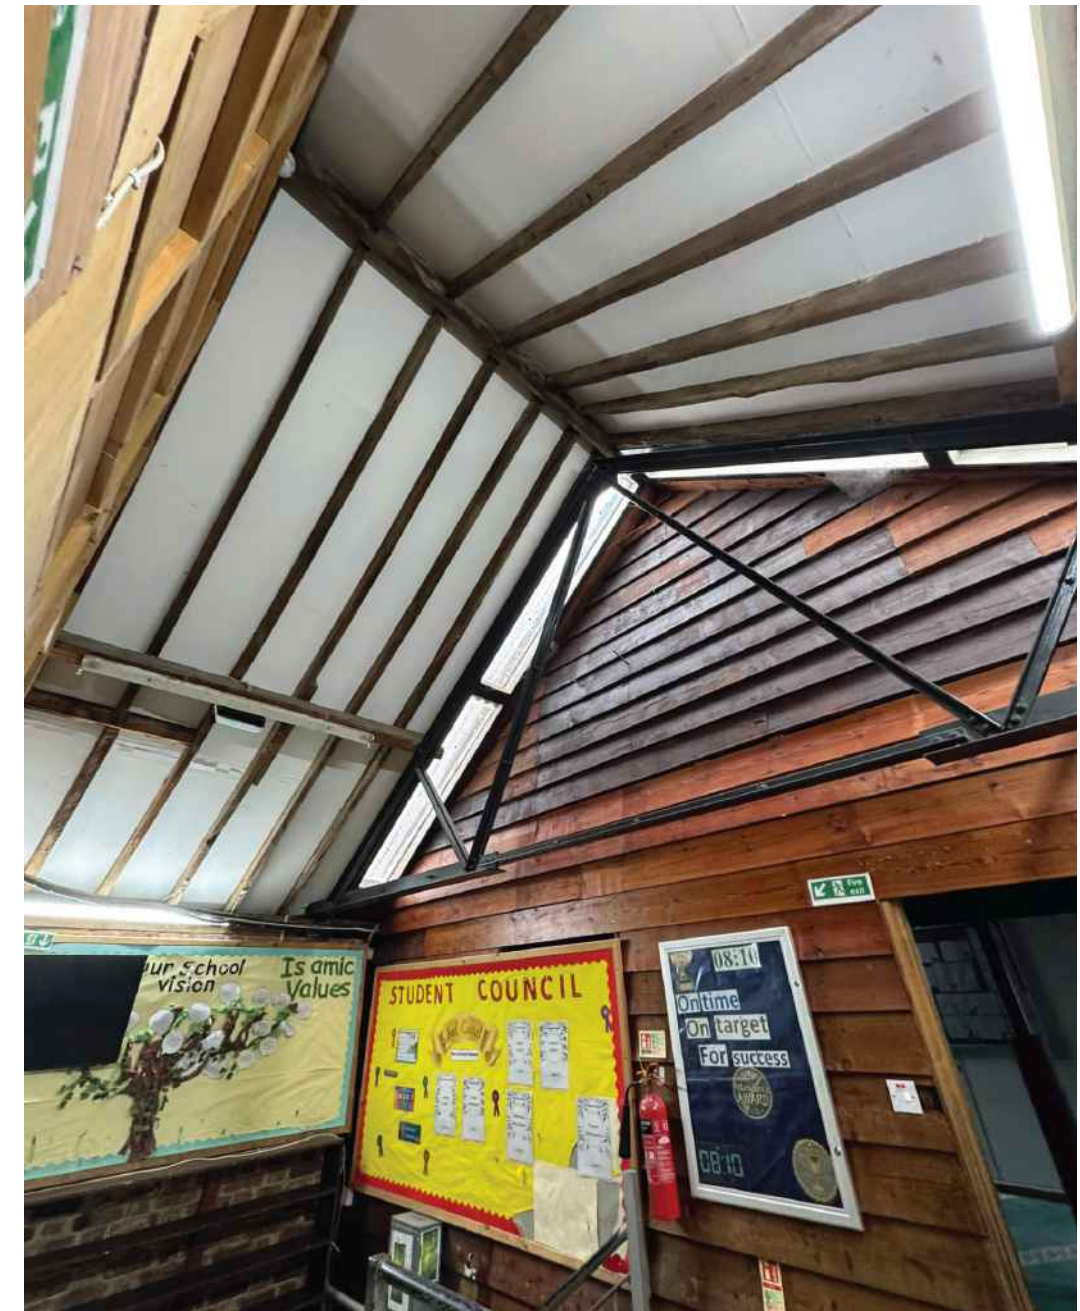
**Photo 02 - North End of 19th Century Barn**

The photo shows the gable end of the 18th Century Barn (timber boarded). The steel truss support the end of the 19th Century Barn roof structure.

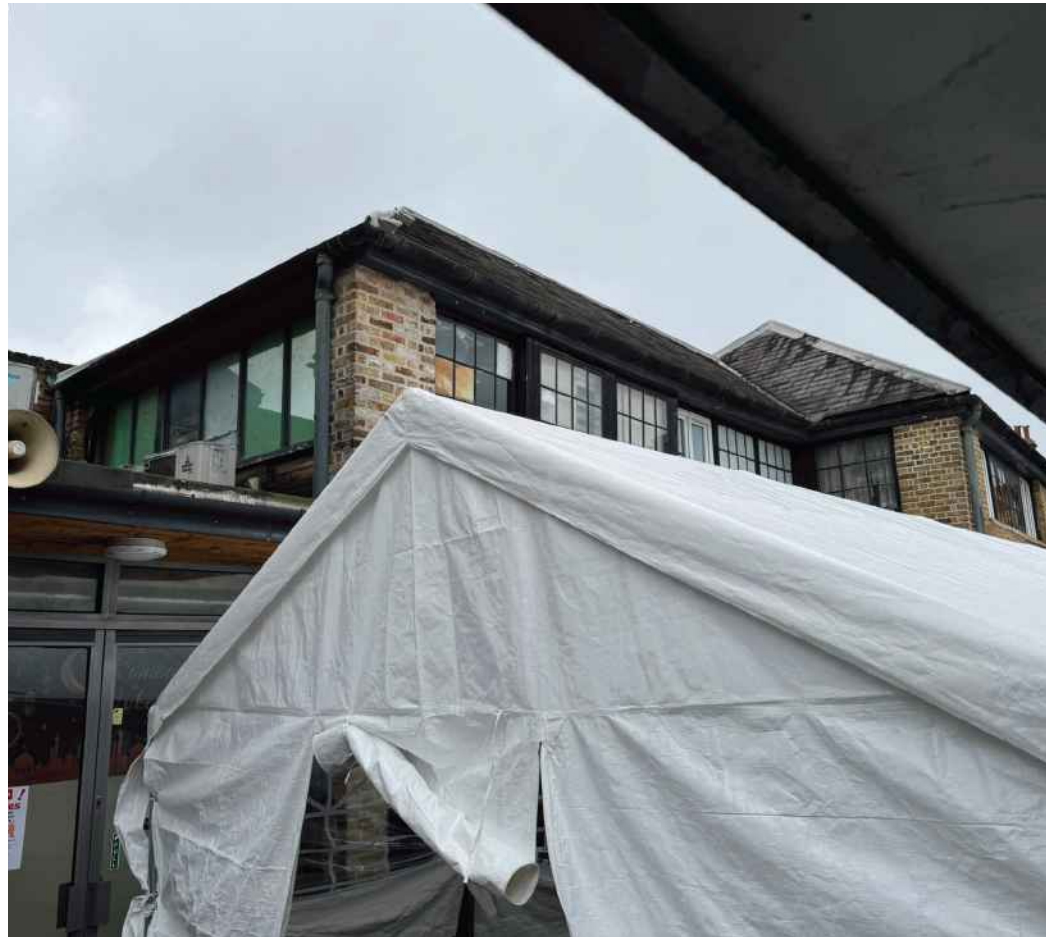
**Photo 03 - View of South East Corner of the 19th Century Portions**

There are a number of large openings within the east elevation at both ground and first floor levels, and within the south elevation at first floor level - Photo 03.

The elevation contains a series of large window openings at both ground and first floor. The window in the south elevation is full width between the return walls forming the west and east elevations.

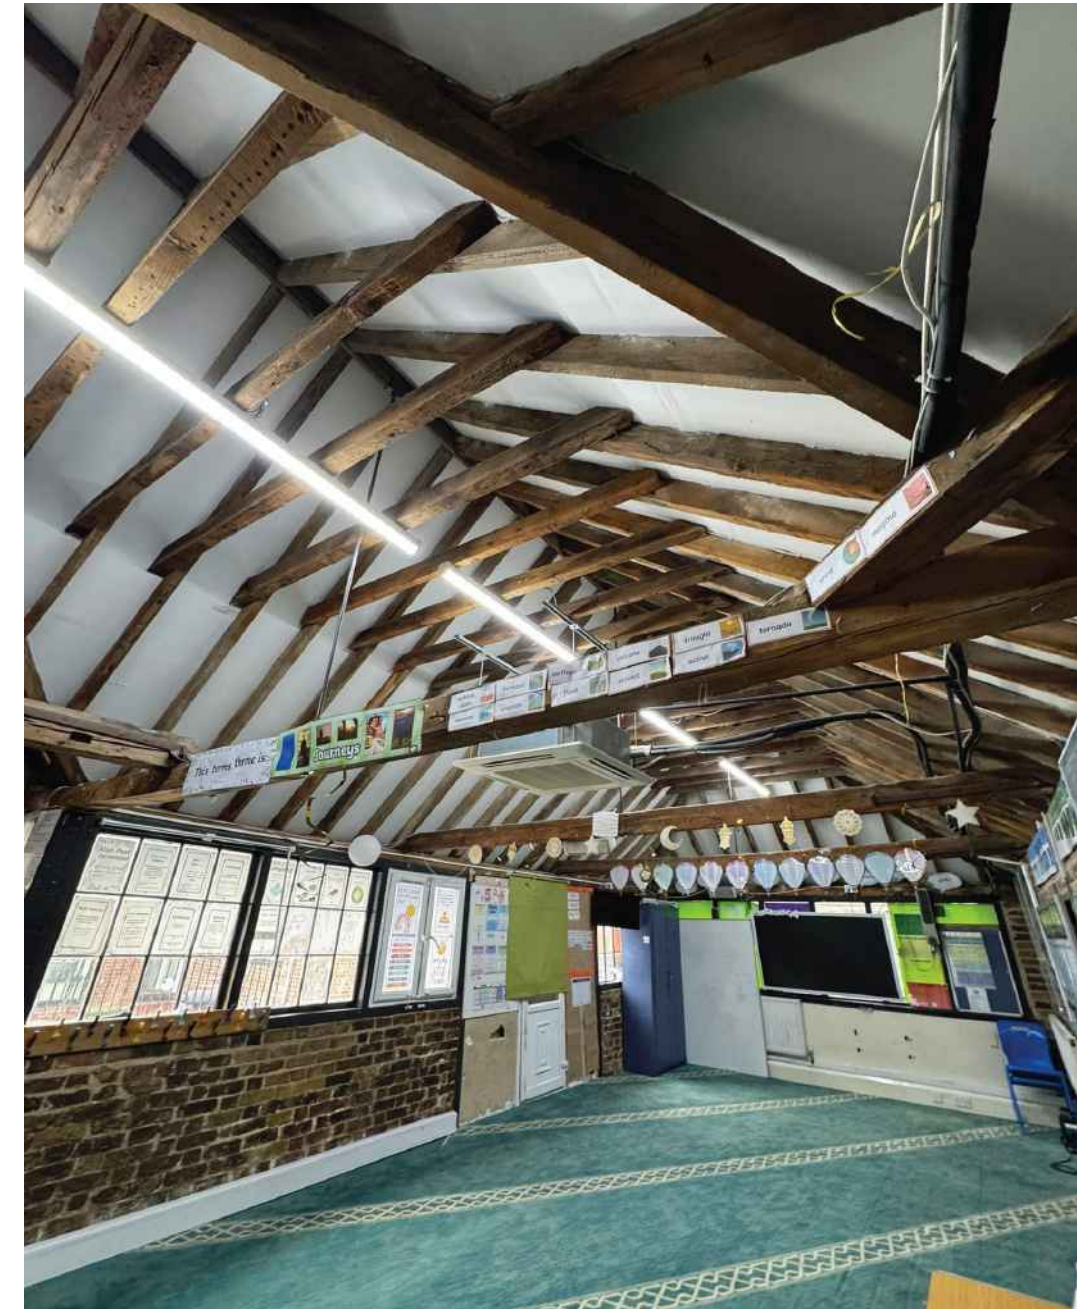
**Photo 04 - View of the Southern Portion of Roof at First Floor - Looking South**

The ground floor and first floor are understood to comprise a suspended timber construction. The first floor is open plan other than around the stairwell. The ceiling at first floor level follows the profile of the pitched roof - Photo 04.

The ceiling at first floor follows the profile of the roof structure.

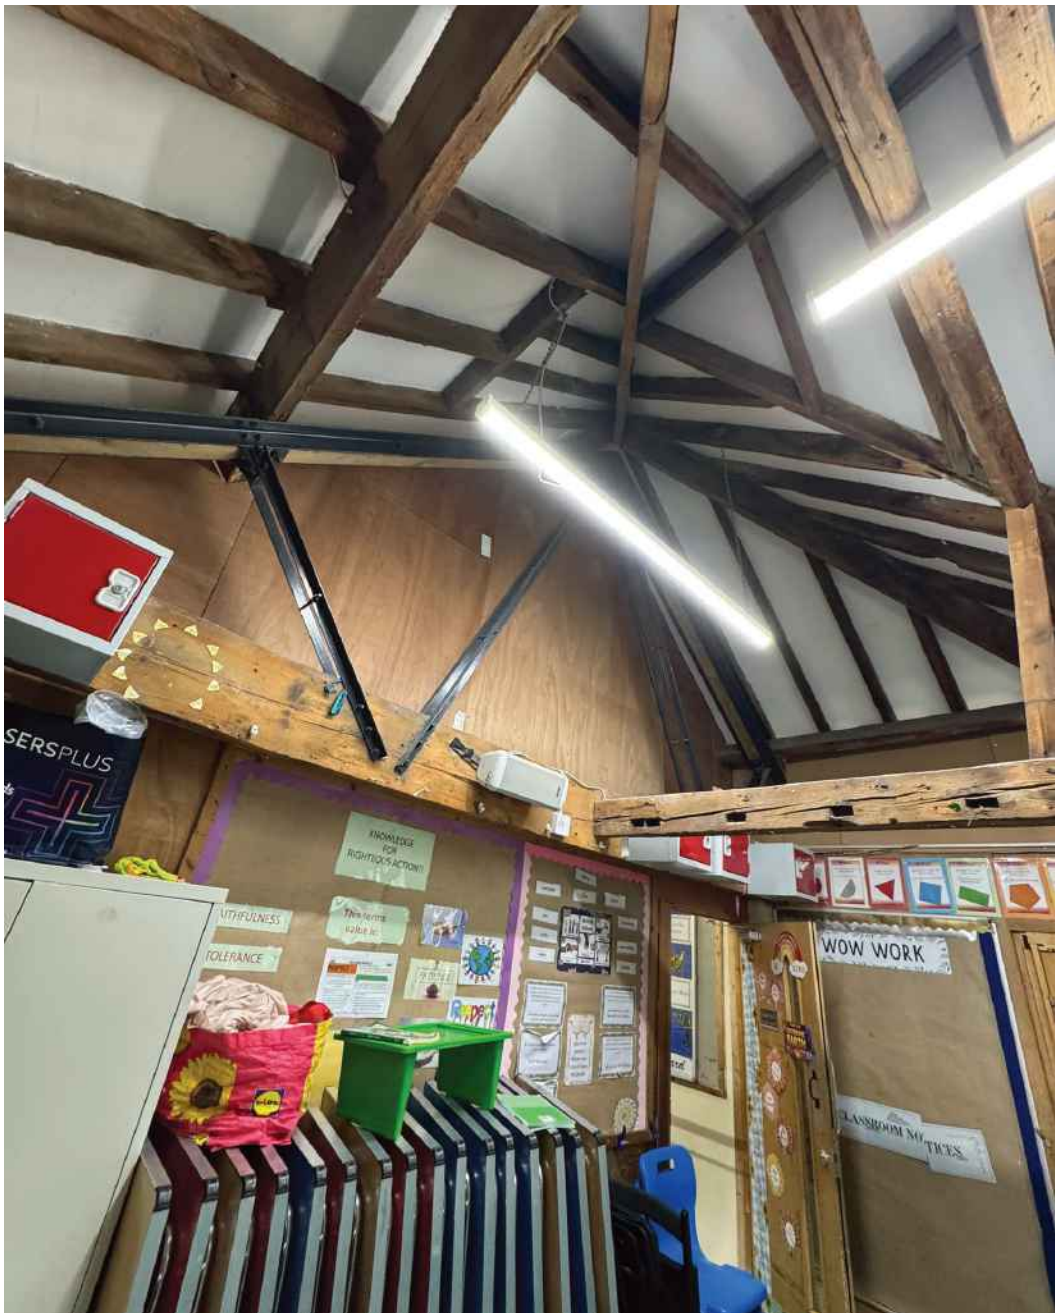
**Photo 05 - Northern Portion of the Roof - Looking North**

At the northern end of the barn, where the building is wider, the rafters are supported at mid-span by a timber purlin. The purlins span between two trusses: a steel truss with a timber tie chord - Photo 05, and a steel roof truss with a steel tie chord - Photo 06. There is a glazed skylight up the full length of both roof pitches between the 19th and 18th century portions of the building - Photo 06.

The photo shows the steel and timber truss spanning between the east and west elevations.

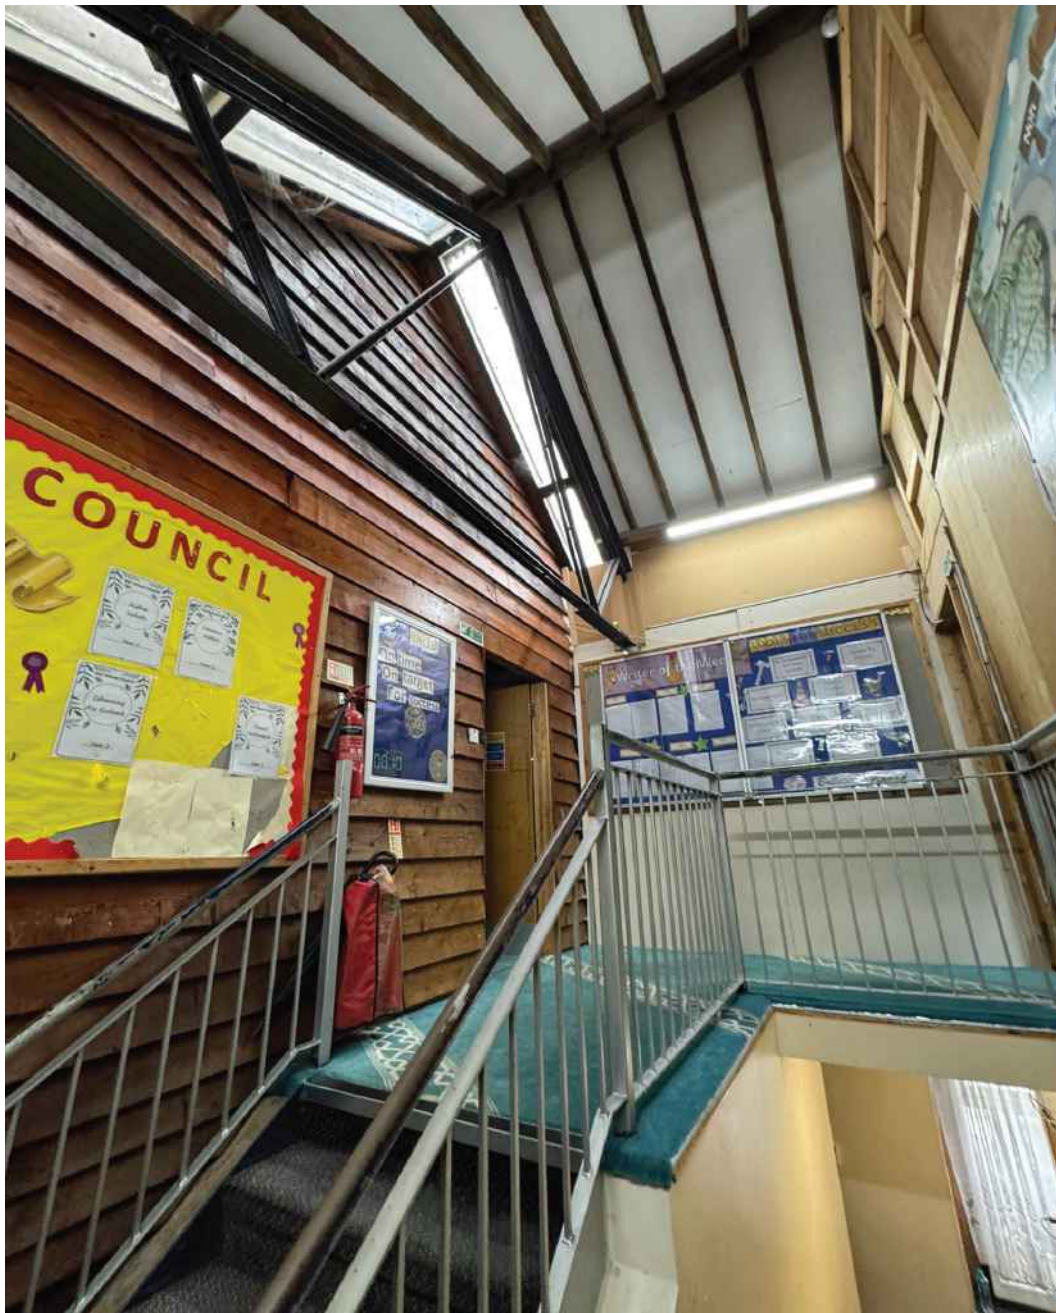
**Photo 06 - Northern Portion of the Roof - Looking North**

The photo shows the steel truss spanning between the east and west elevations and the full width skylight between the 18th and 19th Century portions of the building.

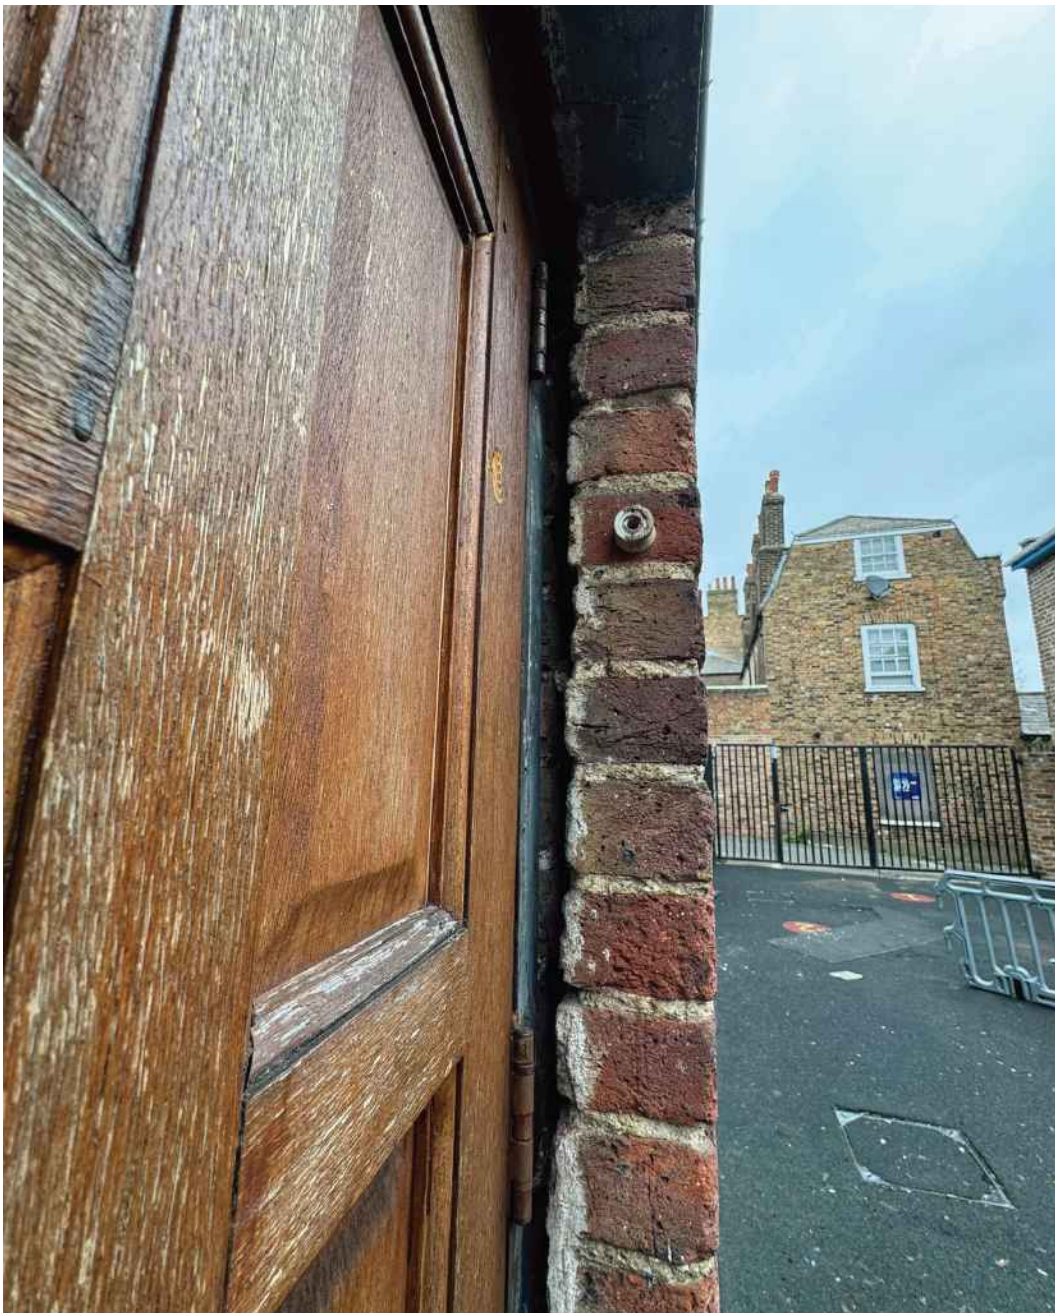
**Photo 07 - Bowing Brickwork by Doorway in East Elevation - Looking North**

The brickwork adjacent to the ground floor doorway in the east elevation was observed to be bowing outward at first floor level – Photo 07. Further outward bowing is evident at eaves level along the east elevation, with the deformation most pronounced at mid-span of the elevation – Photo 08.

The bowing, and subsequent cracks in the brickwork, are likely to be the result of the lateral thrust forces from the roof structure (see section ii. below), exacerbated by the limited capacity of this part of the building to resist horizontal forces.

We observed that the brickwork adjacent to the doorway in the east elevation is bowing out at the level of the first floor.

Based on our current understanding of the building, possible strengthening works may include installing new framing internally to provide additional restraint to the elevations and resistance against lateral stability loads in the east-west direction. The new framing would likely require the formation of new foundations, and potential underpinning of the existing building. The framing is likely to be either timber or steelwork.

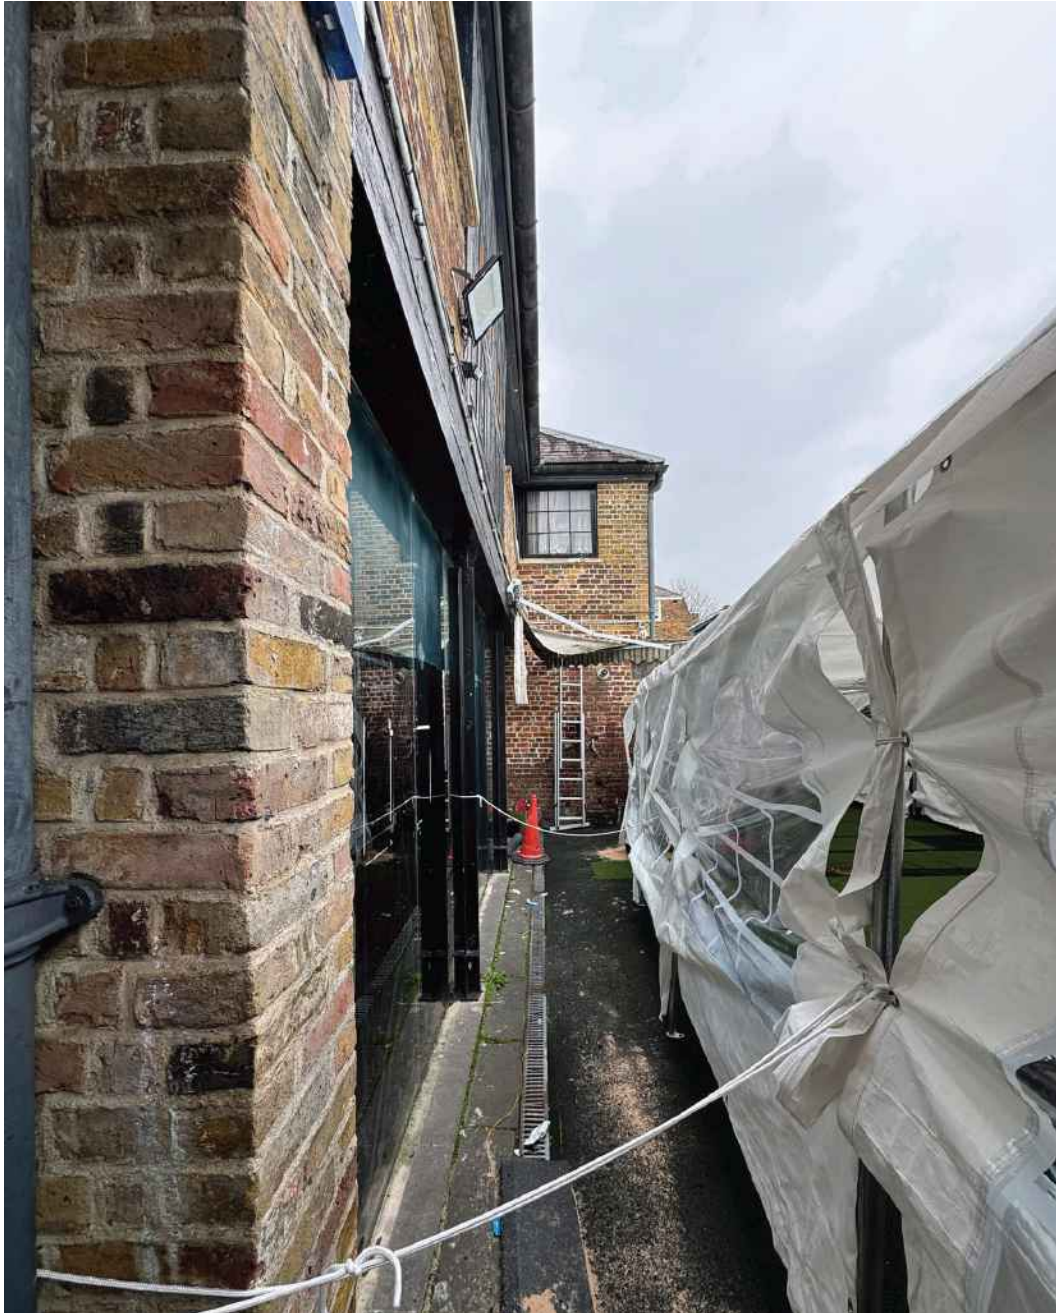
**Photo 08 - Photo Looking North along East Elevation**

We observed that the first floor wall is bowing out at eaves level. This was most prominent in the middle of the elevation.

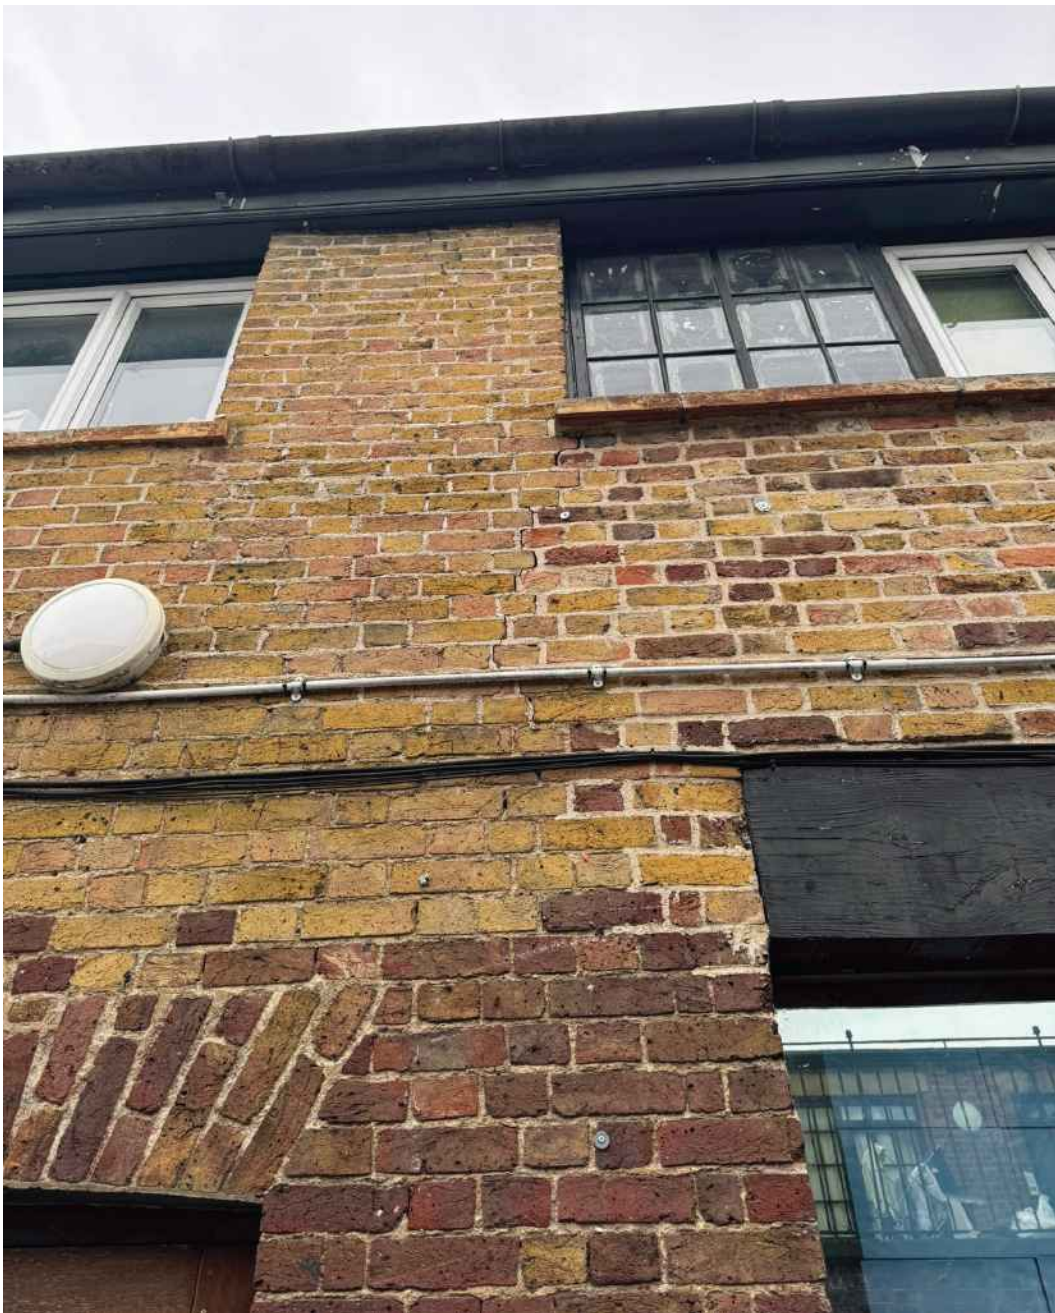
**Photo 09 - East Elevation - Interface between 19th and 18th Century Portions**

Vertical cracks were also observed in the east elevation at both ground and first floor at the interface between the 19th and 18th century portion of the buildings – Photo 09. The cracks indicate differential movement between the two portions of building. Cracks were also observed in the corners of the brickwork along the east elevation – Photo 10.

We observed vertical cracks in the east elevation on the line of the junction between the 19th and 18th Century portions of the building.

Further general localised repairs would be required to address the symptoms of the movement, such brickwork repairs to the elevations.

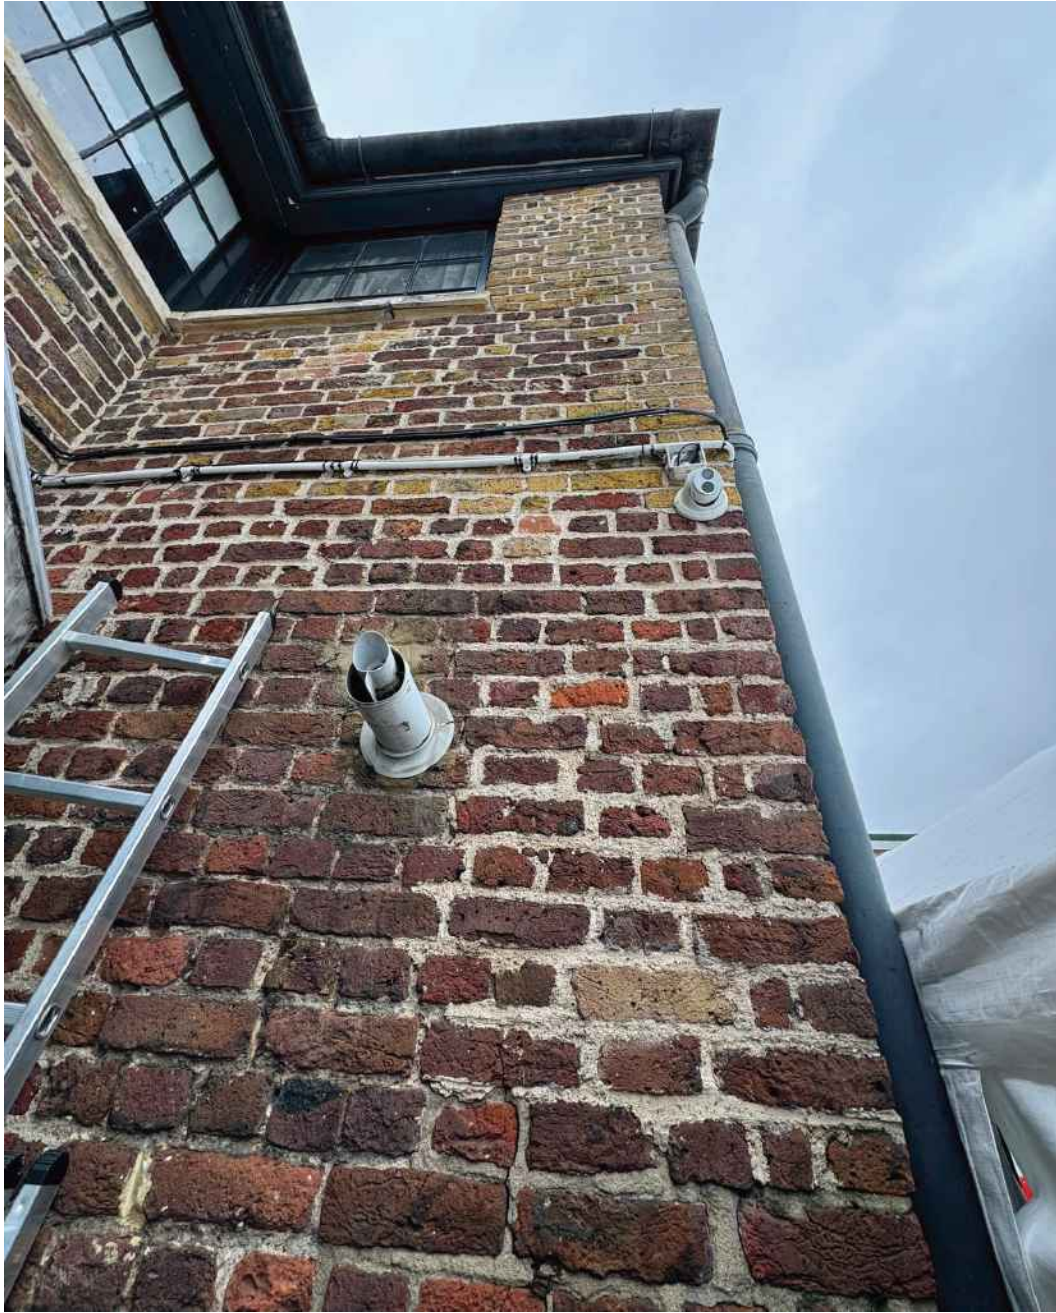
**Photo 10 - Return Wall in East Elevation**

We observed cracks and distortion in the brickwork forming east elevation. These were concentrated near the corners, including at the return wall in the elevation.

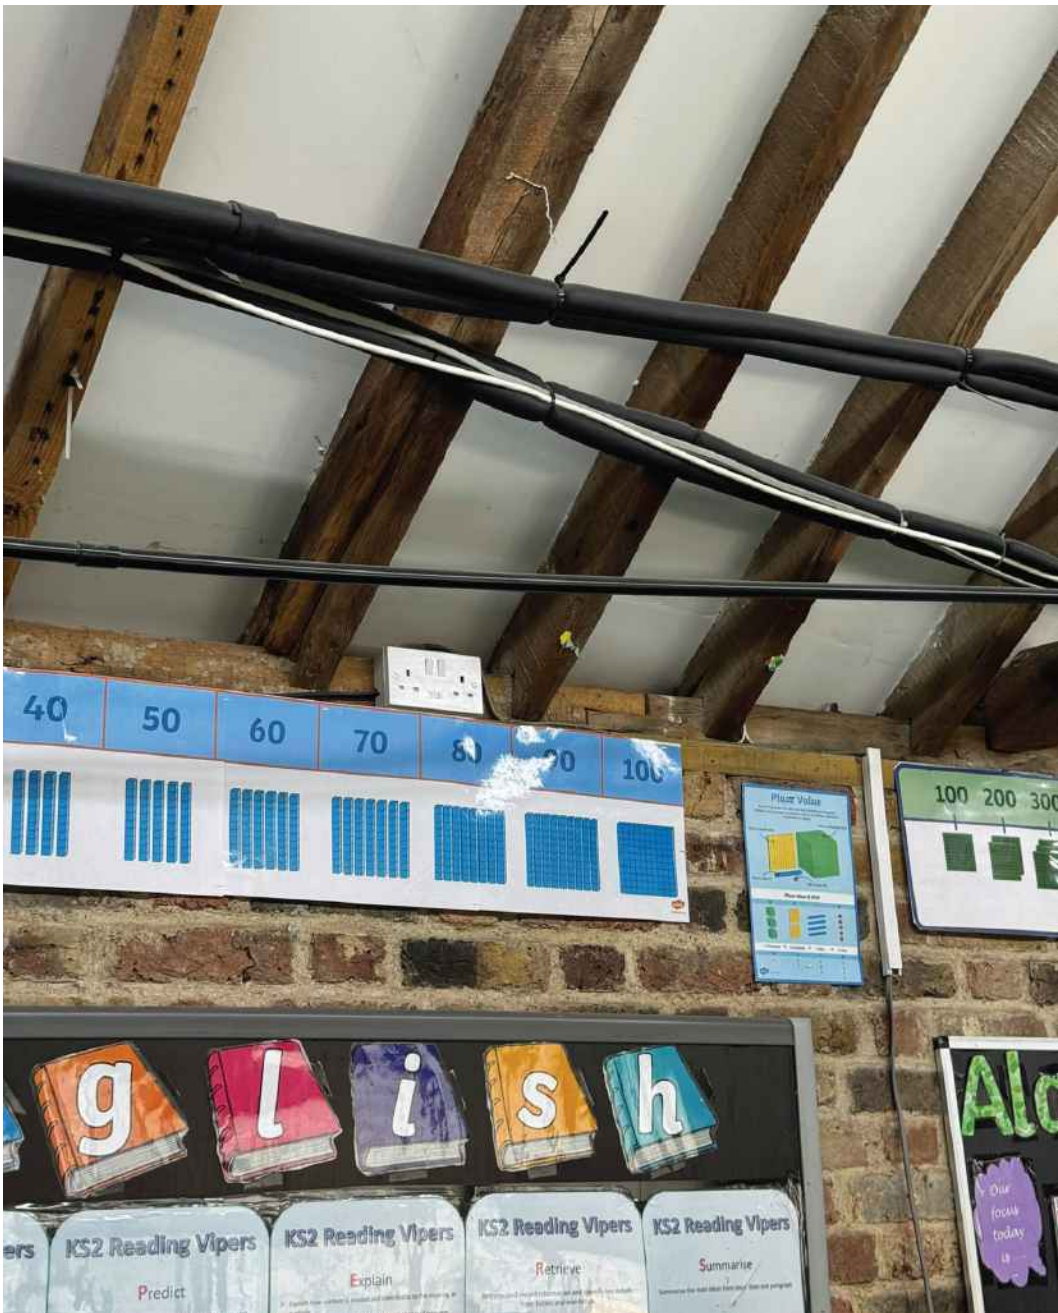
Photo 11 - First Floor - Timber Wall Plate

There are a number of half lap joints in timber wall plate at eaves level – Photo 11. The cumulative effect of these repeated half lap connections introduces multiple points of weakness along the length of the wall plate, reducing the wall plates' ability to span between the eaves-level roof ties without excessive lateral movement.

There are a number of half lap joints in the existing timber wall plate. The laps do not align with the location of the eaves level ties.

The existing roof structure may also need to be improved to limit further spreading and racking of the roof. This may include installing additional ties at eaves level, as well as installing sheathing to the roof to allow it to act as a diaphragm to span between the framing elements and resist racking.

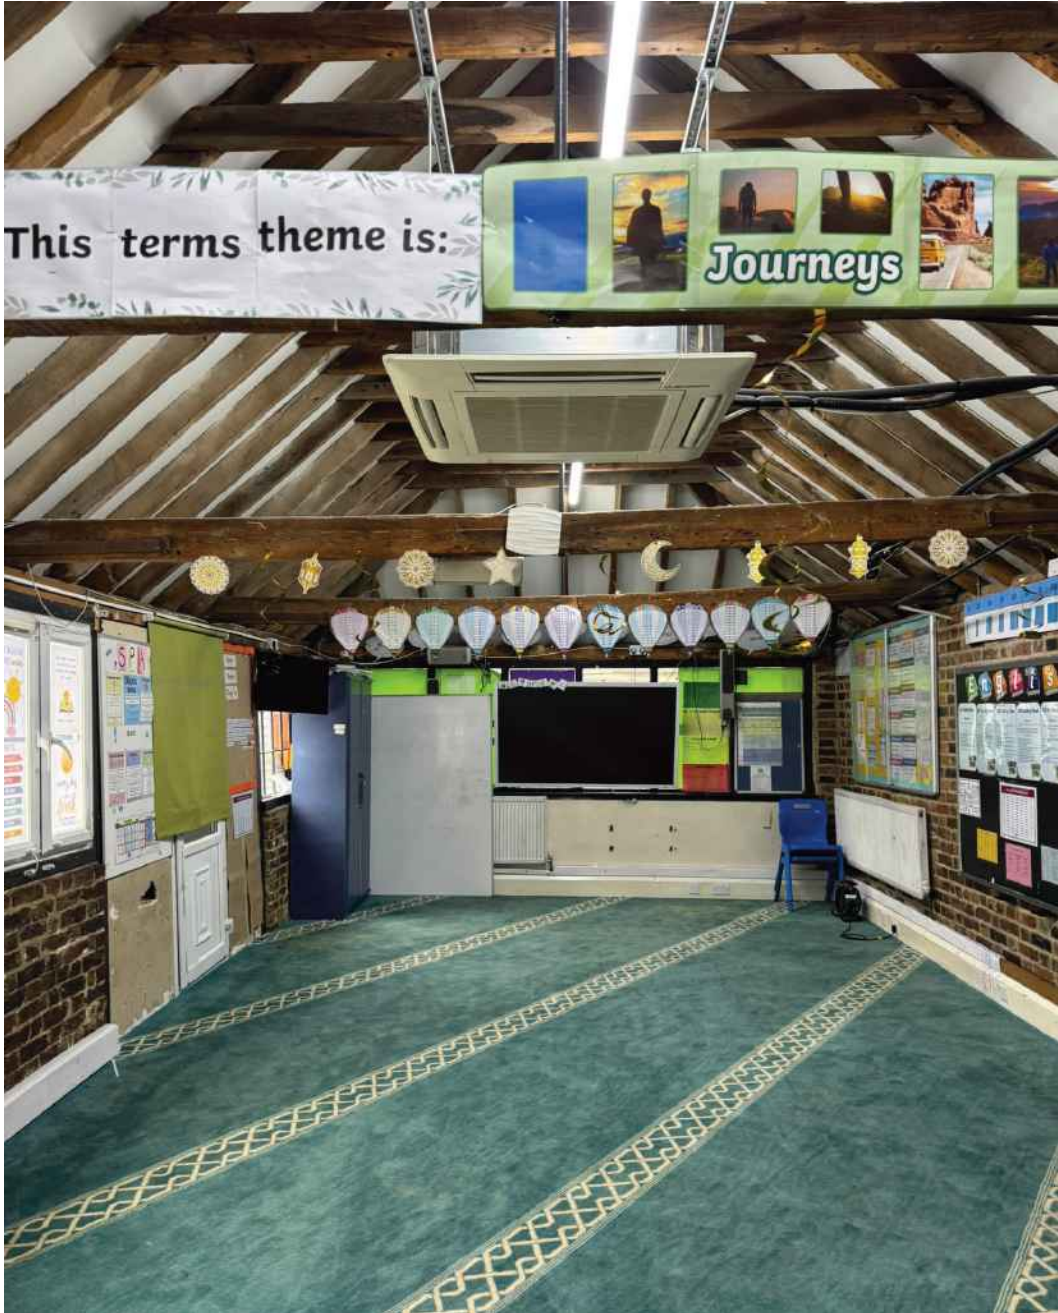
Photo 12 - First Floor - Southern Portion

In addition, the eaves-level ties were observed to be sagging under their self-weight – Photo 12. For the ties to act effectively in tension, they must be relatively straight. The existing deflection indicates that the ties would need to be straightened under load before they can adequately resist and transfer the horizontal thrust forces from the roof.

We observed that the eaves level ties have sagged under thier selfweight, reducing their effectiveness to act as ties.

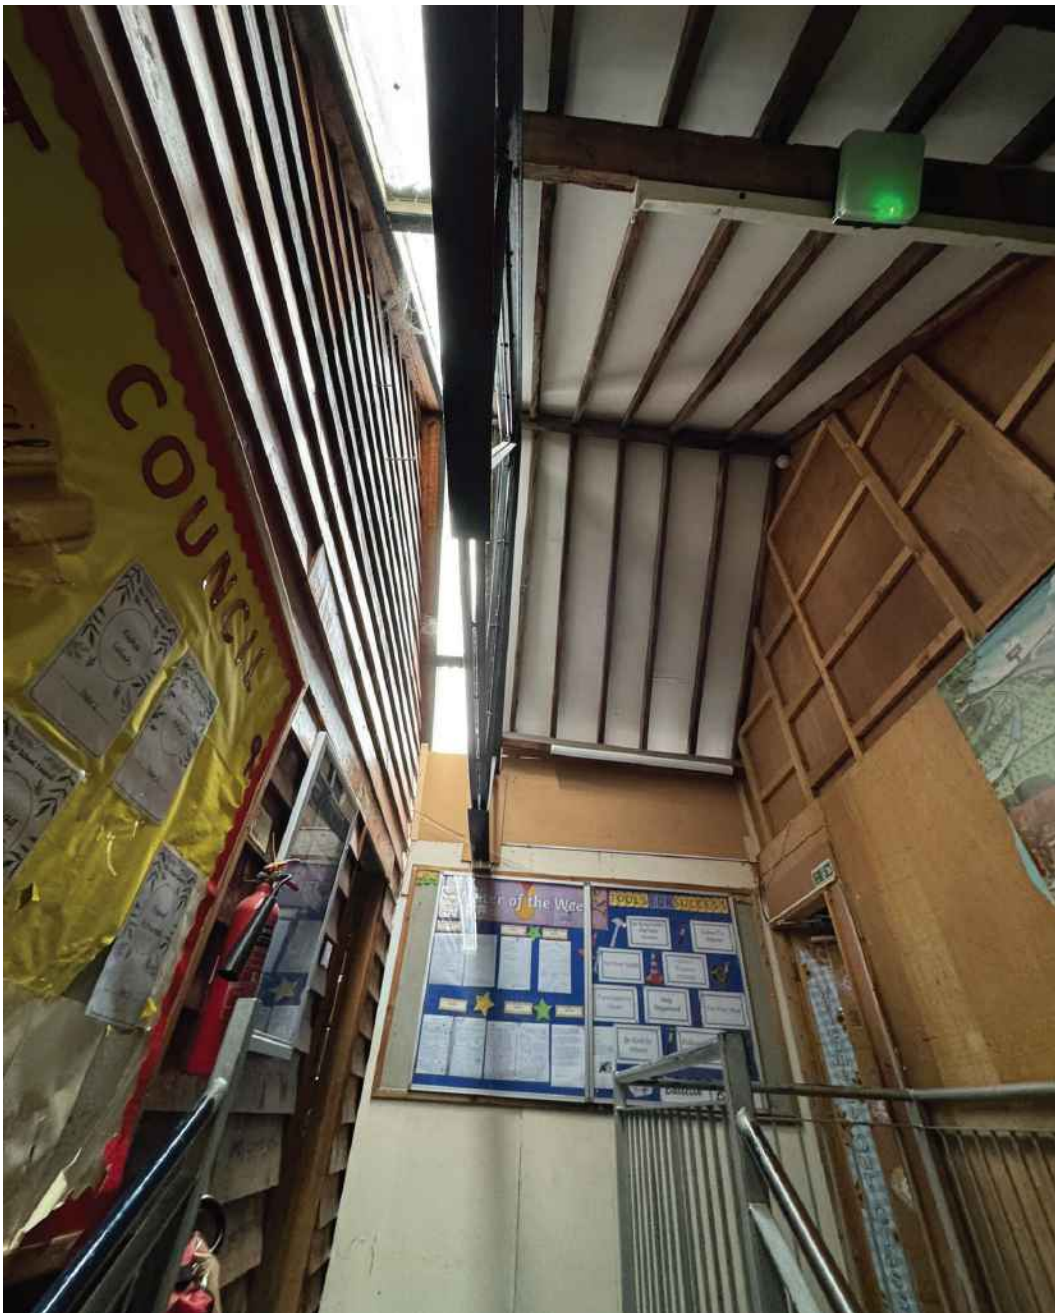
**Photo 13 - First Floor - Northern Portion - Roof Structure**

The northern portion of the wall appears to be tied across the width of the roof more effectively. However, the rafters appear to be racking towards the north – Photo 13. This suggests that the roof is not adequately braced in the north-south direction.

The rafters forming the northern part of the roof appear to be racking, with the ridge moving north relative to the wall plate.

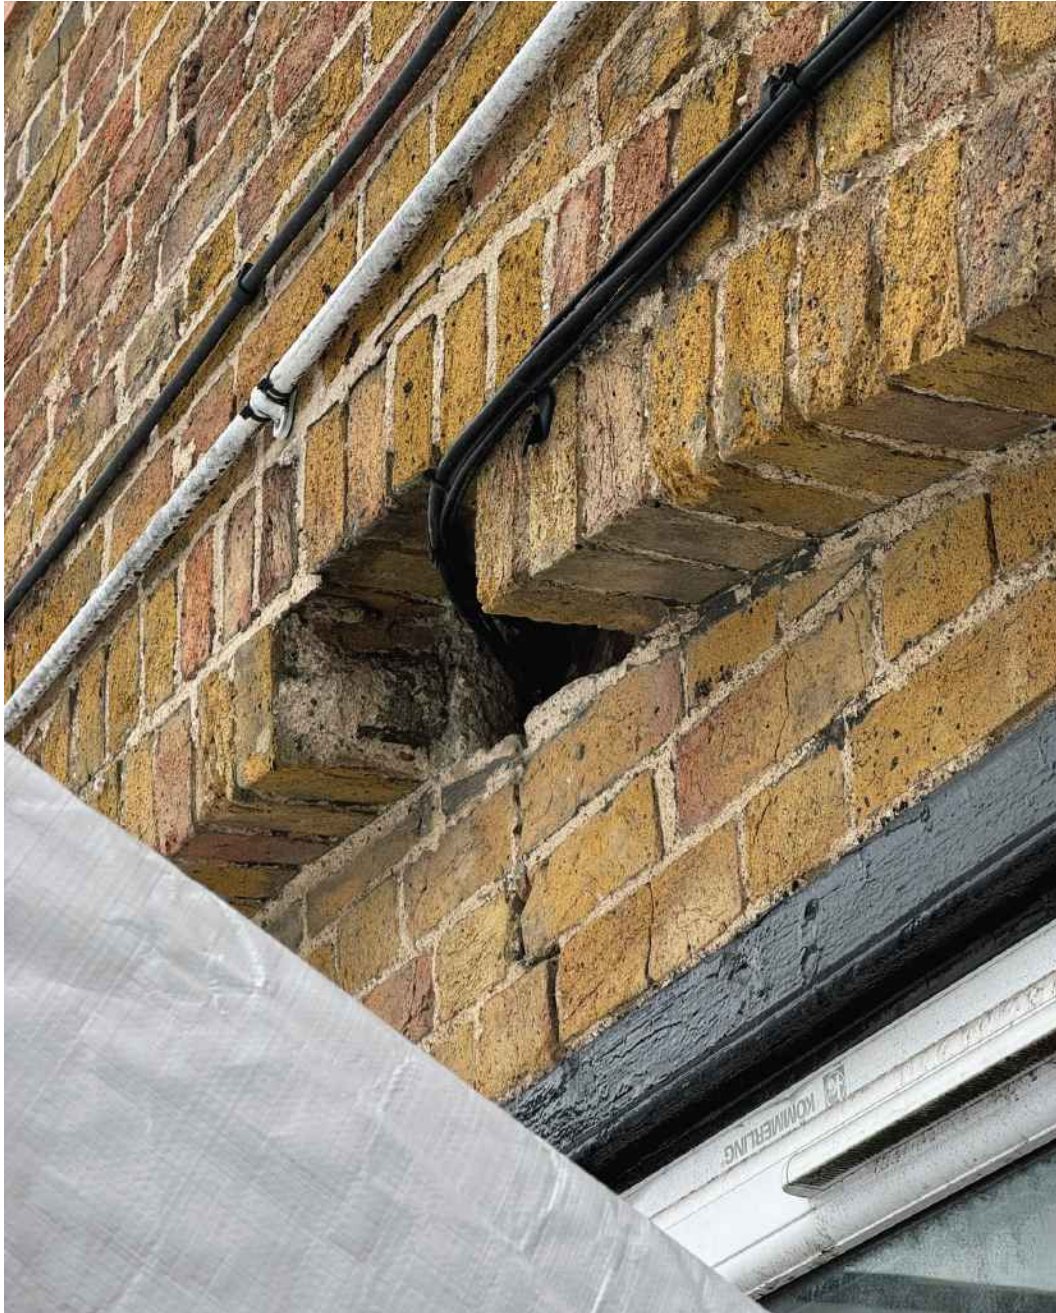
**Photo 14 - East Elevation - Damage to Brickwork Arch**

Damage was observed to the brickwork forming the arch over one of the window openings at ground floor level in the east elevation. A number of bricks are missing from the inner ring of arched brickwork – Photo 14. The damage appears to relate to the installation of services through the external elevation. The damage to the arch has removed the arch's capacity to arch over the opening below and could result in movement or spreading of the arch.

Damage to the existing arched masonry in the east elevation which appears to be due to previous services installations.

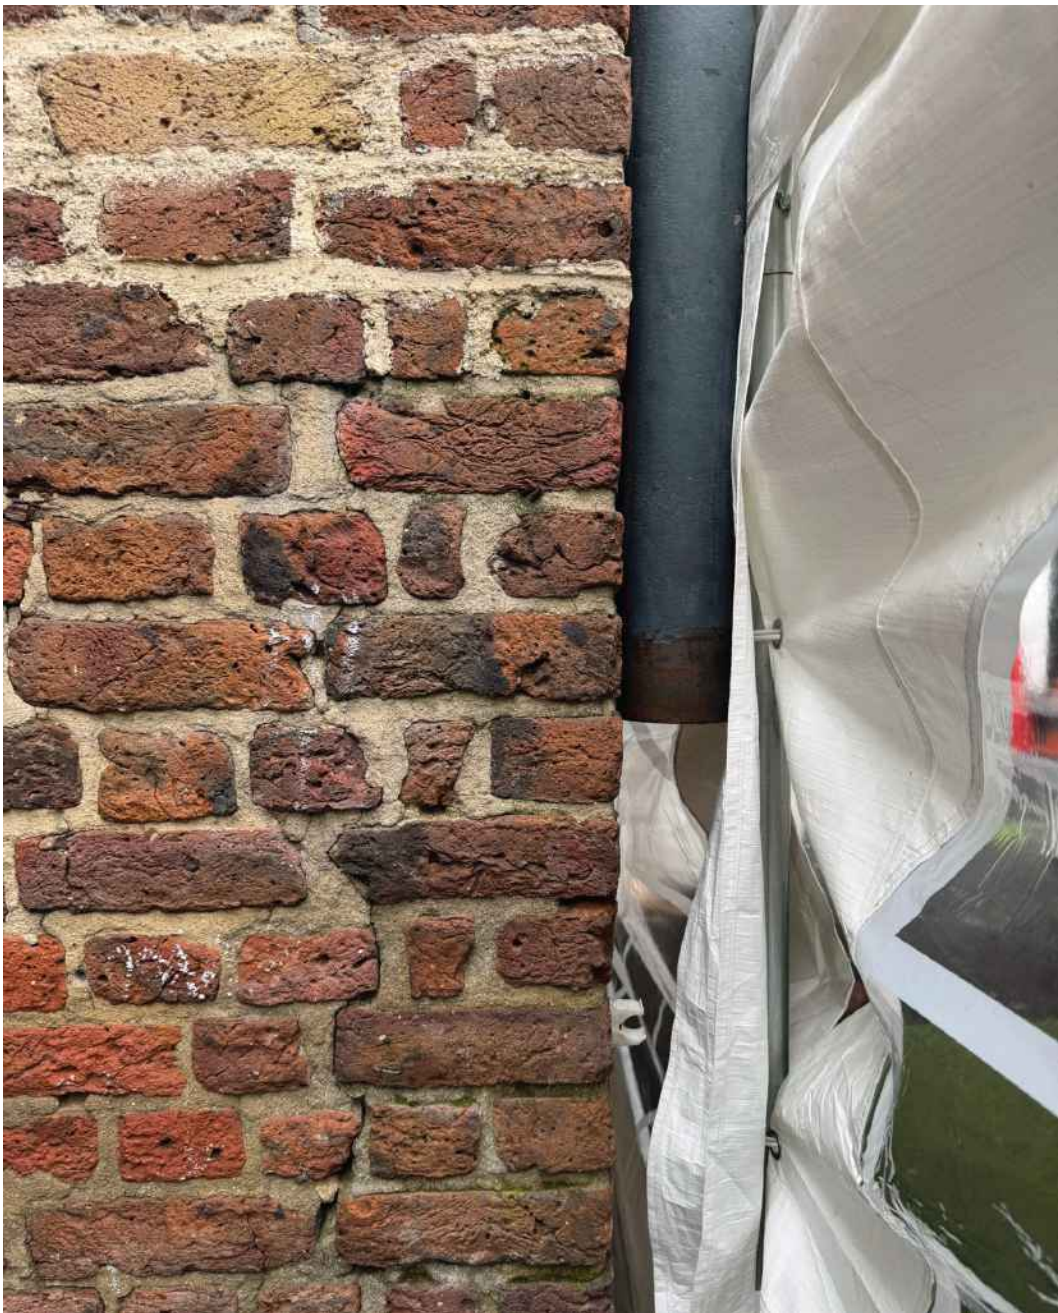
**Photo 15 - Surface Water Down Pipe - East Elevation**

A number of issues were identified in relation to the existing surface water drainage arrangements around the building, including a rainwater pipe discharging approximately 1 m above external ground level – Photo 15. The external ground levels also fall towards the building – Photo 16. Whilst a slot drain is present in front of the elevation, it appeared to be poorly maintained.

The defects associated with the surface water drainage increase the risk of saturation of the existing masonry, and potential softening of the clay the building is founded on.

Persistent wetting of the brickwork is likely to accelerate deterioration and may increase the risk of timber decay where timber elements are in contact with the masonry. Whilst increased moisture content in the ground may lead to local softening of the clay, potentially resulting in differential settlement of the building.

The existing rainwater downpipe terminates approximately 1m above the external ground level, resulting in repeat wetting of the existing elevation.
