# Assunnah Islamic Centre, Bruce Grove

## Structural Engineering Condition Report

19th Century Barn

April 2026

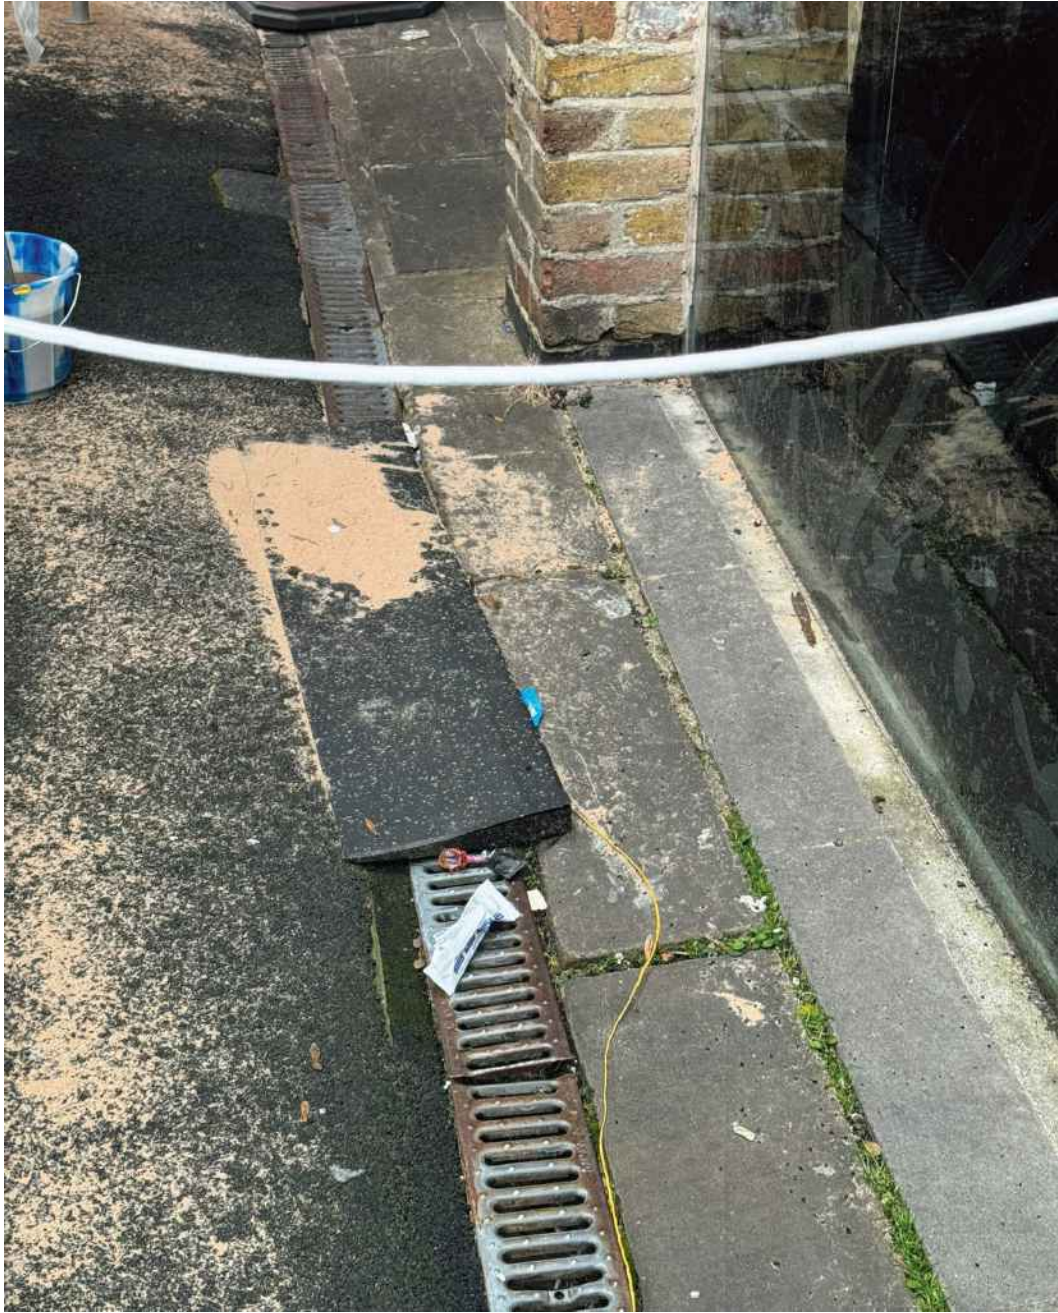
**Photo 16 - Drainage along East Elvation**

A number of issues were identified in relation to the existing surface water drainage arrangements around the building, including a rainwater pipe discharging approximately 1 m above external ground level – Photo 15. The external ground levels also fall towards the building – Photo 16. Whilst a slot drain is present in front of the elevation, it appeared to be poorly maintained.

The defects associated with the surface water drainage increase the risk of saturation of the existing masonry, and potential softening of the clay the building is founded on.

Persistent wetting of the brickwork is likely to accelerate deterioration and may increase the risk of timber decay where timber elements are in contact with the masonry. Whilst increased moisture content in the ground may lead to local softening of the clay, potentially resulting in differential settlement of the building.

The existing slot drain along the east elevation is paritially blocked in some areas, limiting its effectiveness and increasing the risk of water ingress to the building.
