# **Simon Pryce Arboriculture**

## **Report**

**Site:** 102 Florence Road, London, N4 4DR

**Subject:** Trees and other vegetation near the building and their effects on it.  
Specification for necessary or appropriate work.

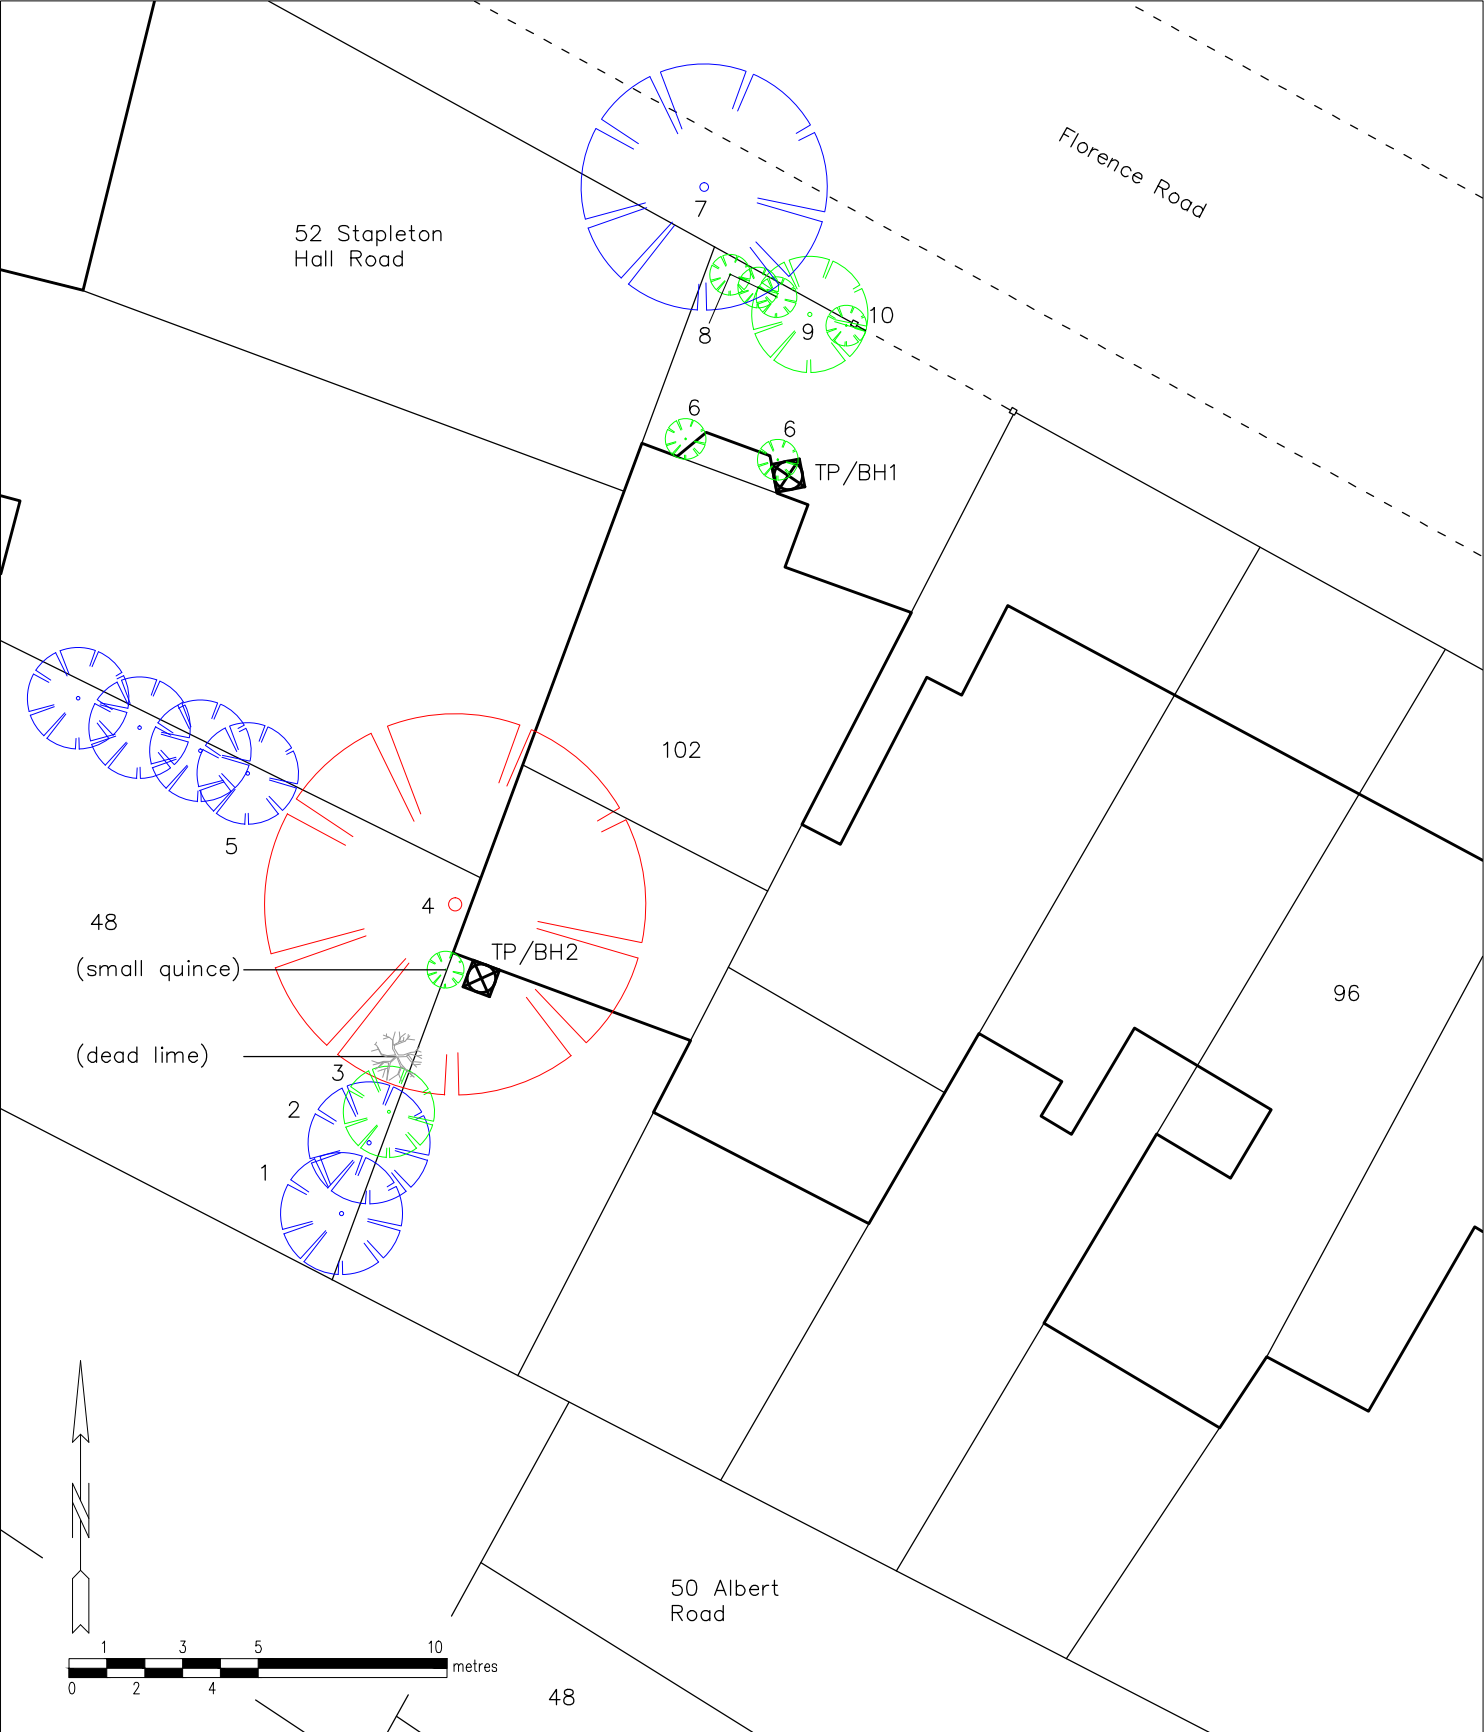
- 3.1 The most significant trees are all offsite and include a large eucalyptus close to the rear extension and some pollarded limes in the back garden of no.48 Stapleton Hall Road and a Norway maple belonging to Haringey Council in the pavement in front. The eucalyptus was topped several years ago and has regrown vigorously to form a large crown. The Norway maple was also reduced a few years ago and has regrown.
- 3.2 These are described individually in the schedule forming the second part of this report, with recommendations for any necessary or appropriate work. They are numbered on the attached site plan.

- 6.1 Site investigation shows that the damage in the house is subsidence caused by the sub soil shrinking as it has been dried by roots from nearby trees and other vegetation.

- 6.2 The main causes are the large eucalyptus and pollarded limes to the rear and the Council's Norway maple growing in the street in front. These have all been reduced at various times and are regrowing, with their water uptakes increasing in the process.

- 6.3 The eucalyptus is too large and too close to the house for any form of pruning to be effective, so the only viable arboricultural option is to remove it. The other trees are smaller and farther from the house, so they could be reduced again but it will be essential to cut regrowth regularly in order to maintain the benefit.
