## 92 Crouch Hill, London, N8 9ED

| Job Title | CAS682-Section 211, 92 Crouch Hill, London, N8 9ED |
| Survey brief | <p>Carry out inspection of mature tree in rear garden and prepare report to support Section 211 notice to carry out treeworks within a Conservation Area.</p> <p>Client wishes the tree to be reduced to abate a future nuisance.</p> |

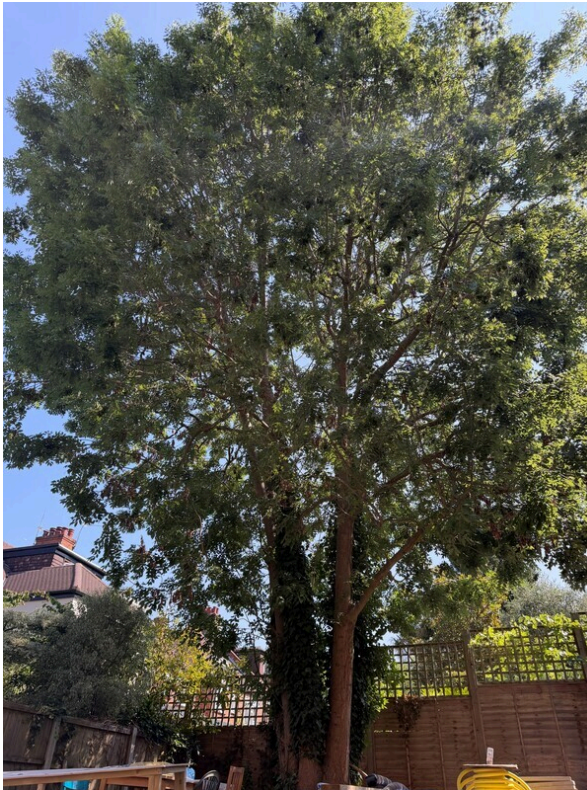
| Additional plans/Site photos | <p><i>Tree in rear garden of number 92</i></p> |

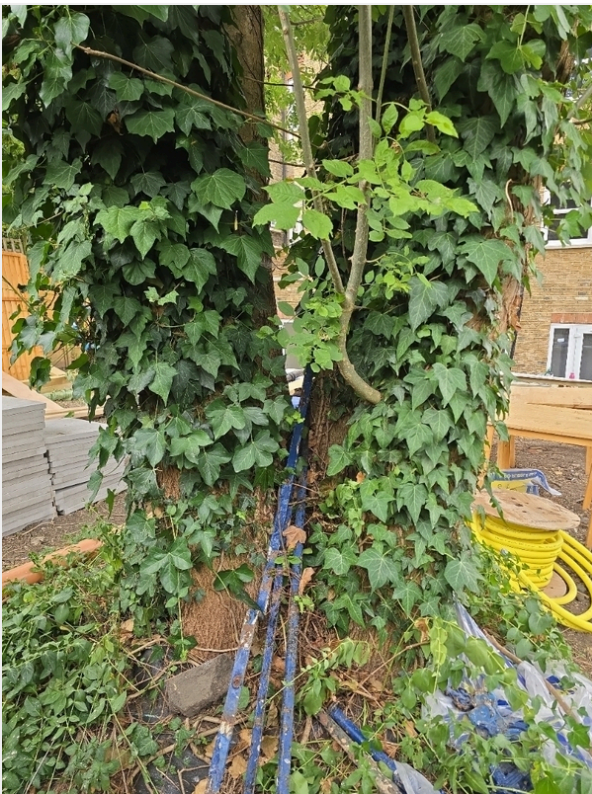
| Defects to be remediated | Inclusion of primary union with significant expansion cracks.<br>Foreseeable encroachment to neighbouring properties. |

*T01 - Including union holding some soil*

| Tree works required | Reduce overall height by 3-4m (30%) to reduce wind-loading on primary union and abate foreseeable encroachment to neighbouring properties. |

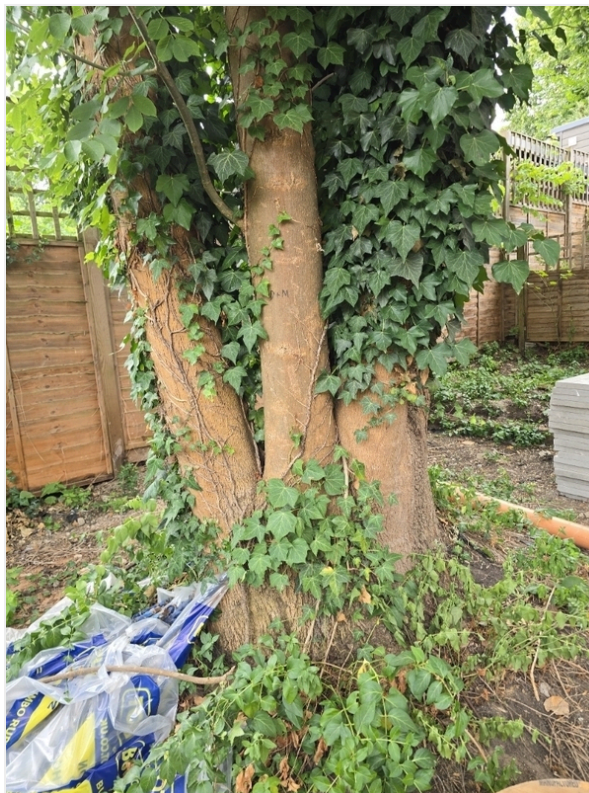
*T01 - Multi-stemmed regrowth from stump*

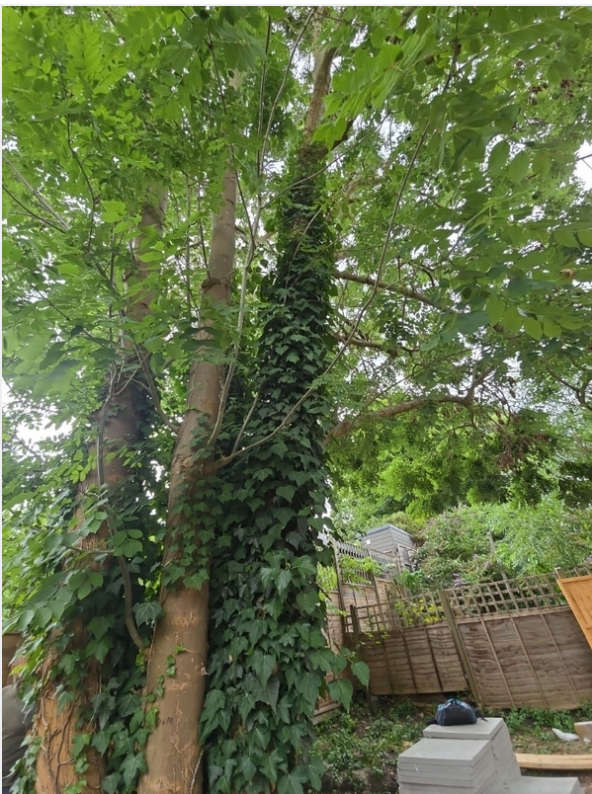
*T01 - Ivy clad stems to 3m*

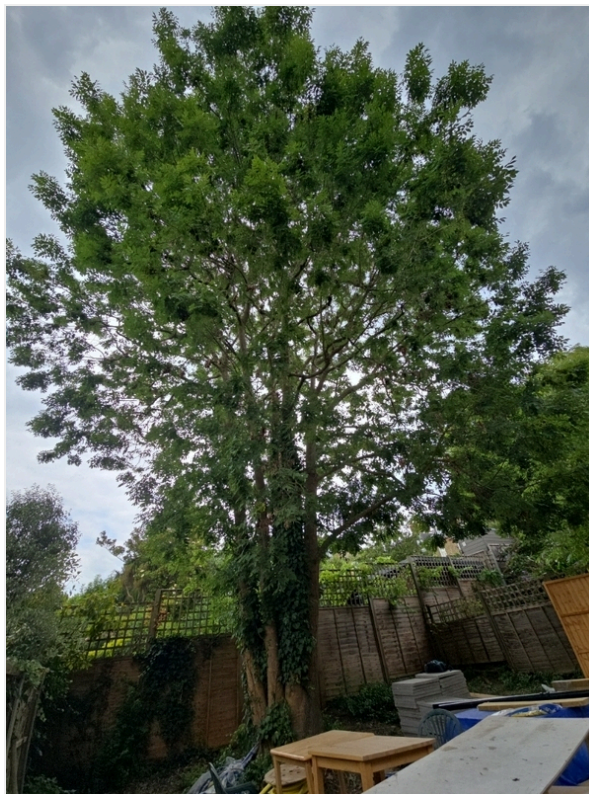
*T01 - Overview of tree (historically reduced)*

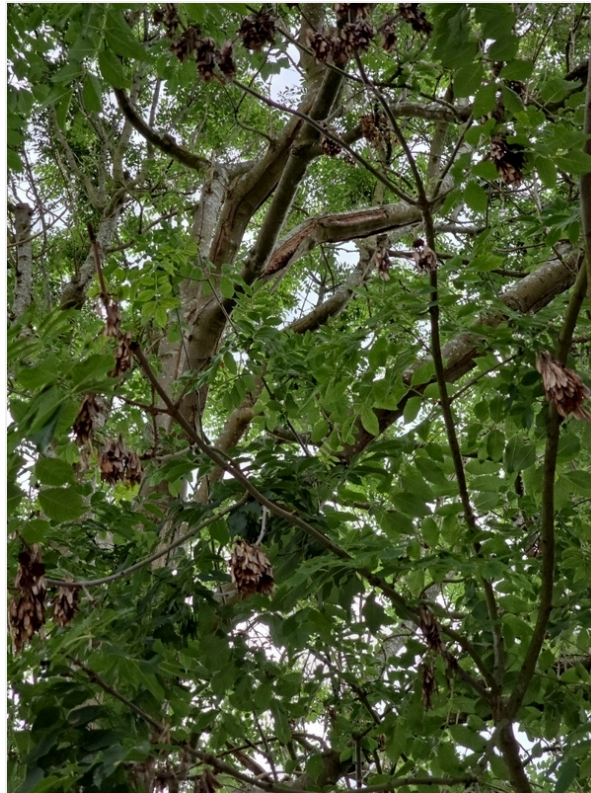
| Observations/Condition notes | Multi-stemmed regrowth from stump.<br>Minor inclusion of primary union.<br>Ivy on lower stems.<br>Expansion cracks on stems and primary branches from rapid adaptive growth suggesting significant wind-loading.<br>Crack in branch in upper canopy.<br>Previously reduced, old pruning wounds. |

*T01 - Expansion cracks visible on stems and primary branches*
