Gypsum Plaster Removal Report

Project no: 192  
Project name: SOUTHWOOD LANE  
Drawing title: Strip Out Report

Drawing no: 192-DET-101  
Date: 07/08/2026  
Rev: First Issue  
Drawn by: GF Checked by: JF

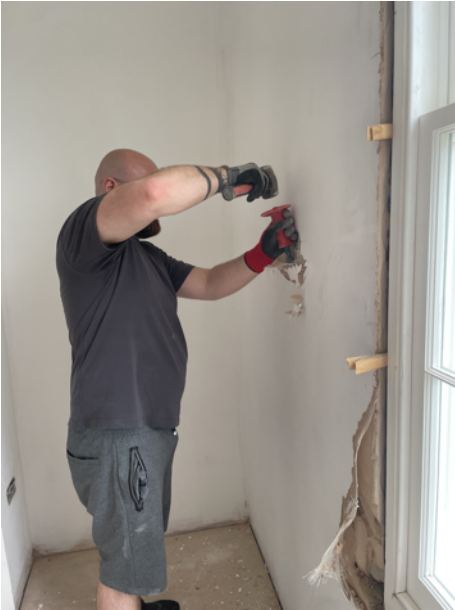
Carefull removal of gypsum plaster using hand tools

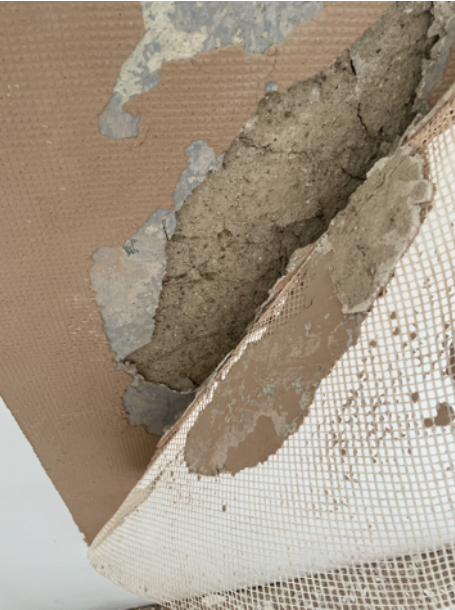
Lime plaster behind gypsum with face coming off during removal

The exposed areas of masonry or laths will be made good using a two-coat lime plaster system, carefully brought flush with the adjacent historic plasterwork. Upon full curing of the base coats, a breathable primer will be applied to the entire surface, followed by two coats of superfine lime finish plaster.

In order to retain as many areas of historic lime plaster as possible we are proposing to use a fibre reinforcing mesh. This will be embedded within the finish coat to provide additional reinforcement across the interface between the existing and new plaster. This is intended to help accommodate minor differential movement and reduce the likelihood of shrinkage or settlement cracking, while maintaining a breathable and compatible lime plaster system.

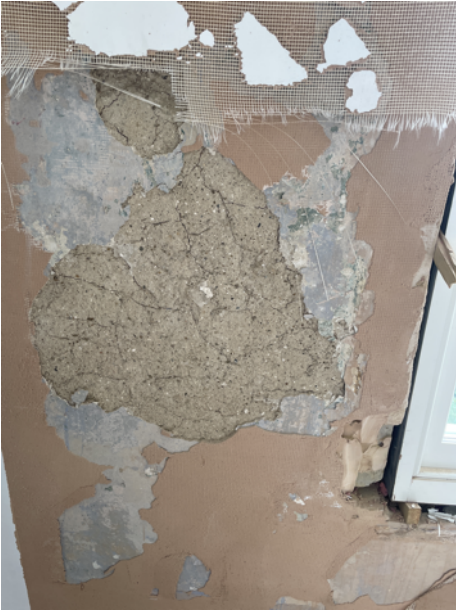
Lime plaster behind gypsum with face coming off during removal

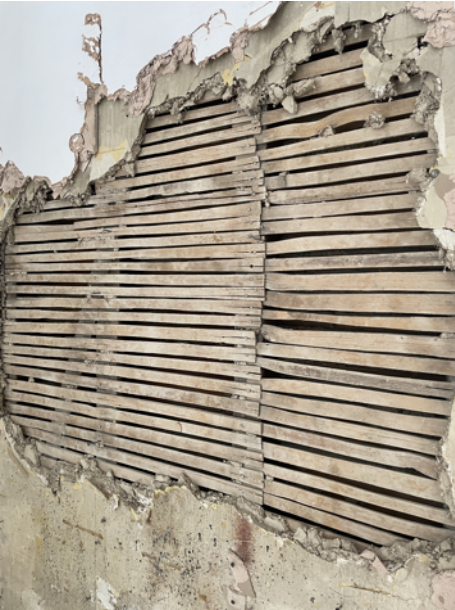
The plasterboard has been removed from partitions and ceilings. In some areas there is existing lime plaster and laths behind. Where the lime plaster was loose or crumbling this has been taken back to the existing laths which are to be reused (to partitions only).

Existing laths behind areas of cracked or blown lime plaster

Where lime plaster has had to be removed from the ceilings the laths are proposed to be removed and replaced due to safety concerns. See below justification from J.E. Putney & Sons
