Render removal report

Project name: SOUTHWOOD LANE

Drawing title: Lower Ground Floor Render Strip Out Report

Drawing no: I92-DET-201

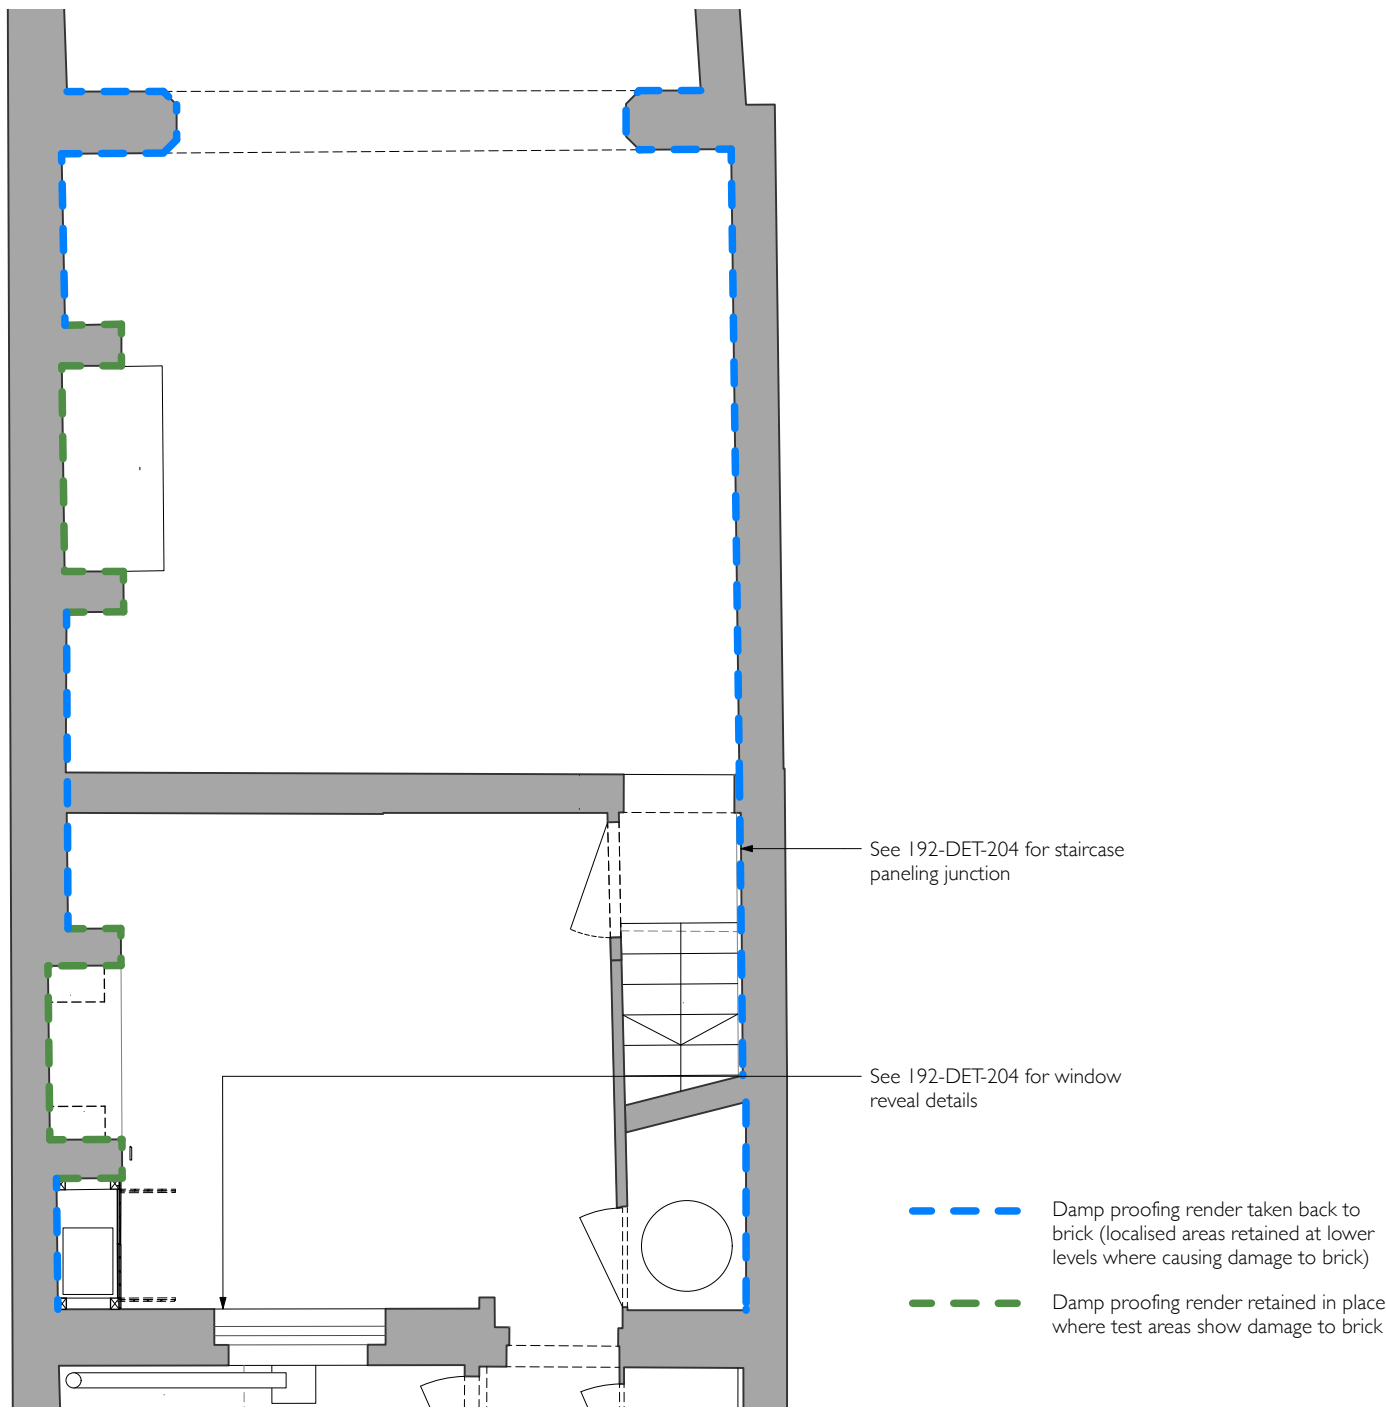
1 Lower Ground Floor Render Removal Plan  
Scale: 1:50

At the higher levels, the render is easier to remove from the brick. The resistance is lower, meaning that the damage to the brick is more limited. Some of the brick faces are coming away, but the bricks remain stable. It is proposed to continue carefully removing the render from these areas and to lime render over the brickwork, using a NHL2 Natural Hydraulic Lime in accordance with the lime render methodology below.

At lower levels and particularly to the chimneybreasts, the damp-proof render has bonded more firmly with the brick. As a result, the faces are blowing and, in some cases, the brick is crumbling. Further removal in these areas is not advised. These exploratory areas will be repaired in accordance with methodology below and lime render applied over as per lime render methodology below.

Where test areas have caused the bricks to crumble and fail these areas will be repaired using the following methodology

- Exposed masonry will be made good using a two-coat lime plaster system using a NHL2 Natural Hydraulic Lime in a 3 to 1 ratio
- Upon full curing of the base coats, a breathable primer will be applied to the entire surface, followed by two coats of superfine lime finish plaster.
- A fibre reinforcing mesh will be embedded within the finish coat to provide additional reinforcement across the interface between the existing and new plaster. This is intended to help accommodate minor differential movement and reduce the likelihood of shrinkage or settlement cracking, while maintaining a breathable and compatible lime plaster system
- See I92-DET-204 for proposed details

- Works to follow best practice guidance from: A Guide to the Repair of Old Brick Walls by SPAB & Repointing Brick and Stone Walls - Guidelines for Best Practice by Historic England
- Only bricks that are severely damaged (e.g. cracked, spalled, or severely chipped) will be cut out and replaced. Bricks to be cut out using a plugging chisel to remove surrounding mortar or stitch drilling where required.
- Replacement bricks to be as per spine wall bricks - see I92-DET-401
- Bricks to be laid in lime NHL2 Natural Hydraulic Lime mortar
