### **Subsidence damage investigation report for**

**15 Birchington Road, Crouch End**

Prepared by **Trevor Heaps** BSc, MICFor, RC. Arbor.A.

Our Ref: TH 5699

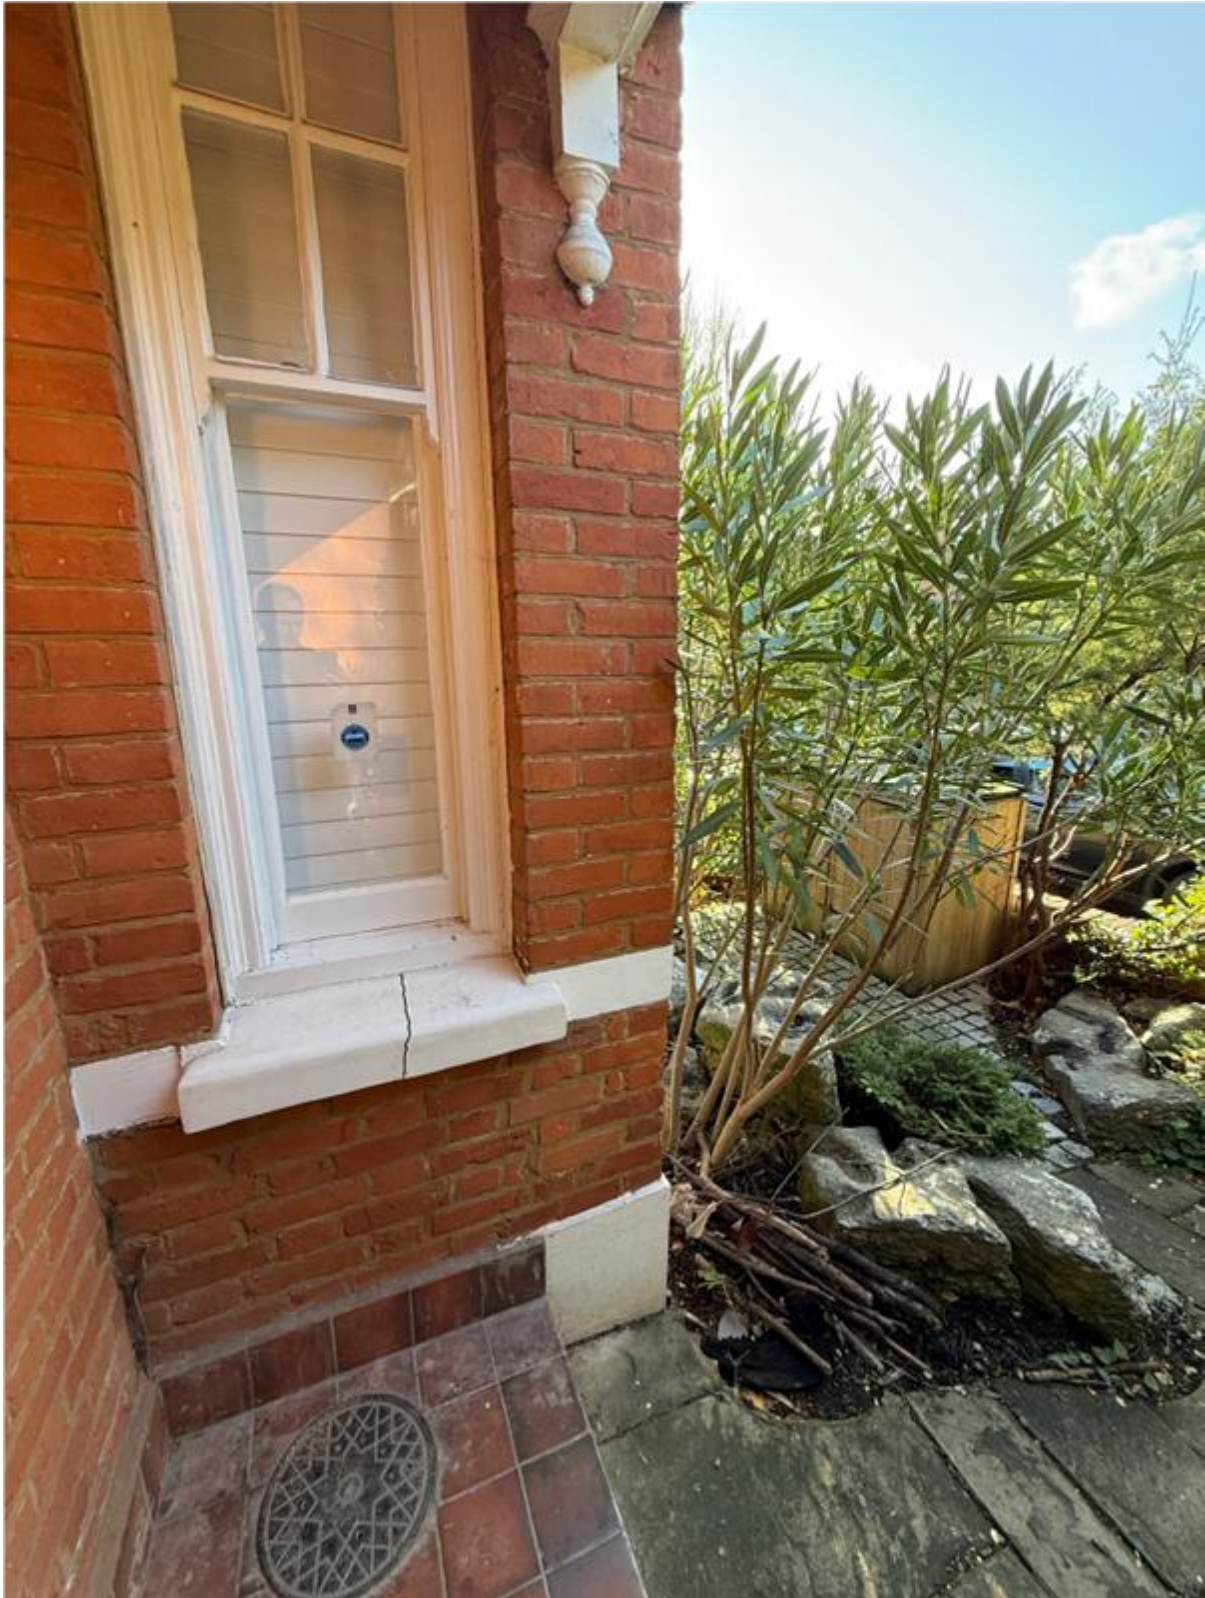
10.3 Cracks have developed around the edges of the front bay window (ground floor and first floor).

**Photo 1** – looking SE at one side of the bay window

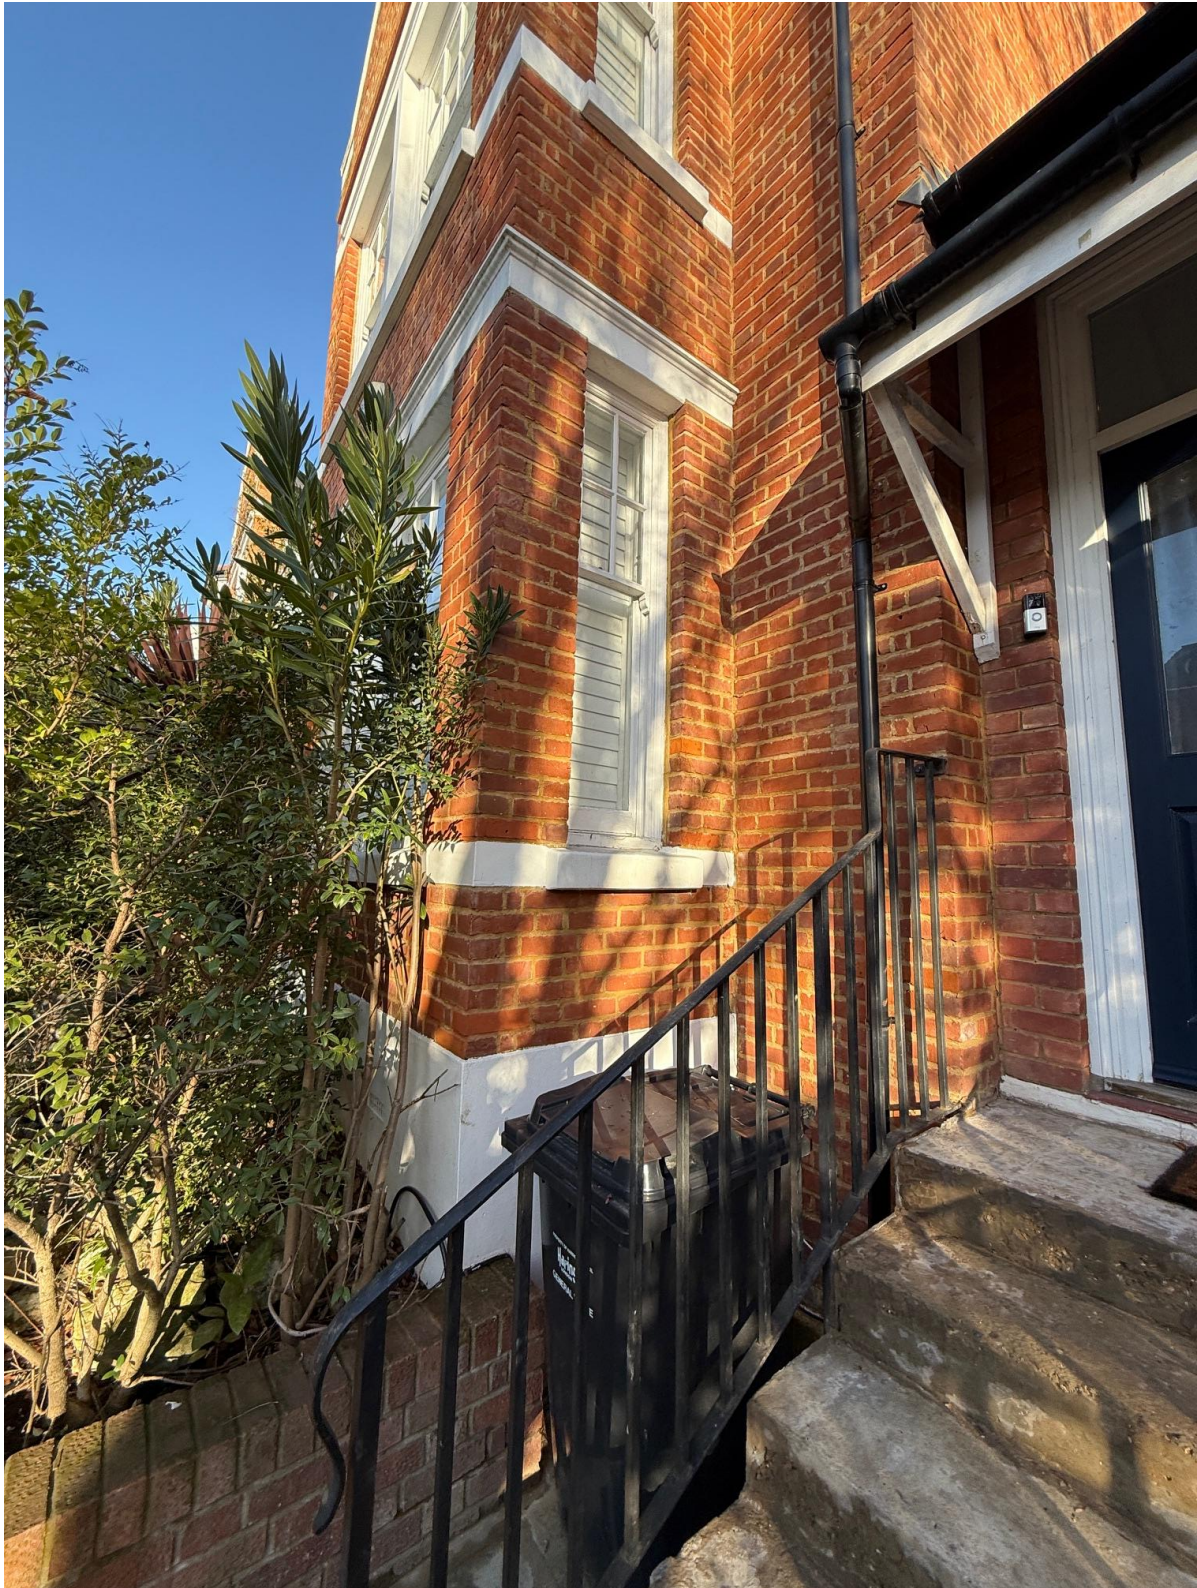
**Photo 2** - looking NW at the other side of the bay window

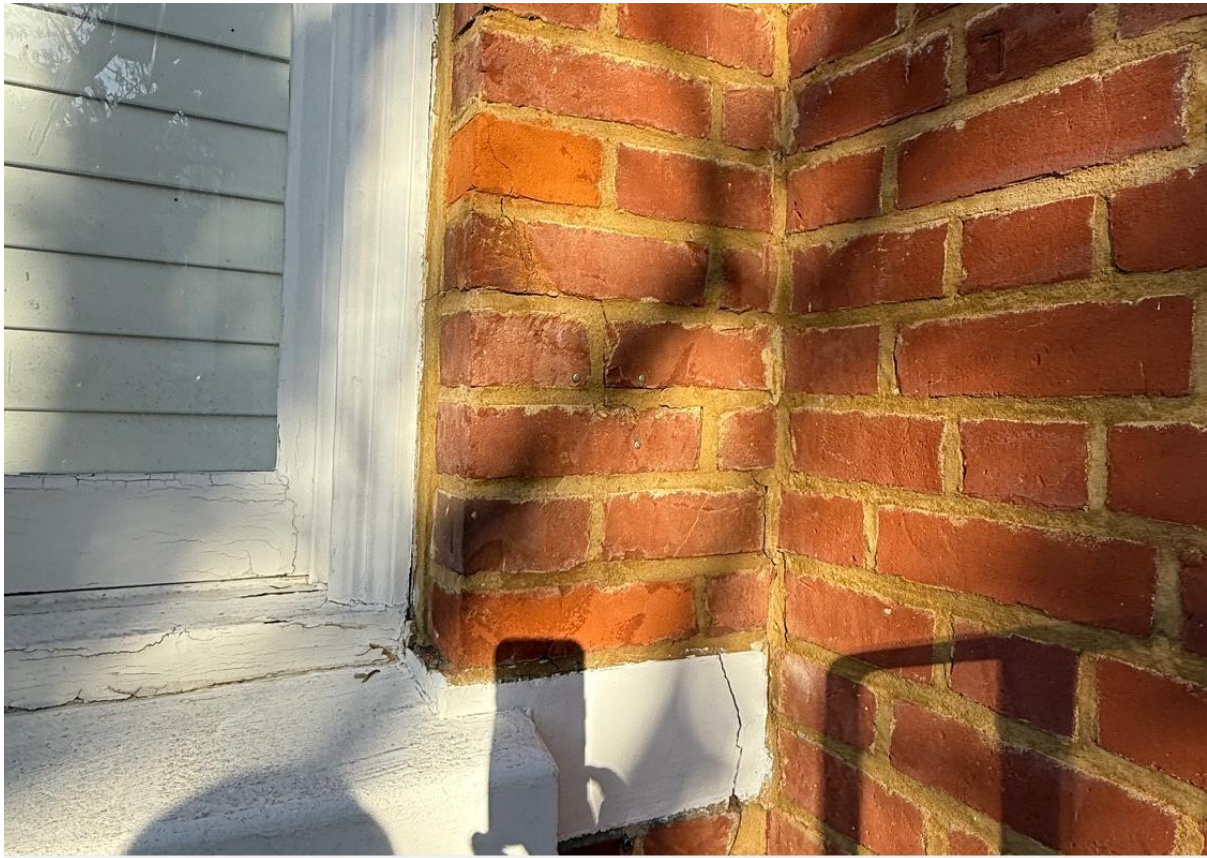
10.4 Tell-tales (crack monitoring wall studs) were noted on the sides of the bay windows, and so the problem appears to have occurred in the past.

**Photo 3** – The ‘tell tales’
