## SITE INVESTIGATION FACTUAL REPORT

Report No: SI-733377  
Client: Sedgwick International UK - Maidstone  
Site: 23 Shepherds Hill  
Client Ref: 8714923  
Date of Visit: 20/10/2023

**Home Emergency Response - Subsidence Investigation - Drainage Services – Crack & Level Monitoring – Property Video Surveys**

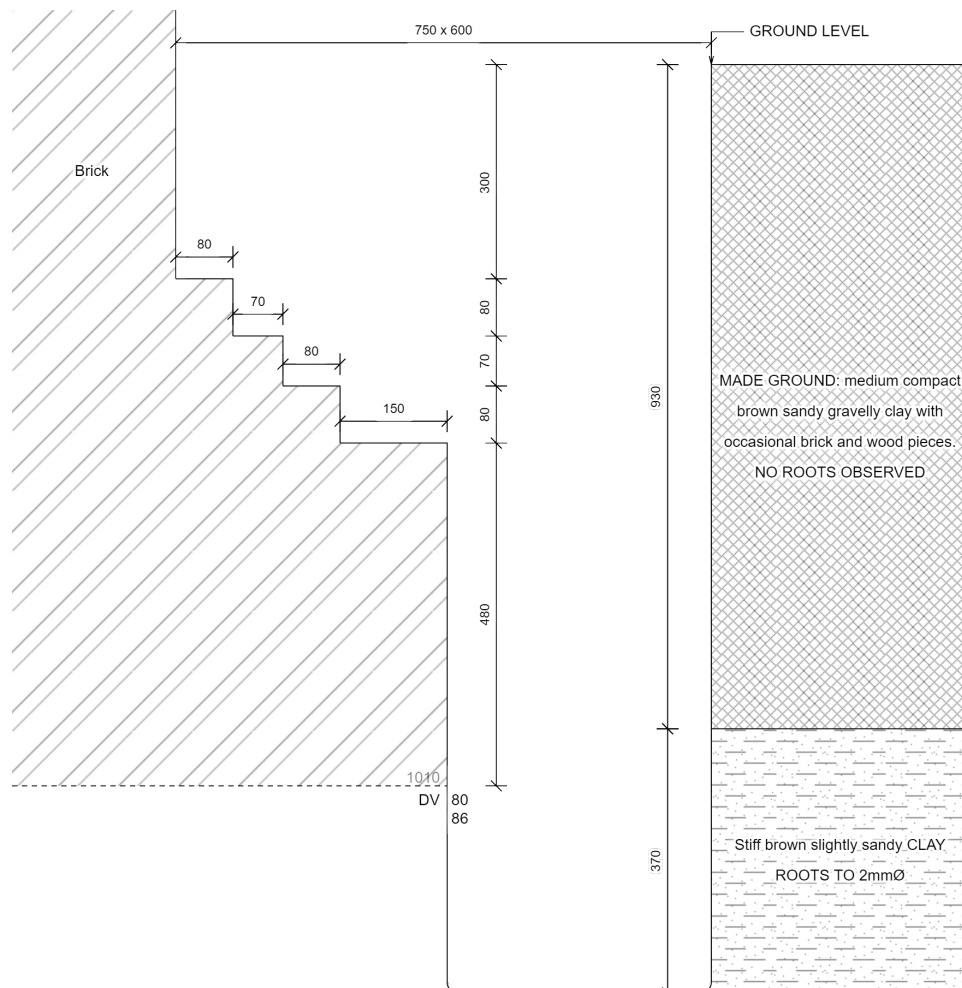
TP1

For Strata below 1300mm see Bore Hole log

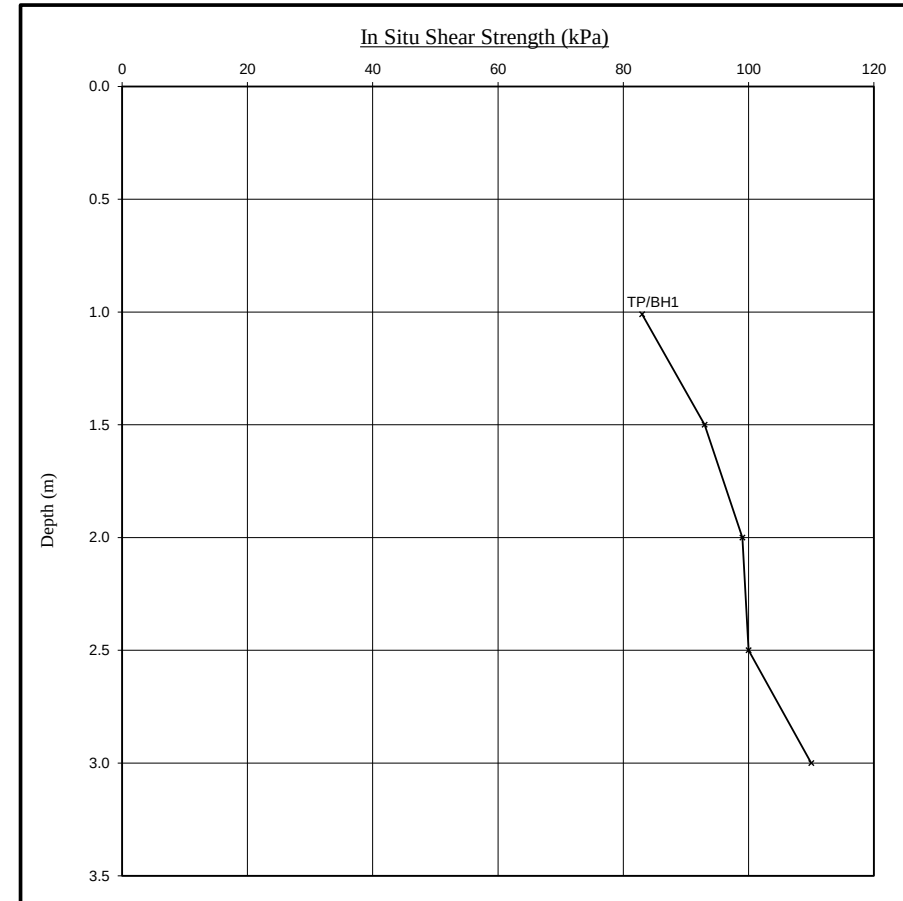
## Shear Strength Profiles

1. Unless otherwise stated, values of Shear Strength were determined in situ by CTS using a Pilcon Hand Vane the calibration of which is limited to a maximum reading of 130 kPa.
2. Unless specifically noted the profiles have not been related to a site datum.

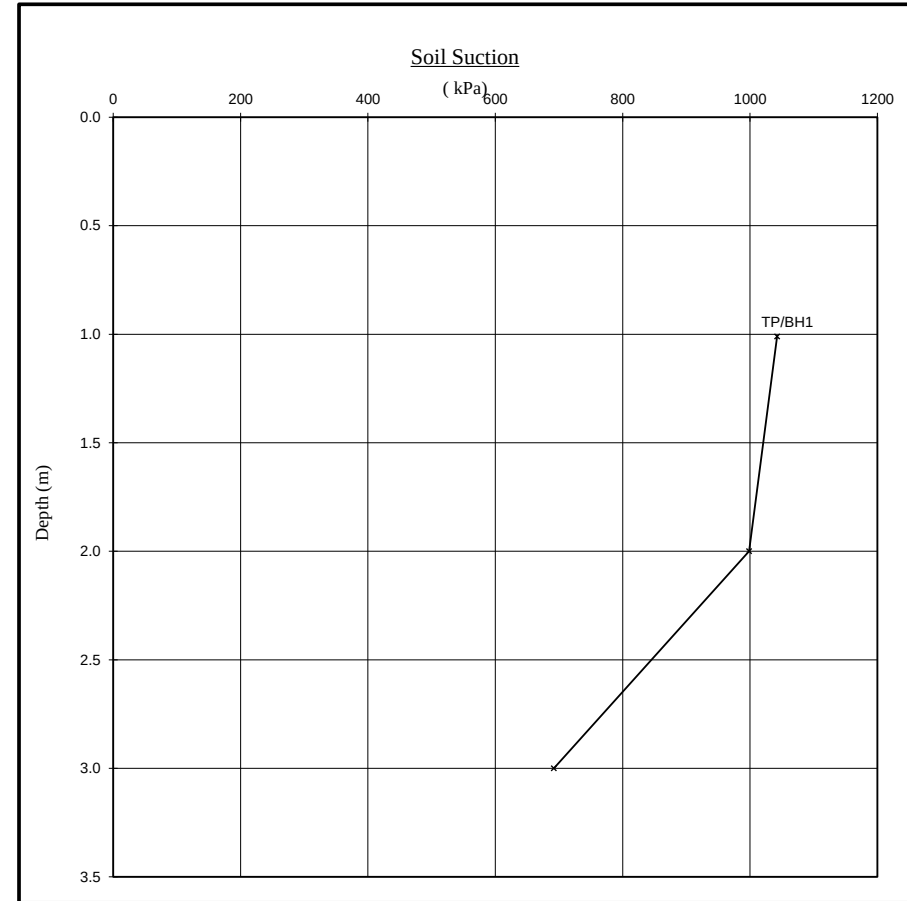
## Soil Suction Profiles

When shown, the theoretical equilibrium suction profiles are based on conventional assumptions associated with London Clay (and similarly overconsolidated clays) at shallow depths. Note that the sample disturbance component is dependant on the method of sampling and any subsequent recompaction. The above plots show this to be 100kPa which is the value suggested by the BRE on the basis of their limited number of tests on recompacted samples. This may or may not be appropriate in this instance and judgement should be exercised.
