## SITE INVESTIGATION FACTUAL REPORT

Report No: SI-733377  
Client: Sedgwick International UK - Maidstone  
Site: 23 Shepherds Hill  
Client Ref: 8714923  
Date of Visit: 20/10/2023

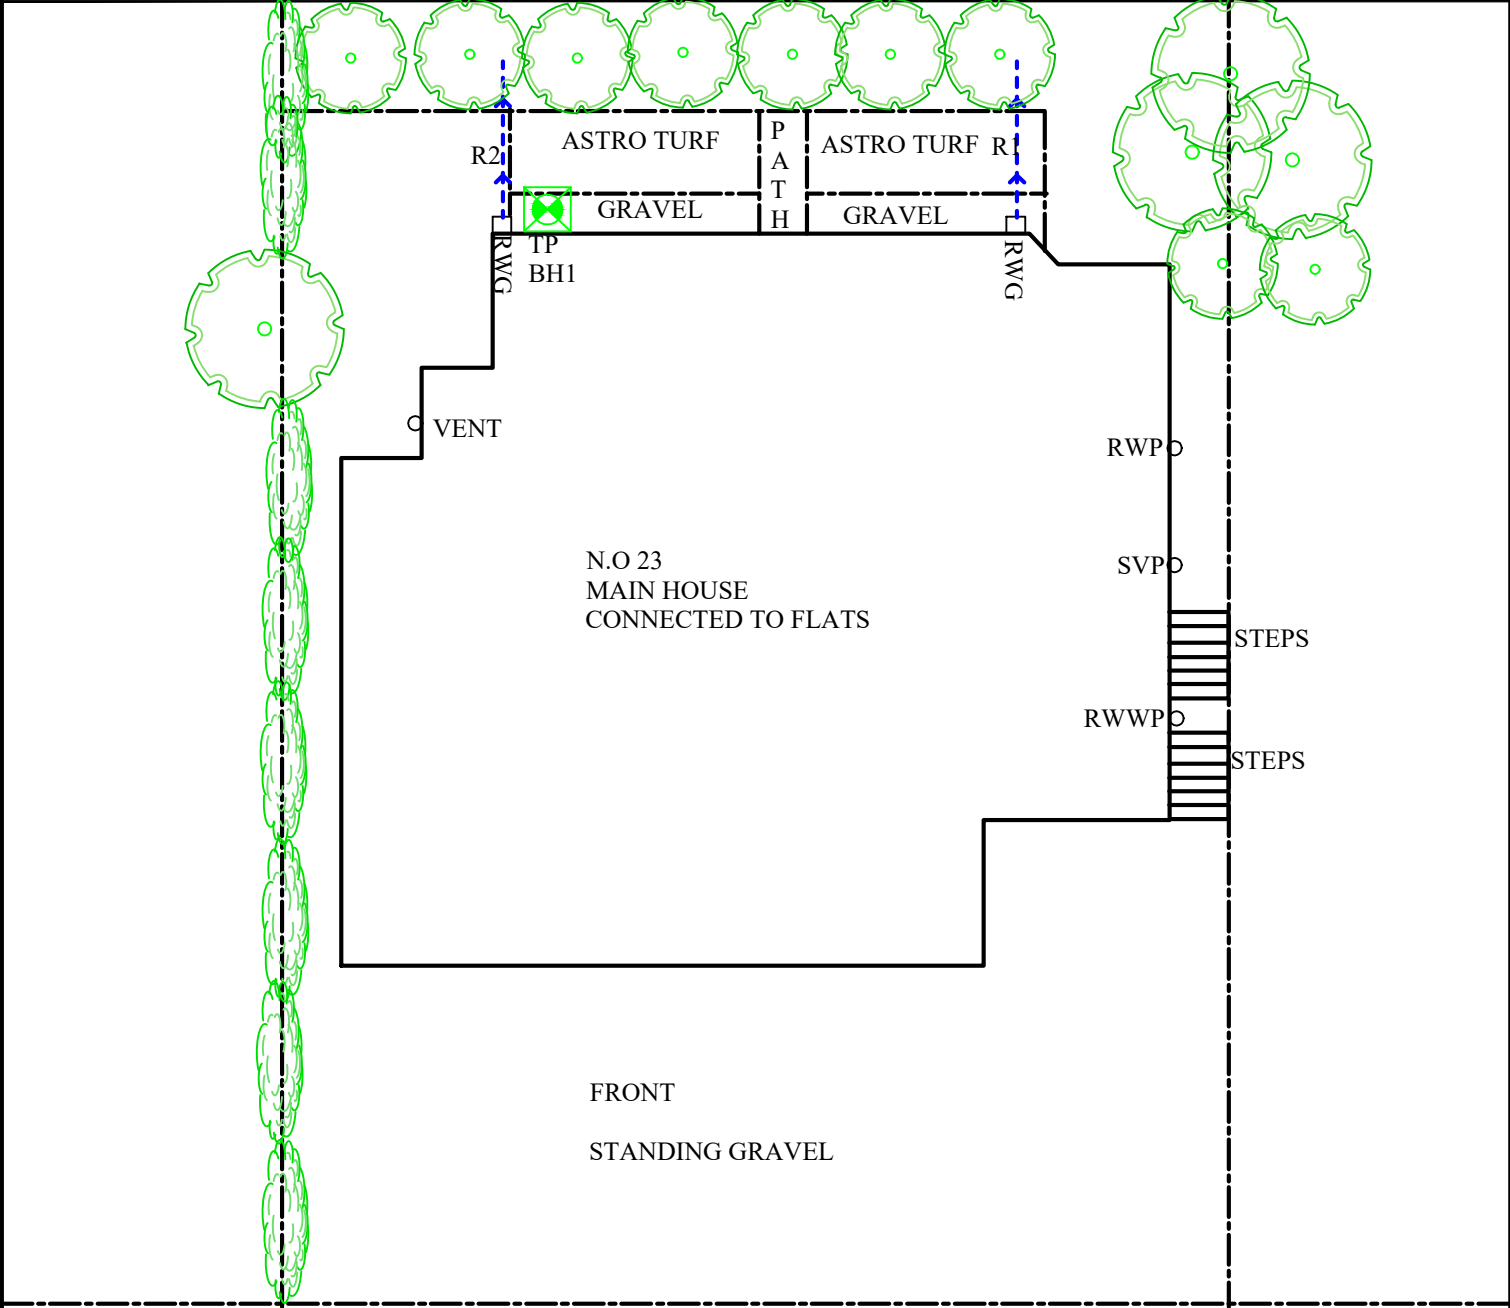
| <div>Investigation<br/>Layout Plan</div> | | Sheet: 1 of 1 | Site: 23 Shepherds Hill |

ON SITE TREE IDENTIFICATION FOR GUIDANCE ONLY. NOT AUTHENTICATED.

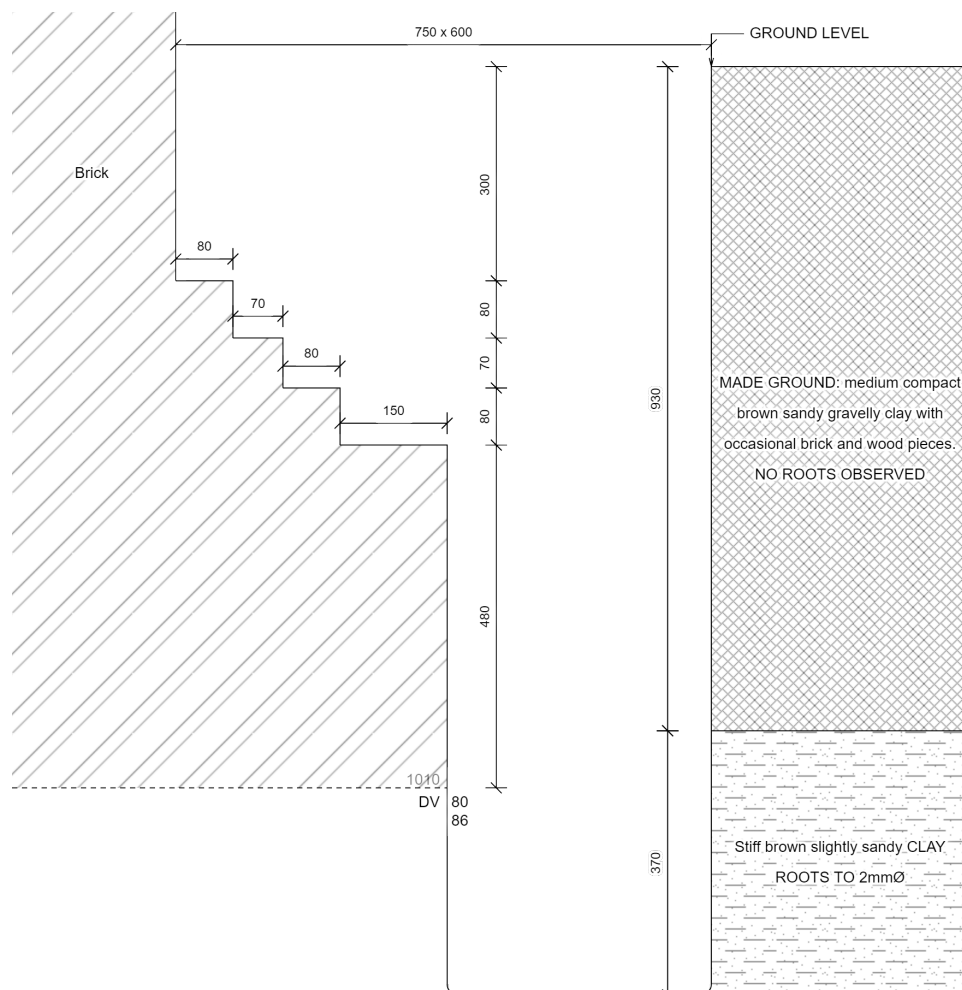
**TRIAL PIT REF:** TP1

For Strata below 1300mm see Bore Hole log
