23 Shepherds Hill  
LONDON  
N6 5QJ

**CONCERNING SUBSIDENCE DAMAGE**

**ENGINEERING APPRAISAL REPORT**

Our Ref: 8714923

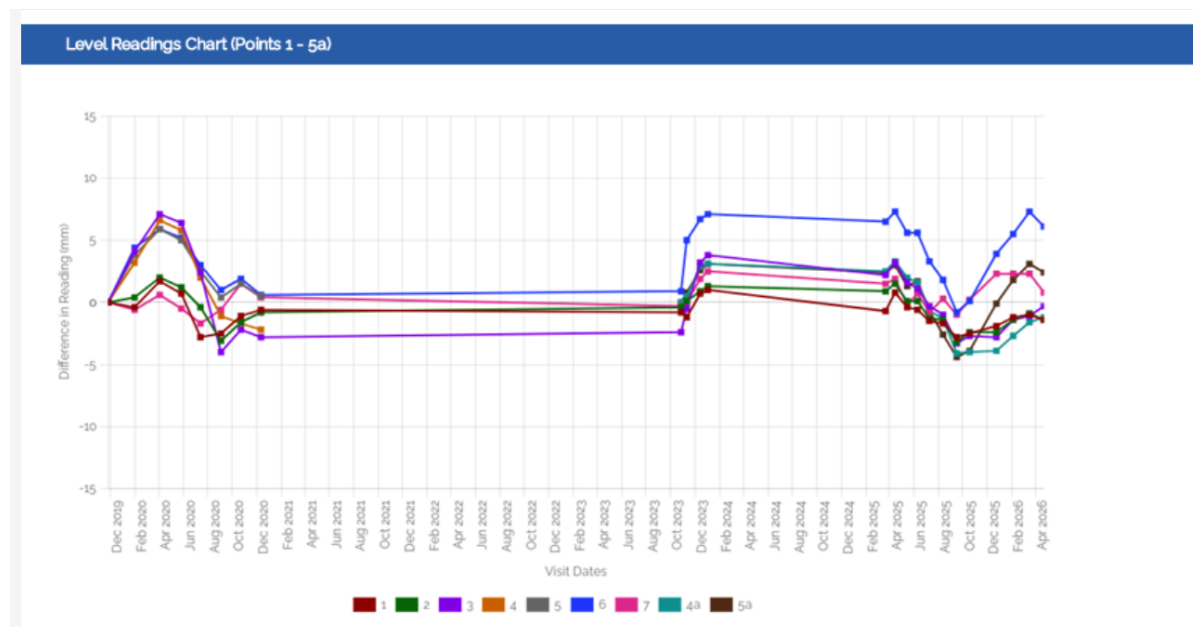
With the implicated vegetation remaining in-situ, the extended level monitoring exercise has shown a pattern of cyclical movement, with significant downwards movement noted during the summer months and recovery of the winter period.

Previous vegetation management works in the form of tree reduction works to the Sycamore trees have failed to provide long-term stability to the rear elevation of the risk address. As shown by the latest level monitoring exercise, we have confirmation the rear elevation of the risk address has been subject to continuous cyclical movement as a result of the implicated vegetation remaining in-situ.

It is recommended that the sycamore trees located in the rear garden of the risk address and neighbouring property No.25 and within proximity to the rear elevation are removed to mitigate against further movement.

The monitoring exercise will continue following the removal of the implicated vegetation to confirm stability prior to proceeding to final repairs. Sedgwick Mitigation Centre will liaise with the Local Authority in this regard.
