# 9 Muswell Hill

Conditions discharge site investigations

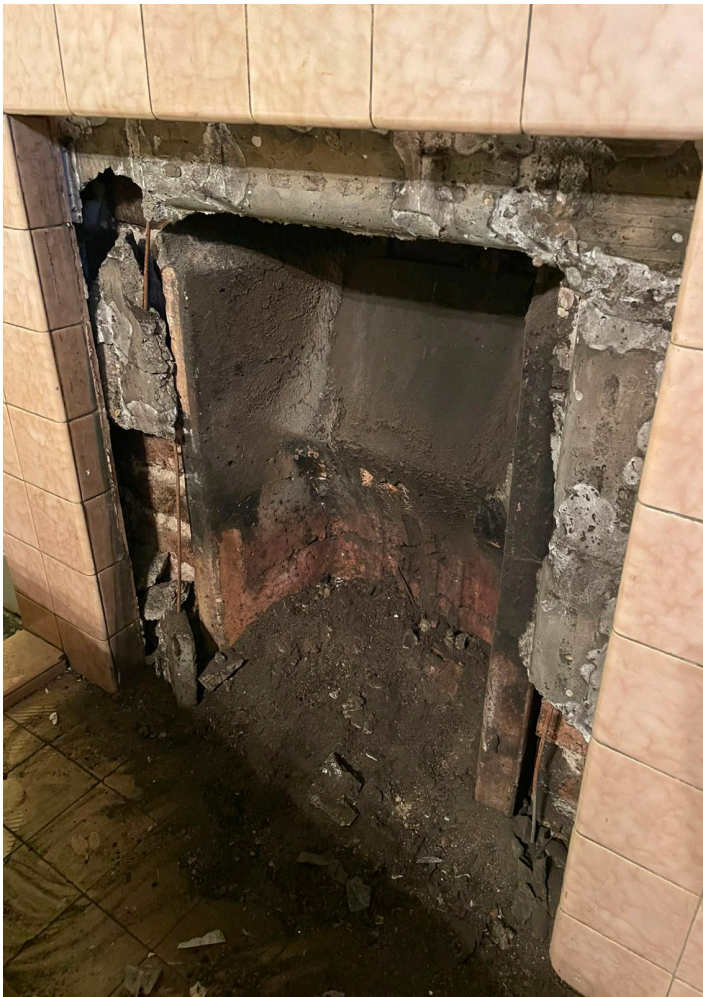
**Front bedroom fireplace**

- Brick visible behind modern concrete and tile surround.
- Remains of clay fire back when fireplace was in use inset into brickwork.

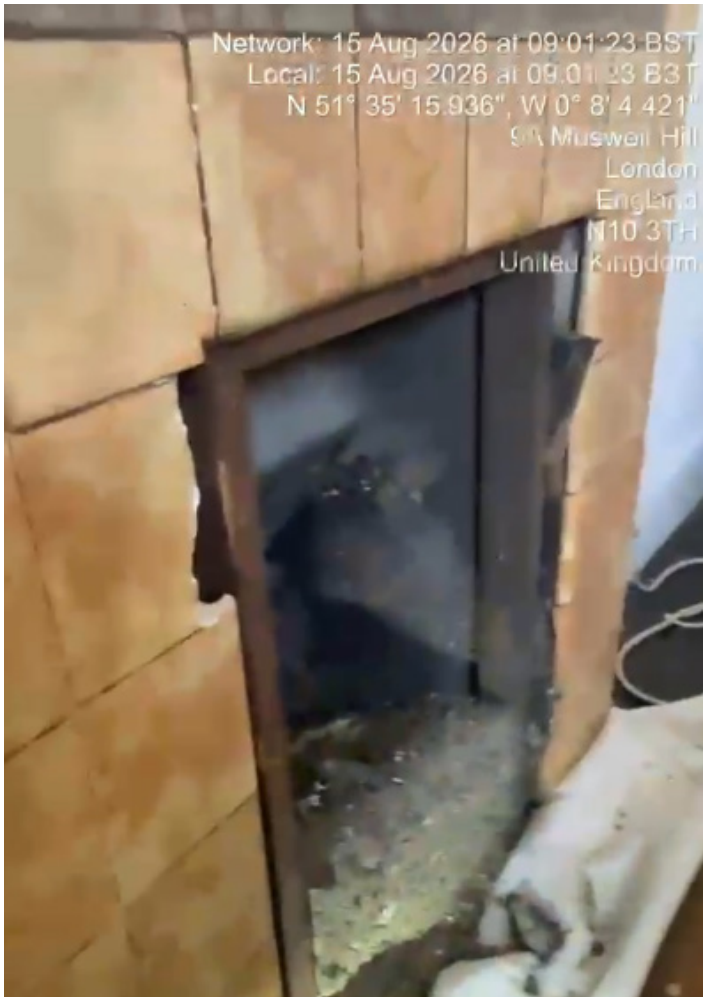
**Rear bedroom fireplace**

- Timber frame visible within opening to hold timber board in front.
- Remains of clay fire back when fireplace was in use inset into brickwork.

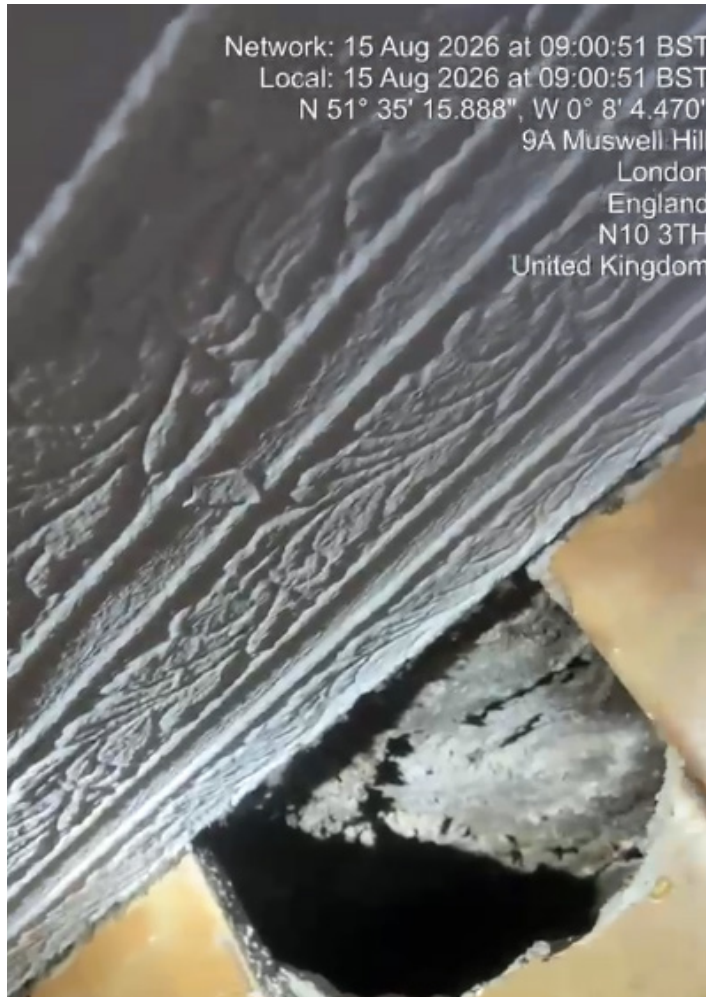
**Rear bedroom fireplace**

- Tile removed to side of fireplace showing brick behind

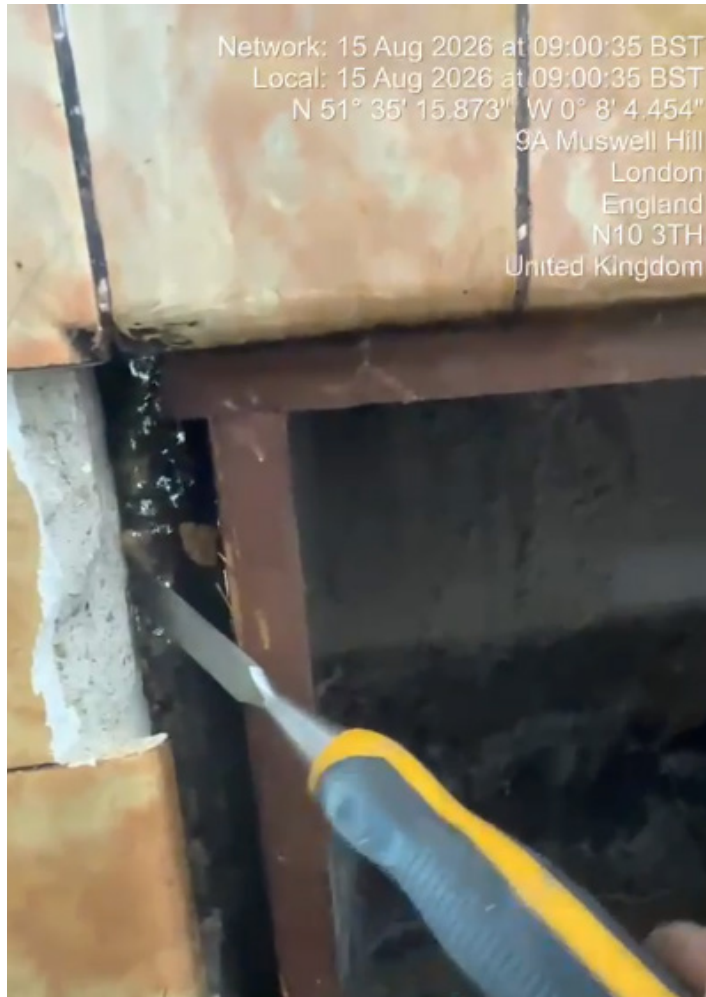
**Rear bedroom fireplace**

- Tile removed to inner side of fireplace showing brick behind.
- Modern concrete backing to tiles.

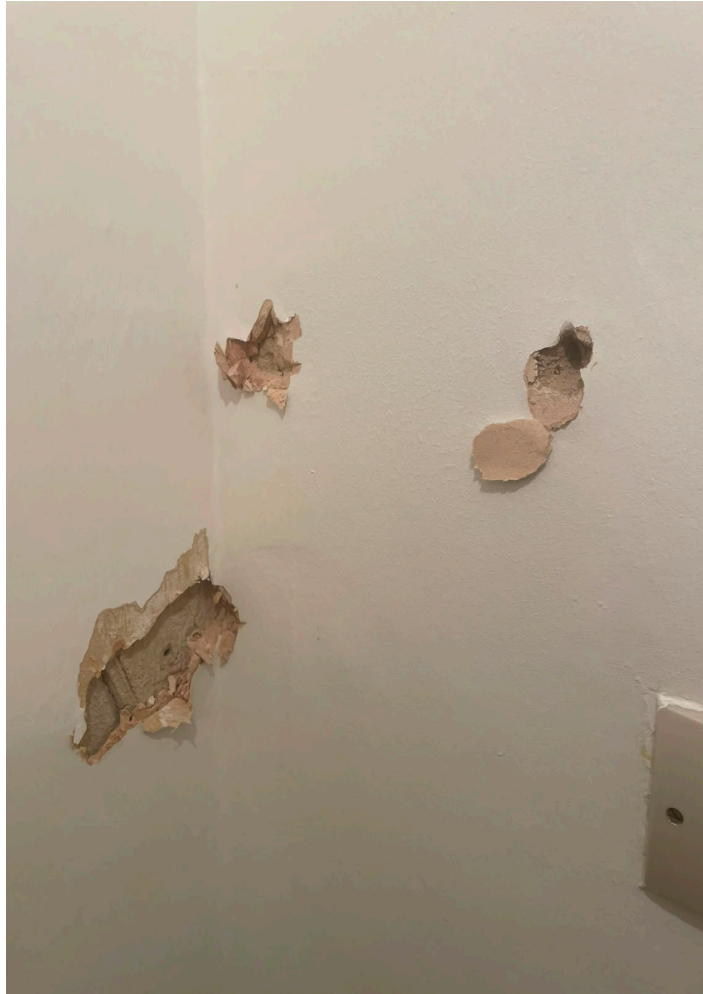
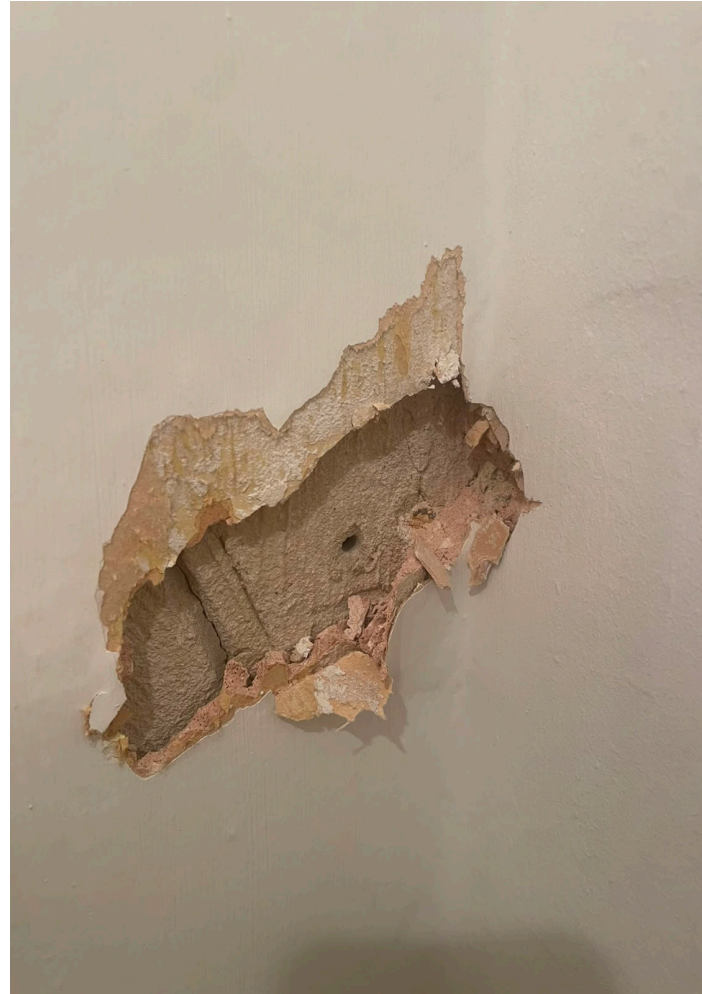
### WC walls

- Modern concrete blockwork construction of WC walls with gypsum plaster finish visible from opening up works.

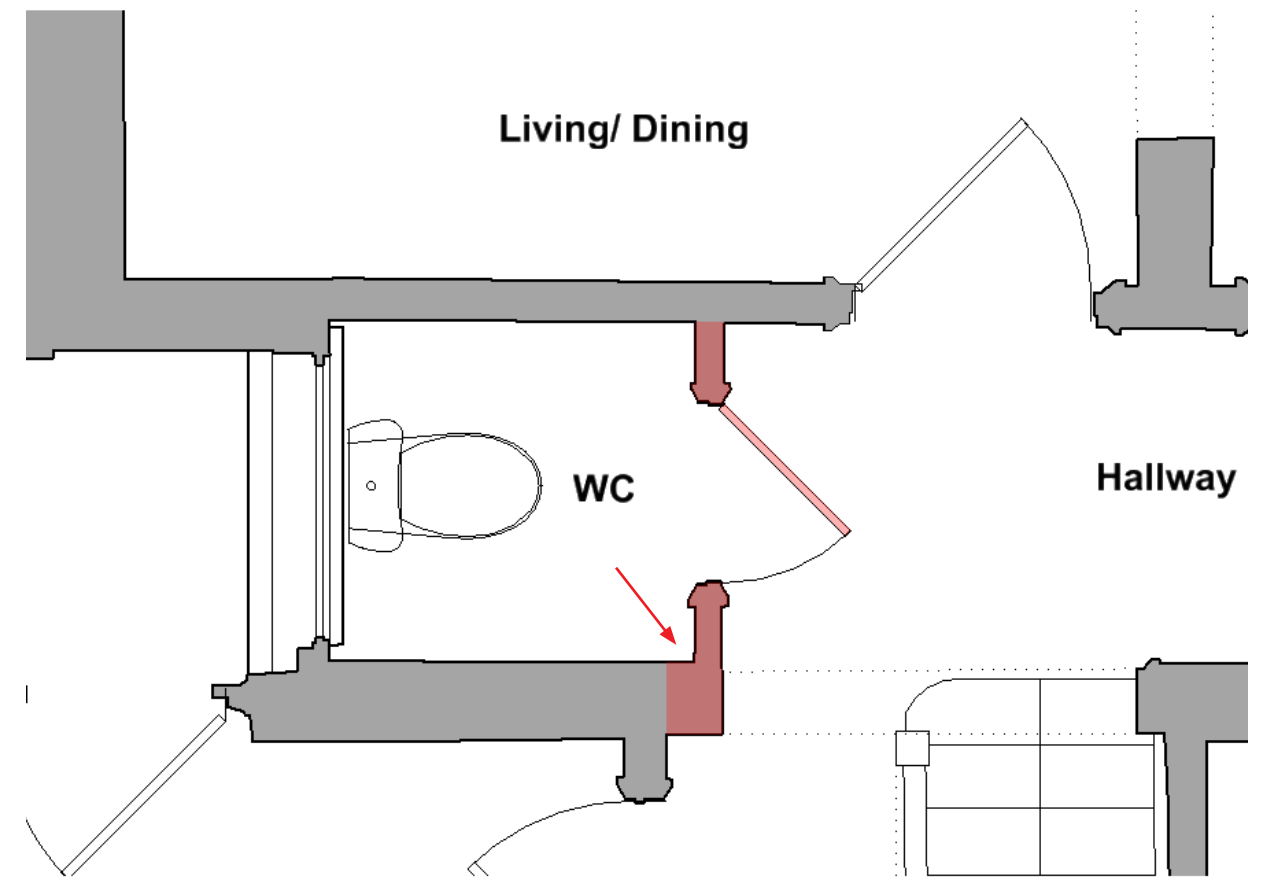
### WC plan

- Location of opening up works in modern wall shown with red arrow.
