## SITE INVESTIGATION FACTUAL REPORT

Report No: SI-330698  
Client: Crawford Claims Management  
Site: Flat 1, 94 Stapleton Hall Road  
Haringey  
Client Ref: SU2000002  
Date of Visit: 9/8/2021

# Investigation Layout Plan

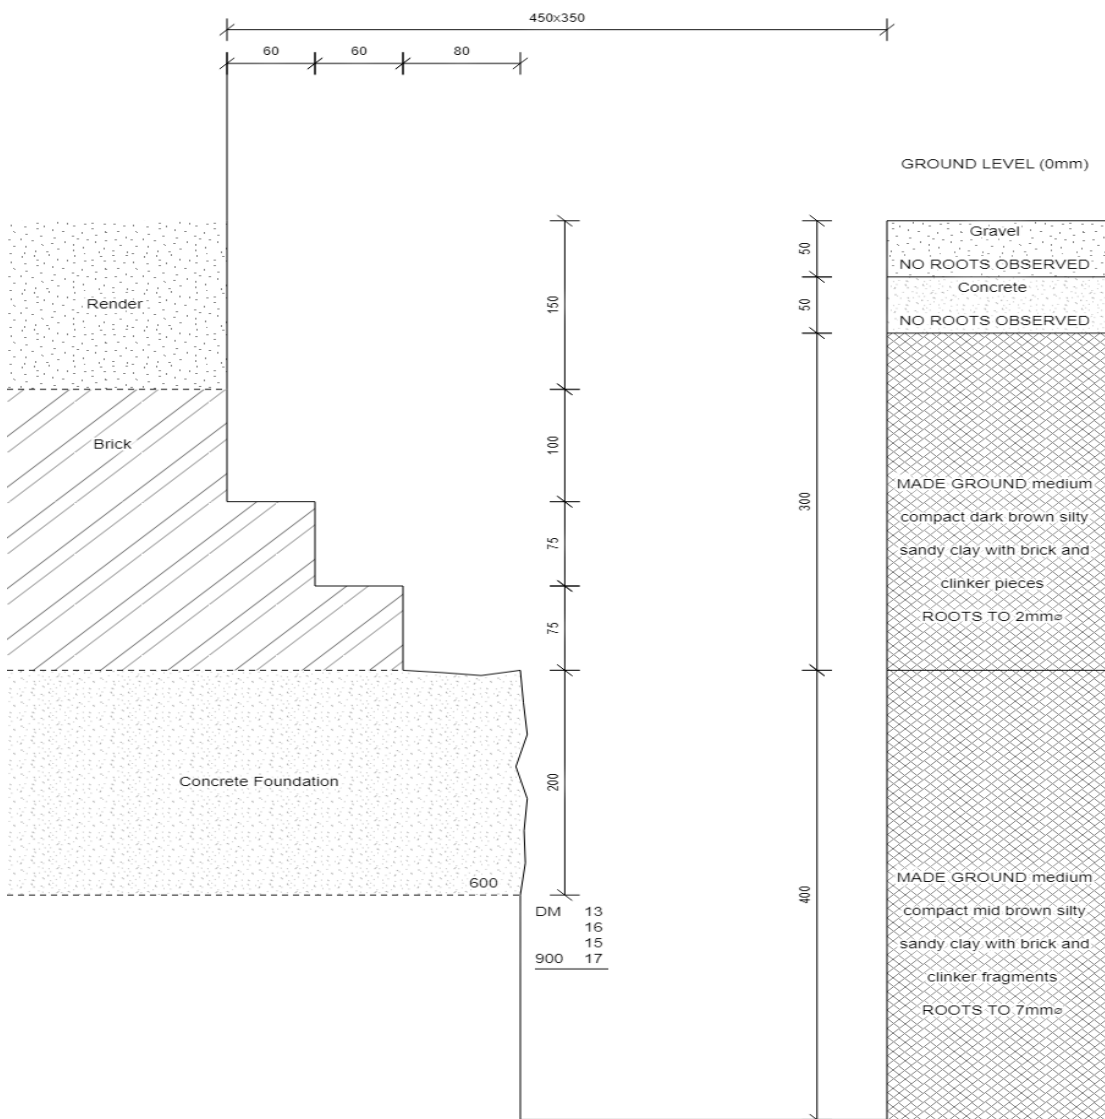
Trial Pit

For strata below 800mm see bore hole log
