## SITE INVESTIGATION FACTUAL REPORT

Report No: 007130

Client: Crawford Claims MGMT

Site Address: Flat 1, 94 Stapleton Hall Road, N4 4QA

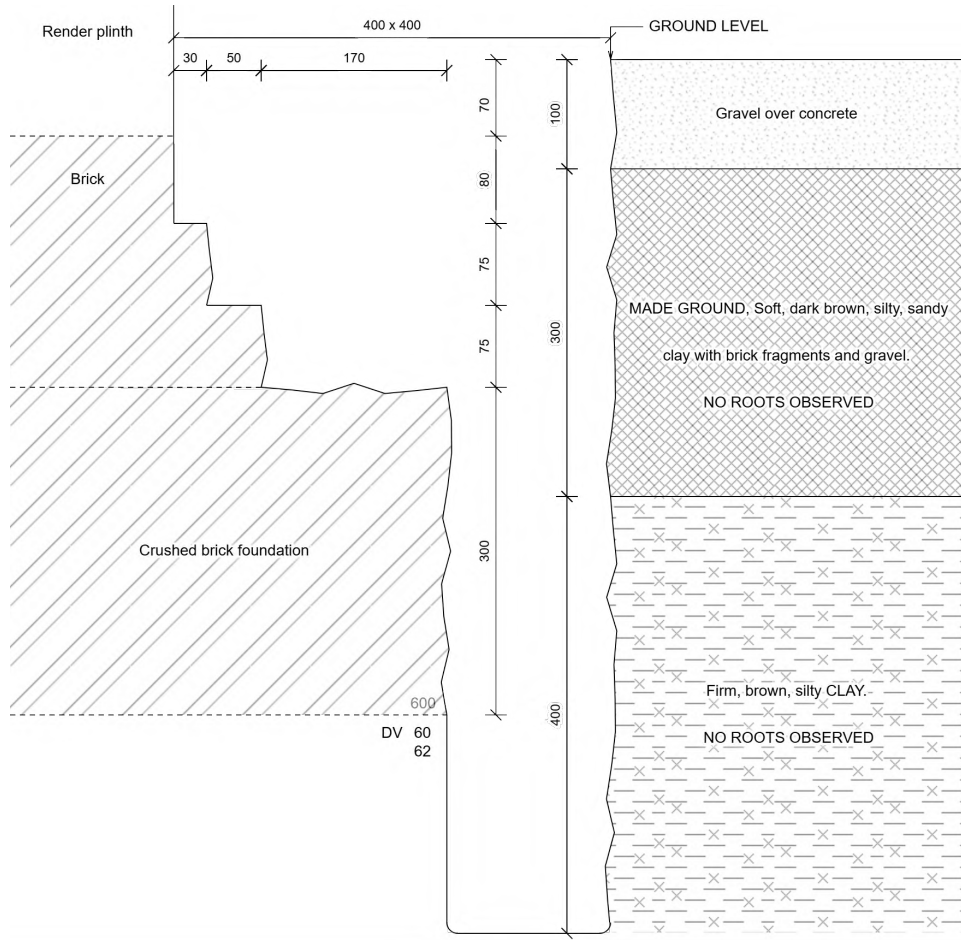
REPORT NUMBER: C5018341 / 391411.1.1.1  
TRIAL PIT REF: TP1 DATE: 02/02/2026  
CLIENT: Crawford & Co SITE: 94 STAPLETON HALL ROAD  
JOB NO: SI-007130 WEATHER: Dry  
EXCAVATION METHOD: Hand tools

For Strata below 800mm see Bore Hole log
