**TECHNICAL REPORT ON A SUBSIDENCE CLAIM**

**Crawford Reference: SU2000002**

**94 Stapleton Hall Road Ltd  
Flat 1, 94 Stapleton Hall Road  
London, N4 4QA**

**SUBSIDENCE CLAIM**

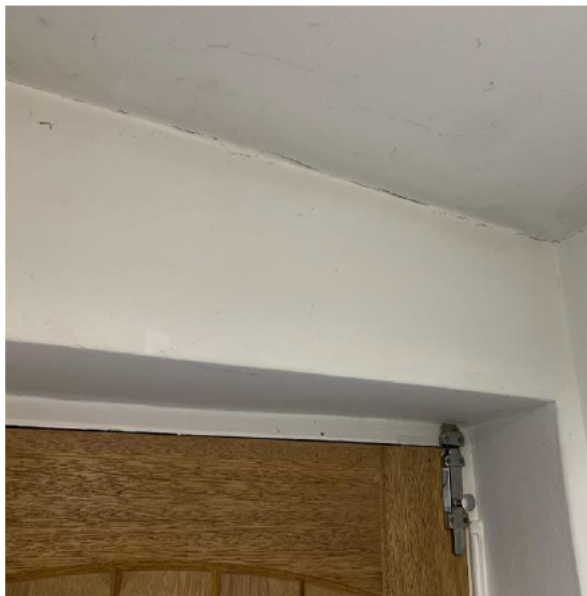
Hall - wall/ceiling cracking

Fine cracks between hall walls and ceiling (flank and kitchen internal wall).

Further investigation of the damage is beyond our brief which is to determine if the cause is due to subsidence or other events covered by the insurance policy. The damage is minor and can be addressed during the course of routine decoration.

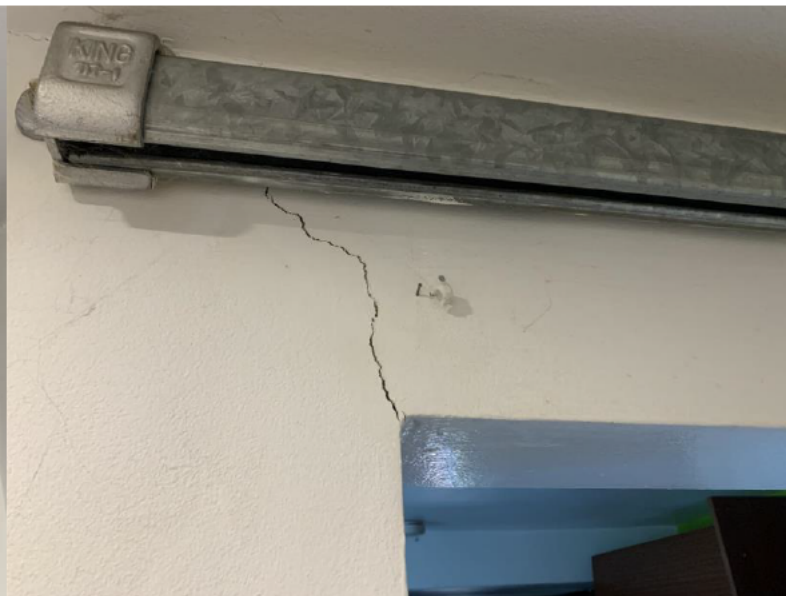
Hall - crack above kitchen door

Crack above door to kitchen (off hall)

In structural terms the damage falls into Category 1 of Table 1, Building Research Establishment<sup>6</sup> Digest 251, which describes it as "very slight".

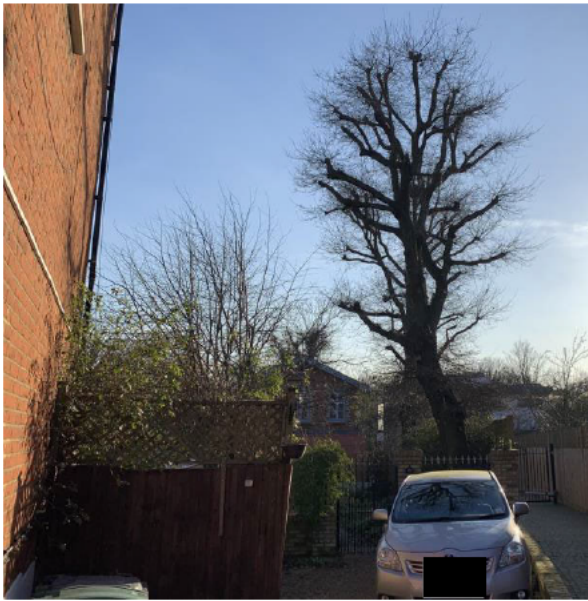
Pollarded tree in garden at rear

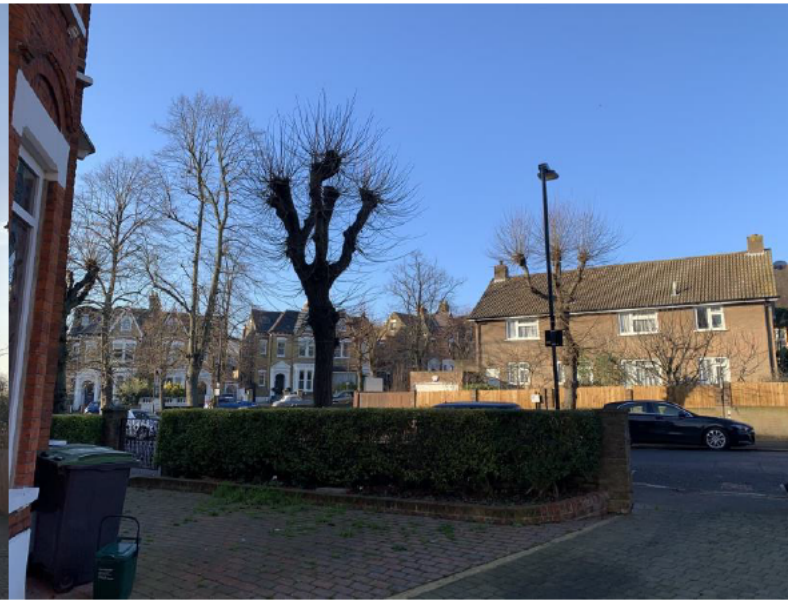
We do not consider this as subsidence per se. Subsidence in London Clay is normally caused by trees extracting moisture from beneath the footings in the summer months. In this instance, the Council street trees are regularly pollarded to restrict their moisture demand and the closest tree is 12m away and only 8m high. As such, it is outside the normal zone of influence. Likewise, leaking drainage rarely affects impermeable clays like the London Clay. There is a rainwater pipe close to the back door but the cyclical nature of the damage (albeit very slight) does not indicate this is a factor.

Pollarded Council Lime Tree

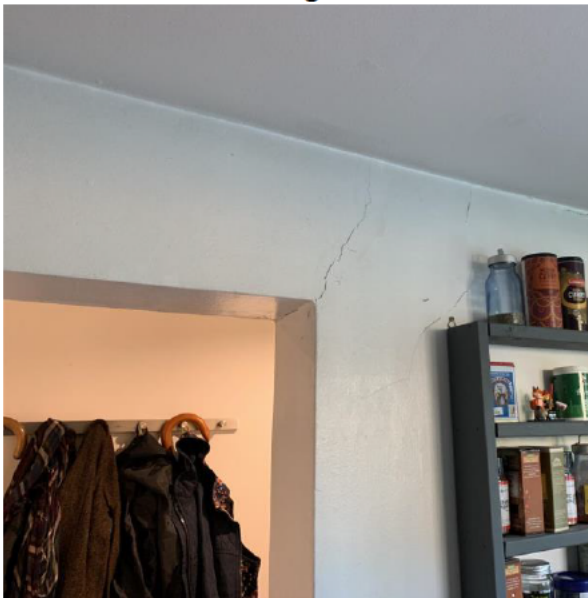
Crack above door to kitchen. This was hairline but worsened slightly in September 2019. A new crack also appeared adjacent to this, also very minor.

The pattern and nature of the damage is indicative of normal seasonal movements associated with shallow foundations on a clay subsoil, typical of much of the older housing stock in London built on the London Clay. There is possibly also an element of thermal movement given the westerly aspect of this elevation. Masonry expands and contracts with changes in temperature, so expansion will tend to cause cracks in the perpendicular wall (ie above the kitchen door).

Kitchen - two cracks above door to hall
